TESTING AND EVALUATION OF LARGE SIGNS SLIPBASE SUPPORT ON
SLOPE AT MASH TEST LEVEL 3 IMPACT CONDITIONS

A Thesis

Major Subject: Civil Engineering

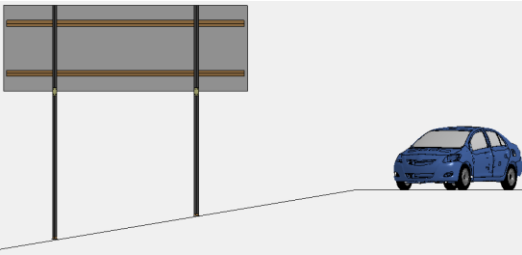
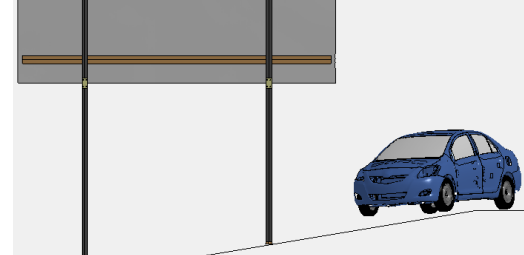
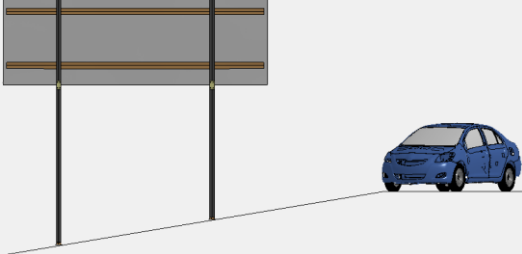
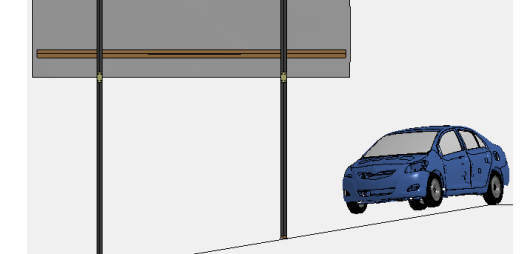
Table 38. Sequential Images of FE Simulations for Car at High Speed.

The hinge on the right support was activated at 0.62 s. By 0.66 s, the upper fuse and hinge plate connection on the left support leg was completely ruptured. After the complete rupture of connection plates of the left leg, the support began to move in the direction of the vehicle. At the same time, the sign panel started tilting towards the vehicle with the right leg still intact. Support and sign panel didn't come in contact with the vehicle. At 0.7 s the vehicle safely crossed the signpost assembly. By 0.7 s, the connection on the right support was completely ruptured. Table 38 shows the complete sequential photographs of the simulations.

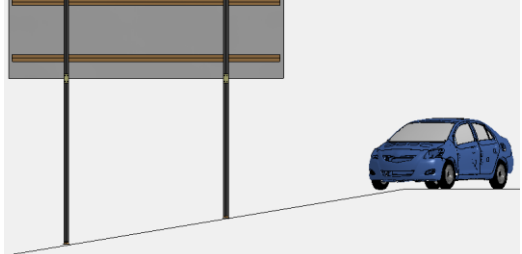
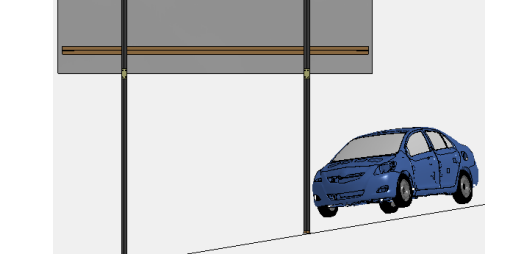
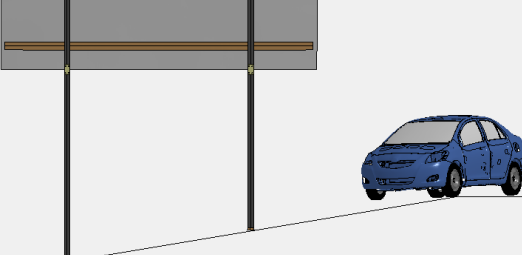
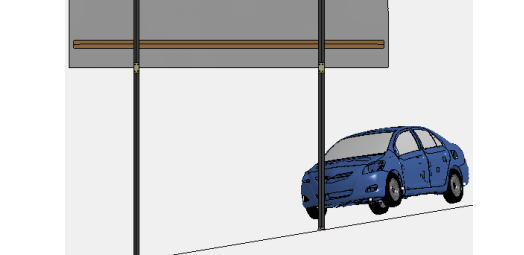
0.08 s	0.3 s

0.14 s	0.38 s

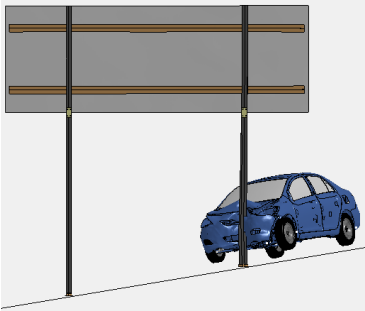
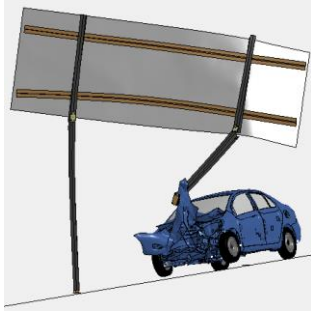
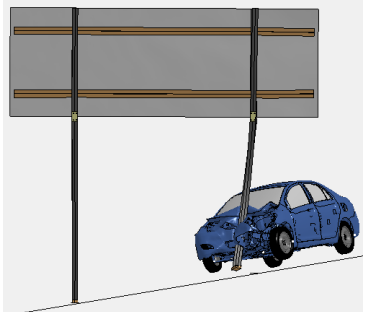
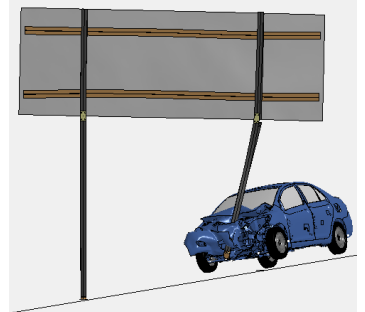
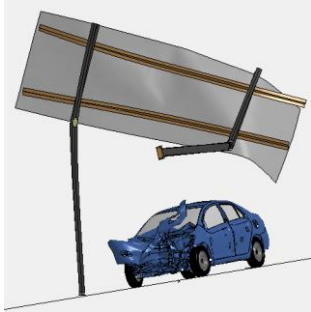
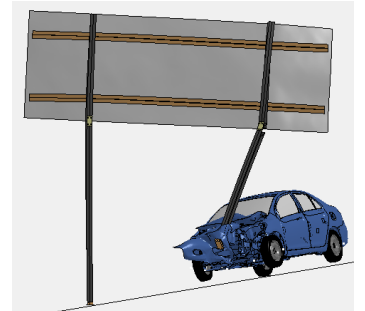
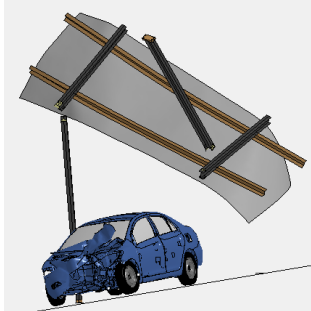
Table 38. Continued

0.46 s	0.56 s

0.48 s	0.58 s

0.5 s	0.62 s

0.52 s	0.75 s

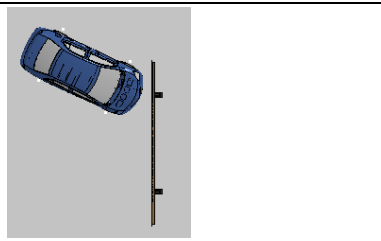
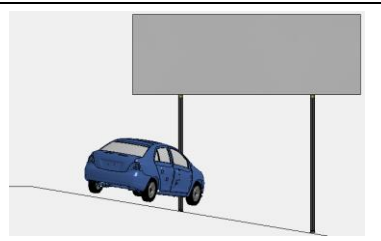
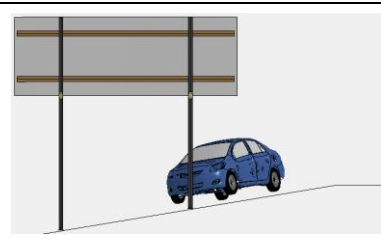
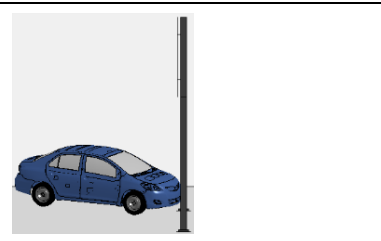
Figure 85. Summary of Finite Element Simulation for 1100C Vehicle at High Speed.

0.00 s	0.42 s	0.46 s	0.75 s

Top View	Front View	Back View	Side View		
<p>General Information Test Agency: Texas A&M Transportation Institute Test Standard: Sloped Terrain; Car (1100C); High Speed</p> <p>Test Article Type: Sign Support System Name: MASH TL-3 Sign Support System Material or Key Elements: Steel Soil Type: Concrete Pavement</p> <p>Test Vehicle Type/Designation: 1100C Make and Model: Finite Element Yaris Curb: 2420 lb. Dummy: No Dummy</p>		<p>Impact Conditions Speed: 62 mph Angle: 25 degrees Location/Orientation: Left Leg</p> <p>Occupant Risk Values Longitudinal OIV: 9.18 ft./s Lateral OIV: 1.96 ft/s Longitudinal Ridedown: 1.6 G Lateral Ridedown: 1.4 G</p> <p>Max. 0.050-s Average Longitudinal: -6.7 G Lateral: -1.4 G Vertical: -3.1 G</p>		<p>Post-Impact Trajectory Stopping Distance: N/A</p> <p>Vehicle Stability Maximum Roll Angle: 10.4 degrees Maximum Pitch Angle: 5.4 degrees Maximum Yaw Angle: -0.9 degrees</p> <p>Vehicle Roof Deformation: Yes Max Deformation: Nil</p>

Data from the accelerometer, located in the vehicle at the center of gravity was used to compute occupant risk factors based on MASH safety criteria. The TRAP program was used to digitize the values obtained from the finite element model. In the longitudinal direction, the occupant impact velocity was 9.18 ft/s at 0.65 seconds, the highest 10-ms occupant ridedown acceleration was 1.6 G from 0.6715 to 0.6815 seconds, and the maximum 50-ms average acceleration was -6.7 G between 0.4285 and 0.4796 seconds. In the lateral direction, the occupant impact velocity was 1.97 ft/s at 0.658 seconds, the highest 10-ms occupant ridedown acceleration was 1.4 G from 0.695 to 0.705 seconds, and the maximum 50-ms average was -1.4 G between 0.4185 and 0.4685 seconds. The maximum roll, pitch, and yaw angles were 10.4, 5.4, and -0.9 degrees respectively (See Figure 84). Figure 85 summarizes the above data and other important information from the test.

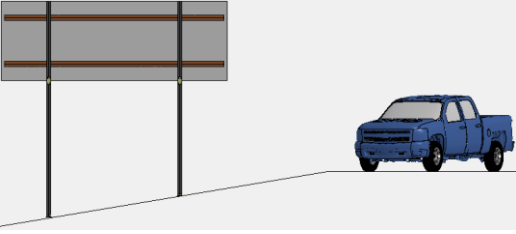
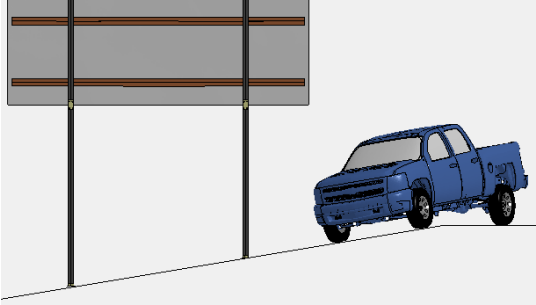
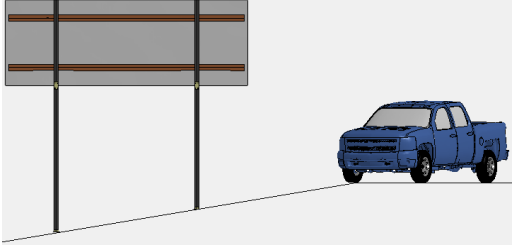
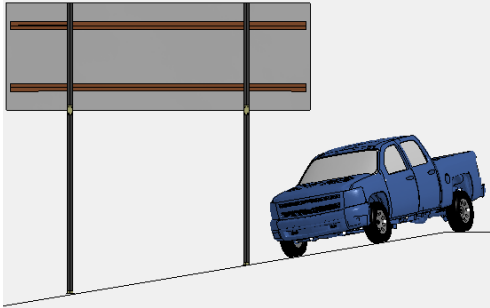
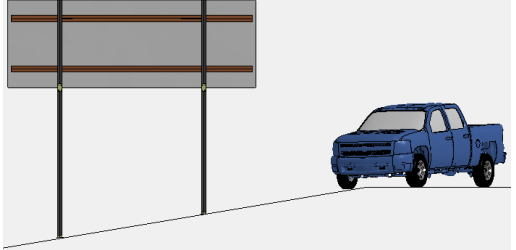
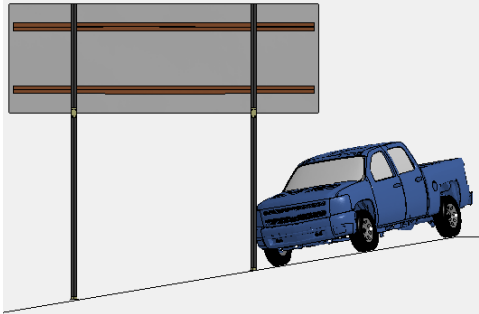
Table 39. Sequential Images of FE Simulations for Pickup Truck at Low Speed.

By 1.7 s, the upper fuse and hinge plate connection on the left support leg was completely ruptured. After the complete rupture of connection plates of the left leg, the support began to move in the direction of the vehicle. At the same time, the sign panel started tilting toward the vehicle with the right leg still intact. Support and sign panel didn't come in contact with the vehicle. At 2.15 s the vehicle safely crossed the signpost assembly. Table 39 shows the complete sequential photographs of the simulations.

0 s	0.8 s

0.3 s	1 s

0.4 s	1.1 s

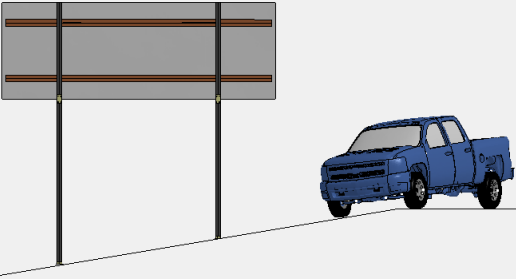
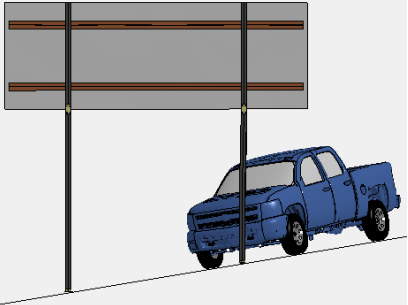
0.6 s	1.35 s

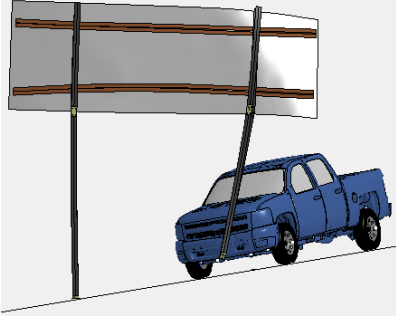
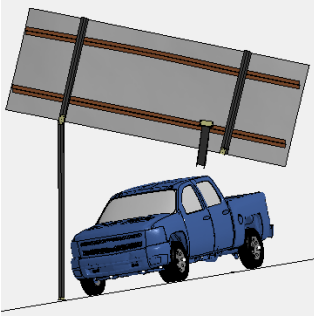
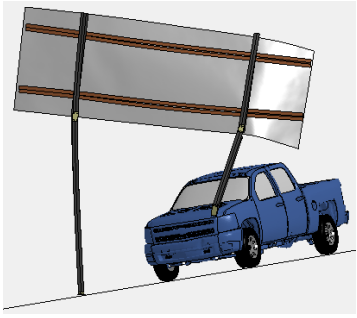
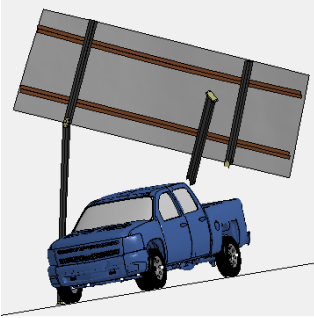
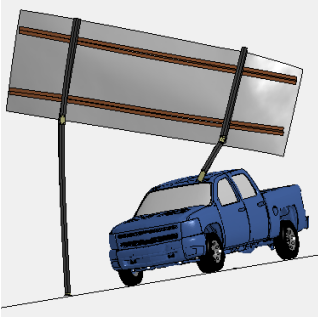
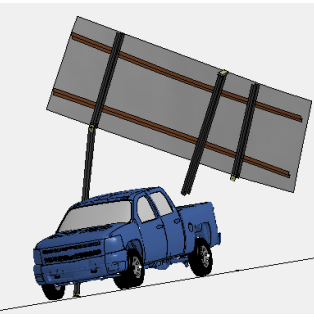
Table 39. Continued

1.45 s	1.85 s

1.6 s	1.95 s

1.7 s	2.1 s

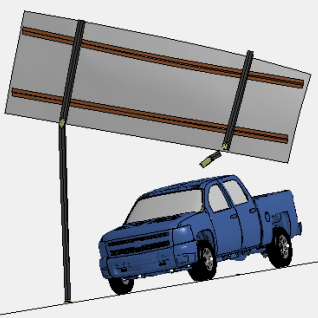
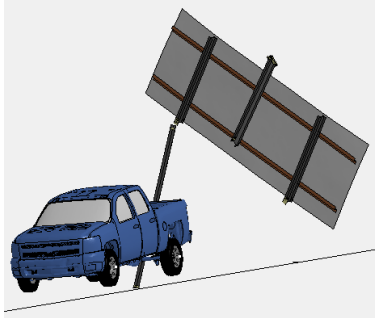
1.75 s	2.5 s

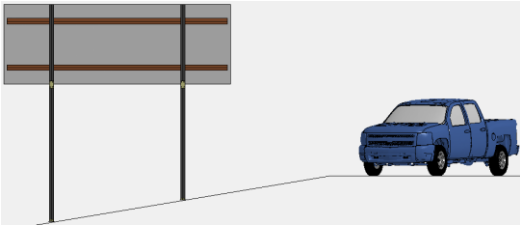
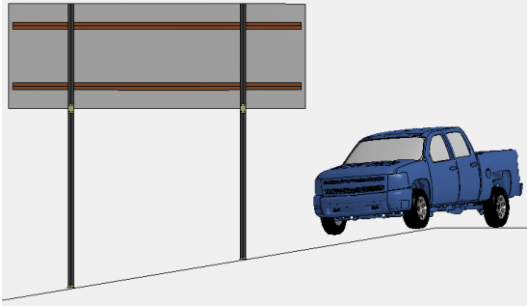
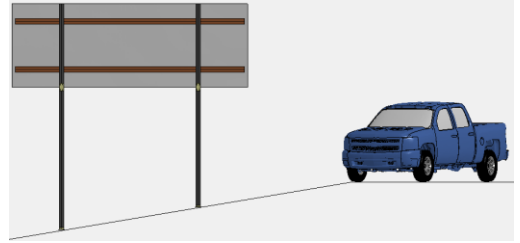
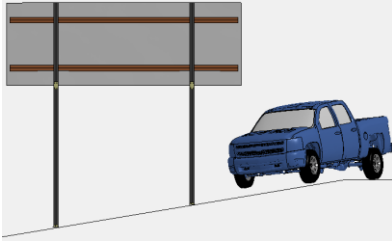
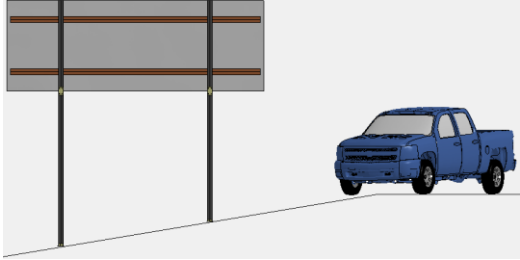
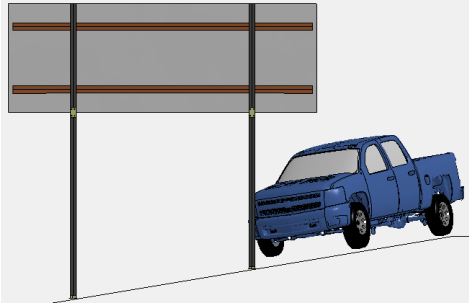
Table 40. Sequential Images of FE Simulation for Pickup Truck at High Speed.

By 0.64 s, the upper fuse and hinge plate connection on the left support leg was completely ruptured. After the complete rupture of connection plates of the left leg, the support began to move in the direction of the vehicle. At the same time, the sign panel started tilting toward the vehicle with the right leg still intact. Support and sign panel didn't come in contact with the vehicle. At 0.72 s the vehicle safely crossed the signpost assembly. Table 40 shows the complete sequential photographs of the simulations.

<p>0 s</p>	<p>0.26 s</p>

<p>0.08 s</p>	<p>0.3 s</p>

<p>0.14 s</p>	<p>0.38 s</p>

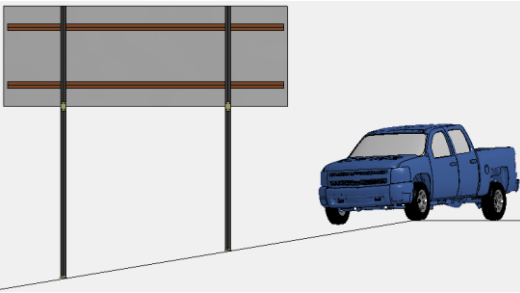
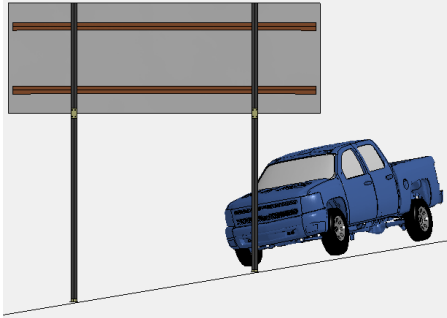
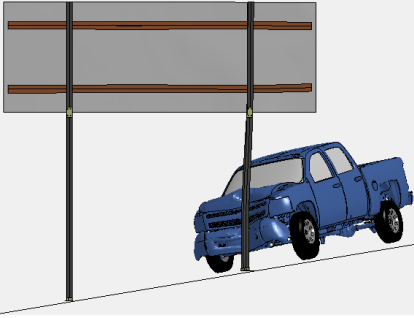
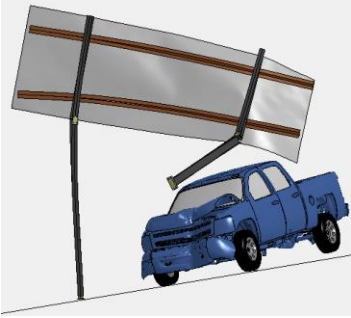
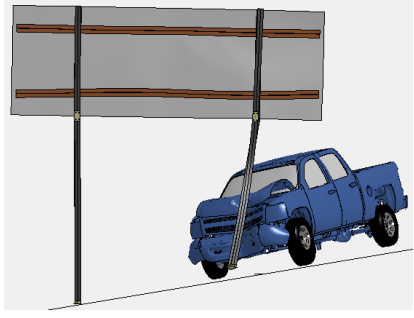
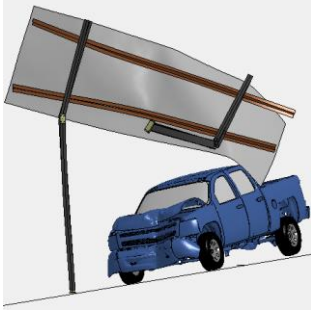
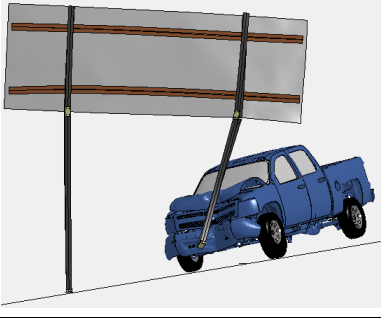
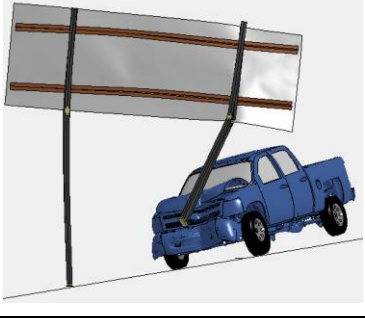
Table 41. Continued

<p>0.22 s</p>	<p>0.42 s</p>

0.46 s	0.56 s

0.48 s	0.6 s

0.5 s	0.68 s

0.52 s	0.74 s
