POST-CRASH FIRE FORENSIC ANALYSIS OF AEROSPACE COMPOSITES

A Thesis

Major Subject: Mechanical Engineering

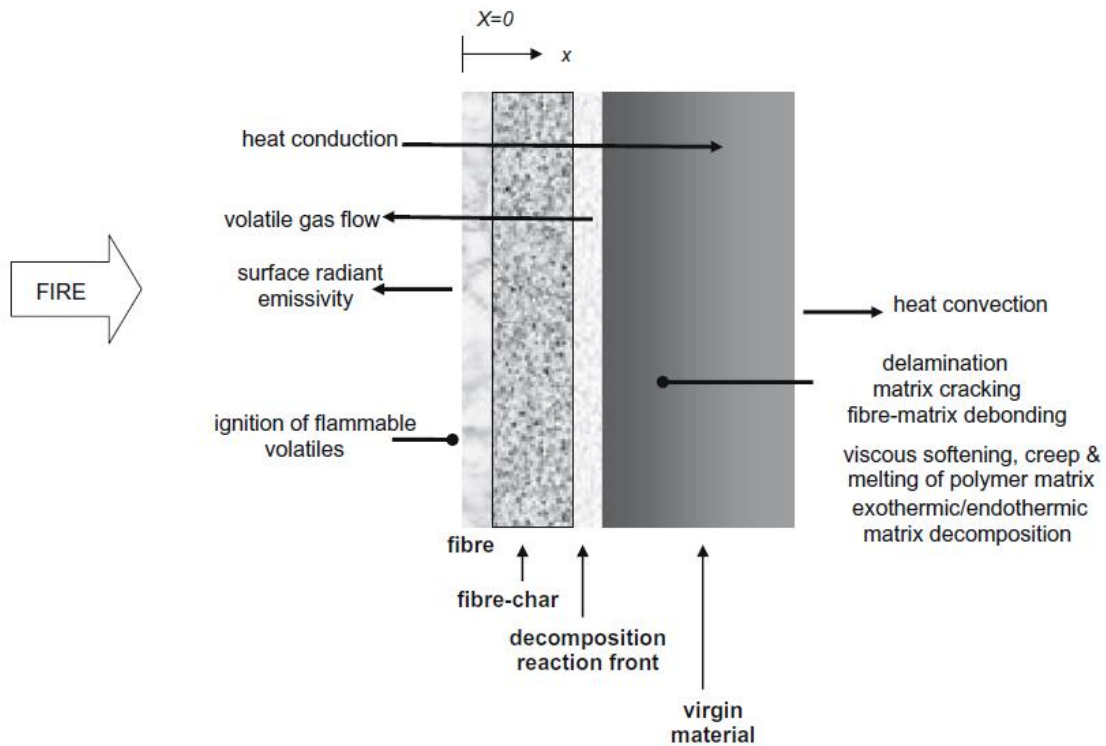
Figure 1.1 Schematic of the reaction processes in the through-thickness direction of a hot, decomposing polymer composite during fire exposure (Reprinted with permission from [10]).

thermal, and failure processes [10]. The physical processes include constituent material expansion and contraction, ply-delamination, matrix cracking, and the formation of high-pressure regions due to matrix outgassing. The chemical processes involve the phase changes that occur inside the composite material, including the softening, melting, and decomposition of the matrix, as well as char formation and growth. The thermal processes involve the evolving temperature distributions, heat transfer through the material due to conduction, convection of the gases formed during the decomposition, and pyrolysis of the polymeric matrix and organic fibers. Lastly, the failure processes involve the permanent degradation of the mechanical properties of the composites and failure of the load-carrying capability of the composite structures due to fire [3, 10]. Figure 1.1 (reprinted with permission from [10]) shows a schematic of the reaction processes in the through-thickness direction of a hot, decomposing polymer composite during fire exposure.

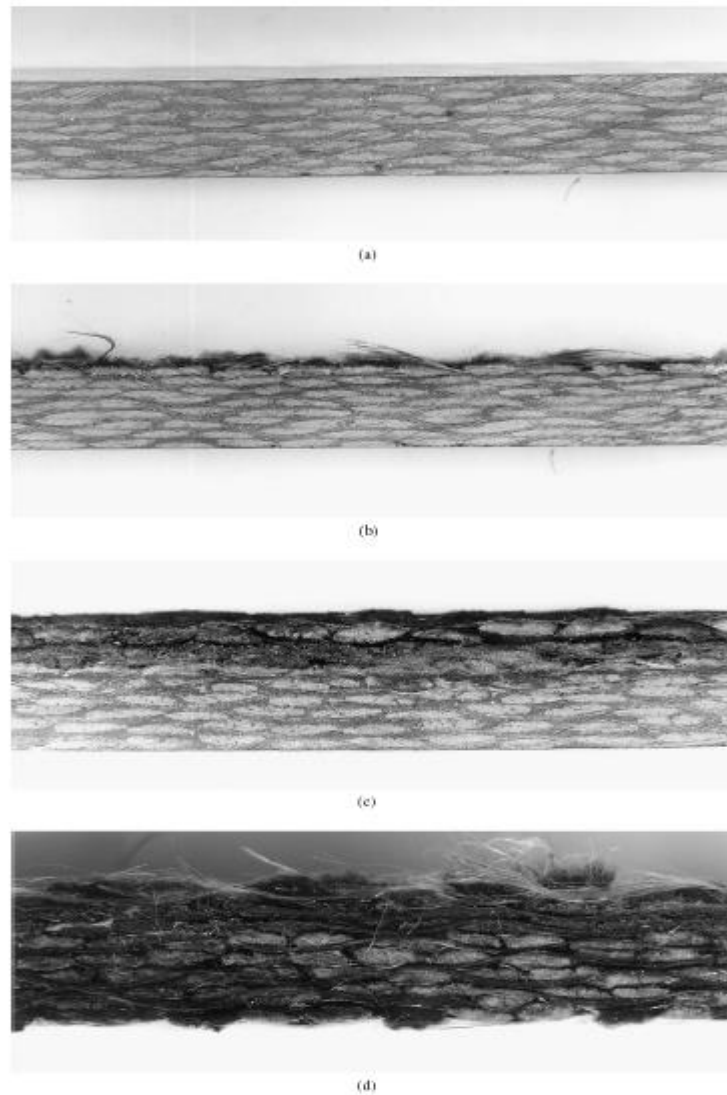
Figure 1.2 Photographs of a woven E-glass/polyester composite cross-section after being exposed to a heat flux of 50 kW/m^2 for (a) 0, (b) 85, (c) 325, and (d) 1800 s, respectively. The composite was 11.5 mm thick and did not have a thermal barrier coating. The upper surface was exposed to the heat source (Reprinted with permission from [8]).

burning [3]. Mouritz and Mathys [8] used cone calorimetry to investigate the effect of through-thickness heat flux and fire exposure duration on the char formation in an 11.5 mm thick E-glass woven roving fabric and an isophthalic polyester composite laminate. Figure 1.2 (reprinted with permission from [8]) shows the cross-section of the woven composite after being exposed to an upper surface heat flux of 50 kW/m^2 for four different time periods: (a) 0, (b) 85, (c) 325, and (d) 1800 s. As shown in the figure, the char layer thickness increased with the increase in heat flux exposure duration. Moreover, the char developed through the entire 11.5 mm specimen thickness (Figure 1.2d) due to the total thermal decomposition and combustion of the polyester matrix.

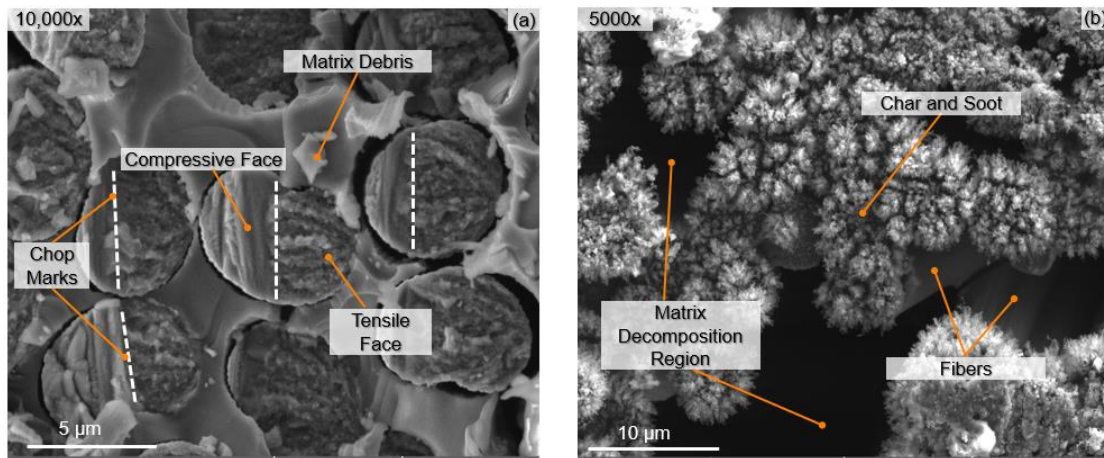
Figure 1.4 SEM images of a 21-ply cross-ply Cytec Cycom 5215 T40-800 graphite-epoxy specimen failed in compression; (a) before and (b) after 36 s vertical burning (WD = 9 mm).

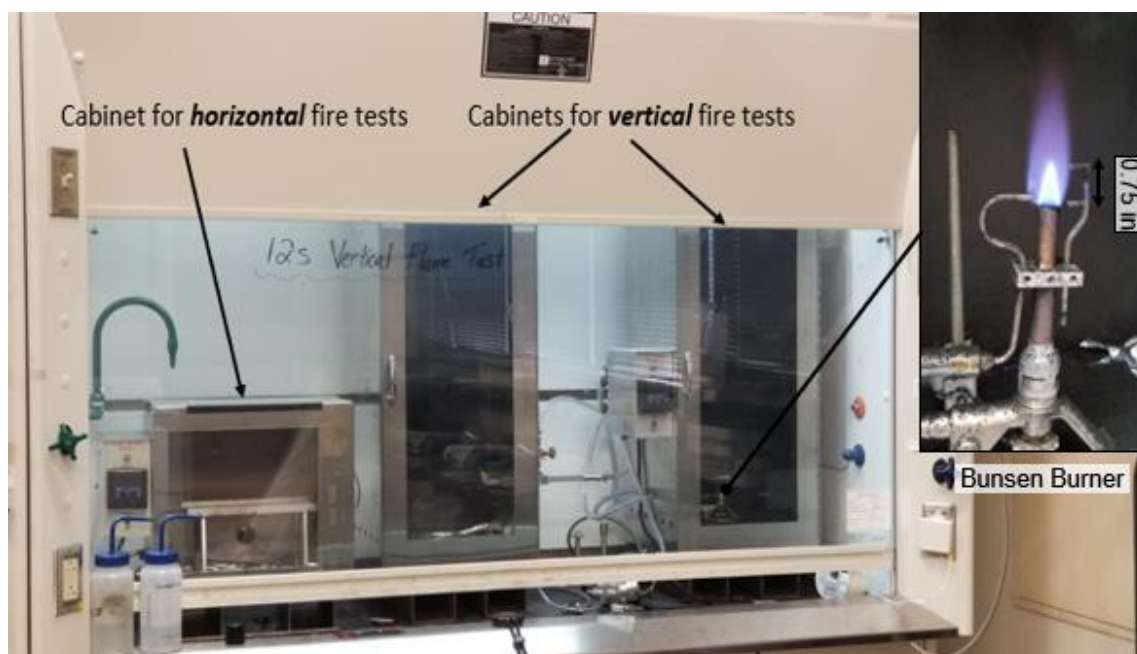
Figure 3.1 Draft-free cabinets that meet the FAA fire testing requirements.

The FAA has defined vertical and horizontal Bunsen burner test protocols [19] to address fire tests specified in the Federal Aviation Regulation (FAR) 25.853 and FAR 25.855. These protocols are used to verify the fire resistance of aircraft cabin and cargo compartment materials. Draft-free cabinets that meet the FAA fire test requirements were used to conduct vertical and horizontal Bunsen burner tests in accordance with the FAR 25.853 (Figure 3.1).

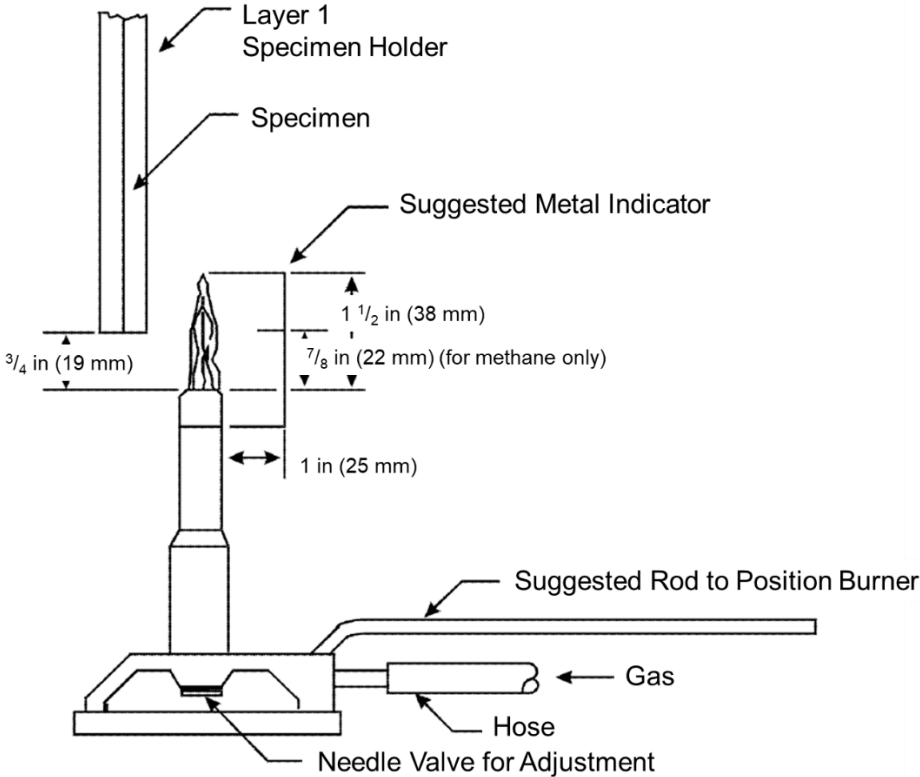
Figure 3.2 Burner plumbing and burner flame height indicator (Reprinted from [19]).

Figure 3.2 (reprinted from [19]) shows a schematic of the burner plumbing and burner flame height indicator used for both the horizontal and vertical burning test configurations. Following the FAA recommendations, all burning tests were

performed using methane fuel and an optimal flame profile consisting of an inner cone height of $\frac{7}{8}$ in and flame tip height of 1.5 in (Figure 3.2). During the burning tests, the fractured specimen ends were completely immersed in the flame with a standoff distance of $\frac{3}{4}$ in from the edge of the burner. Consistent with the FAA Bunsen burner protocol, this standoff distance puts the fractured surface of the specimen at the top of the inner (blue) cone of the flame [19]. Figures 3.3a, b (adapted from [19]) show schematics of specimen positioning with respect to the flame for (a) vertical fire tests and (b) horizontal fire tests.

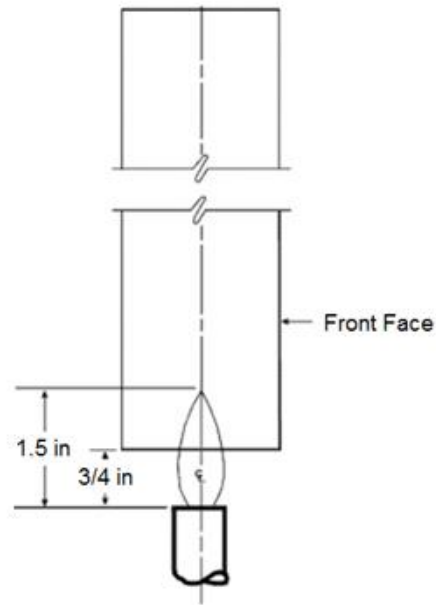
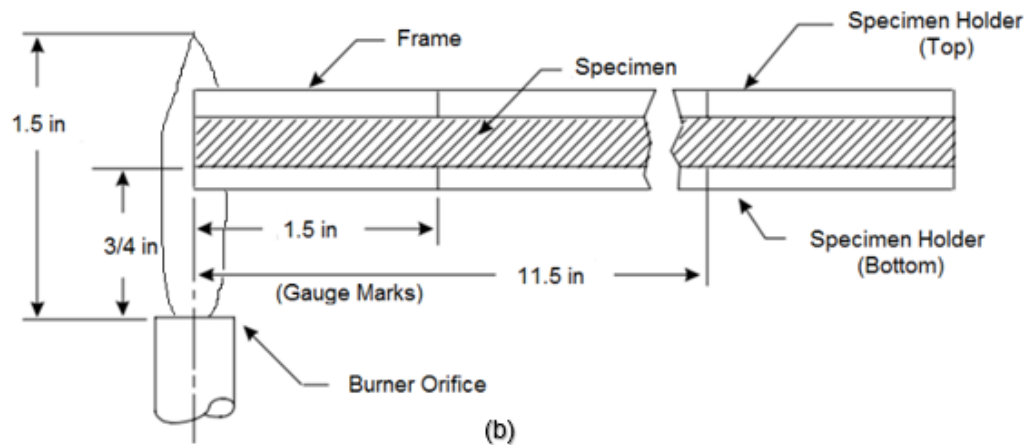
Figure 3.3 Schematic of specimen positioning with respect to the flame (a) for vertical fire tests and (b) horizontal fire tests (Adapted from [19]).

In the vertical fire test configuration, the specimens were held upside down into the flame (Figure 3.3a). In the horizontal fire test configuration, only the fractured edge of the bottom planar surface of the specimen was immersed into the flame (Figure 3.3b). The difference in fire damage extent and severity between UNC0

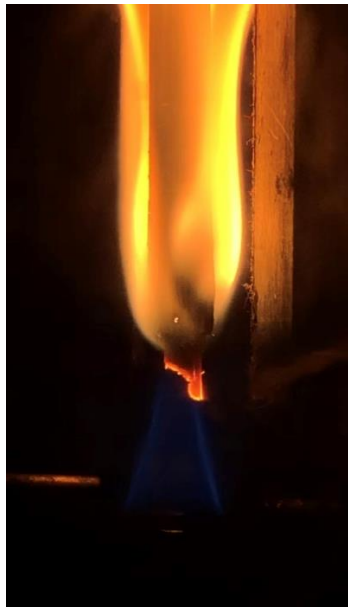
Figure 3.4 Picture of a 21-ply cross-ply Cytec Cycom 5215 T40-800 graphite-epoxy UNC0 specimen during vertical burning test using a Bunsen burner.

60 s. These times were based on low exposure (12 s) and high exposure (60 s) durations specified in the FAA Bunsen burner test protocols [19]. An intermediate test duration (36 s) was added to get a center point. To ensure the reproducibility of the results, a minimum of three replicates was used for all burning tests. Figure 3.4 shows a 21-ply cross-ply Cytec Cycom 5215 T40-800 graphite-epoxy UNC0 specimen during a vertical test using a Bunsen burner.

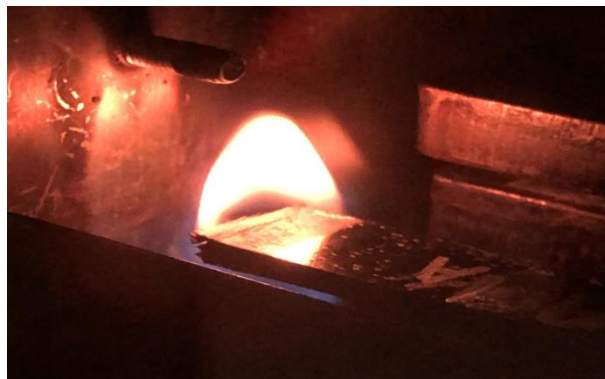
Figure 3.5 Picture of a 21-ply cross-ply Cytec Cycom 5215 T40-800 graphite-epoxy UNC0 specimen during horizontal burning test using a Bunsen burner.

The FAA fire testing protocol [19] for horizontally-oriented specimens requires only one exposure time (typically 15 s). In this work, horizontal fire testing was performed on mechanically-failed graphite-epoxy UNC0, SBS, and IPS specimens for durations of 15, 45, and 75 s. These durations allowed an increment in fire exposure times similar to the vertical burning tests. For both vertical and horizontal tests, the intermediate and long exposure times were three and five times longer than the low exposure time defined by the FAA. Again, to ensure the reproducibility of the results, a minimum of three replicates was used for all horizontal burning tests. Figure 3.5 shows a 21-ply cross-ply Cytec Cycom 5215 T40-800 graphite-epoxy UNC0 specimen during a horizontal test using a Bunsen burner.

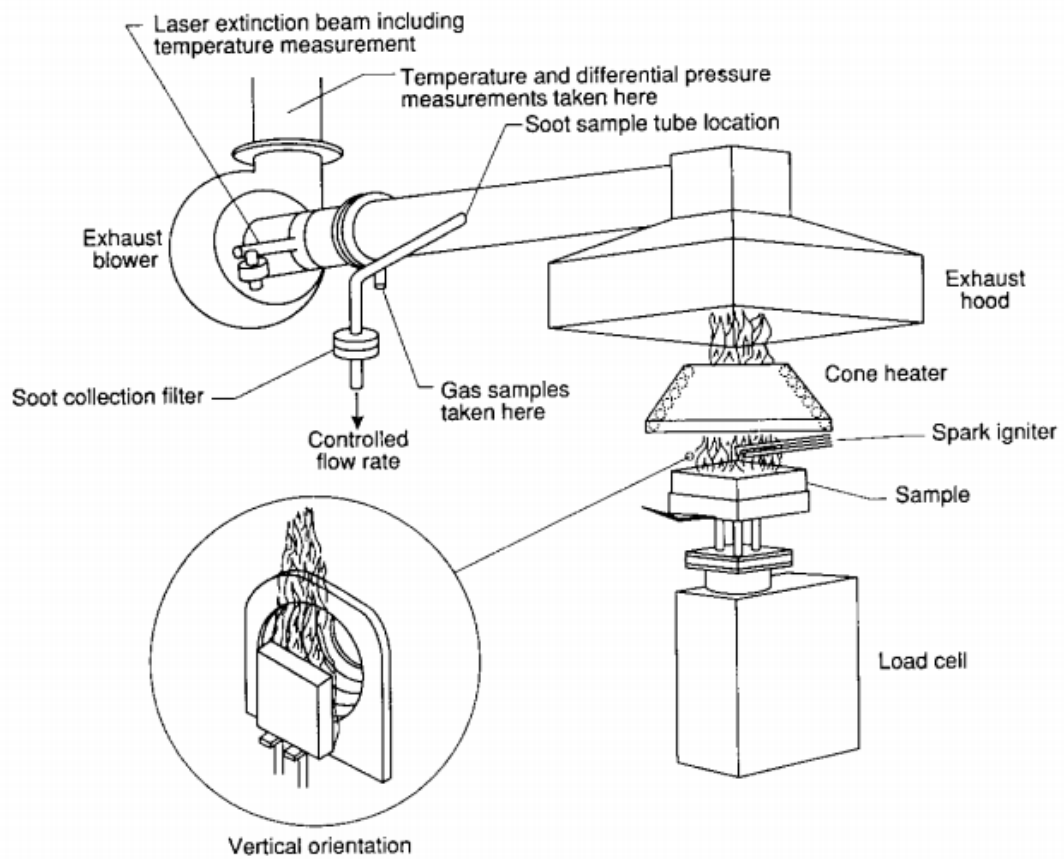
Figure 3.6 A schematic view of a cone calorimeter (Reprinted with permission from [20]).

The cone calorimeter (Figure 3.6; reprinted with permission from [20]) is an instrument used for small-scale fire testing. Cone calorimetry can be used to determine many fire reaction properties for a bench-scale coupon in only a single test. These properties include the ignition time, peak and average heat release rate, time of sustained flaming, mass loss, smoke density, and the yield of soot, carbon monoxide (CO), carbon dioxide (CO₂), and other combustion gases formed during the burning process [3]. The cone calorimeter is based on the oxygen-depletion calorimetry technique that allows the measurement of the heat release rate by measuring the amount of oxygen consumed by the fire during the test [3, 9]. This is possible since the heat release per unit of oxygen consumed is constant [21].

The cone calorimeter is widely used in flammability tests since it provides similar burning conditions to a real (direct) fire test. In addition, cone calorimetry permits a wide range of heat fluxes (*e.g.*, 0-100 kW/m²) and can be used to *i*) predict the fire performance of a material in a large-scale fire test; *ii*) compare the fire reaction properties of different materials; *iii*) check whether or not a material meets the fire requirements necessary for a certain application; and *iv*) produce data to validate fire models [3].

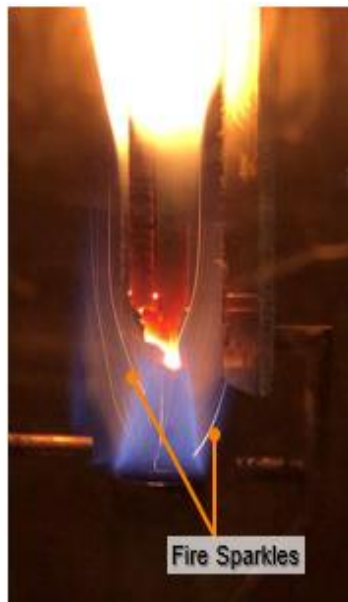
Figure 5.1 Fire sparkles during the 12 s vertical burn test on a 21-ply cross-ply Cytec Cycom 5215 T40-800 graphite-epoxy UNC0 specimen.

Melt dripping of the epoxy matrix was observed during the 12 s fire tests. This tar-like substance (melt dripping) induced fire “sparkles” during specimen burning and leaked onto the tip of the Bunsen burner after the tests (Figure 5.1). The melt dripping of a given polymer strongly depends on its glass transition temperature, and the original polymer melt viscosity and degradation [22]. Unlike matrix decomposition which involves polymer bond breakage, during melt dripping a solid-viscous liquid phase change takes place inside the material due to high temperature exposure [22]. The relative degree and extent of the melt dripping was undoubtedly affected by the vertical specimen orientation during fire testing (*i.e.*, specimens were held upside down into the flame). In essence, any epoxy-based melt dripping would tend to accumulate on the broken carbon filament ends extending from the fracture surface; this arguably contributed to increased char deposits at and near these surfaces.

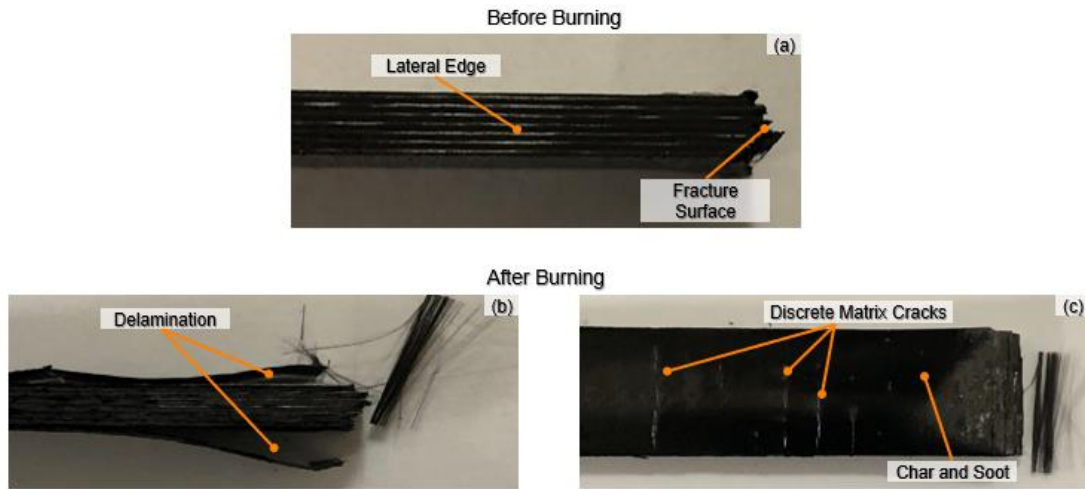
Figure 5.2 Pictures of a 21-ply cross-ply Cytec Cycom 5215 T40-800 graphite-epoxy UNC0 specimen; (a) before and (b) and (c) after vertical burning for 60 s.

The fire damage (*i.e.*, extensive fire matrix decomposition, fire-induced delamination, and residual thickness increase) on specimens exposed to the 36 s and 60 s fire tests was more widespread and severe than that for the 12 s exposure. For specimens burned for the 36 and 60 s exposure durations, the damage extended throughout the total length of the specimens and fire-induced delamination occurred. The smoke released during the burning of the specimens was more intense as the fire exposure duration increased. The through-thickness delamination induced by the fire was more severe at the specimen outer plies. In addition, discrete matrix cracks formed parallel to the fibers in the outer 90-degree plies of the specimens. Figure 5.2 shows typical macro-scale pictures of an UNCO specimen (a) before and (b, c) after burning for 60 s. The fire damage includes char and soot deposition on the lateral edges and planar surfaces of the specimen, discrete matrix cracking, and ply-delamination.

In addition, the time for UNCO specimens to self-extinguish after the burner flame was stopped was highly dependent on the fire exposure duration. UNCO specimens burned for short durations (12 s) took more time to self-extinguish compared to specimens burned for longer fire durations (*i.e.*, 36 and 60 s). This makes sense since the degree of epoxy matrix decomposition and consumption for specimens with longer direct fire exposure was greater than that for specimens burned for less time. Moreover, the increased char layers formed in specimens with longer fire exposure likely impeded further burning once the direct flame was discontinued [3, 8].

specimens used in vertical tests (Figure 5.2) and horizontal tests (Figure 5.25) may be due to differences in specimen in-plane and through-thickness thermal conductivities and other thermal properties. For example, the heat conduction parallel to the fibers will be much greater than through the ply thickness. The thermal conductivities of typical polyacrylonitrile (PAN)-based carbon/graphite fibers in the axial and radial directions are approximately 20 W/m·K and 0.32 W/m·K, respectively [3]. This compares to a value of 0.23 W/m·K for a typical epoxy matrix [3]. This suggests that, for horizontal tests, heat conduction in the outermost ply exposed to the flame will be greatest in the fiber direction. This may explain the greater degree of outer-ply matrix decomposition parallel to the plane in comparison to the through-thickness fire damage (*i.e.*, fire damage was more concentrated in the outermost ply). In contrast, for vertically burned specimens, the 0° fibers provide a more direct heat conduction path to the interior of the specimen, resulting in far more severe internal fire damage (melt dripping, matrix decomposition, delamination, explosive outgassing, *etc.*).

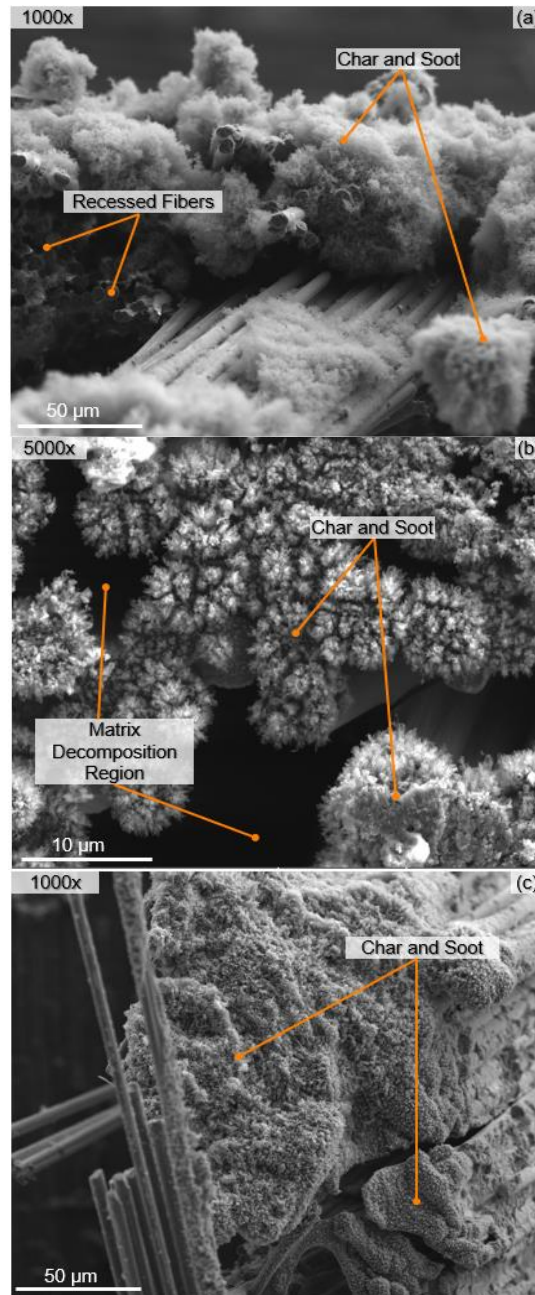
Figure 5.3 SEM images showing char and soot deposition around the perimeter of the fracture surface of 21-ply cross-ply Cytec Cycom 5215 T40-800 graphite-epoxy UNCO specimens burned vertically for (a) 12, (b) 36, and (c) 60 s.

In general, char formation was more pronounced around the perimeter than at the mid-plane of the fractured surfaces. Figure 5.3 shows typical SEM images of the char and soot that were deposited around the *perimeter* of the fracture surface of UNC0 specimens burned for (a) 12 s, (b) 36 s, and (c) 60 s. The figures identify char and soot deposition on the fractured fibers, pockets of matrix decomposition, and recessed fibers. Char was present on the broken fiber ends for all three fire exposure durations and was more pronounced for fibers along the perimeter edges that did not self-extinguish once the applied flame was removed. For all three fire exposure durations, the overall char formed on the fracture surface of the specimens increased slightly with increasing the fire duration. The residual char on the extended broken fibers had a fuzzy (cotton-candy-like) appearance and formed uniformly around the circumference of each fiber, with noticeably more char accumulation at the fractured filament ends. Figure 5.4 shows high magnification SEM images of char formation

Figures 5.12a, c show SEM micrographs taken from the perimeter of the fracture surface of vertically burned SBS graphite-epoxy specimens exposed to direct flame for 12, 36, and 60 s, respectively. Similar to the UNCO specimens (Figure 5.3), proportionally more char accumulated at and near extended broken fibers located around the perimeter of the cross-section where the airflow was greater; little char formed on extended fibers located near the laminate mid-plane. Specimens burned for only 12 s displayed apparent accumulations from melt dripping at the broken filament ends (Figure 5.12a) with very little soot and char deposits. The presence of melt dripping coupled with low amounts of char suggests relatively incomplete combustion/decomposition of the epoxy matrix occurred for the 12 s flame exposure, which no doubt was influenced by the relatively thick SBS specimen geometry. While not shown here, melt dripping was also observed along the lateral edges (sides) of the SBS specimens. Specimens burned for 36 and 60 s (Figures 5.12b, c, respectively) exhibited increasing amounts of extensive char formation on extended broken fibers, as well as appreciable soot deposition. Similar to results for UNCO specimens, the

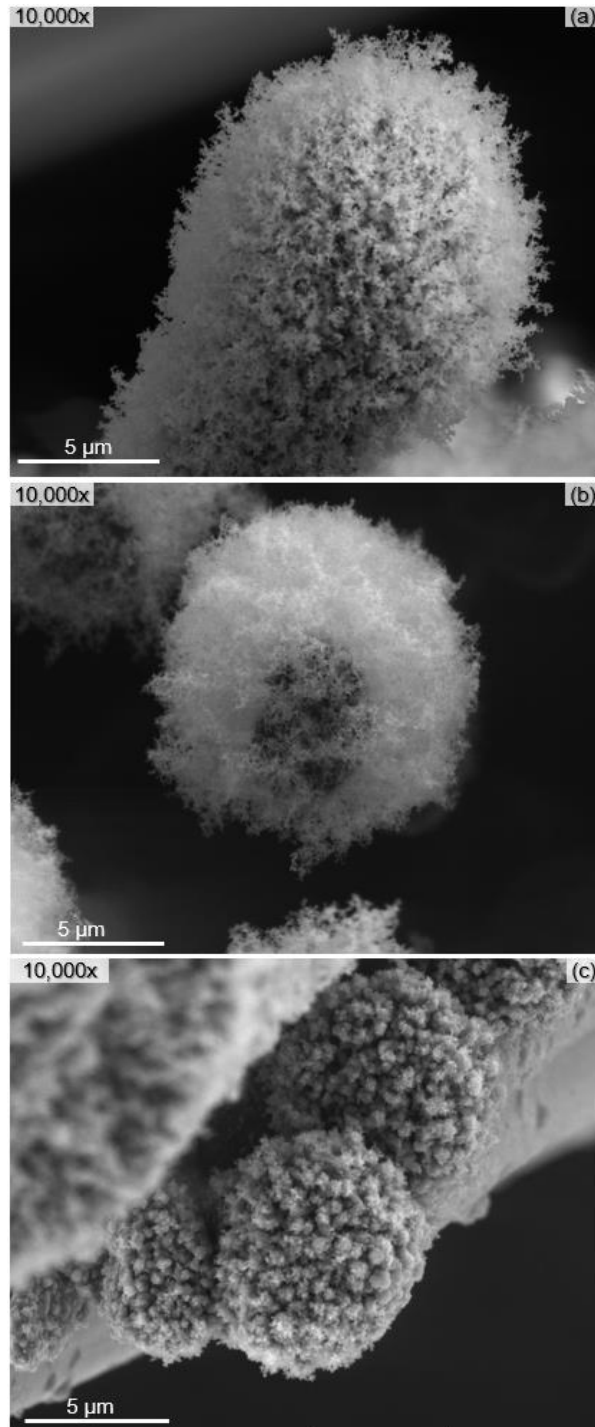
Figure 5.4 SEM images showing the fuzzy (cotton-candy-like) appearance of char formed around single fibers in 21-ply cross-ply Cytec Cycom 5215 T40-800 graphite-epoxy UNC0 specimens burned vertically for (a) 12, (b) 36, and (c) 60 s.

around single fibers located on the perimeter of the fracture surface of UNCO specimens burned for (a) 12 s, (b) 36 s, and (c) 60 s.

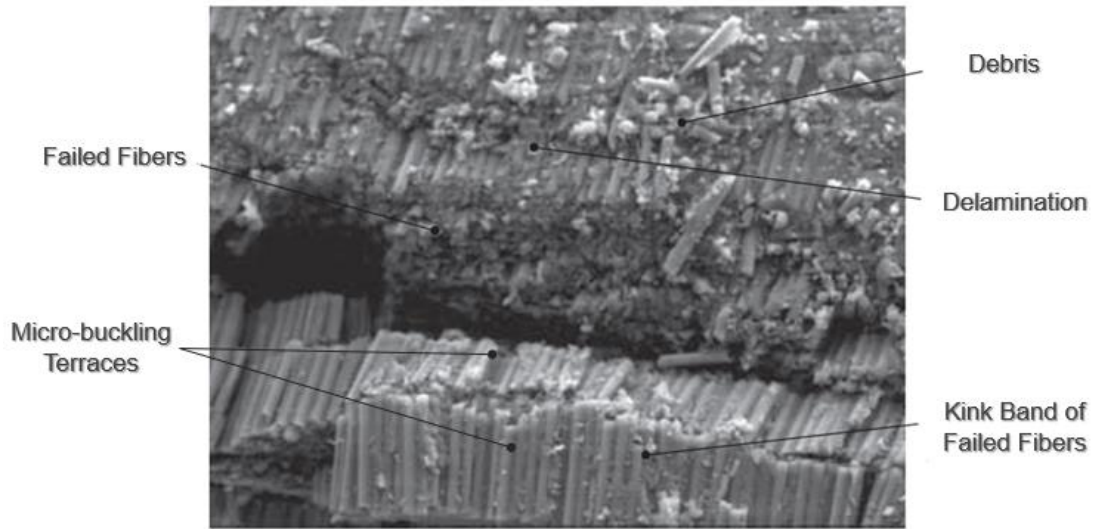
Figure 5.6 Micro-buckling terraces on compression failed CFRP specimen (x700) (Adapted with permission from [23]).

fiber diameters. Figure 5.6 (adapted with permission from [23]) shows a micrographic image of micro-buckling terraces at the fracture surface of a carbon fiber-reinforced polymer (CFRP) composite specimen failed in compression. Similar terraces of micro-buckled fibers were also observed in SEM images of the fracture surface of UNCO specimens vertically burned for 60 s (*cf.*, Figure 5.7). Even after extreme fire exposure, kink bands, micro-buckled fibers and their fracture surfaces were clearly identifiable. Given the loose arrangement of terrace-like structures, it may be possible to dislodge severely burned layers to expose relatively unaffected interior surfaces.

Similar to UNC0 specimens (Figure 5.6 adapted with permission from [23]), terraces of micro-buckled fibers formed in *compressive* regions of failed three-point bend SBS specimens. Figures 5.15a, b show SEM images of micro-buckled fibers in a SBS specimen before fire exposure. Figure 5.15c shows the same specimen after vertical burning for 60 s. After burning, parallel clusters of micro-buckled fibers indicative of compressive failure were still visible, albeit covered in char; some slant-like fiber fracture features also remained. In nearby regions of the specimen, micro-buckled fibers in terrace structures were completely covered with melt dripping (Figure 5.16). This suggests that removal of the outer terraces may be desirable to better identify operative mechanical failure mechanisms.

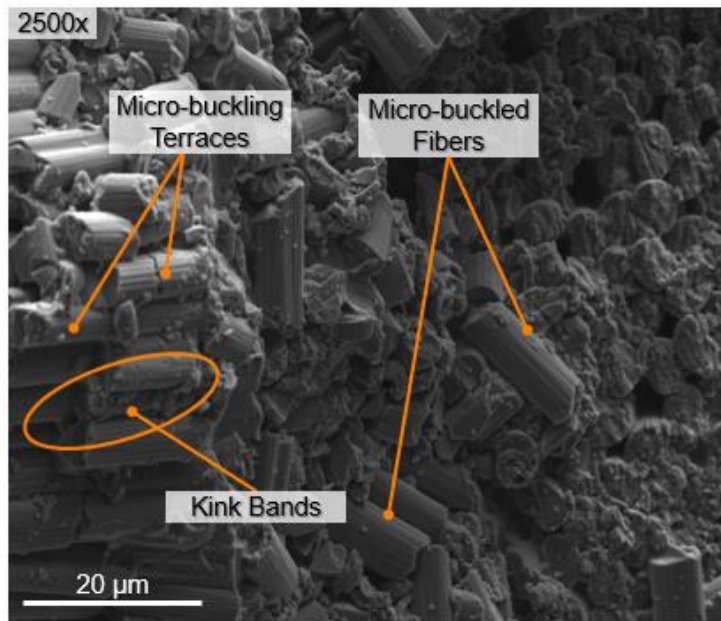
Figure 5.7 SEM image showing micro-buckled fibers in a 21-ply cross-ply Cytec Cycom 5215 T40-800 graphite-epoxy UNC0 specimen burned vertically for 60 s.

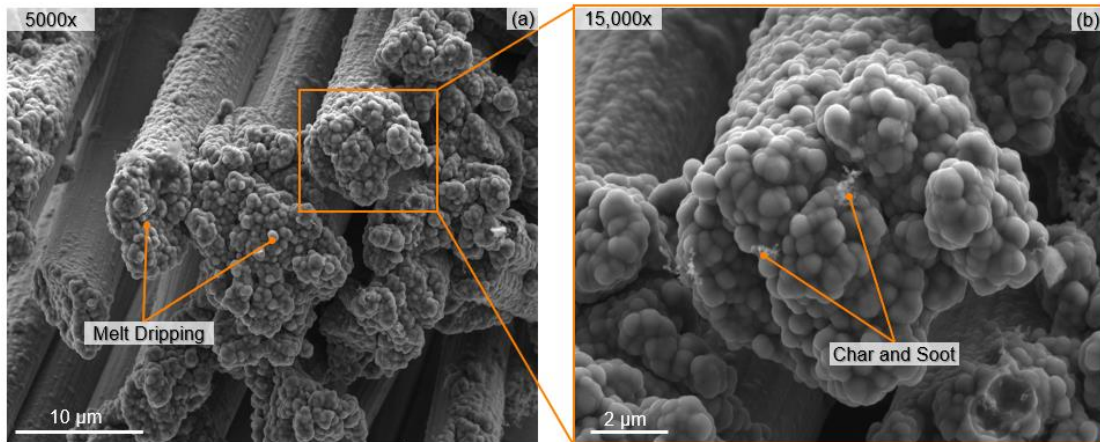
Figure 5.8 (a) Melt dripping on fracture fibers ends of a 21-ply cross-ply Cytec Cycom 5215 T40-800 graphite-epoxy UNC0 specimen burned vertically for 36 s (b) a magnified view of filaments covered with melt dripping.

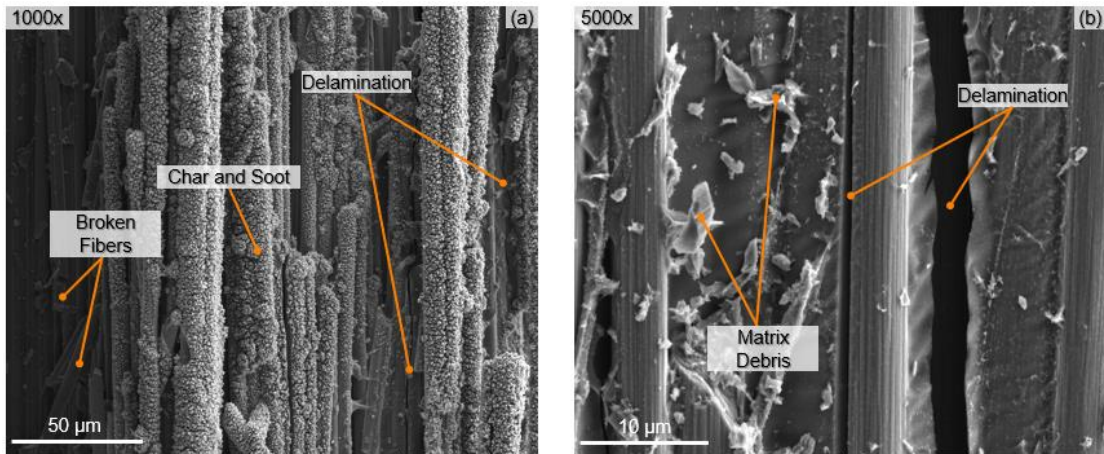
UNC0 graphite-epoxy specimens burned for extended durations also experienced fire-induced delamination, ply-splitting, and matrix-cracking. Figures 5.9a, b show delamination between plies and ply-splitting in an UNC0 specimen after a 60 s burn test. Figure 5.10 shows matrix cracking in the same specimen. Delamination, ply-splitting, and matrix cracking result from large internal local pressures due to the formation of combustion gases, smoke, and vaporized moisture that try to escape to the exterior [3, 10]. Such damage can also arise from thermally induced-strain and temperature gradients in a laminate [3, 10], which can be exacerbated by large differences in local ply orientations such as those occurring in cross-ply UNC0 specimens. In addition, temperature-induced thermal softening of the matrix can result in significant reductions in composite interlaminar fracture toughness and contribute to increased matrix cracking and delamination [10].

Figure 5.9 Delamination in a 21-ply cross-ply Cytec Cycom 5215 T40-800 graphite-epoxy UNC0 specimen burned vertically for 60 s.

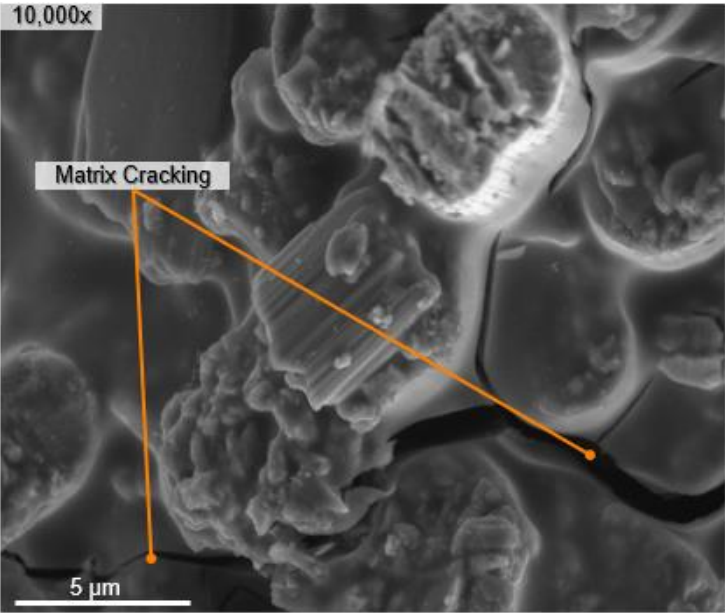
Figure 5.10 Matrix cracking in a 21-ply cross-ply Cytec Cycom 5215 T40-800 graphite-epoxy UNC0 specimen burned vertically for 60 s.

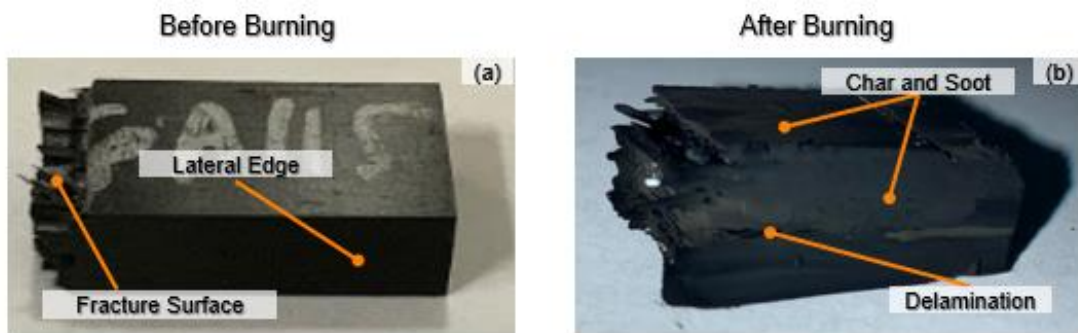
Vertical fire tests were performed on 45-ply unidirectional Cytec Cycom 5215 T40-800 graphite-epoxy SBS specimens (lay-up: $[0]_{45}$) for durations of 12, 36, and 60 s to assess the effects of flame exposure time on char formation. Three repeats were performed for each fire exposure time. Fire damage (*i.e.*, extensive fire matrix decomposition, soot, char, and residual thickness increase) observed was more severe for specimens subjected to the flame for 36 and 60 s. The fire damage mechanisms generated in the vertical burning tests on the SBS specimens were similar to those in the UNCO specimens and extended throughout the length of the burned specimens. Again, the relatively thick SBS and UNCO specimens both display a more compact failure surface that inhibits oxygen flow to the interior of the specimens, resulting in more char formation around the perimeter of the cross-section. Char deposition at the SBS fracture surfaces also served as a thermal barrier that reduced fire damage penetration into the composite at the laminate interior; this is consistent with observations from the literature [3, 8]. Again, for all three fire exposure durations, the lateral specimen edges (sides) continued to burn after the flame was extinguished. Similar to UNCO specimens, SBS specimens exposed for 12 s took longer to self-extinguish than for 36 and 60 s fire tests. Figure 5.11 shows typical macro-scale pictures of an SBS specimen (a) before and (b) after fire exposure for 60 s. The fire damage included local delamination near the fracture surface, char formation and soot deposition on the lateral edges and outer ply surfaces, and a significant increase in the residual thickness of the burned specimen.

Figure 5.11 Picture of a 45-ply unidirectional Cytec Cycom 5215 T40-800 graphite-epoxy SBS specimen; (a) before and (b) after vertical burning for 60 s.

Mechanically-failed SBS specimens subjected to three-point bending will break into two distinct halves, as suggested by the single half shown in Figure 5.11 a. Occasionally, an individual half will longitudinally split (*i.e.*, completely delaminate) into two $\frac{1}{4}$ -specimens due to high inter-laminar stresses. Pairs of mating $\frac{1}{4}$ -specimens were clamped together and subjected to 12, 36, and 60 s fire exposure tests. After 12 s of fire exposure, the mating pieces remained separated. After 36 and 60 s of fire exposure, however, the mating pieces adhered together. Clearly, increased fire exposure led to some degree of interfacial bonding between initially separated layers. This could be due to various aspects of melt dripping and subsequent matrix decomposition, or the presence of tougheners, surfactants, plasticizers, flame retardants or other additives blended into the commercial Cycom 5215 epoxy prior to resin infusion and curing. The exact composition of most commercially-available thermosetting epoxies is proprietary and very difficult to determine. It is unclear whether the use of unmodified (neat) epoxy would lead to the same adhesion between

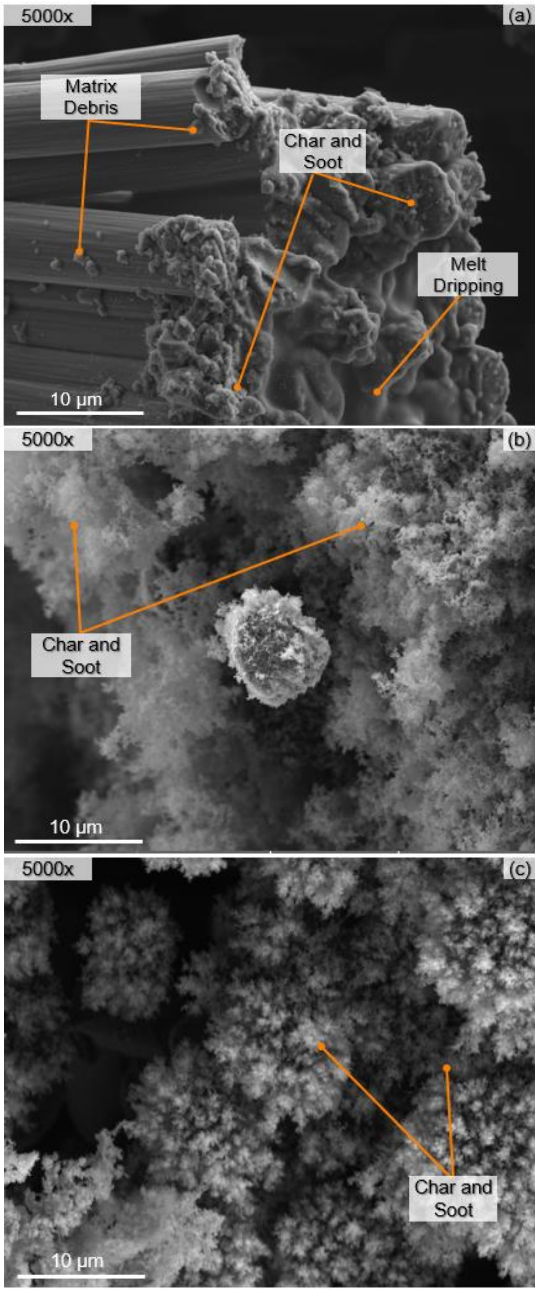
Figure 5.12 SEM images showing char and soot deposition on the fracture surface of 45-ply unidirectional Cytec Cycom 5215 T40-800 graphite-epoxy SBS specimens after vertical burning for (a) 12, (b) 36, and (c) 60 s.

The degree of char formation and soot deposits on the fracture surfaces of horizontally-burned SBS specimens was much lower than that for similar specimens used in vertical fire tests (Figure 5.12). Figure 5.28 shows SEM images of the fracture surface of SBS specimens burned horizontally for (a) 15, (b) 45, and (c) 75 s. For specimens burned for 15 and 45 s, relatively minor amounts of char and soot residues formed on the fiber ends, and tensile failure regions and compressive chop marks were clearly visible (Figures 5.28a, b). For the 75 s tests (Figure 5.28c), many extended and recessed fibers were covered with melt dripping that obscured fracture surface features. In contrast to vertical fire tests where melt dripping by-products flowed

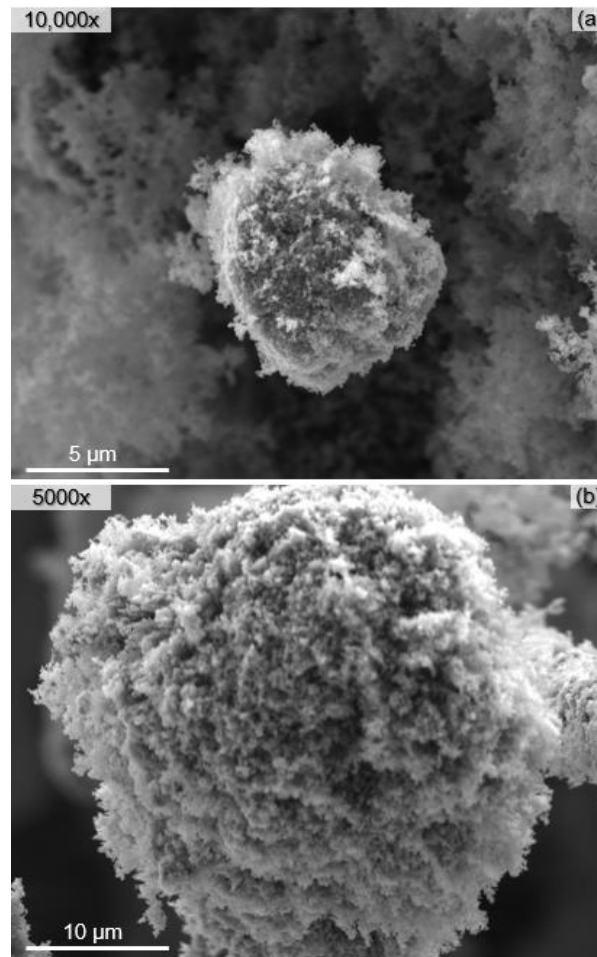
char formed at and around the extended fiber ends exhibited a fuzzy (cotton-candy-like) appearance (Figure 5.13).

Figure 5.13 SEM images showing the fuzzy (cotton-candy-like) appearance of char formed around single fibers in 45-ply unidirectional Cytec Cycom 5215 T40-800 graphite-epoxy SBS specimens burned vertically for (a) 36, and (b) 60 s.

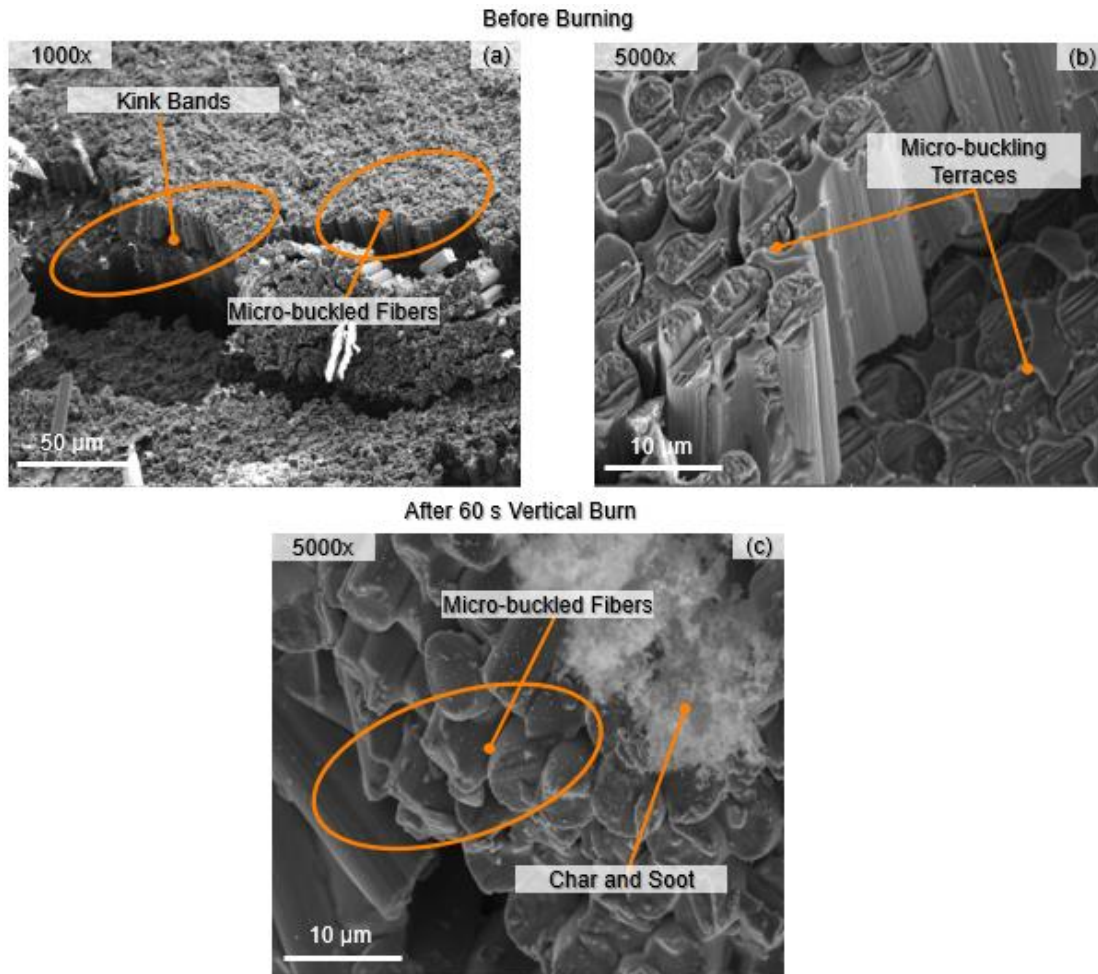
Figure 5.15 Micro-buckled fibers in Cytec Cycom 5215 T40-800 graphite-epoxy SBS specimens: (a) unburned specimen, (b) magnified view of the unburned specimen, and (c) specimen vertically burned for 60 s.

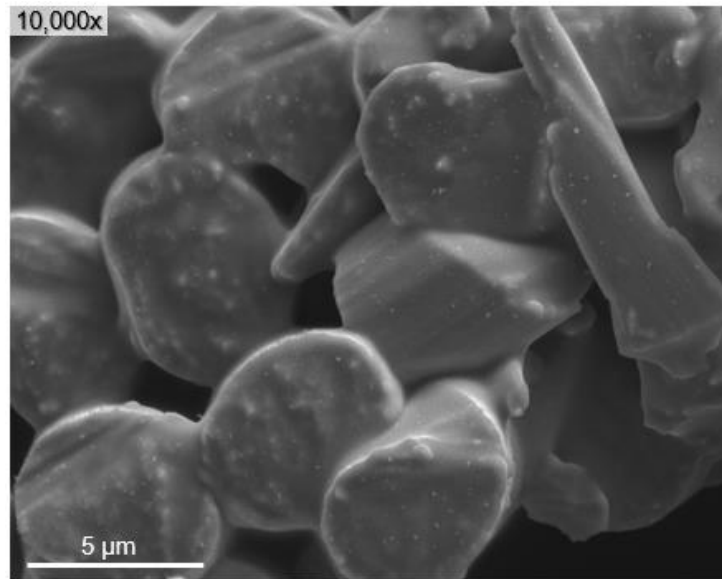
Figure 5.16 Micro-buckled fibers in Cytec Cycom 5215 T40-800 graphite-epoxy SBS specimens completely covered in melt dripping.

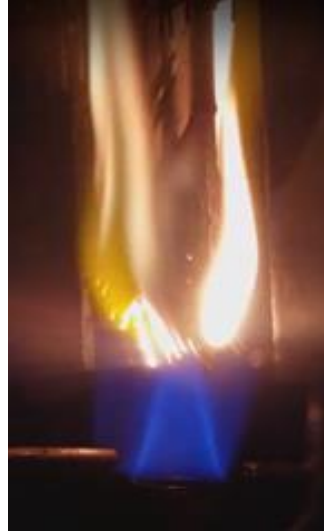
Due to their highly irregular fracture surface geometries, the IPS specimens were positioned above the Bunsen burner during fire tests such that the blue tip of the flame was at the same level as the fractured fibers at the longest lateral edge of the specimen, as shown in Figure 5.17 and location 1 in Figure 5.18a. Specimens subjected to fire exposures of 12, 36, and 60 s each experienced large-scale matrix decomposition and delamination that increased substantially with increasing fire exposure. For longer exposure times, almost complete matrix decomposition occurred over the majority of the specimens and fire-induced delamination spanned the entire length of the specimens. Virtually no char, soot, or epoxy was visible at the graphite filament ends located at the laminate midplane along the centerline of the composite that were exposed to direct flame (location 2 in Figure 5.18a); bundles of bare graphite fibers (with no evidence of cured epoxy matrix or char) remained at this location after burning. IPS specimens burned for 12, 36, and 60 s were largely destroyed during fire testing. These specimens displayed much higher degrees of matrix decomposition, significantly lower levels of residual char formation, and more fiber thermal damage than the UNCO and SBS specimens tested under similar conditions. The large free surface area present in failed IPS specimens resulted in enhanced oxygen flow throughout the specimens, more complete combustion of the organic matrix, and relatively little residual char formation. For these reasons, additional vertical tests of IPS specimens were performed with a *reduced fire exposure duration* of 6 s. In contrast to the UNCO and SBS specimens, which generated more char on exposed fiber ends with increasing fire exposure times, the

Figure 5.17 Positioning of the IPS specimen during vertical burn tests.
