POST-CRASH FIRE FORENSIC ANALYSIS OF AEROSPACE COMPOSITES

A Thesis

Major Subject: Mechanical Engineering

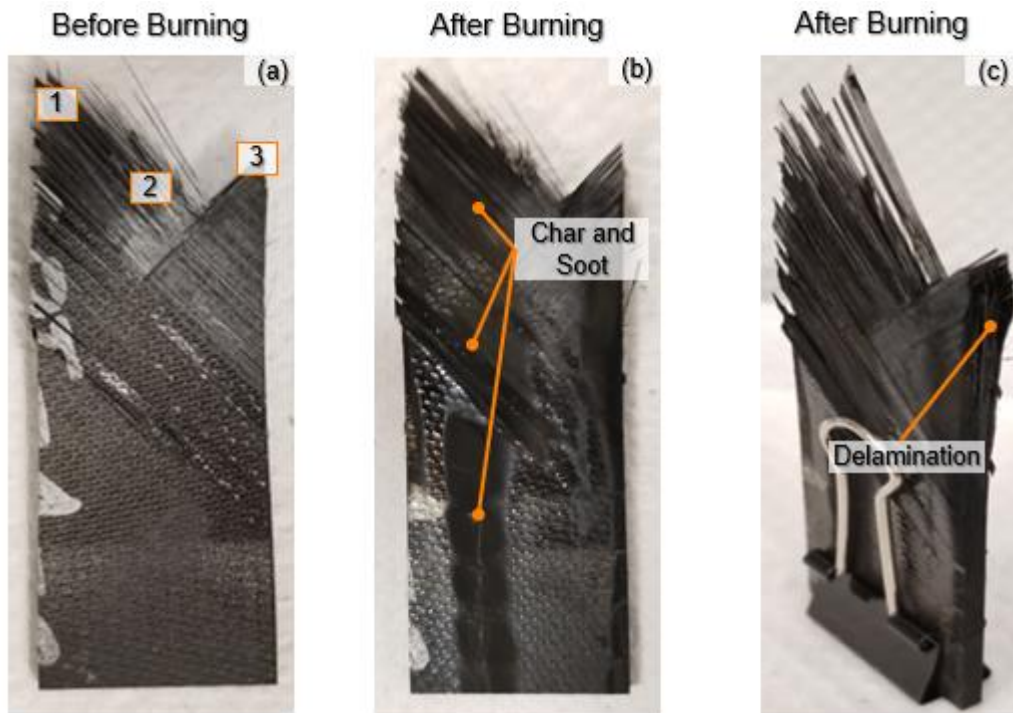
Figure 5.18 shows typical macro-scale pictures of an IPS specimen (a) before and (b, c) after fire exposure for 6 s. Char and soot were observed on the exposed filament ends, lateral specimen edges (sides), and on planar outer ply surfaces. Pre-existing mechanical delamination appeared to grow significantly after fire exposure. The locations 1 (longest lateral edge), 2 (laminate centerline), and 3 (shortest lateral edge) shown in Figure 5.18a define the approximate locations of SEM images taken of the failure surfaces. Figure 5.19 shows that IPS specimens burned for 6 s developed significant char on extended fibers at both lateral edges, as well as the laminate centerline.

Figure 5.18 Pictures of a 16-ply Cytec Cycom 5215 T40-800 graphite-epoxy IPS specimen (a) before and (b) and (c) after vertical fire exposure for 6 s. In (a), locations 1, 2, and 3 denote the longest lateral edge, laminate centerline, and shortest lateral edge, respectively.

Due to their highly irregular fracture surface geometries, the IPS specimens were positioned above the Bunsen burner during fire tests such that the blue tip of the flame was at the same level as the fractured fibers at the longest lateral edge of the specimen, as shown in Figure 5.17 and location 1 in Figure 5.18a. Specimens subjected to fire exposures of 12, 36, and 60 s each experienced large-scale matrix decomposition and delamination that increased substantially with increasing fire exposure. For longer exposure times, almost complete matrix decomposition occurred over the majority of the specimens and fire-induced delamination spanned the entire length of the specimens. Virtually no char, soot, or epoxy was visible at the graphite filament ends located at the laminate midplane along the centerline of the composite that were exposed to direct flame (location 2 in Figure 5.18a); bundles of bare graphite fibers (with no evidence of cured epoxy matrix or char) remained at this location after burning. IPS specimens burned for 12, 36, and 60 s were largely destroyed during fire testing. These specimens displayed much higher degrees of matrix decomposition, significantly lower levels of residual char formation, and more fiber thermal damage than the UNCO and SBS specimens tested under similar conditions. The large free surface area present in failed IPS specimens resulted in enhanced oxygen flow throughout the specimens, more complete combustion of the organic matrix, and relatively little residual char formation. For these reasons, additional vertical tests of IPS specimens were performed with a *reduced fire exposure duration* of 6 s. In contrast to the UNCO and SBS specimens, which generated more char on exposed fiber ends with increasing fire exposure times, the

For IPS specimens subjected to longer fire exposure times (*i.e.*, 12, 36, and 60 s), virtually no residual char formed on fibers located near the *longest lateral edge* (location 1 in Figure 5.18a) or at the specimen *centerline* (location 2 in Figure 5.18a). In contrast, significant char only formed on broken fiber ends located near the *shortest lateral edge* (location 3 in Figure 5.18a); this location was farther removed from the blue flame tip than the other points considered. Figures 5.20a–5.22a show SEM images of the fracture surface at the longest lateral edge for specimens burned for 12, 36, and 60 s, respectively. Similarly, Figures 5.20b–5.22b show SEM images of the increasing amounts of char and soot deposited on fibers at the shortest lateral edge for specimens burned for 12, 36, and 60 s, respectively. Since no significant char was present at the longest lateral edge for specimens, epoxy matrix cracks, angled fiber fractures, matrix debris, and micro-buckled fibers are all clearly visible in the images. These features are similar to typical fracture characteristics found in *unburned* IPS specimens. Any char that did form and then was subsequently burned off did not appear to significantly change the identifiable mechanical failure mechanisms. This trend did not hold true, however, for fibers located along the centerline of the IPS specimens. As an aside, the SEM images presented in Figures 5.20–5.22 were taken at different working distances (WDs) to accommodate for large variations in specimen geometries, as well as differences in the out-of-plane locations of individual clusters of fibers.

Exposed graphite filaments located near the mid-plane of the fracture surface along the IPS specimen centerline (location 3 in Figure 5.18a) were severely altered when specimens were burned for 12, 36, and 60 s. The fibers thermal degradation was so severe that it eliminated any possibility of identifying fiber mechanical failure mechanisms. Figure 5.23 shows SEM images of broken fibers located along the centerline of IPS graphite-epoxy specimens burned for (a) 12, (b) 36 and (c) 60 s. In each case, the family of fibers became longitudinally thinner and developed needle-like shapes. Moreover, voids and cavities formed at the fiber ends in specimens burned for 60 s (Figure 5.24). Graphite/carbon fiber ends thinning is mainly caused by oxidation [23] occurring about a threshold temperature of 350-450°C [3]. Graphite/carbon fiber oxidation occurs at very low rates when the fibers are initially embedded in an epoxy matrix, since the char formed and deposited on the fiber

For *vertical* fire tests of IPS specimens, fibers located at the laminate centerline (location 2 in Figure 5.18a) suffered severe thermal degradation. In those cases, the matrix surrounding the fiber bundles was completely decomposed and individual filaments experienced substantial oxidation damage and thinning (Figure 5.23). For horizontal fire tests, however, fiber bundles located along the laminate centerline were not as adversely affected by fire exposure. Figure 5.30 shows SEM images of fiber bundles located at the centerline of IPS specimens horizontally burned for (a) 15, (b) 45, and (c) 75 s. For the 15 and 45 s fire exposures, individual fiber bundles remained encased in the epoxy matrix and there was little evidence of char formation (Figure 5.30a, b). For the 75 s tests, the epoxy matrix was largely decomposed but the individual fibers appeared to remain relatively intact. Moreover,

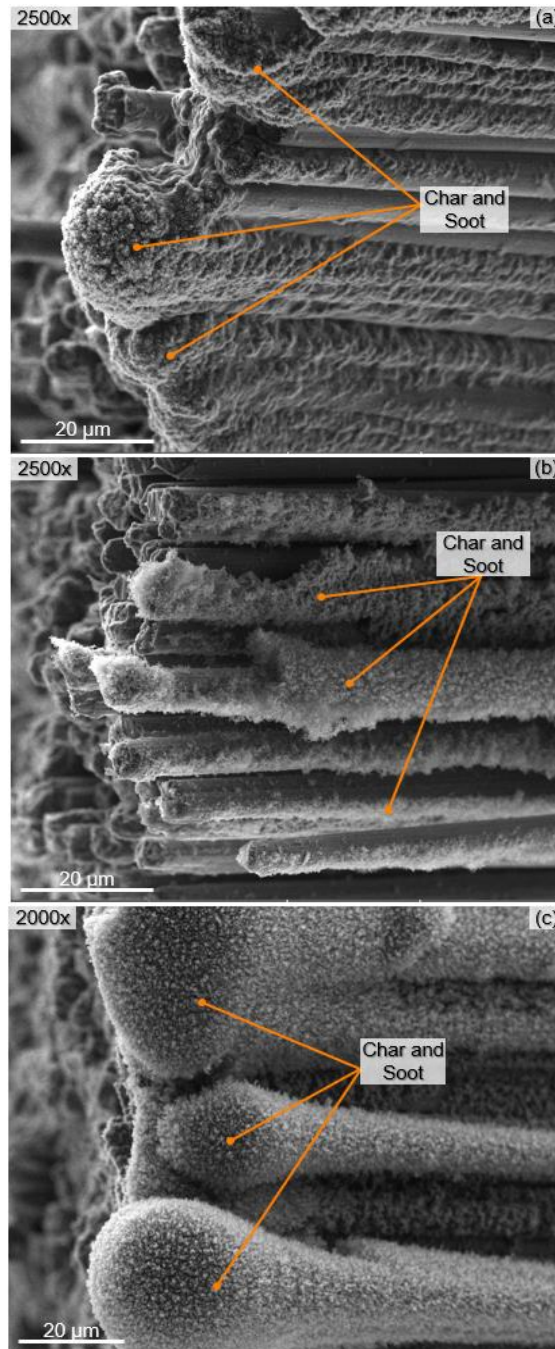
Figure 5.19 SEM micrographs showing char and soot deposition on fractured fibers located at (a) the longest lateral edge, (b) center and (c) shortest lateral edge of 16-ply Cytec Cycom 5215 T40-800 graphite-epoxy IPS specimens subjected to 6 s vertical burn test. These correspond to locations 1, 2, and 3, respectively, in Figure 5.18a.

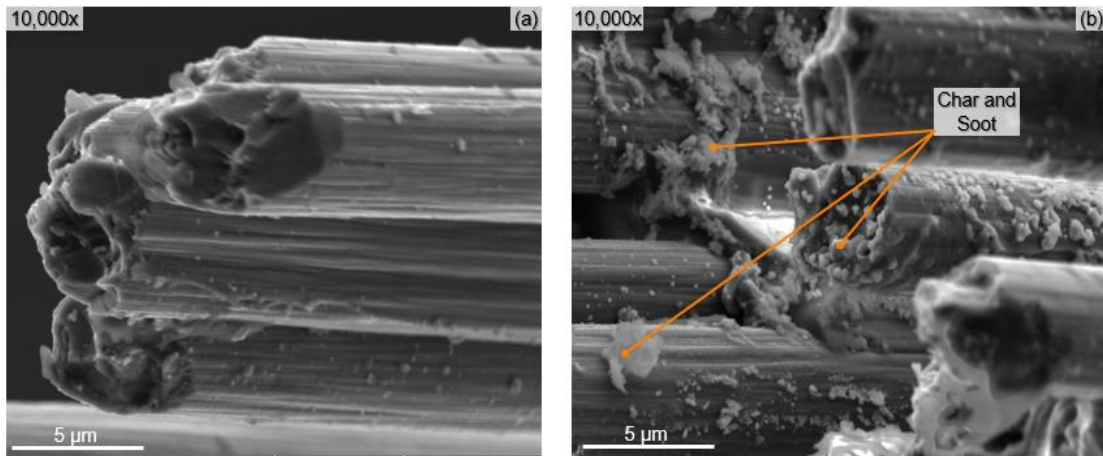
Figure 5.20 SEM images showing char formation on (a) the longest and (b) shortest lateral edges of 16-ply Cytec Cycom 5215 T40-800 graphite-epoxy IPS specimens burned vertically for 12 s both taken at a WD of 15 mm. These correspond to locations 1 and 3 in Figure 5.18a.

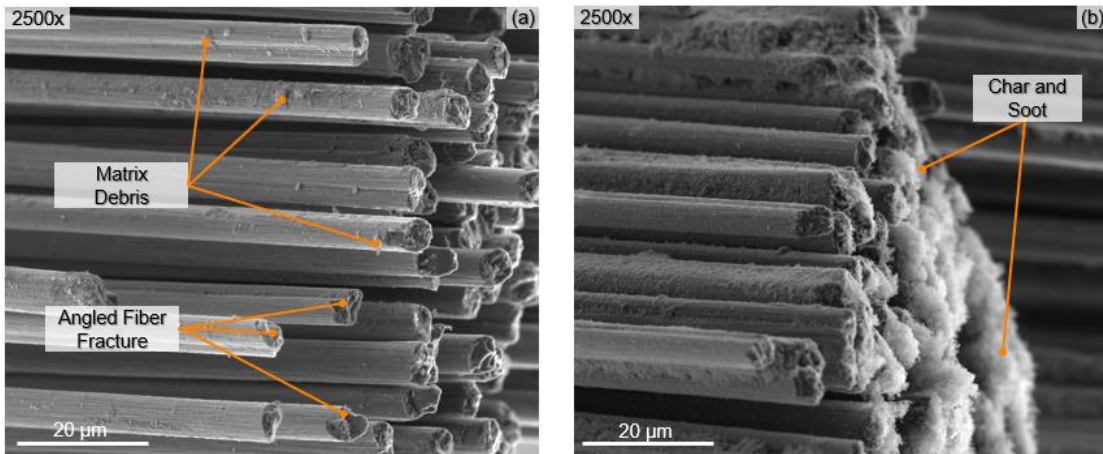
Figure 5.21 SEM images showing char formation on (a) the longest and (b) shortest lateral edges of 16-ply Cytec Cycom 5215 T40-800 graphite-epoxy IPS specimens burned vertically for 36 s taken at WDs of 9 and 11 mm, respectively. These correspond to locations 1 and 3 in Figure 5.18a.

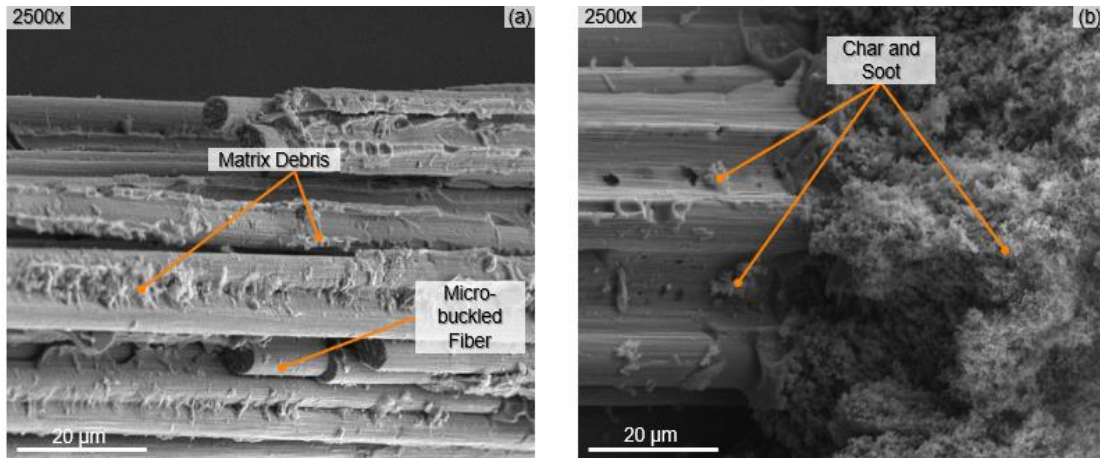
Figure 5.22 SEM images showing char formation on (a) the longest and (b) shortest lateral edges of 16-ply Cytec Cycom 5215 T40-800 graphite-epoxy IPS specimens burned vertically for 60 s taken at WDs of 12 and 25 mm, respectively. These correspond to locations 1 and 3 in Figure 5.18a.

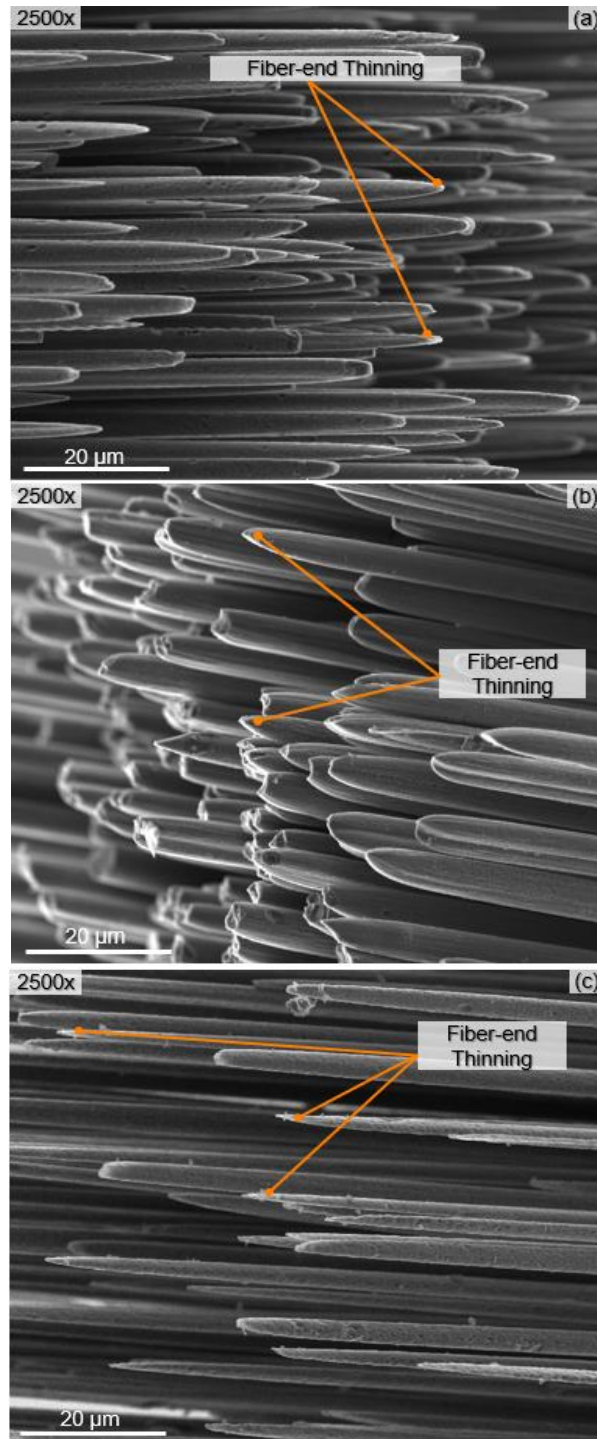
Figure 5.23 Fiber-end thinning of filaments located at the mid-plane of 16-ply Cytec Cycom 5215 T40-800 graphite-epoxy IPS specimens vertically burned for (a) 12, (b) 36 and (c) 60 s taken at WDs of 9, 15, and 10 mm, respectively.

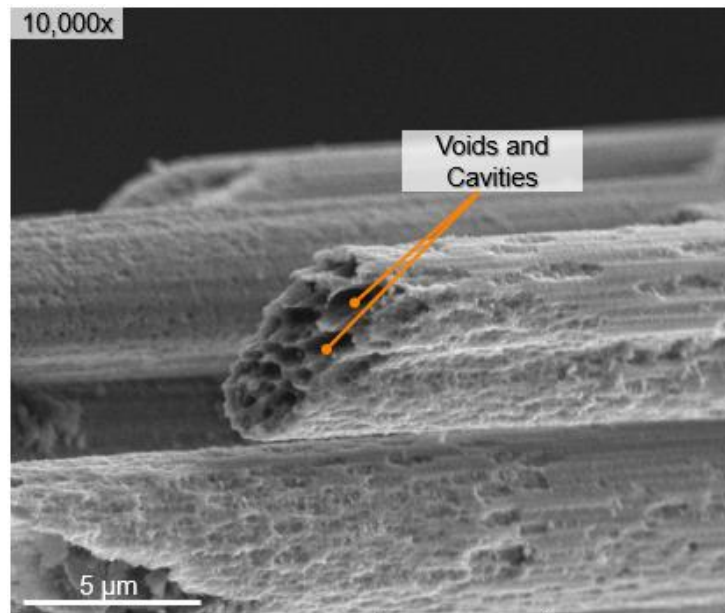
Figure 5.24 SEM image showing voids and cavities on a fiber from a 16-ply Cytec Cycom 5215 T40-800 graphite-epoxy IPS specimen burned vertically for 60 s.

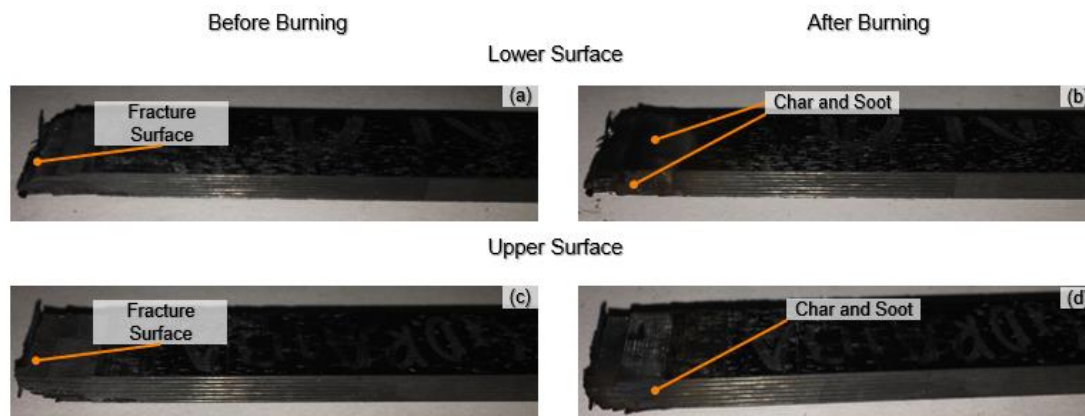
the applied flame was stopped. The local matrix decomposition, surface char, and soot were more severe over the lower outer ply surface exposed to direct flame; such damage was more pronounced for the 45 and 75 s fire tests. Unlike the case for vertical tests, no delamination or residual thickness increase occurred for all three fire exposure durations (*i.e.*, 15, 45, and 75 s). Figure 5.25 shows typical macro-scale images of the lower and upper surfaces of an UNC0 specimen before and after horizontal burning for 75 s. The lower surface of the specimen (Figures 5.25a, b) suffered matrix decomposition over the region exposed to direct flame. In contrast, the upper surface of the specimen (Figures 5.25c, d) was not appreciably affected by the fire.

Figure 5.25 Pictures of a 21-ply cross-ply Cytec Cycom 5215 T40-800 graphite-epoxy UNC0 specimen; (a, c) before and (b, d) after horizontal burning for 75 s.

specimens used in vertical tests (Figure 5.2) and horizontal tests (Figure 5.25) may be due to differences in specimen in-plane and through-thickness thermal conductivities and other thermal properties. For example, the heat conduction parallel to the fibers will be much greater than through the ply thickness. The thermal conductivities of typical polyacrylonitrile (PAN)-based carbon/graphite fibers in the axial and radial directions are approximately 20 W/m·K and 0.32 W/m·K, respectively [3]. This compares to a value of 0.23 W/m·K for a typical epoxy matrix [3]. This suggests that, for horizontal tests, heat conduction in the outermost ply exposed to the flame will be greatest in the fiber direction. This may explain the greater degree of outer-ply matrix decomposition parallel to the plane in comparison to the through-thickness fire damage (*i.e.*, fire damage was more concentrated in the outermost ply). In contrast, for vertically burned specimens, the 0° fibers provide a more direct heat conduction path to the interior of the specimen, resulting in far more severe internal fire damage (melt dripping, matrix decomposition, delamination, explosive outgassing, *etc.*).

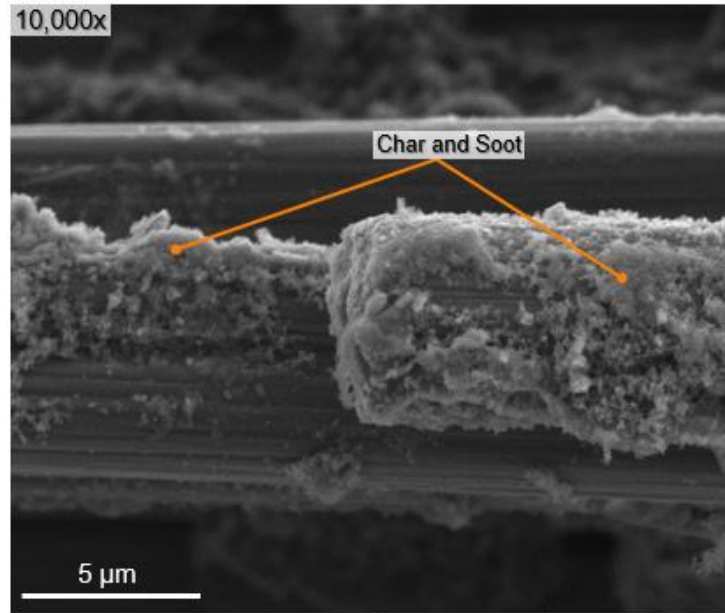
The amount of char formed at the fracture surface of UNCO specimens burned horizontally was different from specimens burned vertically. For horizontal tests, char was only deposited at the fire-exposed edge at the perimeter of the fractured surface. Figure 5.26 shows a typical SEM image of a horizontal UNCO specimen burned for 15 s. No large-scale cotton-candy-like char was deposited at the fractured fiber ends. Some char formed along the length of the extended fibers. SEM images of the fracture surface of UNCO specimens used in the 45 and 75 s horizontal fire tests have not yet

Figure 5.26 SEM image of the char and soot deposition at the fracture surface of a 21-ply cross-ply Cytec Cycom 5215 T40-800 graphite-epoxy cross-ply UNC0 specimen used on 15 s horizontal fire test.

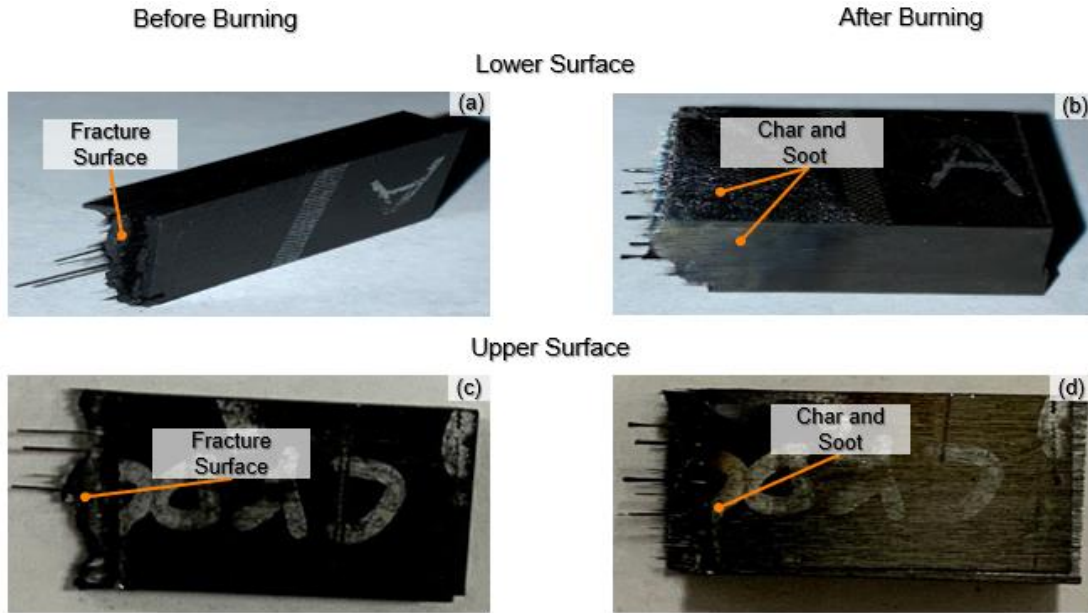
Figure 5.27 shows typical macro-scale pictures of the lower planar surface of a typical SBS specimen before and after horizontal burning for 75 s. The outermost ply exposed to direct flame (Figures 5.27a, b) sustained far more fire damage than did the interior plies. The lower edges of the fracture surface and lateral sides of the specimen also displayed proportionally more matrix decomposition than points more removed from the fire-exposed surface; this was particularly true for regions directly immersed in flame. In contrast, the upper outer ply and upper (unexposed) surface (Figures 5.27c, d) showed little fire damage at the proximity of the fracture surface.

Figure 5.27 Pictures of a 45-ply unidirectional Cytec Cycom 5215 T40-800 graphite-epoxy SBS specimen; (a, c) before and (b, d) after horizontal burning for 75 s.

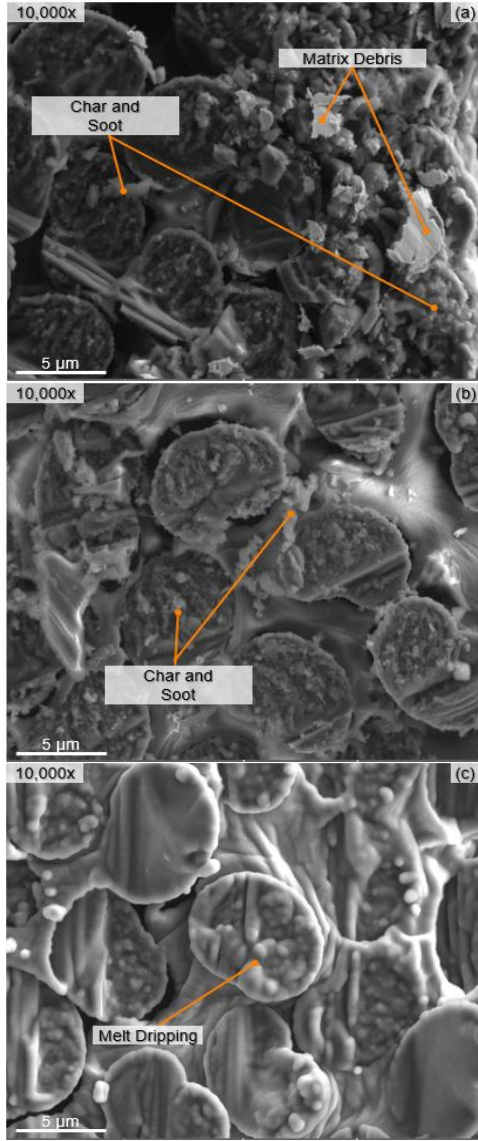
The degree of char formation and soot deposits on the fracture surfaces of horizontally-burned SBS specimens was much lower than that for similar specimens used in vertical fire tests (Figure 5.12). Figure 5.28 shows SEM images of the fracture surface of SBS specimens burned horizontally for (a) 15, (b) 45, and (c) 75 s. For specimens burned for 15 and 45 s, relatively minor amounts of char and soot residues formed on the fiber ends, and tensile failure regions and compressive chop marks were clearly visible (Figures 5.28a, b). For the 75 s tests (Figure 5.28c), many extended and recessed fibers were covered with melt dripping that obscured fracture surface features. In contrast to vertical fire tests where melt dripping by-products flowed

parallel to the fibers (due to gravity) and tended to accumulate at the filament ends, these by-products flowed parallel to the fracture surface in horizontal fire tests. Again, this suggests the relative orientation of both the flame and fracture surfaces affect composite thermal damage development, as well as post-fire forensic assessments.

Figure 5.28 SEM image showing char and soot deposition at the fracture surface of 45-ply unidirectional Cytec Cycom 5215 T40-800 graphite-epoxy SBS specimens used for (a) 15, (b) 45, and (c) 75 s horizontal fire tests.

extended beyond the nominal fracture plane. After fire exposure, any melt dripping that occurs may accumulate on the extended filament ends (Figure 5.8) or coat the entire fracture surface (Figure 5.28c), depending on the fracture surface orientation relative to the flame.

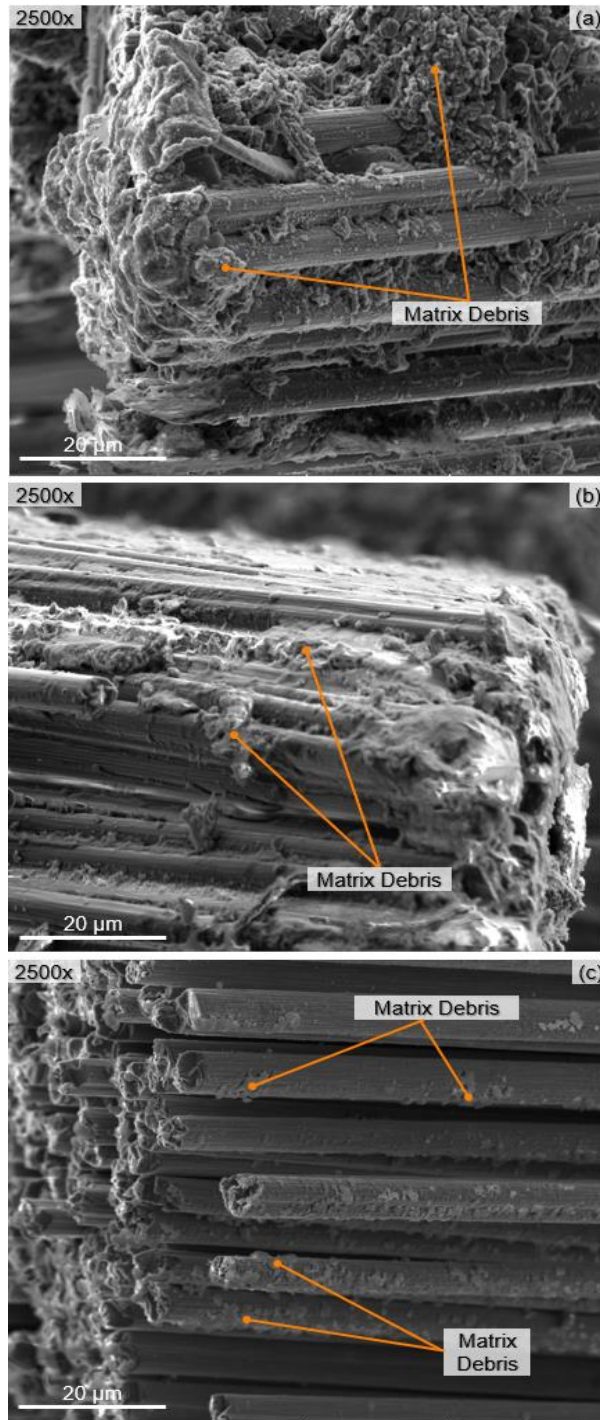
Figure 5.30 SEM images showing fiber tows from the centerline of 16-ply Cytec Cycom 5215 T40-800 graphite-epoxy IPS specimens after horizontal burning for (a) 15, (b) 45, and (c) 75 s.

angled/slant fracture of individual filaments typical of in-plane shear failure was clearly visible (Figure 5.30c). It is obvious that horizontal testing of IPS specimens resulted in significant heat transfer due to convection that *bypassed* the specimen, resulting in far less thermal damage than for the case of vertical burning. These results suggest that under certain circumstances, post-crash fires may leave portions of composite aircraft structures relatively unaffected.

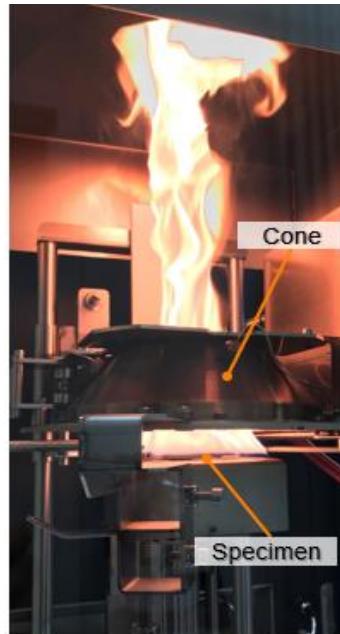
Figure 5.31 Cone calorimetry testing of a 4 x 4 in² 32-ply Cytec Cycom 5215 T40-800 graphite-epoxy CAI specimen.

During cone calorimetry testing, the 4 x 4 in² CAI sample was positioned horizontally *under* the cone (*i.e.*, indirect heat source) and a *through-thickness* heat flux of 50 kW/m² was applied continuously until the specimen self-extinguished. The specimen auto-ignited 81 s after initial heat flux exposure and self-extinguished 373 s after ignition. Figure 5.31 shows the CAI specimen after auto-ignition during cone calorimetry testing. During the test, large-scale matrix decomposition initiated at the upper heat-exposed surface of the specimen and eventually penetrated the entire thickness. After testing, no epoxy matrix or char was visible at the heat-exposed upper surface of the sample, *i.e.*, nearly complete matrix decomposition occurred (Figure 5.32a). The upper 45th ply of the composite appeared to consist of a blanket of *loose* bare graphite fibers (Figure 5.32b), which hindered SEM imaging of the upper surface. The unconfined loose arrangement of fibers at the composite outer surface made the broken and micro-buckled fibers at the CAI failure plane virtually *indistinguishable* from the surrounding fibers, based upon visual inspection. As an aside, *the inability to use visual inspections to precisely identify composite aircraft structural failure locations has the potential to seriously limit the efficiency of post-crash fire forensic analysis.*

During testing, the lower surface of the 32-ply CAI sample rested on a layered structure comprised of a thin aluminum foil, a low-density ceramic wool fiber blanket, and a stainless steel edge support frame. The lower surface of the specimen loosely adhered to the aluminum foil, likely due to melt dripping. After gently removing the foil, some matrix decomposition was apparent in the bottom 45 ply. Please note that detailed destructive micro-sectioning and ply-by-ply SEM inspection of semi-intact interior regions of the sample were not possible due to COVID-19 restrictions on laboratory access.

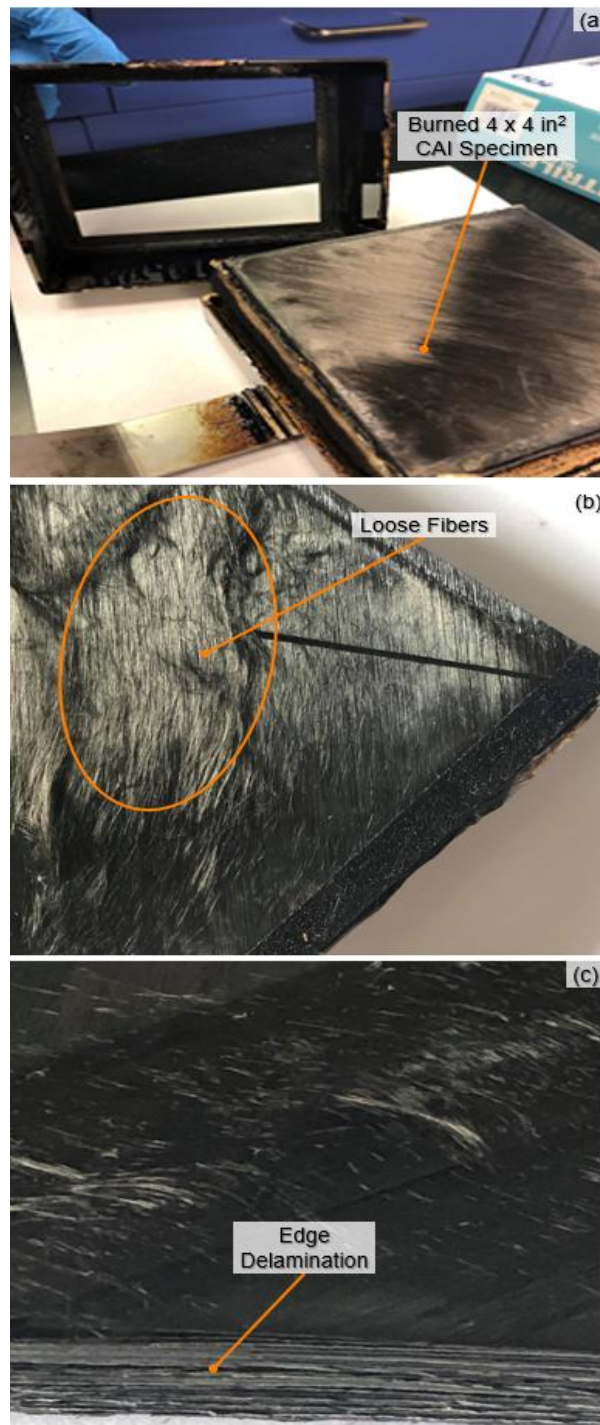
Figure 5.32 (a) 4 x 4 in² 32-ply Cytec Cycom 5215 T40-800 graphite-epoxy CAI specimen after cone calorimeter fire testing using a heat flux of 50 kW/m², (b) zoomed-in picture of the specimen showing loose fibers (c) zoomed-in picture of the specimen showing edge delamination.

During indirect fire testing, the CAI sample also experienced large-scale multi-ply-delamination along all four specimen edges that was most severe along the unloaded edges that intersected the composite failure plane (Figure 5.32c). In addition,

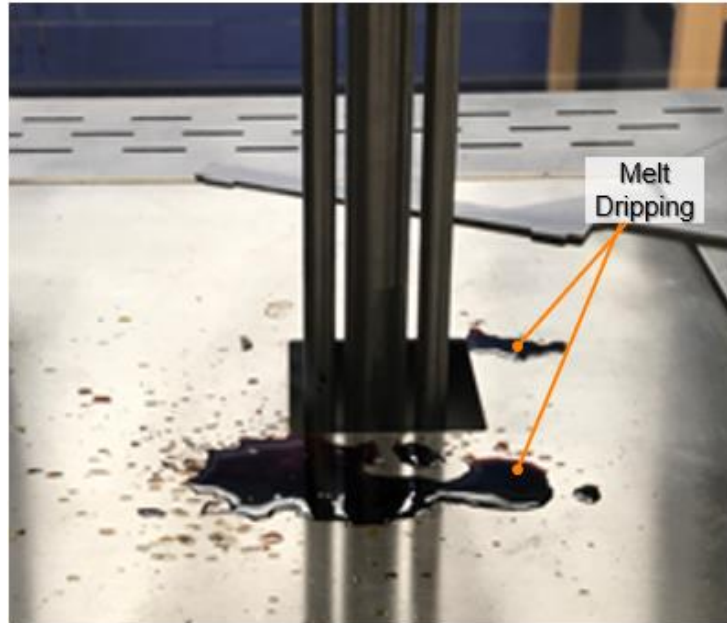
Figure 5.33 Melt dripping from the 4 x 4 in² 32-ply Cytec Cycom 5215 T40-800 graphite-epoxy CAI specimen.

large amounts of melt dripping emanated from the edges of the specimen and flowed onto a horizontal metallic shelf located immediately below the cone calorimeter assembly (Figure 5.33). The melt dripping appeared to be a viscous tar-like substance that solidified after cooling; a melt drip sample was collected and sent to colleagues at Mississippi State University for carbon-hydrogen and nitrogen (C-H-N) and other chemical composition analyses. Such a substance may also have accumulated on extended graphite fiber ends during vertical burn tests on UNCO specimens (Figure 5.8), as well as been the source of interfacial bonding between pairs of mating ¼ SBS specimens subjected to vertical burning (as discussed in section 5.1.2). These issues remain to be fully explored.
