**MARY KAY O'CONNOR  
PROCESS SAFETY CENTER**  
TEXAS A&M ENGINEERING EXPERIMENT STATION

20<sup>th</sup> Annual International Symposium  
October 24-26, 2017 • College Station, Texas

**Study of the Effects of Flow Conditions on the Performance of Corrosion  
inhibitors under CO<sub>2</sub> Environment**

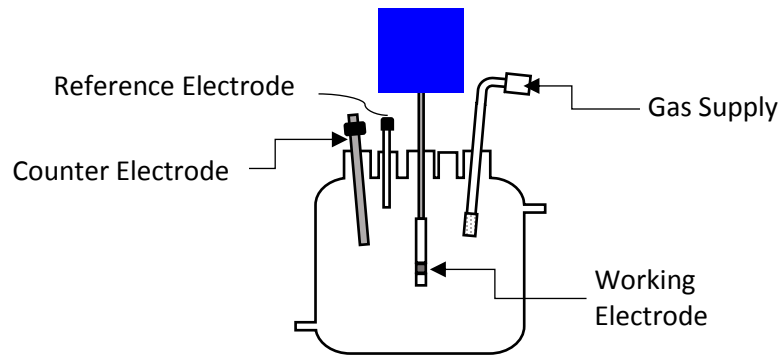
Figure 1. Schematic of a Rotating Cylinder Electrode (RCE)

The apparatus used for the test was a 12 mm outside diameter rotating cylinder electrode (RCE) by PINE Research Instrumentation. The basic diagram of the setup used is shown in Figure 1.

This instrument is convenient in the study different flow conditions as it allows to move the metal sample respect to the fluid to simulate different turbulent conditions at low velocity (PINE Research 2016). It is possible to adjust the hydrodynamic conditions in the pipe by varying the rotation rate in rpm to mimic Reynolds Number or Wall Shear Stress. The transition from laminar to turbulent flow in an RCE corresponds to a Reynolds Number of 200 approximately (PINE Research 2016).

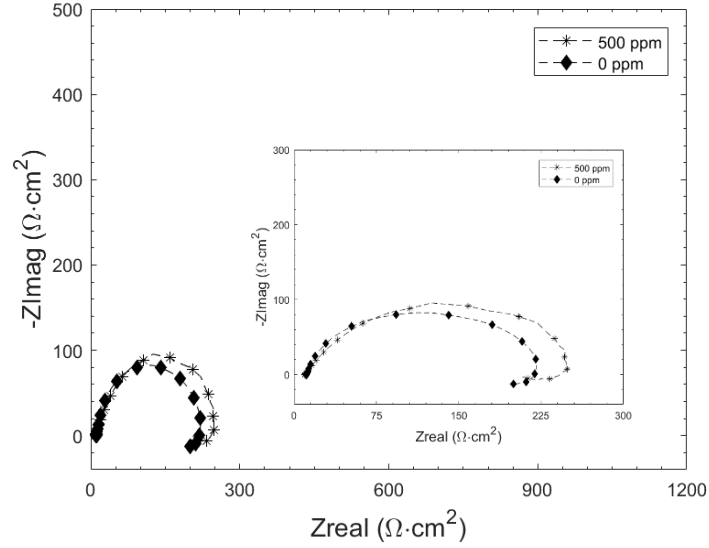
Figure 3e. Comparison of Nyquist plot for carbon steel C1018 in 3.5% NaCl under CO<sub>2</sub> after 1 h immersion: ♦ no inhibitor (0 ppm) and 500 rpm, \* 500 ppm inhibitor and 500 rpm

Figure 3e shows the comparison of the Nyquist plots at a rotation of 500 rpm. We can observe an increase in the diameter of the curve once the inhibitor is added which can indicate higher charge transfer resistance in presence of inhibitor. This hypothesis will be further investigated by using different concentrations of inhibitor and performing surface analysis.
