## Measured Crawlspace Conditions Under Manufactured Homes

**David Beal**  
Research Analyst

**David Chasar**  
Research Engineer  
Florida Solar Energy Center  
Cocoa, Florida

### ABSTRACT

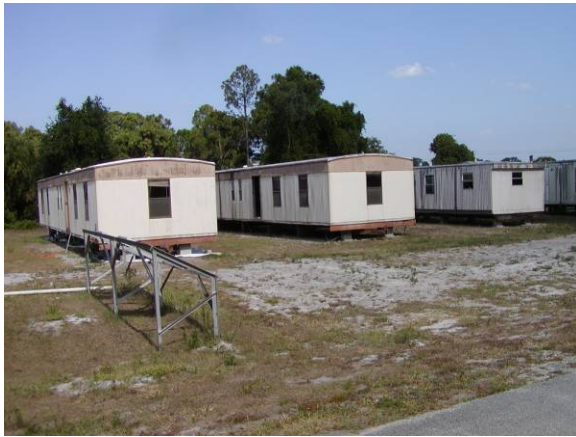
**Figure 1** The Three experimental houses

The three singlewide homes are sited side-by-side at the site (Figure 1). Two of the homes are virtually identical 14' by 60' units, and the third is a 12' by 60' unit. One of the homes had to be moved into place for the three homes to be side-by-side, so when this was done a ground cover of 6-mil polyethylene was installed under the house (Figure 2). All houses were in poor condition, with badly breached rodent barrier (an air barrier installed under the home's floor insulation, isolating the home from the crawl space) and rotten spots in all three floors. For the sake of uniformity between the houses, it was decided to remove the floor's rodent barrier and insulation from all homes and remove all interior walls from the homes. When this was done the bad spots in the floor were repaired, and new vinyl flooring was installed on all three homes, creating a

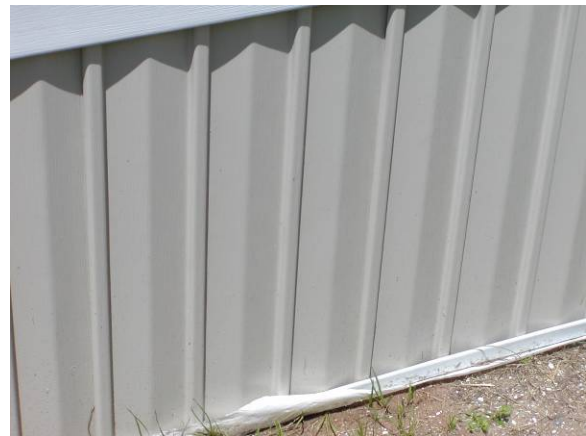
**Figure 5** Solid skirting

Test three (Figure 5 and 8) employed solid, un-perforated skirting. We were unable to measure how airtight the crawl space was or whether the ground cover completely covered the ground. Hurricane Jeanne destroyed the test configuration before air tightness measurements could be taken.

However, we believe these crawlspaces were typical of poorly vented crawls one might find under a manufactured home.

The results of these tests are presented below (Figures 6-8); three different crawlspace configurations chosen as representative of what is found in the field. The first test conducted was of open crawlspaces (Figure 2 and 6) with no skirting. As many local codes and park regulations prohibit un-skirted homes, the other tests used skirting. First tested was "standard" perforated skirting (Figure 4 and 7). Trends observed in the field are revealing more and more homes with the siding run all the way down to the grade level, or a solid faux rock skirting used. The result of these practices is a poorly vented crawlspace, simulated for these tests with solid skirting (Figure 5 and 8).

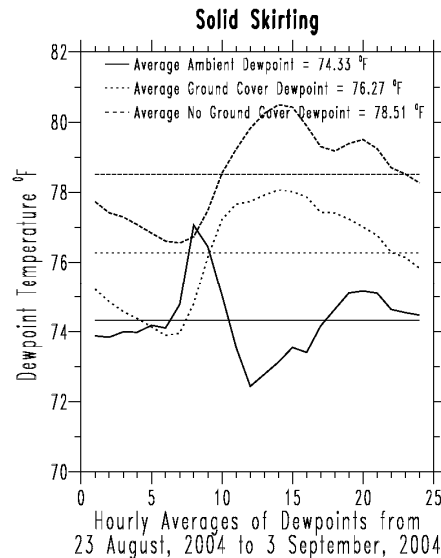
**Figure 8** Dewpoints with solid skirting

As can be seen from the graphs, skirting installations increase the dewpoint under manufactured homes. Solid skirting (Figure 8) installed on a home without a ground cover increases the dewpoint under homes above the ambient dewpoint on average 7°F or more from 12 noon until 15:00. Installation of a ground cover mitigates this dewpoint increase, but crawlspace dewpoints are still increased over 5 °F during the same time period.
