WESTERN LEDGE REEF WRECK: THE ANALYSIS AND RECONSTRUCTION OF
THE LATE 16TH-CENTURY SHIP OF THE SPANISH EMPIRE

A Dissertation

DOCTOR OF PHILOSOPHY

May 2012

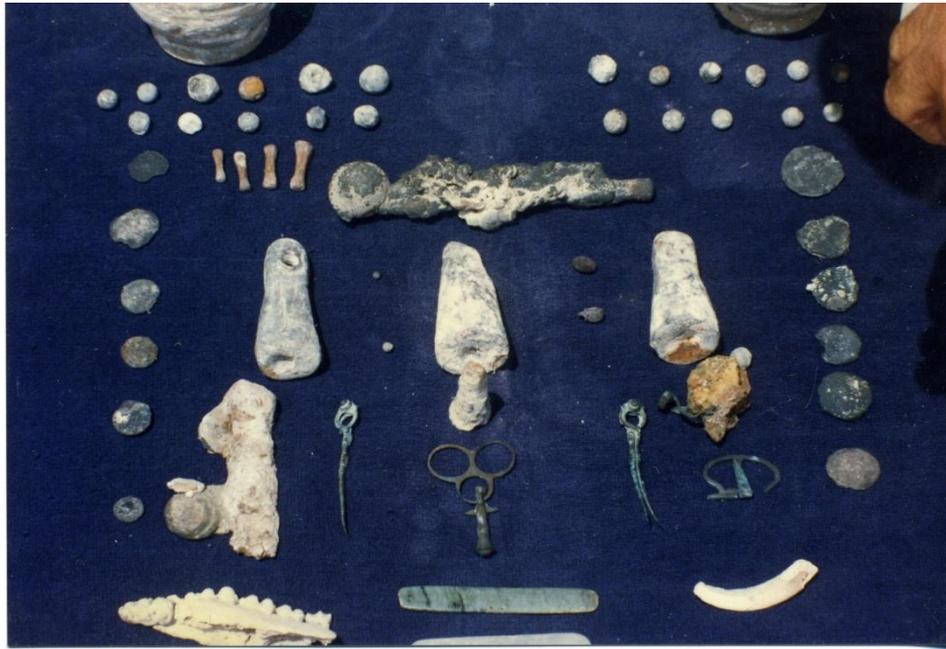
Figure 3.2: Selected artifacts from Malpas collection. (photo courtesy of NMB)

Although largely undocumented, this legally permitted operation (based on Bermuda's Wreck and Salvage Act of 1959) produced several significant finds, kept by Malpas, forming his extensive personal collection (fig. 3.2).² These include at least twelve intact olive jars, fragments of *majolica* and Columbian Plain ceramics, twelve heavily encrusted silver coins which could not be identified or dated, a total of seven pieces of ship's ordnance, iron and lead round shot of different caliber, three anchors, a ship's bell, three sounding leads, a jade amulet, a bosun's whistle, and numerous other smaller pieces (see Appendix 1). Reportedly, all the ship's ordnance was found in one large pile with no evidence of gun carriages and not on top of the hull remains, suggesting that these could have been jettisoned by the crew. Out of the original seven, only four guns have survived, including two wrought-iron swivel *versos* and two cast iron muzzle-loading cannons; they were donated by Malpas to the Bermuda Maritime Museum (BMM) in 1991 (fig. 3.3).³ Due to the fact that one of the recovered cast iron cannons had the number 500 and the year 1577 inscribed slightly forward of the touchhole, the general site was often referred to as the "1577 Wreck" (fig. 3.4). This was an alternative name to the Malpas Wreck.⁴

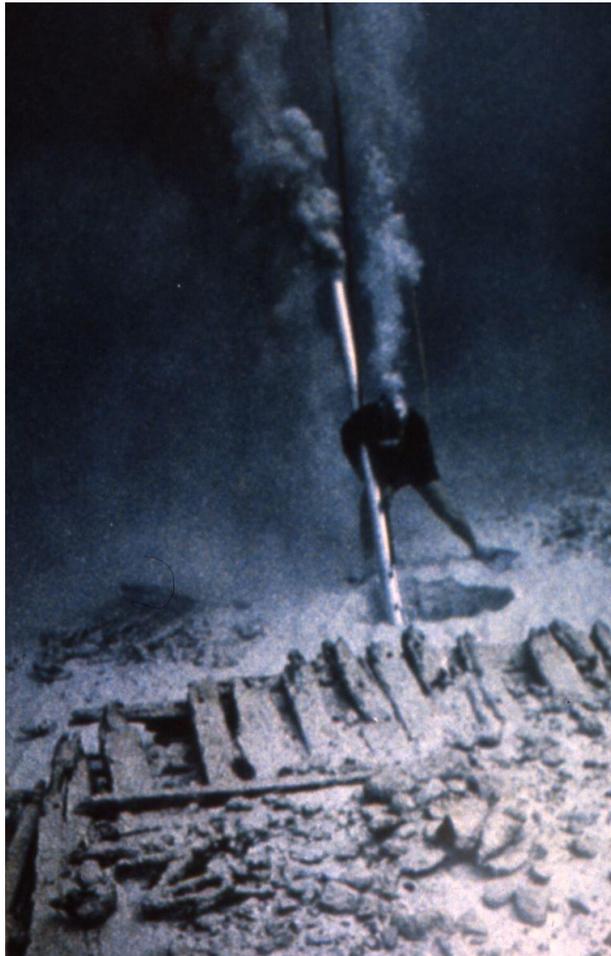
Figure 3.5: Photograph of the salvage work carried out on the Malpas Wreck.
(Peterson 1977, 728.)

Malpas claimed that he and his associates exposed the entire extant section of the shipwreck, constituting a rectangle approximately 10 m long by 5 m wide. The structure appeared to represent part of the starboard side of the hull, including a preserved fragment of the stem (fig. 3.5). The section was comprised of at least 19 framing timbers preserved from the turn of the bilge to the level of the second futtocks and possibly beyond. On average, these had roughly square cross-sections. Based on the relative scale of the photographs they measured between 21 cm and 27 cm molded width. Although the framing timbers showed distinct overlapping between the futtocks, the pattern was quite vague. Significantly, Malpas indicated that he never found evidence of dovetail scarfs joining the framing elements. Other exposed timbers included a few ceiling planks, a possible stringer, and about five external planks (fig. 3.6). Except some limited weekend excavations, Malpas and Canton were not concerned about the structural details of the vessel but rather in combing the vicinity of the wreck as well as the sand underneath the timbers for artifacts, which when encountered they occasionally raised.⁶

found during the survey appeared to be a well-preserved lower hull of a smaller vessel. Due to spatial proximity, however, confusion arose over time; investigators supposed a tentatively identified starboard section of the Malpas Wreck and a bottom section of newly discovered IMHA-3 Wreck could be parts of one and the same vessel.¹¹ This suggestion surfaced from time to time in conversations, but could never be validated. The fact that these were two separate shipwrecks sharing the same sand hole was finally confirmed by the author in a series of interviews with Malpas, Tucker, Dr. Philippe Rouja, and Anson Nash conducted between 2007 and 2011, review of the original survey journals, notes, drawings, and sketches from 1988 and 1989, and detailed analyses of large prints of the original photographs of both shipwrecks, which were digitally remastered in a professional studio (refer to fig. 3.5, fig. 3.6).

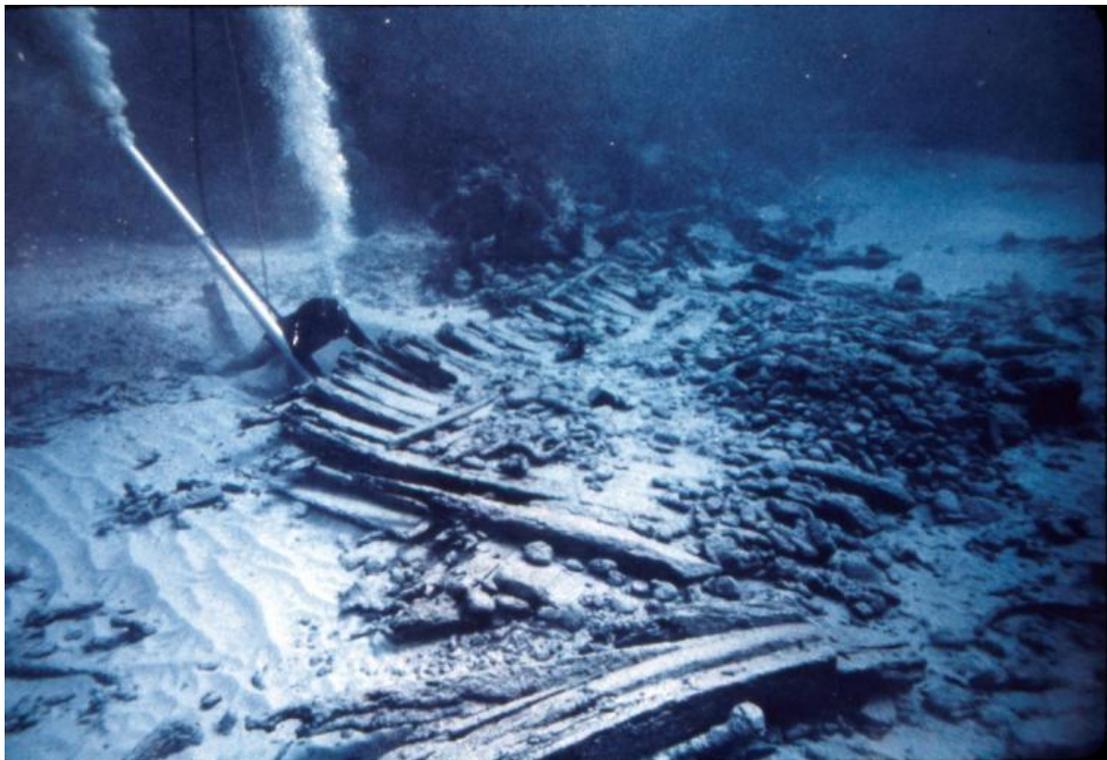
Figure 3.6: Photograph of the Malpas Wreck showing the full extent of the preserved hull. (Benchley 1971, 116-7.)

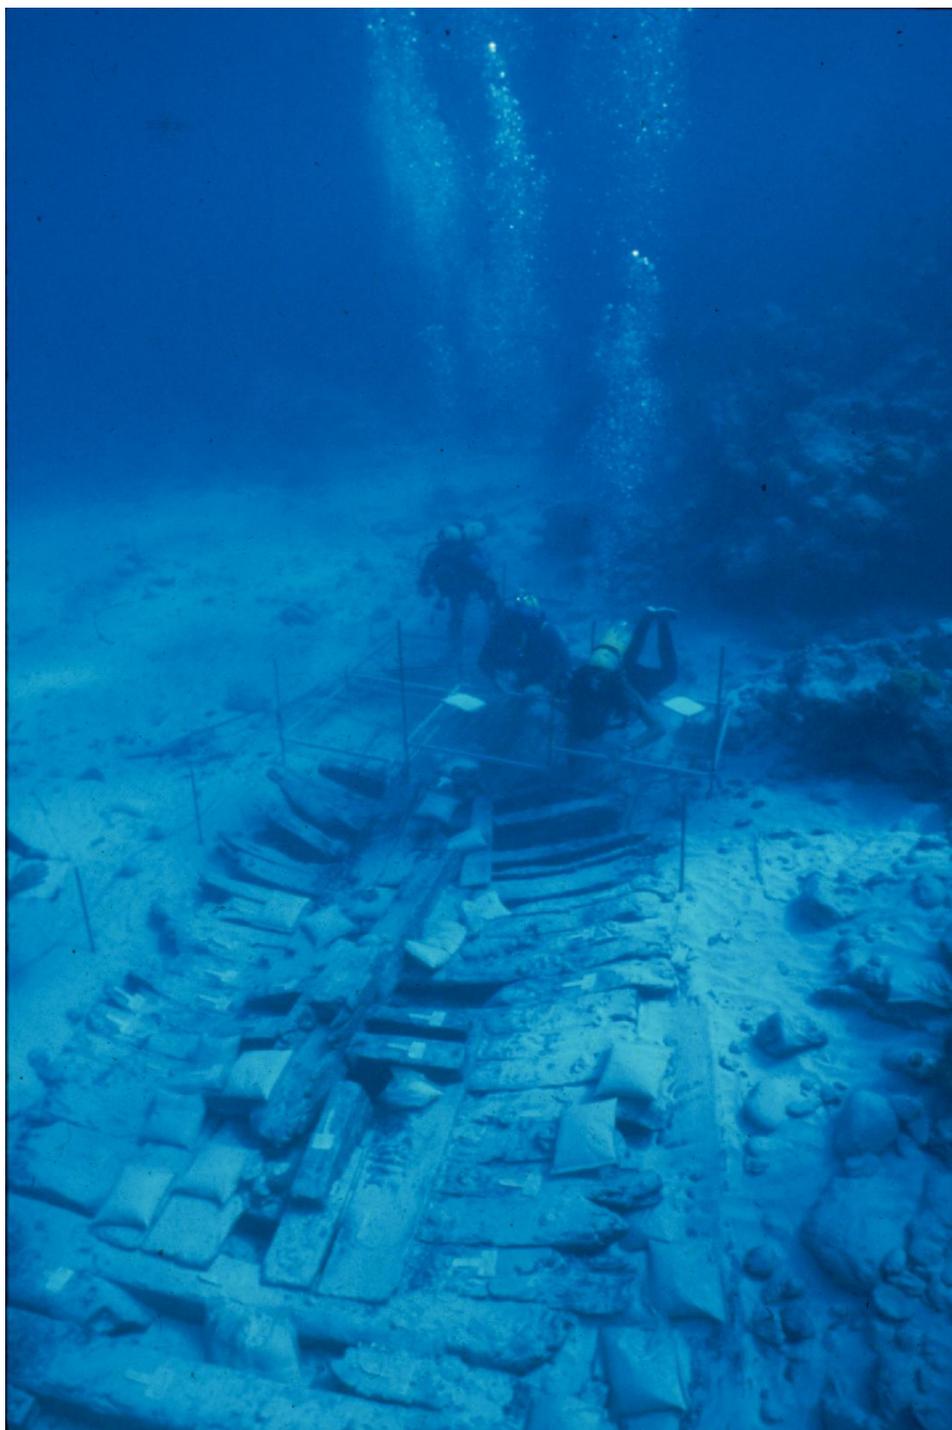
Figure 3.8: Exposed hull remains of the Western Ledge Reef Wreck (IMHA-3). (photo courtesy of NMB)

Upon completion of the 1988 survey, the partly exposed midship of IMHA-3 was photographed and sketched. Based on the uncovered mast step assembly and coarse earthenware sherds recovered from undisturbed ballast, the structure was tentatively identified as belonging to the 16th century Iberian tradition, although it could be dated as late as the 17th century. The vessel was well-preserved from the main mast step forward and aft based on the overall length of the unexcavated ballast pile. This assessment prompted the BMM director, Dr. Edward C. Harris, to broker an agreement with the original permit holders allowing systematic scientific excavation of the site by an international team of archaeologists.

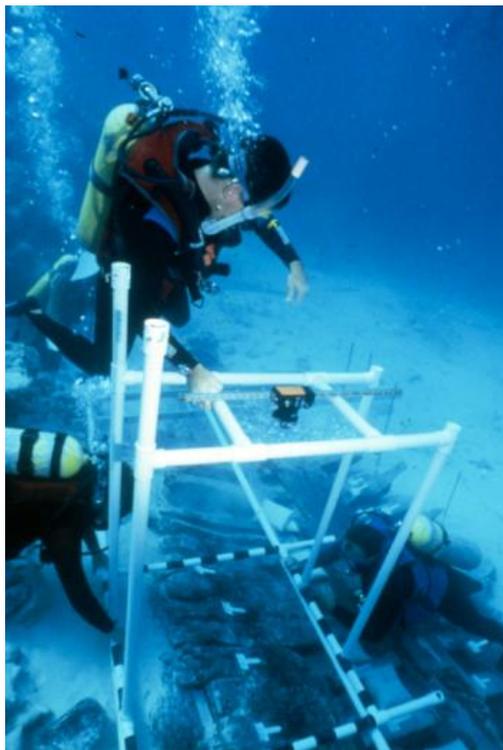
Figure 3.10: Using the grid system to photograph the Western Ledge Reef Wreck during the 1990 and 1991 ECU field seasons. (photo courtesy of NMB)

Over the course of two summers, in 1990 and 1991, the timbers were uncovered and recorded using a three tiered 1 meter grid system erected over the hull and the stern assembly (figs. 3.9 and 3.10). The position of the grid was oriented to the

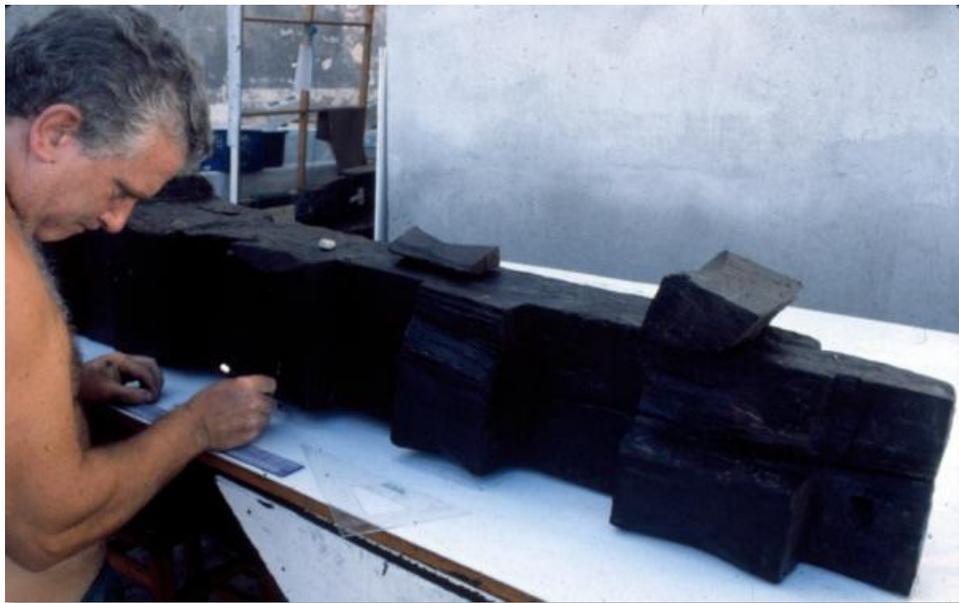
Figure 3.14: Recording the timbers of the Western Ledge Reef Wreck timbers at the Bermuda Maritime Museum during the 1991 ECU field season. (photo courtesy of NMB)

The team managed to complete as many as six drawings per day, depending on the size of the timber, number of sides drawn, cross-sections taken, and the amount of cleaning involved (figs. 3.13 and 3.14). Upon completion of the recording process, the timbers were placed inside wet storage tanks for initial desalinization. Shortly thereafter further progress of the project was delayed and then completely discontinued; thus, the final analysis of the hull structure and conservation of the timbers remained unfinished.

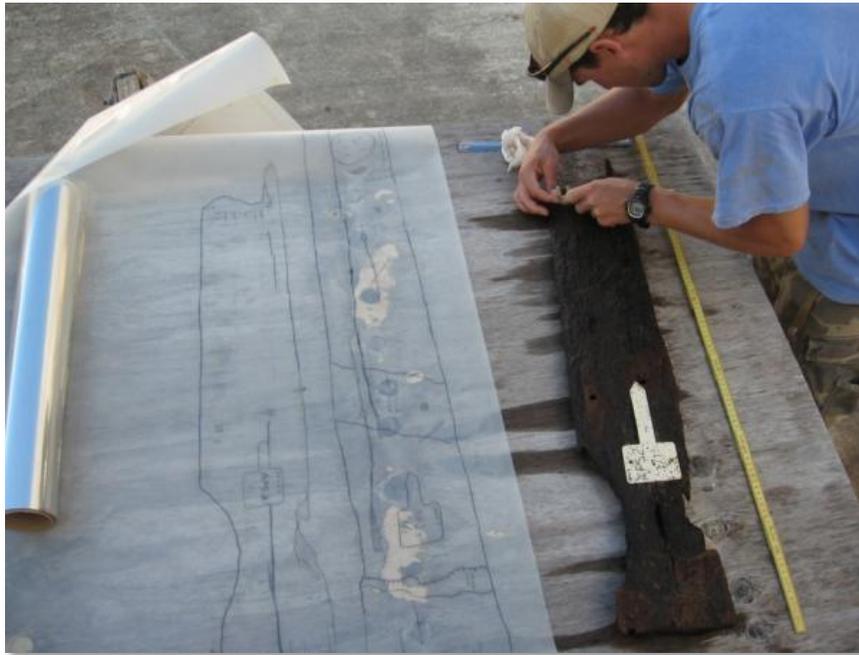
Figure 3.15: Piotr Bojakowski checking the measurements of the timbers in 2007 against the drawings produced in 1991.

During the 2007 field season the team began assessing the physical condition of the IMHA-3 timbers stored in three concrete wet storage tanks on the museum grounds (figs. 3.15 and 3.16). The level of external timber deterioration was evaluated using a 2 mm stainless steel pin. Even though it was a subjective method, the pin tests proved to be an expedient way to assess the approximate degradation level of the waterlogged wood. Depending on the timber surface, the pin measurements ranged consistently between 10 mm and 12 mm. To evaluate the level of internal timber deterioration, core samples were taken with an incremental wood borer. These samples are currently awaiting further chemical tests; hence, they could not be included in this dissertation. Regardless of the outcome of this dissertation's analysis, conservation of the timber

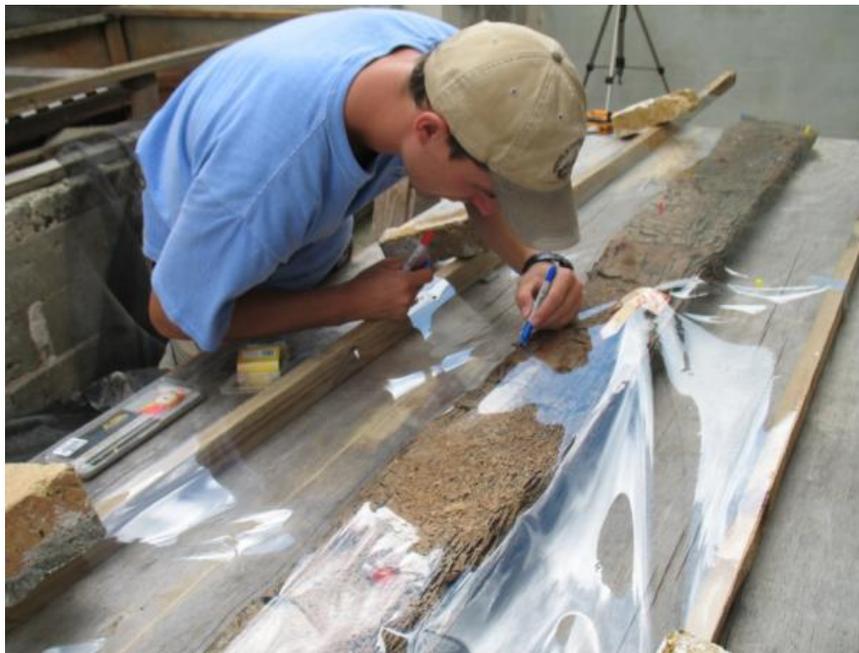
Figure 3.16: Piotr Bojakowski creating a 1:1-scale drawing of a timber to check for distortion and shrinkage against the drawings produced in 1991.

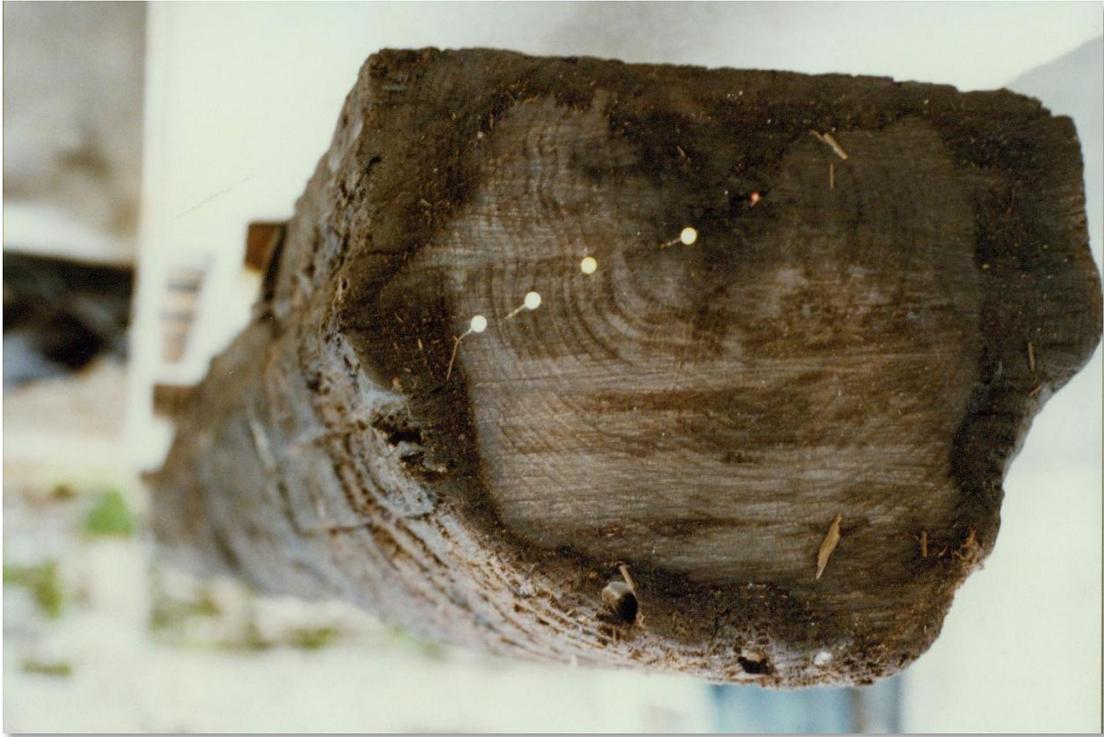
Figure 4.3: View of the tree-rings along the bow face cut along the central section of the keel. (photo curtsey of NMB)

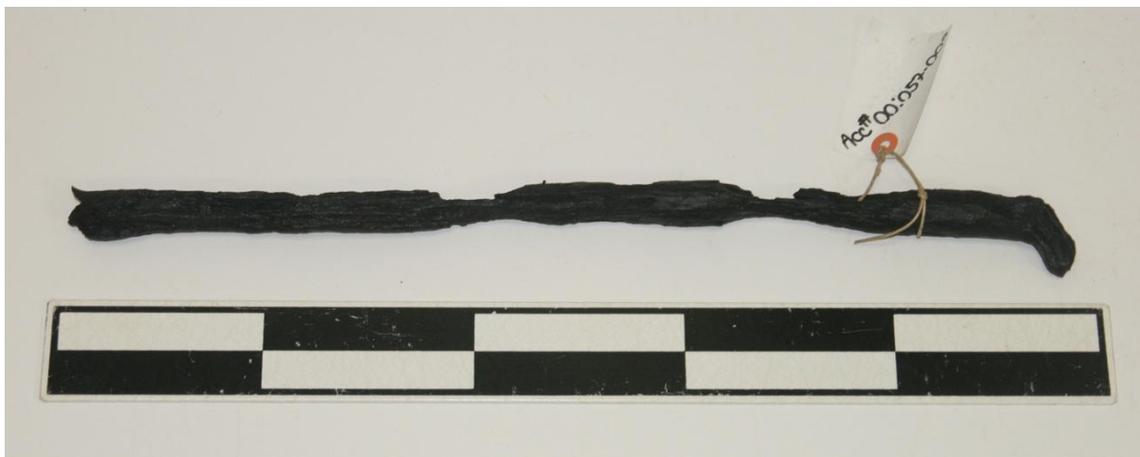
Figure 4.7: Preserved section of a wrought iron bolt with clenched tip (00:057-009) (one scale unit equals 10 cm).

Like the bolts from the Molasses Reef Wreck collection, those studied here fell into two size groups, with the differentiation based on the maximum shank diameter.²⁸ The first group includes those that measure 26 mm or less, while the second includes those that measure between 26 mm and 29 mm (refer to table 4.4). One of the preserved bolts from the first group measure 49 cm in length, 25 mm in diameter and has clenched tip (fig. 4.7).

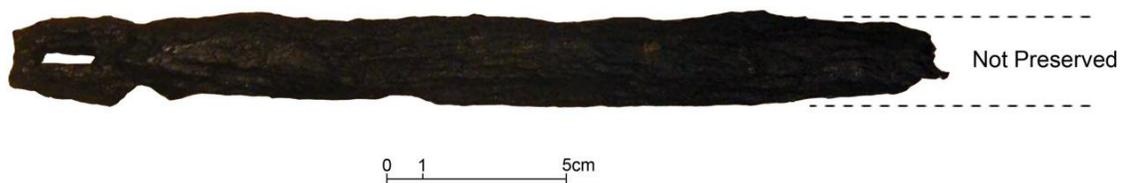
Figure 4.8: Partly preserved forelock bolt (00:057.013).

Upon closer examination, a few of the impressions indicate the presence of a forelock bolt type. These are associated with countersunk heads located outboard and impressions of about 50 mm diameter rings inboard. As illustrated by a poorly preserved and broken epoxy cast of a forelock bolt, its extant shank diameter is about 25 mm, while the forelock slot measures 17 mm in length by 4 mm in width (fig. 4.8). Both types of bolts were driven into pre-drilled holes; this is based on the evidence of a mistakenly produced partial hole in floor timber A (FR A) which had to be drilled from the inside of the structure. These holes could be drilled and the bolts inserted and secured only after most of the hull timbers, particularly the keel, both stem and sternpost, frames, keelson, and possibly some planking, were assembled. As such, they functioned as a permanent fixture binding the keel and keelson through the floor timbers, as well as the heel, stern knee, and the sternpost.

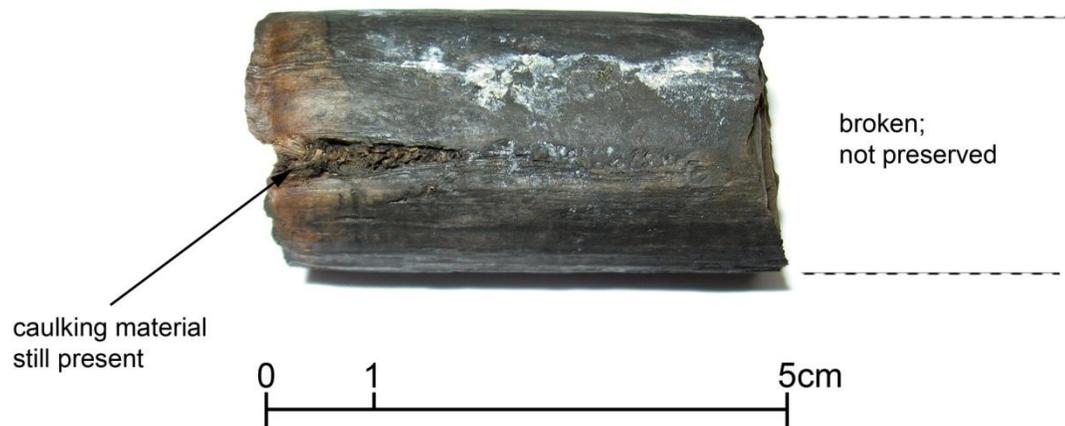
Figure 4.10: Example of a partly preserved treenail with a V-shaped caulking cut and caulking material.

Another interesting aspect of the treenails associated with the lower planks is the presence of black residue, possibly pitch or tar. It appears that before being inserted, the treenails were covered with some unidentified resinous substance perhaps as a measure against leaking. In addition, a 65% of treenails found on the Western Ledge Reef Wreck were also caulked, but not wedged, in a similar fashion as those from the *Mary Rose*.²⁹ With wedging, a wooden wedge, plug, or peg is driven into a treenail from outboard, inboard, or from both sides. The outboard ends (the heads) of the treenails from the Western Ledge Reef Wreck, however, were split in a narrow V-shape almost at a right angle to the run of the planks. These caulking cuts formed either a single line or two perpendicular lines resembling a cross. The cuts were slightly expanded by being tightly packed with what appeared to be a type of fibrous material similar to oakum (fig. 4.9). Based on the investigation of a sample of treenails that could be removed from the planks, the depth of the caulking cuts is quite inconsistent and ranges anywhere from 5 mm to about 20 mm (9% to 36%, respectively, of the average planking thickness) (fig. 4.10). These depths are only slightly shallower than the depths of the caulking scars at the plank edges, which suggests that both were done by the same group of workers as a part of the same process. It is unknown, however, why only some and not all the

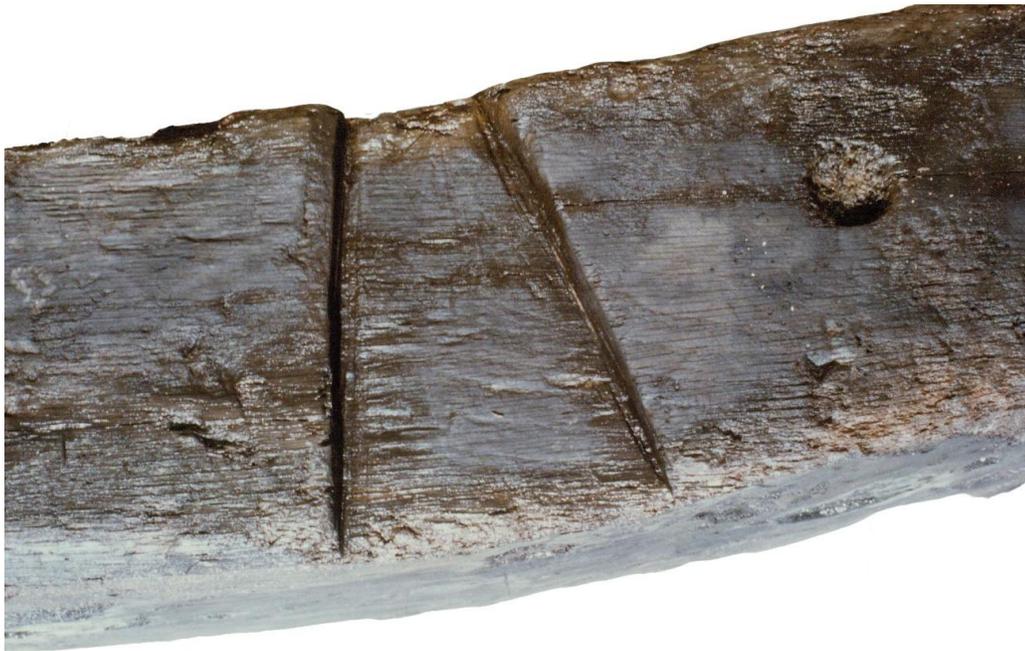
Figure 4.28: Example of the dovetail mortise on the port side of floor timber A. (FR A)

The scarfs have a basic trapezoidal shape with the inboard edge parallel to the vertical center line of the frame and the outboard edge angled (fig. 4.28). They are narrow and measure 6 cm to 8 cm on top, expanding to between 11 cm and 14 cm on the

bottom. Since the top is smaller than the bottom, these were put together by sliding the tenoned futtock into the mortised floor from below. The joint was first reinforced with the nails and subsequently treenails, for which holes had to be drilled across the adjoining timbers.

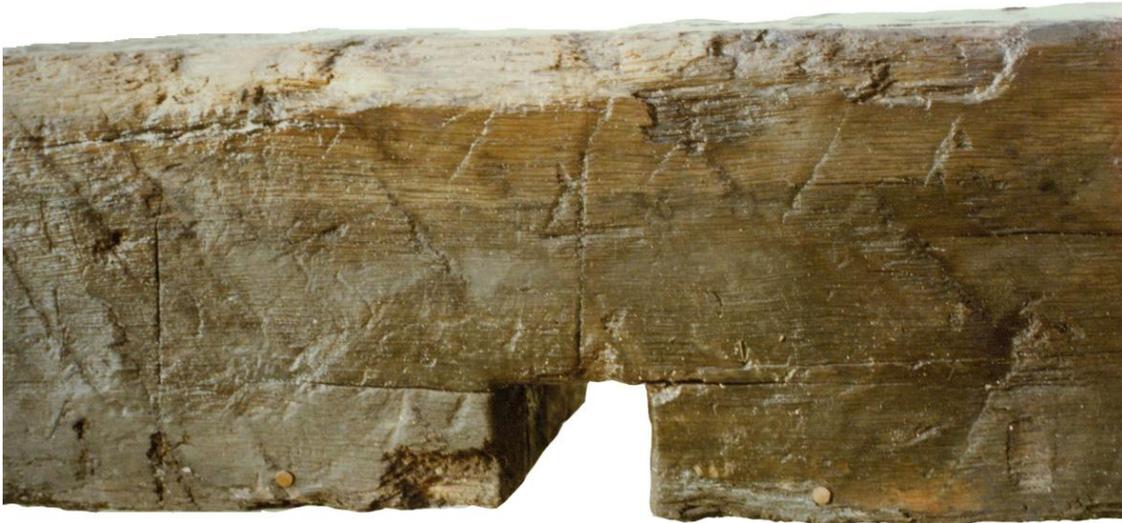
Figure 4.34: Adze and axe marks along the forward face of the floor timber A. (FR A)

The majority of the floor timbers appear to be squared off with broad axes. Fore-and-aft surfaces are evenly adzed diagonally or with the grain. Deviations from this pattern are associated with obstruction areas such as knots or dubbing for attaching the first futtocks. To help seat the planking, the outer surfaces received better quality workmanship and attention to detail. These surfaces were generally adzed across the grains with very regular long strokes producing smooth uniform surface. In the case of dovetail scarfed frames, some of the strokes continue across both the floor timber and the first futtock, providing yet another indication that these frames must have been pre-assembled and fastened to the keel before planking was installed. The inboard and outboard edges of the dovetail mortises were cut with axes, while the more-difficult-to-work interiors were adzed with deeper and shorter strokes (fig. 4.34).

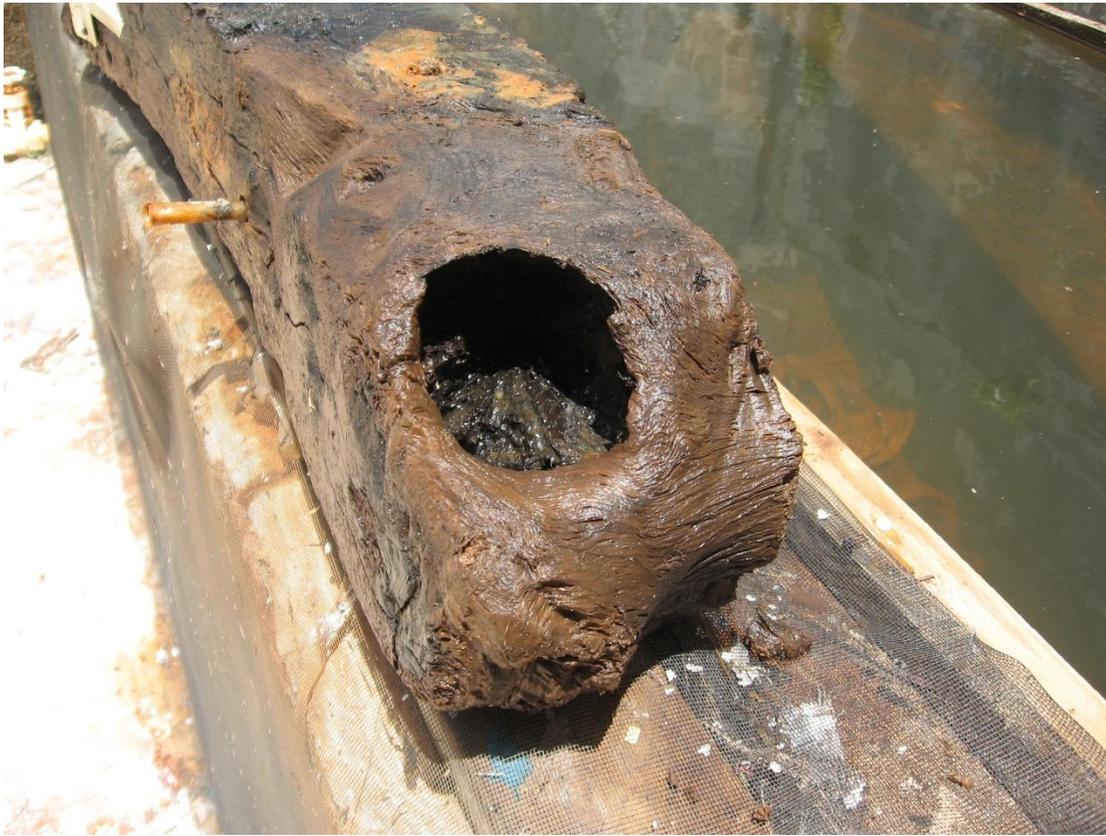
Figure 4.37: Inboard end of the deteriorated portside first futtock of third frame aft (FR 3 P1) showing knots and original branches.

general shape of the original timber, it is evident that these came from compass timbers as well. Despite the fact that the upper and most of the lower ends are broken off, the impression is that the futtocks are either tree roots or branches (fig. 4.37). Although any reliable calculations are problematic, the visual tree-ring count for a sample of futtocks reveals that the timbers came from 32 to 40 years old oaks. The first futtock tenons were first cut with axes, and then the adjacent surfaces were finished with adzes to produce a tight fit with the mortised floor timbers. The tool marks on other surfaces, generally associated with different adzing patterns, closely correspond with what was already noted for the floor timbers. Since most of the extant first futtocks are structural elements of the pre-assembled frames, both floor timbers and futtocks were worked on as units. Except their irregular surfaces and outlines, the short lengths and extreme deterioration of the three preserved floating futtocks prohibit from drawing any reliable conclusions related to their fabrication. The outboard planking surface of the starboard first futtock associated with the sixth frame aft (FR 6) has evidence of a treenail that might have plugged a hole left after removing a ribband fastener. Although inconclusive, the treenail measures 26 mm in diameter and it is the only one, out of five, that does not penetrate the full extent of the timber.

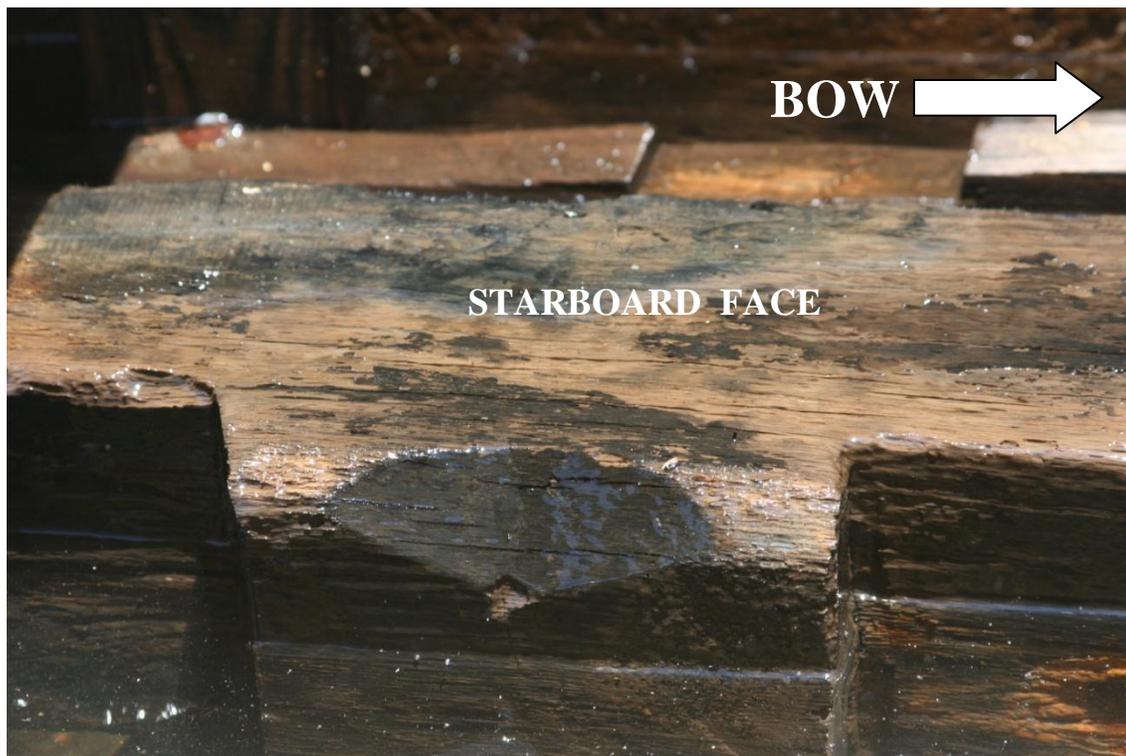
Figure 4.51: Wood between the notches showing reverse-triangle or chevron-shaped finish.

On the starboard side, the wood between the notches shows curious linear cuts, possibly carpenter scribe marks. These may have served as guides in the fabrication process. Additionally, the outboard bottom corners of the wood between the notches are finished with reverse-triangle, or chevron-shaped bevels (fig. 4.51). Although the true function of these beveled edges is still unknown, it is assumed that they could reduce potential wood splitting, but also facilitated access to the space under the keelson for cleaning the bilge.

carpenter marks. These could have been used as guides for the correct cutting of the notches. Additionally, the outboard corners of the wood between the notches are finished with chevron-shaped bevels.

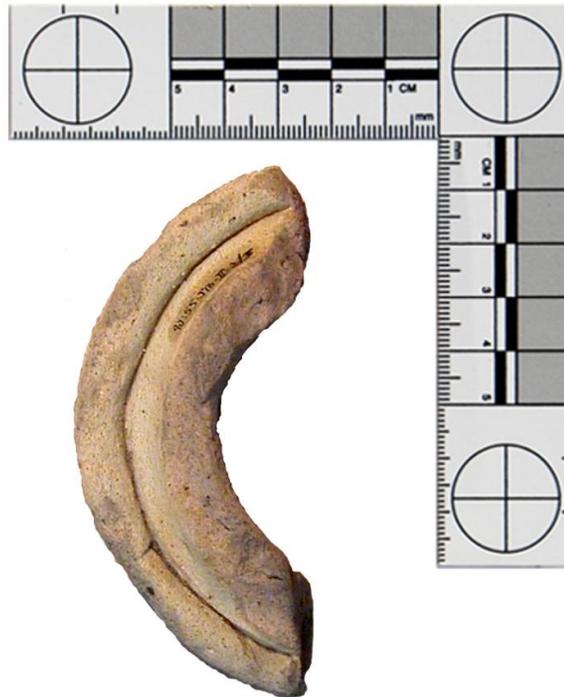
Figure 6.4: Olive jar rim fragment (90:55-J16-2/12).

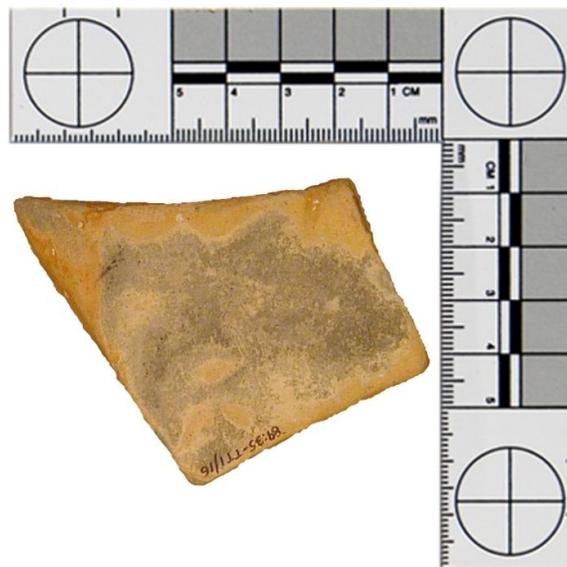
Figure 6.5: Degraded majolica fragment (89:35-TT1/16).

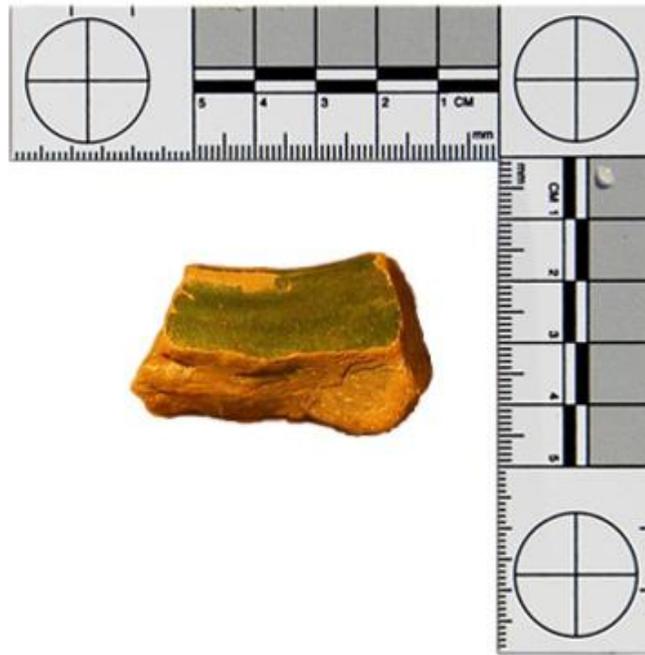
Figure 6.6: Rim fragment of Green Bacín (Green *Lebrillo*). (89:35-SS/30)

Lead-glazing made coarse earthenware vessels less porous and more refined. It was represented on the Western Ledge Reef Wreck by two varieties. The first variety included two body sherds identified as El Morro ware. The second variety included a single, albeit highly diagnostic, rim fragment identified as Green Bacín (or Green *Lebrillo*) from a vessel with a reconstructed inner rim diameter of 14 cm (fig. 6.6). The paste of the El Morro material was red, the interior was covered with yellowish lead glaze, while the exterior had black discolorations of unknown origin. Being utilitarian and quite difficult of date due to irregularities in archaeological reporting, the median range for El Morro ware is between 1550 and 1770.²⁸ In contrast, the Green Bacín rim fragment was characterized by yellowish-cream paste and distinctive green glazing on both interior and exterior. This ceramic type is highly diagnostic and associated with 16th-century context. Deagan maintains that Green Bacín and Green *Lebrillo* have not been reported from any terrestrial or underwater sites after the end of the 16th century, providing a narrow temporal range between 1490 and 1600.²⁹ One of the well-known underwater sites with significant quantities of this ceramic was Molasses Reef Wreck, where Green Bacín and Green *Lebrillo* constituted 24% of all the sherds recovered.³⁰ Although most of the lead-glazed coarse earthenware, particularly Green Bacín and Green *Lebrillo*, had clear Spanish origin, during the late 16th-century Mexico established itself as a major New World production center. Other New World centers associated with El Morro ware were Puerto Rico, Puebla, or Havana.³¹
