## AN ARCHAEOLOGICAL SURVEY FOR THE MILITARY HIGHWAY WATER SUPPLY CORPORATION NORTH SYSTEM 12" WATERLINE LOOP PROJECT IN CAMERON COUNTY, TEXAS

Antiquities Permit 5558

William E. Moore Brazos Valley Research Associates

Contract Report Number 234

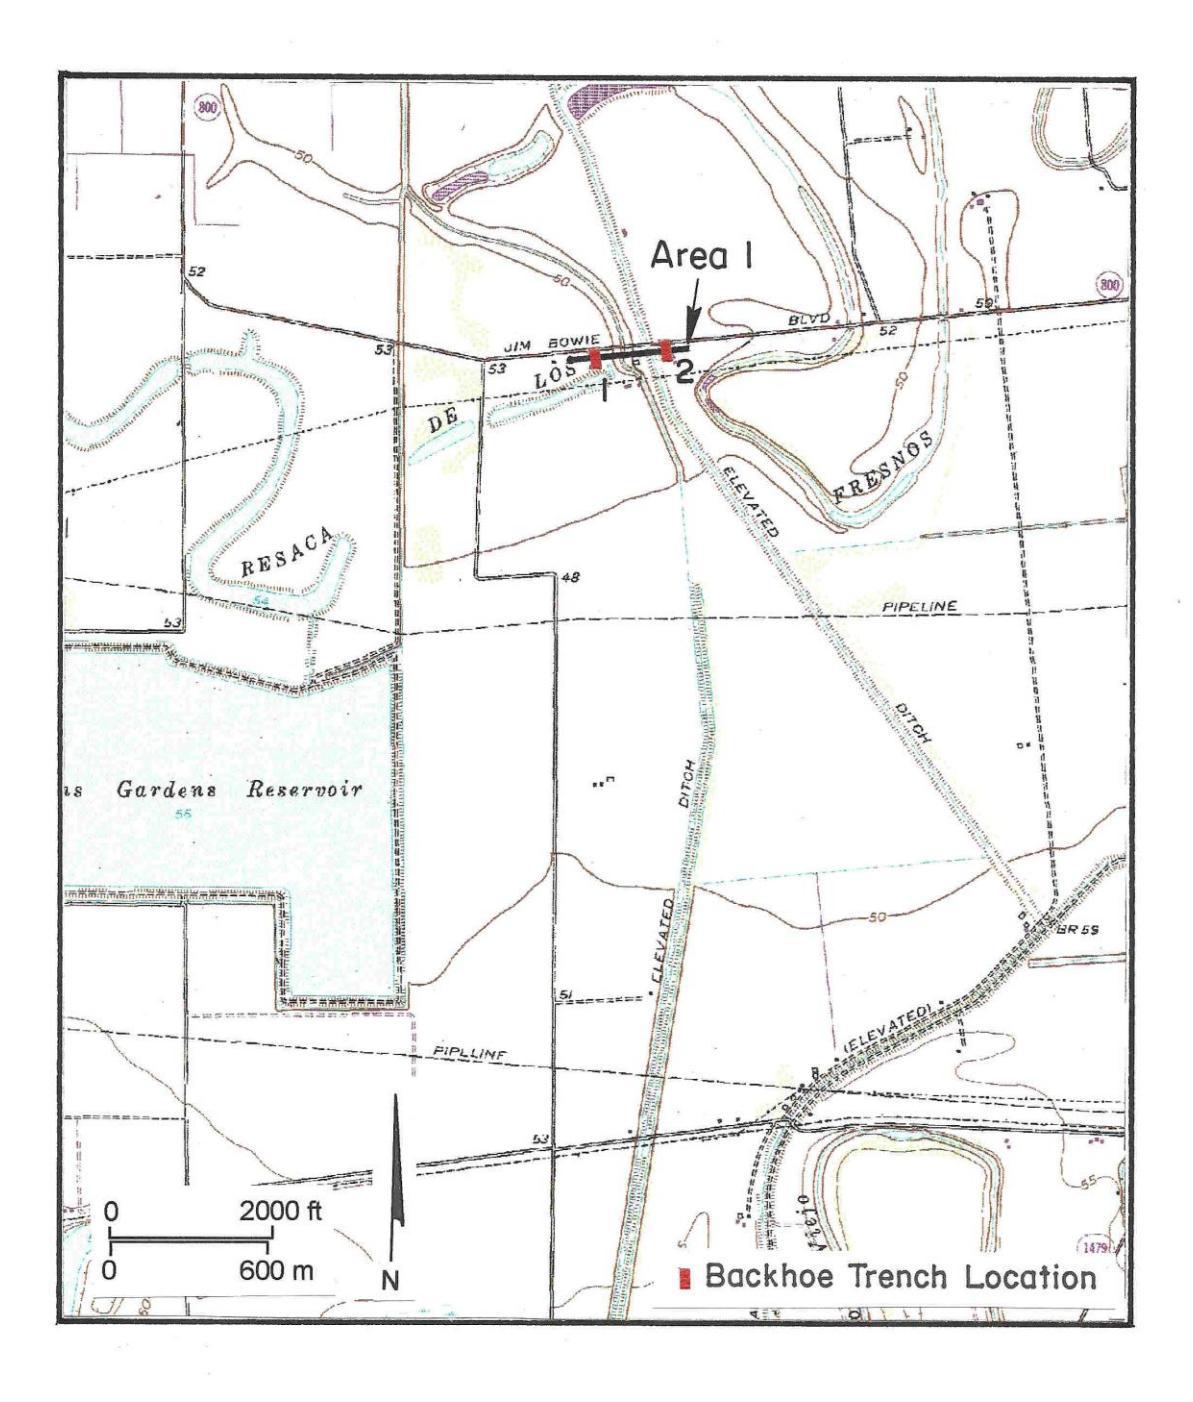
Figure 2. Area 1 and Backhoe Trenches 1 and 2

This trench was excavated on the south side of Farm-to Market Road 800 in the vicinity of *Resaca de los Fresnos* (Area 1) and on the west bank of the *resaca*. It was 5 meters long and 60 centimeters wide and dug to a depth of 1.3 meters. The trench was excavated in arbitrary levels of 30 centimeters, and samples of earth (20 shovels full) were screened using <sup>1</sup>/<sub>4</sub> inch hardware cloth. The soil in this trench consisted of clay loam (10YR 4/4) to a depth of 60 centimeters and clay (10YR 4/5) from 60 centimeters to the bottom of the trench. The location of this trench is depicted in Figure 2 (Area 1).

This trench was excavated on the south side of Farm-to Market Road 800 in the vicinity of *Resaca de los Fresnos* and on the east bank of the *resaca*. It was 5 meters long and 60 centimeters wide and dug to a depth of 1.2 meters. The trench was excavated in arbitrary levels of 30 centimeters, and samples of earth (20 shovels full) were screened using 1/4 inch hardware cloth. The soil in this trench consisted of clay loam (10YR 4/4) to a depth of 50 centimeters and clay (10YR 4/5) from 50 centimeters to the bottom of the trench. The location of this trench is depicted in Figure 2 (Area 1).

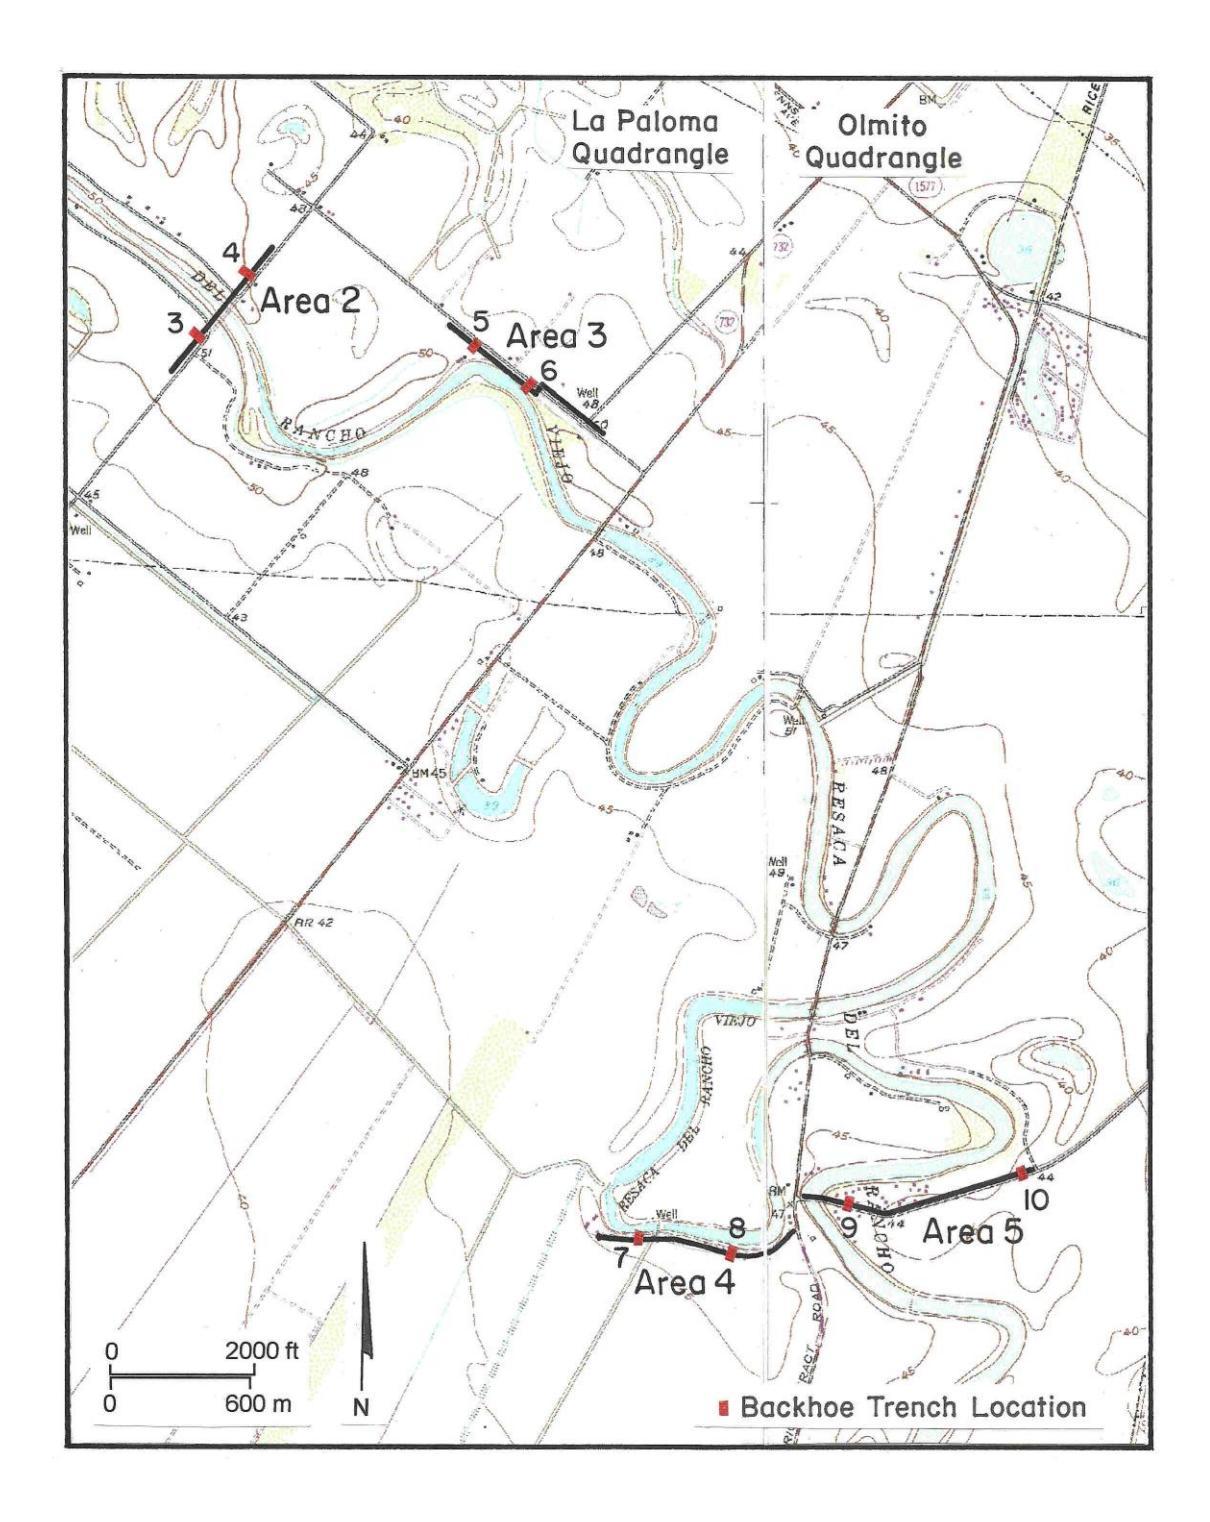
Figure 3. Areas 2-5 and Backhoe Trenches 3-10

This trench was excavated on the northwest side of Gamble Road where it crosses *Resaca del Rancho Viejo* and on the southwest bank of the *resaca*. It was 5 meters long and 60 centimeters wide and dug to a depth of 1.25 meters. The trench was excavated in arbitrary levels of 30 centimeters, and samples of earth (20 shovels full) were screened using <sup>1</sup>/<sub>4</sub> inch hardware cloth. The soil in this trench was clay loam (10YR 4/2) to a depth of 50 centimeters and clay (10YR 5/3) from 50 centimeters to the bottom of the trench. The location of this trench is depicted in Figure 3 (Area 2).

This trench was excavated on the northwest side of Gamble Road where it crosses *Resaca del Rancho Viejo* and on the northeast bank of the *resaca*. It was 5 meters long and 60 centimeters wide and dug to a depth of 90 centimeters. The trench was excavated in arbitrary levels of 30 centimeters, and samples of earth (20 shovels full) were screened using ¼ inch hardware cloth. The soil in this trench consisted of clay (10YR 3/1) over standing water at the bottom of the trench. The location of this trench is depicted in Figure 3 (Area 2).

This trench was excavated on the southwest side of Long Road adjacent to a bend in the *Resaca del Rancho Viejo* and on the north bank of the bend. It was 5 meters long and 60 centimeters wide and dug to a depth of 1.3 meters. The trench was excavated in arbitrary levels of 30 centimeters, and samples of earth (20 shovels full) were screened using ¼ inch hardware cloth. The soil in this trench consisted of sandy loam (10YR 4/1) to a depth of 40 centimeters and loamy clay (10YR 5/3) to the bottom of the trench. The location of this trench is depicted in Figure 3 (Area 3).

This trench was excavated on the southwest side of Long Road adjacent to a bend in the *Resaca del Rancho Viejo* and on the east bank of the bend. It was 5 meters long and 60 centimeters wide and dug to a depth of 1.3 meters. The trench was excavated in arbitrary levels of 30 centimeters, and samples of earth (20 shovels full) were screened using ¼ inch hardware cloth. The soil in this trench consisted of sandy loam (10YR 4/1) to a depth of 40 centimeters and loamy clay (10YR 5/3) to the bottom of the trench. The location of this trench is depicted in Figure 3 (Area 3).

This trench was excavated on the south side of a private road adjacent to a bend in the *Resaca del Rancho Viejo* and parallel to the *resaca*. It was 5 meters long and 60 centimeters wide and dug to a depth of 1.2 meters. The trench was excavated in arbitrary levels of 30 centimeters, and samples of earth (20 shovels full) were screened using ¼ inch hardware cloth. The first 15 centimeters consisted of caliche road material. The soil in this trench consisted of loamy clay (10YR 3/1) to a depth of 40 centimeters and loamy clay (10YR 4/2) with calcium carbonate nodules to the bottom of the trench. The location of this trench is depicted in Figure 3 (Area 4).

This trench was excavated on the south side of a private road adjacent to a bend in the *Resaca del Rancho Viejo* and parallel to the *resaca*. It was 5 meters long and 60 centimeters wide and dug to a depth of 1.3 meters. The trench was excavated in arbitrary levels of 30 centimeters, and samples of earth (20 shovels full) were screened using ¼ inch hardware cloth. The first 15 centimeters consisted of caliche road material. The soil in this trench consisted of loamy clay (10YR 3/1) to a depth of 50 centimeters and loamy clay (10YR 4/2) with clay nodules to the bottom of the trench. The location of this trench is depicted in Figure 3 (Area 4).

This trench was excavated on the north side of a private road that runs parallel to a bend in the *Resaca del Rancho Viejo* and parallel to the *resaca*. It was 5 meters long and 60 centimeters wide and dug to a depth of 1.2 meters. The trench was excavated in arbitrary levels of 30 centimeters, and samples of earth (20 shovels full) were screened using <sup>1</sup>/<sub>4</sub> inch hardware cloth. The soil in this trench consisted of clay (10YR 3/1) to a depth of 70 centimeters and loamy clay (10YR 5/3) to the bottom of the trench. The location of this trench is depicted in Figure 3 (Area 5).

This trench was excavated on the north side of a private road that runs parallel to a bend in the *Resaca del Rancho Viejo* and parallel to the *resaca*. It was 5 meters long and 60 centimeters wide and dug to a depth of 1.3 meters. The trench was excavated in arbitrary levels of 30 centimeters, and samples of earth (20 shovels full) were screened using 1/4 inch hardware cloth. The soil in this trench consisted of sandy loam (10YR 4/2) to a depth of 90 centimeters and sandy loam (10YR 5/3) to the bottom of the trench. The location of this trench is depicted in Figure 3 (Area 5).
