FEASIBILITY TEST OF AN APPROACH AND PROTOTYPE FOR ULTRA LOW COST HOUSING

FINAL REPORT

Interdisciplinary Working Party
Carnegie Mellon University
Pittsburgh, Pennsylvania 15213

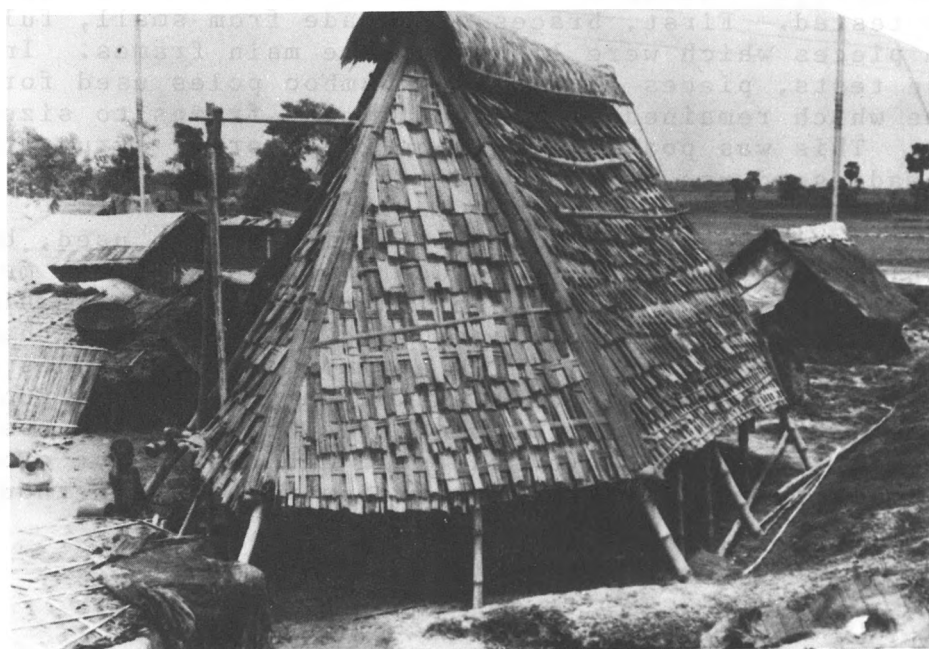
Figure 11. Bustee Camp (Tongi)

3. Tongi Bustee Camp (20 miles north of Dacca) -- One demonstration unit (two-family) was funded by the Presbyterian Mission representative at Tongi following the devastation of the camp by high winds and rain. The team provided supervision of initial construction. The majority of the work was carried out by a contractor of the Mission. The unit was constructed of bamboo frames with bamboo mats and has a 3-foot bamboo floor. Support for the project and continuing interest has been provided by HEED and the Bangladesh Red Cross as well as the camp's engineer. Originally designed for two families, four now occupy the unit due to severe lack of housing in the camp. The government of Bangladesh has announced its intention to build larger units in the low-lying, flood-prone areas of the camp, though to date no funds have been appropriated. The purpose of this test is to test the unit's application as short-term, interim housing in a flood-prone refugee camp environment.

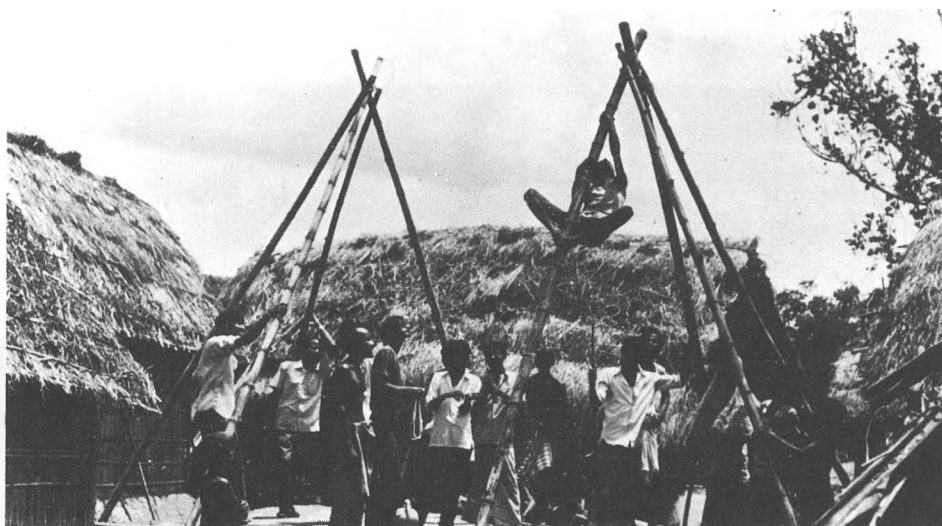
Figure 12. Kunda

C. Village or Rural Housing -- Two units were constructed in a project funded by the Community Development Foundation/ Save the Children Federation at the village of Kunda in the Comilla District. The sites were selected by the CDF local representatives as were the families who were to receive the structures. The purpose of the project was to test the structure as a long-term replacement unit for structures destroyed in natural disasters in rural areas and to test acceptability by local residents. The site selected is one which is repeatedly struck by floods and cyclones, thus the environmental suitability is also observable.

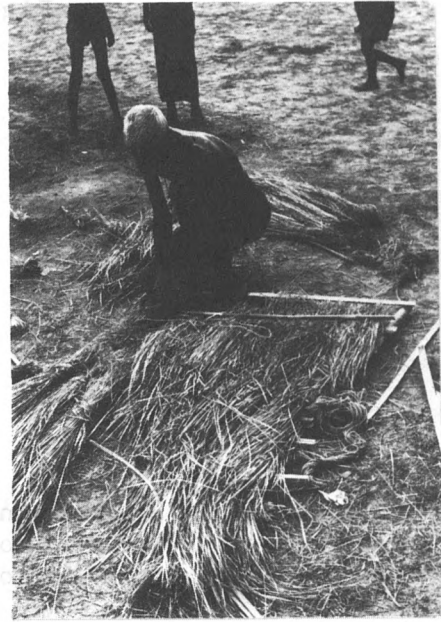
ROOFING TESTS

A variety of roofing techniques were tested, most using strictly indigenous materials but several using a combination of indigenous and synthetic.

Bamboo Shingles: At the Tongi Bustee Camp, and in the first block of structures at the Mirpur Non-local Camp, bamboo shingles made of split, thin culm bamboos were used. These were tied directly to the frame. This proved to be the most expensive method using strictly local materials but offers the most strength. At Mirpur there were complaints that the roofs leaked during the first rains but once the bamboo had swelled the leaks stopped.

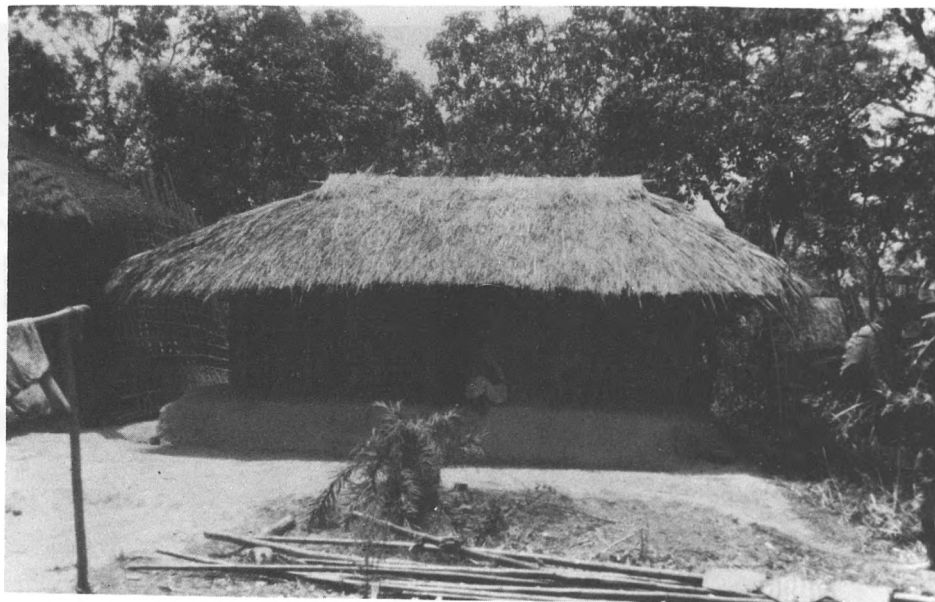
Figure 16
CDF Housing Project

All units were constructed in two Thanas, Rangunia and Mesarai, both in Chittagong District. All recipients were responsible for building their structures and, as no technical or design assistance was provided, units varied in size and design. A typical structure would be a bamboo frame built on a raised plateau of earth stabilized with cow dung. The roof was made of thatched sungrass, the walls of woven bamboo mats. Erection time averaged three days per unit. Total cost of each unit was approximately \$70.

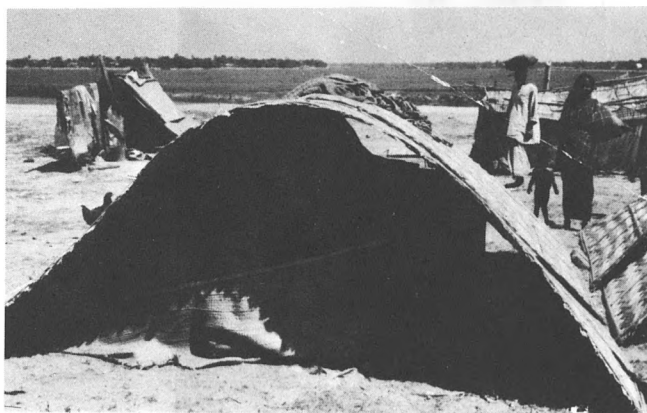
Figure 20
World Vision Housing Program

World Vision Housing Program - In the Bustee Camp at Demra, World Vision distributed one bamboo pole approximately 30' long and one sheet of 10' x 20' bamboo mat (Class II). Distribution was generally for those relocated to the site who had no housing or whose housing was obviously so substandard as to be worthless in the coming monsoon. No technical assistance on methods of erecting or strengthening the units was provided; consequently, most of the units built were of two designs, illustrated below. It should be pointed out that few of these have survived the high winds and that, with only minor assistance such as explaining advantages of proper wind orientation, bracing, etc., many of these units might have lasted longer.
