# EXAMINATION OF PUMP CAVITATION, GEAR MESH AND BLADE PERFORMANCE USING EXTERNAL VIBRATION CHARACTERISTICS

**John S. Mitchell**

Technical Services Manager

Endevco-MHM Division

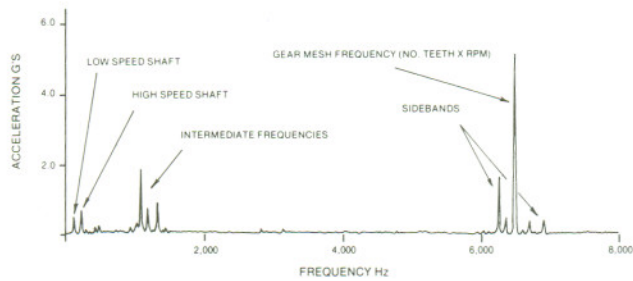
Figure 1. Vibration Signature of a Typical Industrial Double Helical Gear.

In Figure 1, a linear amplitude versus frequency spectrum plot, may be divided into three segments. First are the low frequencies containing running speeds and their harmonics up to approximately the 4th or 5th order. Next, in order of increasing frequency, is a segment beginning at the termination of the low frequencies and extending to a point in the spectrum just below the gear mesh frequency. As shown in Figure 1, a group of synchronous components are often found in this band at frequencies ranging from approximately 1,000 to 2,000 Hz. These components, hereafter designated intermediate frequencies, are likely associated with a resonance and, as will be discussed in later paragraphs, have been prime symptoms of deteriorating mechanical condition.

The final segment contains the gear mesh frequency (number of teeth multiplied by shaft speed) often surrounded by sidebands spaced at multiples of the rotational frequencies.

Although omitted from Figure 1 to enhance resolution, it is not uncommon for the gear mesh frequency to be followed by a harmonic series of its own as illustrated in Figure 2.

Likewise omitted from Figure 1 is the tooth repeat or hunting tooth frequency which may be produced when a deformed tooth or area on the gear meshes with a similarly deformed tooth or area on the pinion. The hunting frequency may be calculated from the following:

In addition to the characteristics discussed thus far, Figures 1-3 each contain spectral components in the vicinity of 1,500 Hz. Observed at varying amplitudes, roughly equivalent to the rotational frequencies, these components typically appear at multiples of the rotational frequencies between 1/3 and 1/2 of gear mesh and hence do not correlate to any obvious mechanical event. During one analysis, an order of magnitude increase was noted in the amplitudes of the intermediate frequencies compared to those recorded approximately six months earlier. Based strictly on the changes noted in the signature, a visual inspection was ordered which disclosed the damaged bearing pictured in Figure 4.

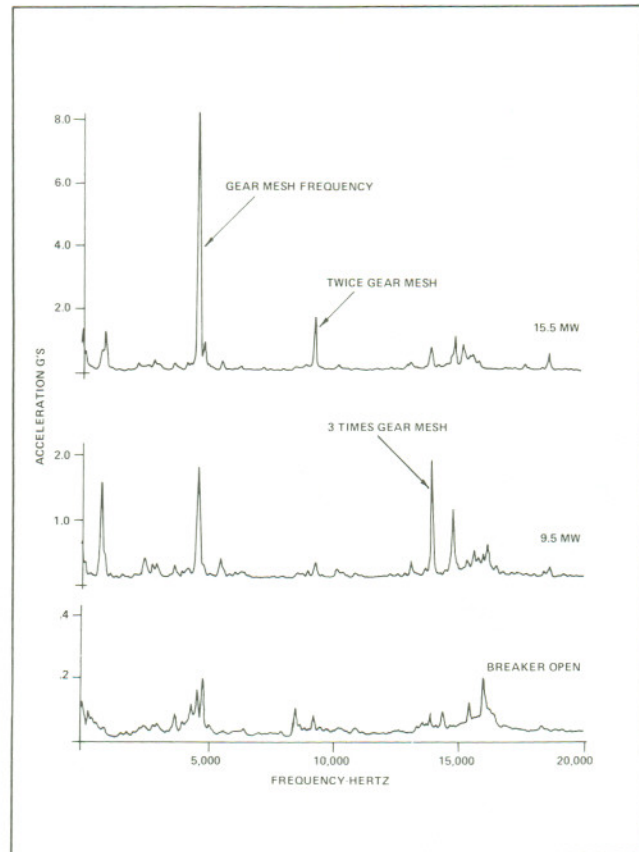
The signatures shown in Figure 2 illustrate an extreme example of load induced variations in the gear mesh frequency. Beginning with the top signature, recorded on the gear of a gas turbine generator at 15.5 MW, a significant decrease occurs as load is reduced to 9.5 MW, pictured in the middle signature.

Figure 2. High Frequency Amplitude Variations Corresponding to Changes in Gear Load.

At synchronous speed and no load the gear mesh frequency has decreased to an amplitude less than its upper sideband as shown in the bottom signature.

In addition to the likely possibility that demodulation of the gear mesh frequency will yield valuable information, the number and appearance of the harmonics of gear mesh are likewise promising as indicators of mechanical condition. Referring back to Figure 2 it can be seen that both the second and third harmonics of gear mesh vary significantly with applied load. In this particular case the relationship of harmonics to the fundamental infers a tooth engagement resembling a square wave at 9.5 MW which becomes more sinusoidal with load.

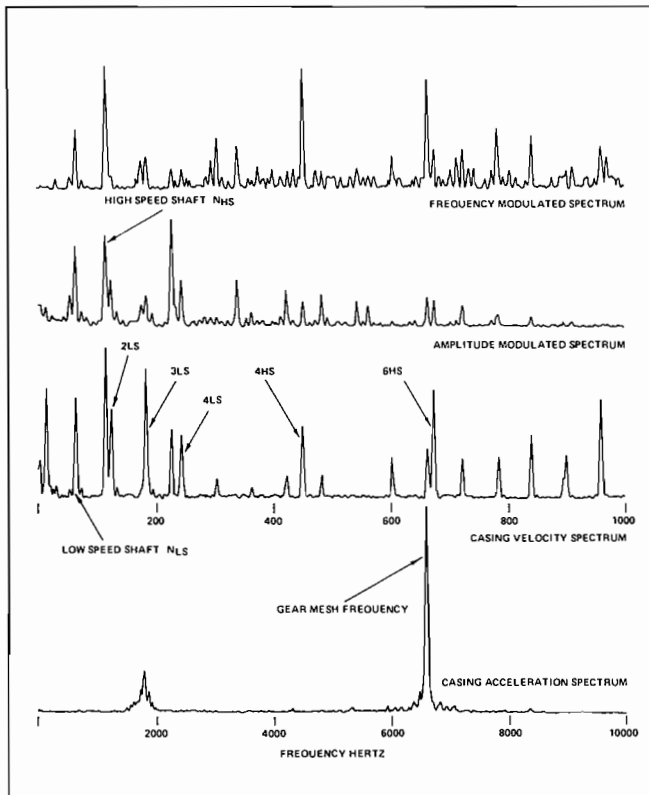
Figure 3 illustrates how demodulation can be utilized to examine gear characteristics. The lower acceleration spectrum contains the gear mesh frequency surrounded by several sidebands. Directly above, a low frequency velocity signature is pictured to show the position and relative amplitude of the rotational frequency components and their multiples. The top two signatures contain the spectral components obtained by amplitude and frequency demodulation of the gear mesh frequency and contain, as expected, the rotational frequencies as well as multiples. It is quite interesting to observe that the three most prominent components in the frequency modulated spectrum are at the high speed shaft rotational frequency and its 4th and 6th order harmonics whereas two of the three most prominent components in the amplitude modulated spectrum are at the high speed shaft rotational frequency and its 2nd order.

Figure 3. Speed Increasing Gear Casing and Demodulated Signatures.

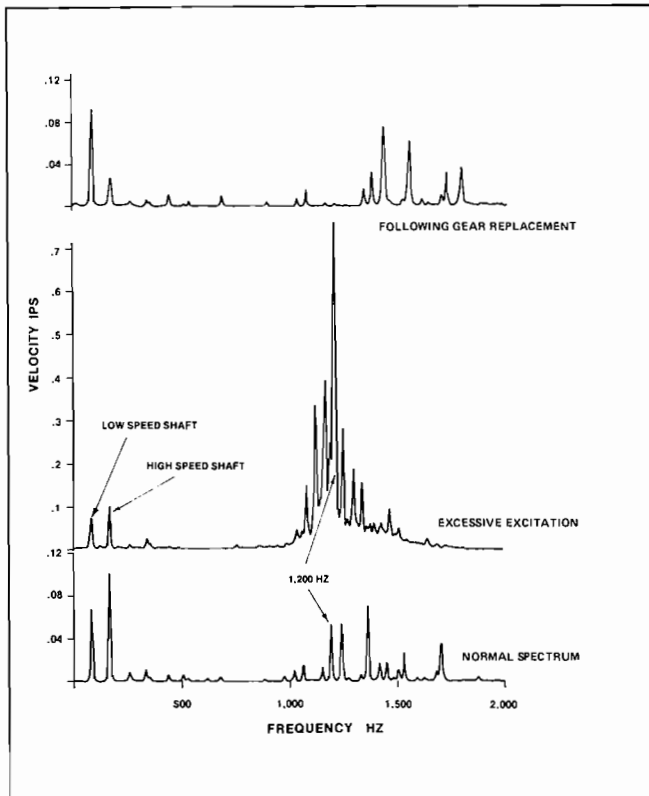
A similar incident on the second gear is illustrated in Figure 5. The normal signature shown at the bottom contains both rotational and intermediate frequencies at amplitudes which are about average for this type equipment. Although

the middle signature shows a vast increase in the intermediate frequencies, neither the rotational frequencies or the gear mesh frequency (not shown) changed by any significant degree. Recognizing a condition of extreme distress, the unit was shut down in an orderly fashion. A visual examination disclosed the heavily pitted gear elements shown in Figure 6. Surprisingly enough the journal bearings were found undamaged despite the severe excitation.

Figure 5. Speed Increasing Gear Casing Acceleration Signatures.

In an effort to learn the origin and cause of the significant increase in the intermediate frequency characteristics, both the gear and the pinion were suspended and shock excited. The results of this test indicated the 1,200 Hz center of the intermediate frequencies corresponded exactly to the fundamental resonance of the low speed gear.

By way of explanation it thus appears likely that the intermediate frequencies correspond to a resonance of one, or possibly both, gear elements. Thus a high amplitude or an increase in amplitude at the intermediate frequencies is likely to be a symptom of uneven or shock meshing which in turn excites the gear into vibration at its fundamental natural frequency.

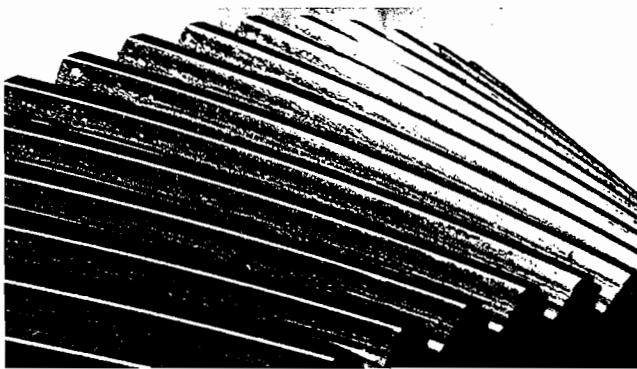
Figure 6. Pitted Low Speed Gear Removed From an Industrial Speed Increaser.

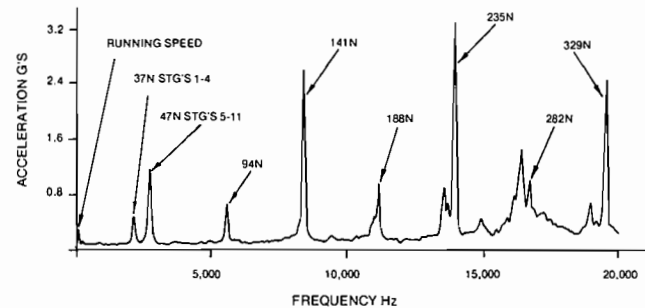
The vibration signatures recorded on axial flow compressors and gas turbines always contain prominent components at blade passing frequencies (number of blades times rotational frequency) as shown in Figures 7 and 8.

Figure 7. Axial Flow Compressor Casing Acceleration Signature.

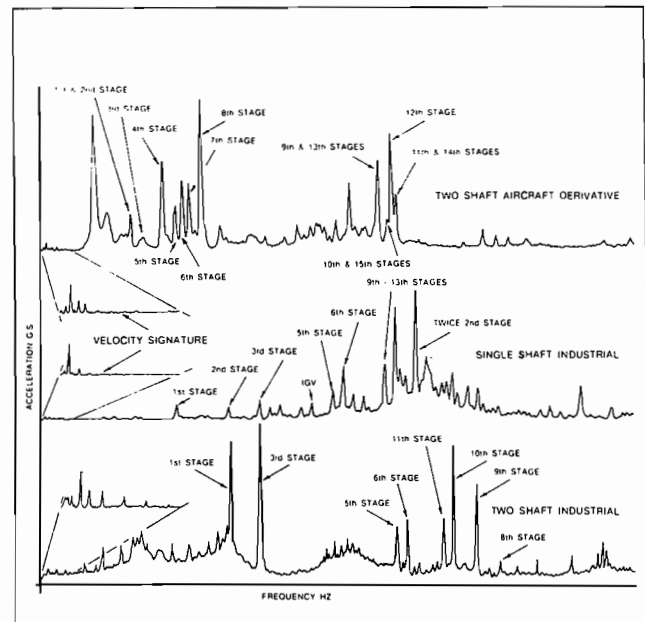
Figure 8. Gas Turbine Casing Acceleration Signatures — Axial Compressor Section.

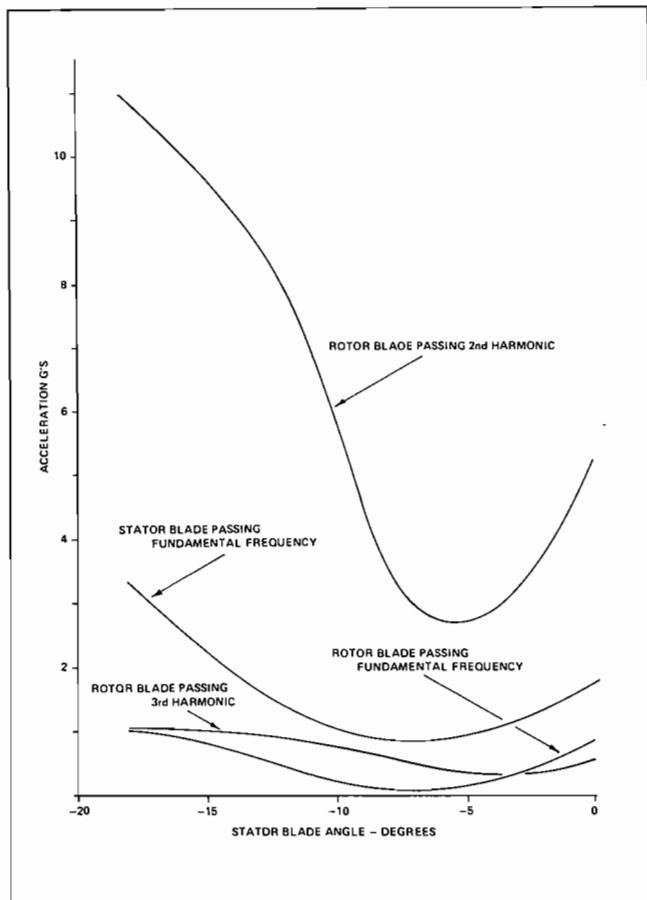
A second curiosity noted during studies of axial flow compressors is the amplitude variation at blade passing frequencies in response to speed, pressure ratio and angle of stator blading. Figure 9 illustrates a typical response at various stator blade angles with speed and pressure ratio held constant. Note that the highest amplitude, which in this case corresponds to twice

Figure 9. Amplitude Variations at Blade Passing Frequency and Multiples as a Function of Stator Blade Position.

the rotor blade passing frequency, occurs with the stator blades in the maximum closed position (large negative angles). As the stators open all the amplitudes decrease, particularly the previously mentioned twice rotor blade passing until a minimum point is reached. Following the point of minimum excitation opening the blades further produces a corresponding increase in amplitude.

The significance of the above response may be in the ability to detect blade anomalies such as damage or an incorrect angle once the normal characteristics of a given machine are known. To test this theory a gas turbine, known to have blade damage in the first stage turbine, was located, recorded and the sonic vibration signatures compared against a group of signatures recorded at the same location on similar units. Interestingly enough there was no measurable difference. This observation was quite puzzling until it was realized that the turbine had been derated to keep exhaust temperature within safe limits and the data was being compared against blade characteristics recorded at a significantly higher power level. Based on the earlier study with axial flow compressors it seemed reasonable to assume that a decreased mass flow through the turbine at the lower power should have produced a corresponding reduction in the amplitude at the first stage blade passing frequency. Hence, although the blade characteristics appeared normal compared to amplitudes recorded at a higher power they might be clearly abnormal when compared to characteristics recorded from a turbine in satisfactory condition at the lower power level.

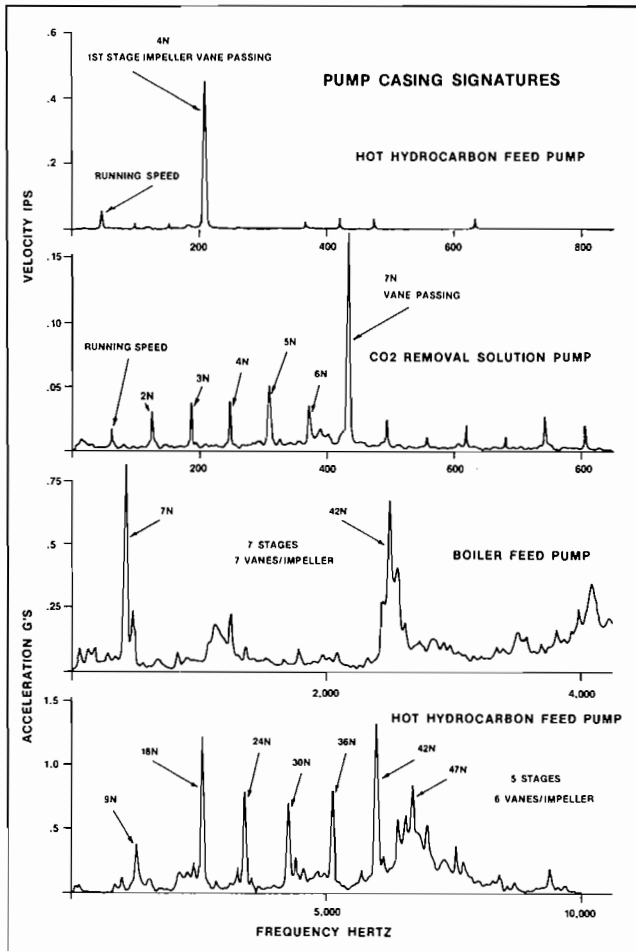
Figure 10 illustrates the prominent vane passing frequencies recorded on a group of centrifugal pumps. Within this group the CO<sub>2</sub> Solution Pump was confirmed by calculations

to be operating with insufficient suction head and in fact had experienced mechanical difficulties for years. The presence of numerous multiples of running frequency in addition to vane passing frequency indicates the pump was in a deteriorated condition when the signature was recorded.

Figure 10. Pump Casing Signatures Displaying Prominent Components at Impeller Vane Passing Frequencies.

Since the signatures recorded in Figure 10 were all obtained during the course of field problems more work needs to be accomplished under controlled conditions to establish the exact relationship between amplitude at vane passing frequency and cavitation.

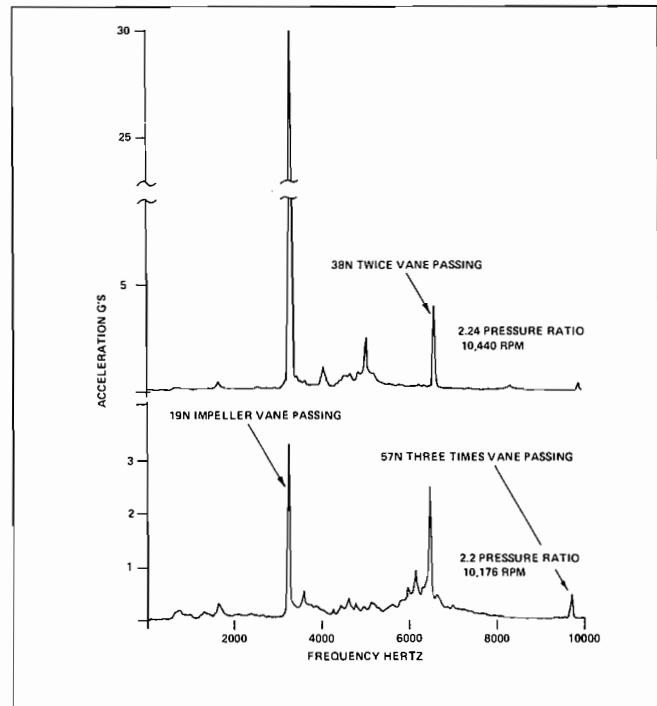
Figure 11 illustrates the response of the impeller vane passing frequency recorded on a centrifugal compressor as speed and pressure ratio were increased to move the operating point closer to surge. Although such a large change is probably an exception rather than the rule it seems logical to assume that measurable variations in vibration will occur in response to changing flow patterns within the machine.

Figure 11. Amplitude Variation of a Centrifugal Compressor Vane Passing Frequency in Response to a Change in Speed and Pressure Ratio.

As an explanation for these observations, it appears likely that approaching a condition such as surge or cavitation increases the turbulence through the impeller passages which in turn appears externally as an increased amplitude at vane passing frequency. While knowledge of this response can be quite beneficial when applied to diagnostics it may be much more valuable incorporated into a monitoring system installed on a critical high head unit where a condition such as surge
