CAVITATION AND RECIRCULATION TROUBLESHOOTING METHODOLOGY

Bruno Schiavello

Engineering Manager, Fluid Dynamics

Ingersoll-Dresser Pump Company

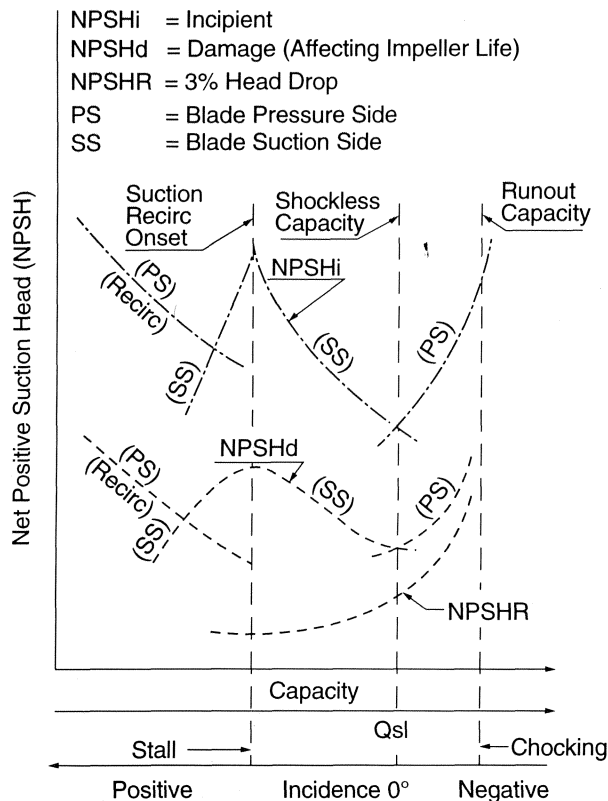
Figure 1. *NPSH-Peculiar Curves Defining Various Cavitation Modes.*

A typical curve of $NPSH_d$ (d = damage) which can produce significant erosion damage throughout the whole range of operations is shown in Figure 1. The $NPSH_d$ is not unique and depends upon the desired impeller life, the pump design, the material

A radial type suction casing with centerline of the suction flange crossing the rotation axis tends to generate zone of positive and negative swirls at the impeller eye, which enhances cavitation at high flow and also likely promote earlier suction recirculation, thus narrowing the typical V-shape damage curve (Figures 1 and 2).

Sheet Cavitation on Suction Side (SCSS). The impeller shockless capacity should be reduced (Figure 1). This is obtained in the most simple way by reducing the net area at the impeller eye and so increasing the through flow (or meridional) velocity. Some inlet devices based on this approach of throttling the impeller eye include: stationary casing wear ring extended into the impeller eye (L-shape, nozzle-shape), stationary ring in the pump suction nozzle, rotating obstruction like venturi inside the impeller eye. An additional effect of these devices, if well designed with appropriate contour, is to produce a lower “effective” peripheral velocity ($U_{eye-eff}$) and so reduce the cavitation damage rate (Table 1) [9, 17]. The original $NPSH_R$ curve is shifted toward lower capacity and marginally risen at part flow. But the optimum range for minimum cavitation erosion rate (V-shape in Figures 1, 2) is moved close to the actual operating range, thus reducing cavitation

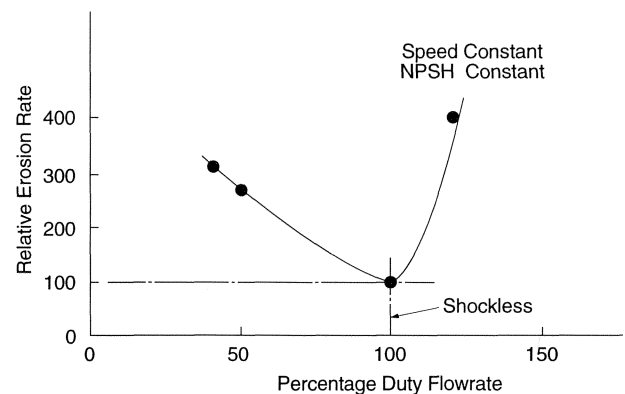
Figure 2. *Variation of Erosion Rate with Capacity [8].*

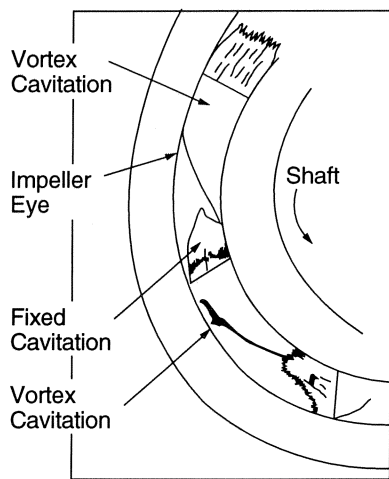
Figure 3. Alternating Sheet Cavitation with Vortex Cavitation [18].

Experimental investigation by means of a high speed movie camera along with stroboscope [18] clearly shows that at low flowrate, two different patterns of cavitation, “sheet cavitation” and “vortex cavitation,” occurred alternatively near the leading edge of the impeller blades, as schematically shown in Figure 3. The cavitation started on the blade suction surface far away from the leading edge, moved upstream with an abrupt stroke, and collapsed on the pressure surface of the next blade. This cavitation, called “vortex cavitation,” is attributed to the impeller suction recirculation. In fact, a vortex is generated by the shear forces at the interface between the reverse flow leaving the impeller near the front shroud, and the ordinary forward flow entering into the impeller near the hub, as shown in Figure 4 (a). Moreover, streams of both backward and forward flow also can be suspected to occur in the blade-to-blade plane in the inlet region of the blade channel, as sketched in Figure 4 (b). Then, shear forces components also exist in this plane and contribute to the generation of a complex vortex in the three-dimensional space. When the inlet pressure (therefore, $NPSH_A$) is low enough and also the strength of the vortex (i.e., intensity of the suction recirculation) is high enough, the pressure in the vortex core drops below the saturation pressure and cavitation conditions are reached. A filament of cavitating flow develops, starting on the suction side of the blade and ending on the pressure side of the next blade, as shown in Figure 4 (c). This vortex oscillates in a direction normal to the blade surface, i.e., more or less in the direction of the main flow, as sketched in Figure 4 (d). Consequently, damage is caused in the form of a single large crater at the midspan of the blade on the pressure side.

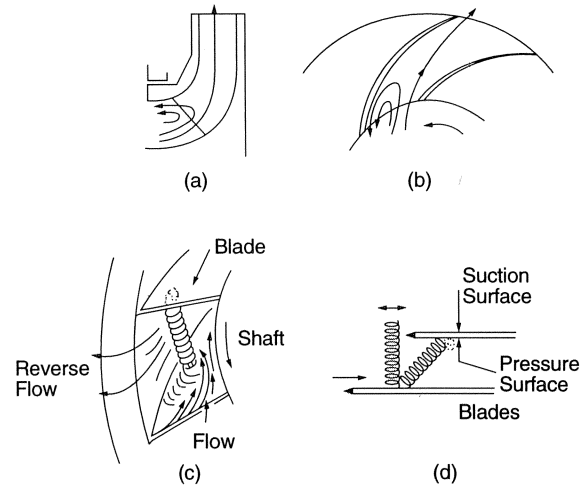
Figure 4. Suction Recirculation (a-b) as Source of the Vortex Cavitation (c-d) (18).

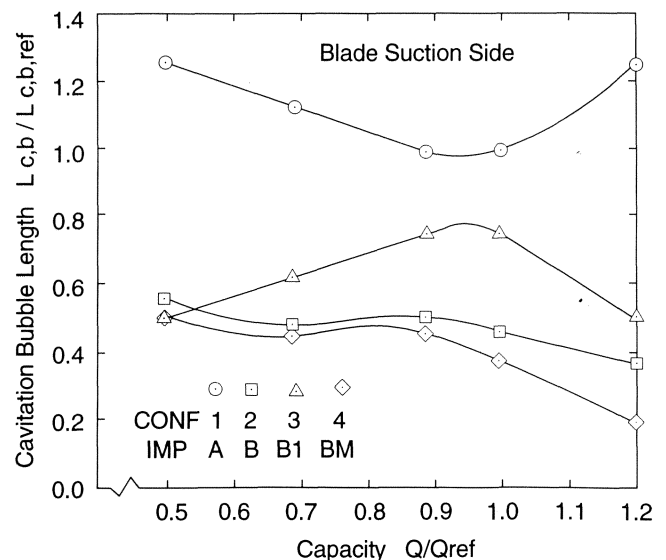
Figure 5. Cavitation Bubble Length at Plant $NPSH_A$ [14].

The effectiveness of these new design criteria for the impeller has been fully proven in the laboratory, in many cases, by using the criterion of the cavitation bubble length, which can be measured with special test rig allowing cavitation visualization [11, 36]. A clear example is shown in Figure 5, which corresponds to an actual field case of four large boiler feed pumps [14, 36, 38]. Heavy damage due to corner cavitation had perforated the impeller hub and attacked the shaft in 14,000 hr for one pump and 6,000 hr for

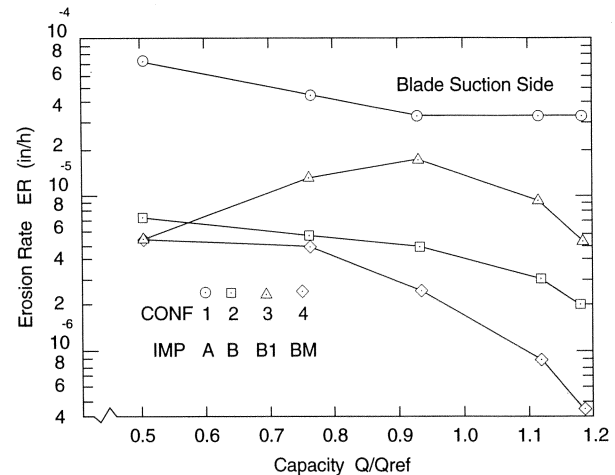
Figure 6. Erosion Rate on Blade Suction Side Vs Capacity [14].

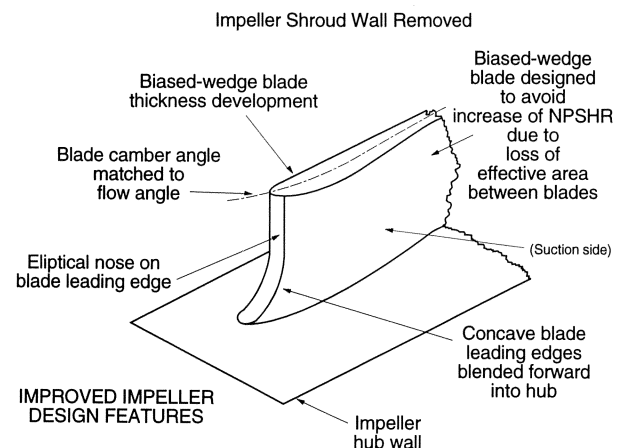
Figure 7. Design Features of Advanced Impeller [41] Patent Pending.

Using this integrated design approach, a new impeller blade geometry has been developed, which includes several new features as listed below and shown in Figure 7 [41].

Feature	Benefit
(a) Elliptical noses on blades	Local pressure-drop spike minimized
(b) Blade camber angle matched to analyzed flow	Cavity reduced or eliminated at BEP
(c) Biased-Wedge blade thickness development	Widens range of cavity-free flow rate
(d) Biased-Wedge blade designed to avoid increase of $NPSH_R$ due to loss of effective area between blades	Maintains $NPSH_R$ of conventional impeller designs
(e) Concave blade leading edge, blended forward	Removes hub-fillet cavitation and damage

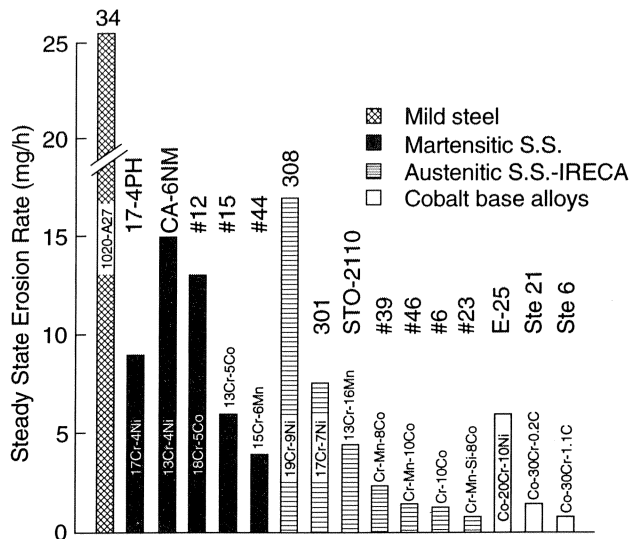
Figure 8. Comparison of Cavitation Resistance of Ferritic, Martensitic and Austenitic Stainless Steels and Cobalt Base Alloys. IRECA is Hydroloy [15].

In Figure 8, the cavitation resistance of Hydroloy HQ913® is compared to that of CA-15 and other alloys commonly used for high energy pump impellers. The laboratory data shown in Figure 8 [55], which were originally published for cobalt manganese modified austenitic stainless, and since confirmed by other researchers [58], indicated that major improvements in cavitation resistance, approaching one order of magnitude, were possible. As previously discussed, this is the extent of improvement needed to complement the optimization of the hydraulic designs. Consequently, following suggestions from the author, materials research
