**AN ARCHAEOLOGICAL SURVEY FOR THE
CITY OF WINTERS WATER IMPROVEMENTS PROJECT
IN RUNNELS COUNTY, TEXAS**

Antiquities Permit 7381

Contract Report Number 273

BVRA Project Number 15-07

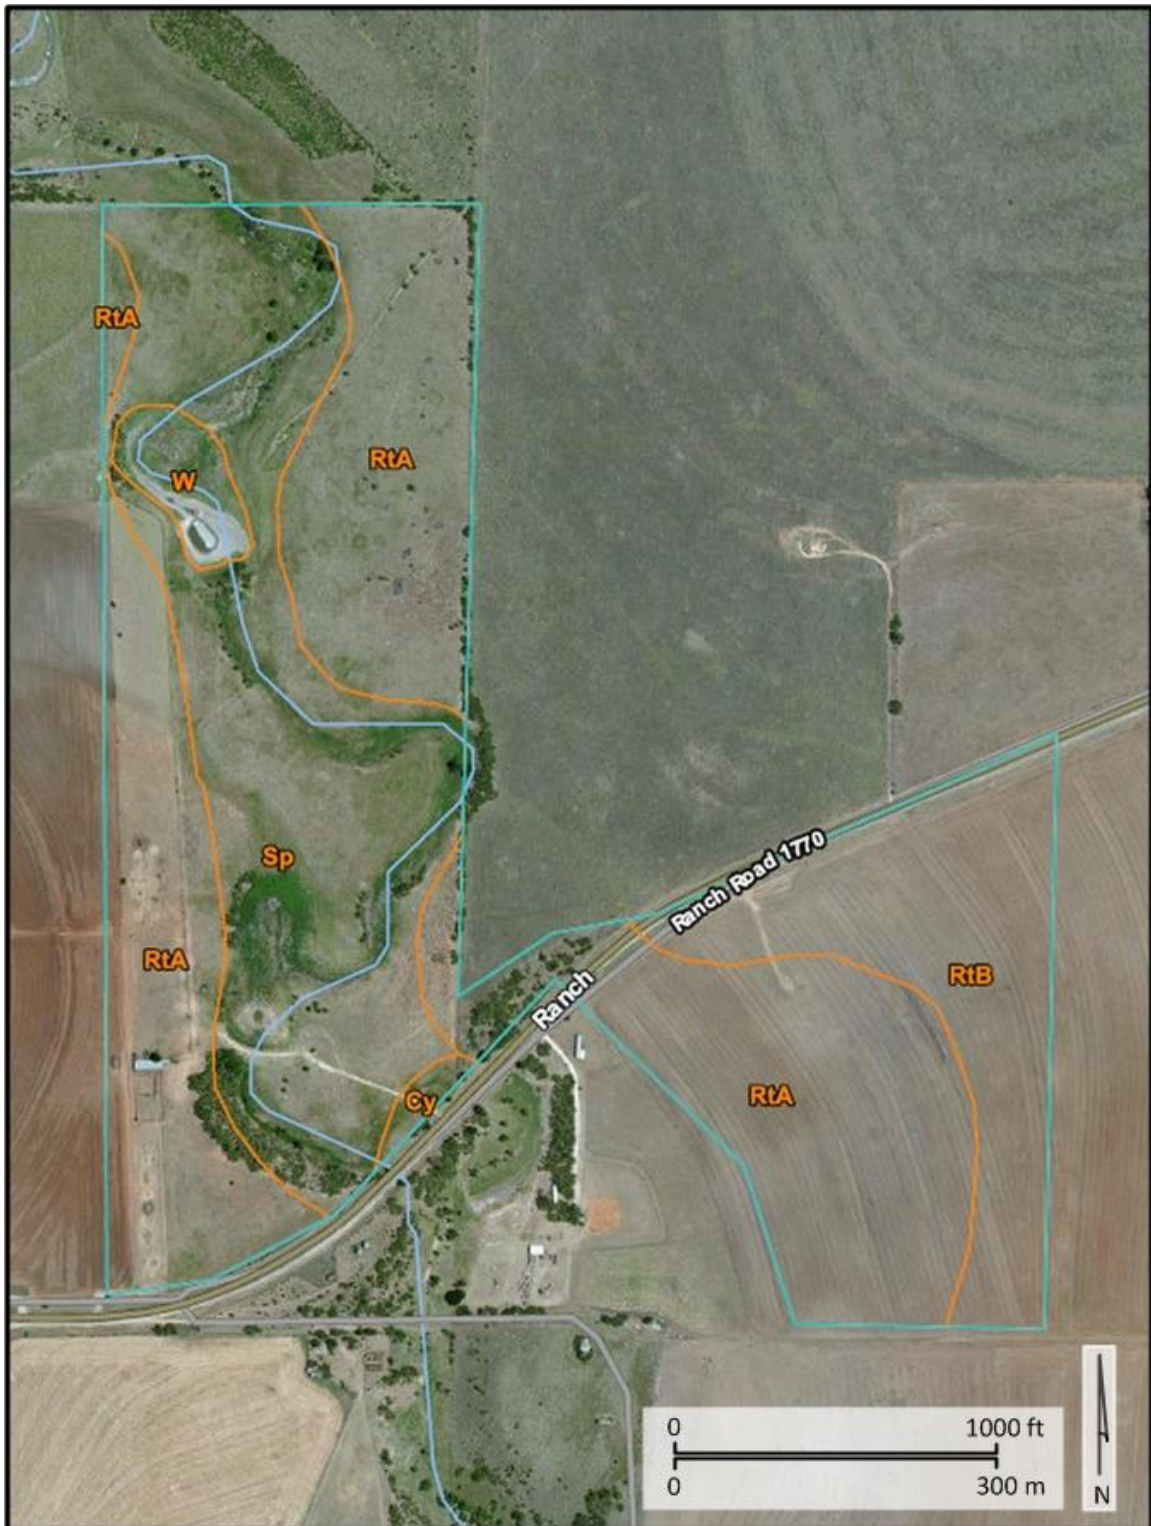
Figure 3. Soils in the Project Area

According to the soil survey for Runnels County (Wiedenfield et al. 1970), the APE is in areas containing soils from the Rowena series, Spur series, and Colorado series. Specific soils are described as Colorado and Yahola soils (Cy), Rowena and Tobasa soils, 0 to 1 percent slopes (RtA), and Spur loam (Sp). The Cy soils are described by Wiedenfield et al. (1970:9) as 80% Colorado loam and 20% Yahola fine sandy loam. They occur as long narrow strips along all of the major streams in the county, especially the Colorado River. The mapping for these soils included the channels of small intermittent streams such as Antelope Creek. Rta soils are described by Wiedenfield et al. (1970:21-22) as smooth scattered areas throughout the outwash plain. These soils have high clay content that is often present on the surface. Sp soils are described by Wiedenfield et al. (1970:23) as occurring as long narrow areas on the higher parts of the floodplain. Most areas within this soil type are level with some gentle slopes along filled in stream channels. The predominant soil series are the Rowena with heavy clay loam (10YR 4/2) to 18 inches, Spur (7.5YR 4/2 over 7.5YR 4/4) with loam to 32 inches, and Tobosa (10YR4/2 over (10YR5/2) with clay to 50 inches.

The field survey identified areas of disturbance that would affect the integrity of a prehistoric site that was not deeply buried. Areas A, B, and D are located in RtA soils where clay at the surface was prominent. It appears from the maps in the soil survey that Area B may also include a portion of Sp soils. Area C is totally within Sp soils and Area E is within Cy soils and perhaps areas of RtA and Sp soils. Perhaps the most obvious disturbance was in Area D, a field that had been recently cultivated. The surface inspection of low probability areas confirmed disturbance to the landscape along those portions of the transmission line that will be placed in highway right-of-way and a lack of cultural materials on the surface anywhere within the APE. Numerous lithic scatters, chipping stations, and quarry sites were reported to the east during the Elm Creek survey by SMU (Lynott 1978), but no raw materials suitable for stone tool manufacture were observed,

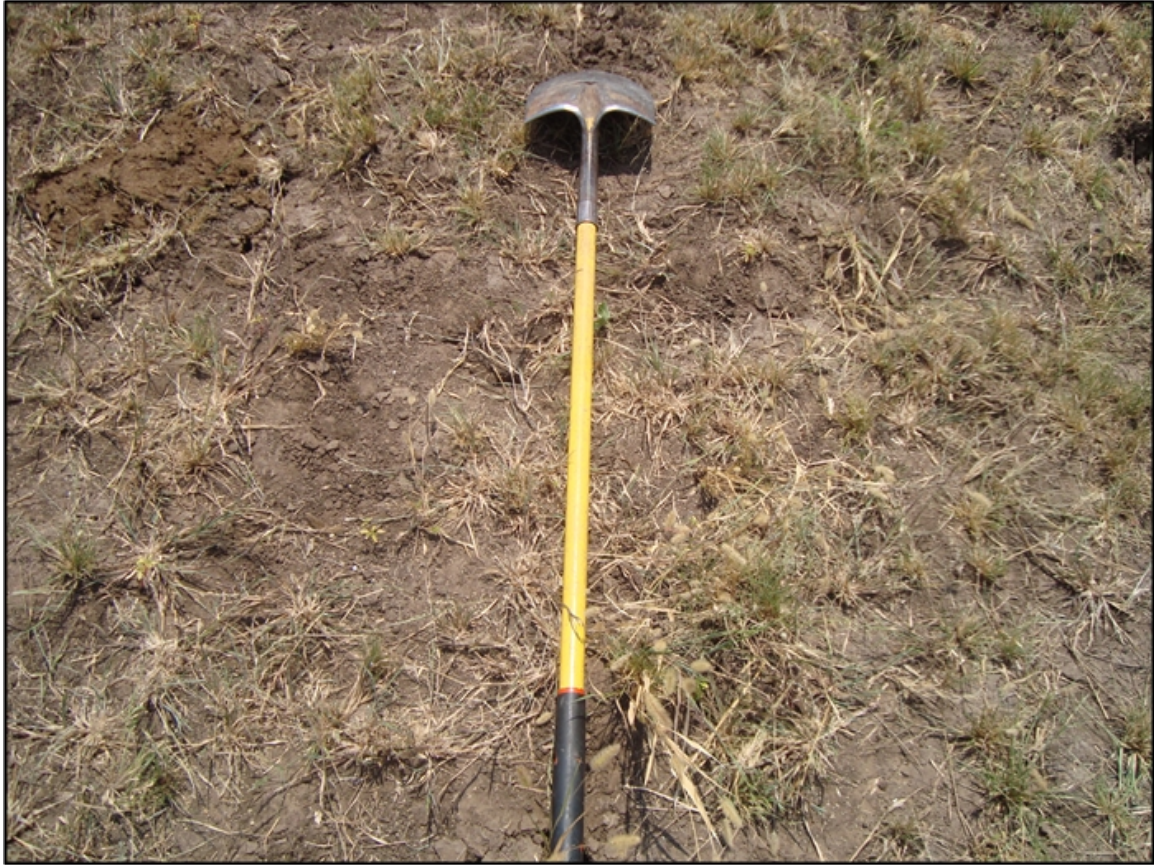
(Photo 889)

Ground Visibility South of Ranch Road 1770

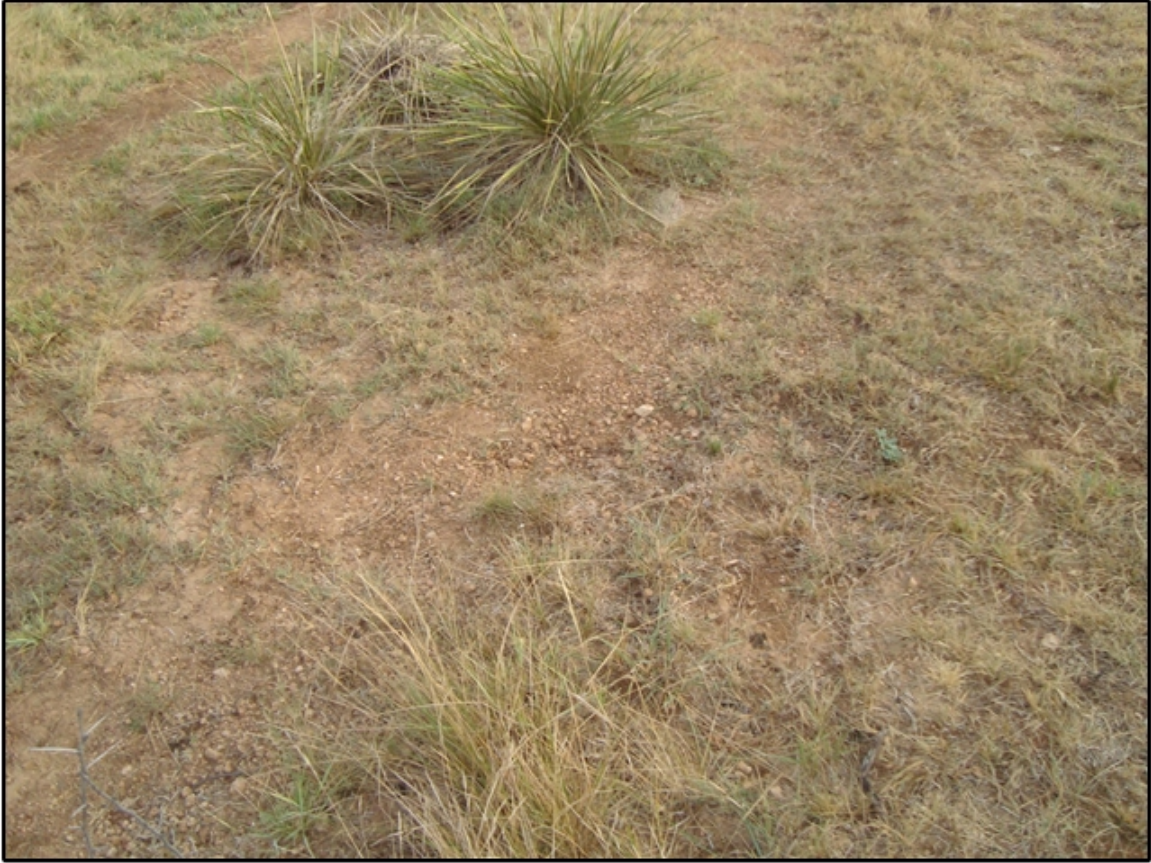
(Photo 901)

Ground Visibility North of Ranch Road 1770 Prior to Crossing of Antelope Creek
