**CHARACTERIZATION OF AGGREGATE RESISTANCE TO DEGRADATION  
IN STONE MATRIX ASPHALT MIXTURES**

A Thesis

Submitted to the Office of Graduate Studies of  
Texas A&M University  
in partial fulfillment of the requirements for the degree of

December 2005

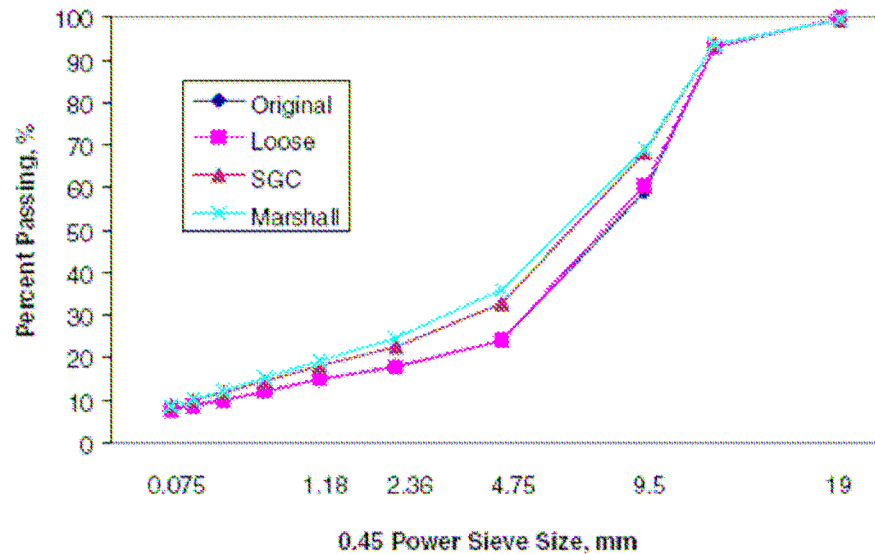
**Figure 2.1: Influence of Compaction on Change in Gradation (after Xie and Watson 2004).**

A laboratory study conducted by Xie and Watson (6) reported experimental evidence of aggregate degradation in SMA mixtures. Specifically, the focus of the study was to track aggregate breakdown due to compaction using the Superpave Gyratory Compactor (SGC) and the Marshall hammer. Furthermore, the influence of L.A. abrasion value and F&E content on the change of aggregate gradation was examined. They found that aggregates experienced breakdown due to compaction; however, the Marshall hammer exhibited more aggregate breakdown, as can be seen on Figure 2.1 through comparing the gradation after compaction with that before compaction.

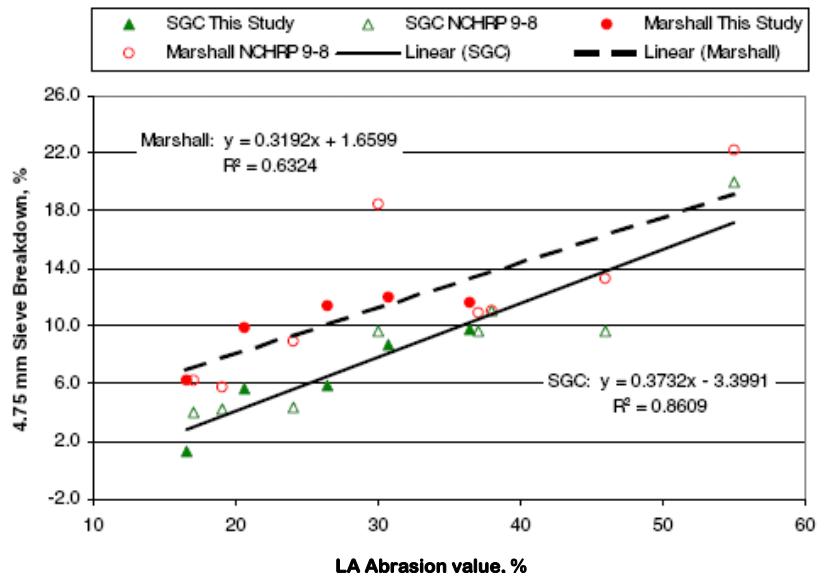
**Figure 2.2: Influence of L.A. Abrasion Value on Aggregate Breakdown (after Xie and Watson 2004).**

The L.A. abrasion value and F&E content were found to affect the amount of aggregate degradation that occurred during compaction. The higher the L.A. abrasion value and/or F&E was, the more aggregate degradation was measured. Figures 2.2 and 2.3 show the correlations of L.A. abrasion value and F&E value with aggregate breakdown measured as the change in percent of aggregate passing the 4.75 mm (#4) sieve. Xie and Watson demonstrated that aggregate degradation is an important factor to consider when selecting aggregates for use in SMA. They emphasized that selecting an aggregate that has a low L.A. abrasion value and controlling the percent of F&E aggregates, can minimize aggregate degradation potential.

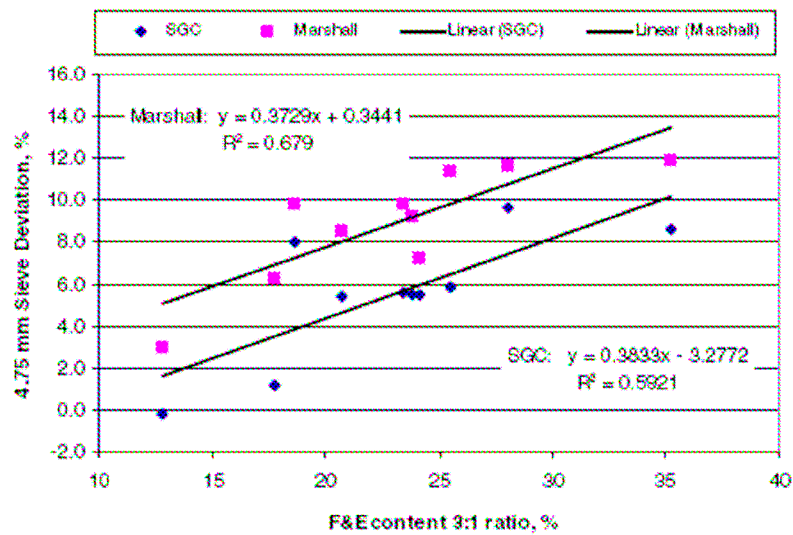
**Figure 2.3: Influence of F&E Content on Aggregate Breakdown (after Xie and Watson 2004).**

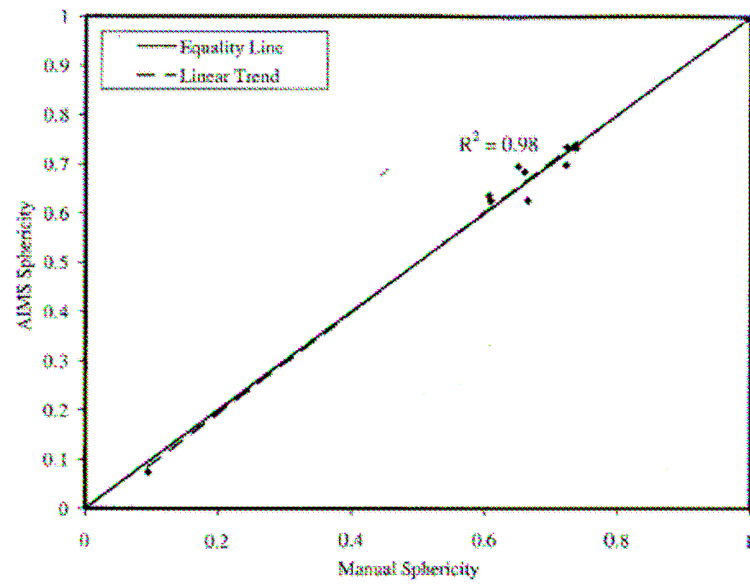
**Figure 2.5: Correlation of Manual and AIMS Method for Measurement of Shape Using two Indices (a) Sphericity and (b) Shape Factor (After Fletcher et al. 2003).**

Fletcher et al. (26) used AIMS to characterize fine and coarse aggregates. They found very good correlation between texture measurements and permanent deformation. Also, the AIMS measurements showed good correlation with the manual method to measure aggregate shape (flat and elongated) as shown in Figure 2.5. McGahan (29) also showed correlation between shape characteristics and HMA performance. A statistical analysis was performed on an aggregate database consisting of volumetric, performance, and aggregate shape measurements. The database consisted of aggregates that were used in projects funded by the Federal Highway Administration (FHWA) and the Texas Transportation Institute (TTI). The results show there is a strong correlation between aggregate shape properties and the recorded performance of the HMA.

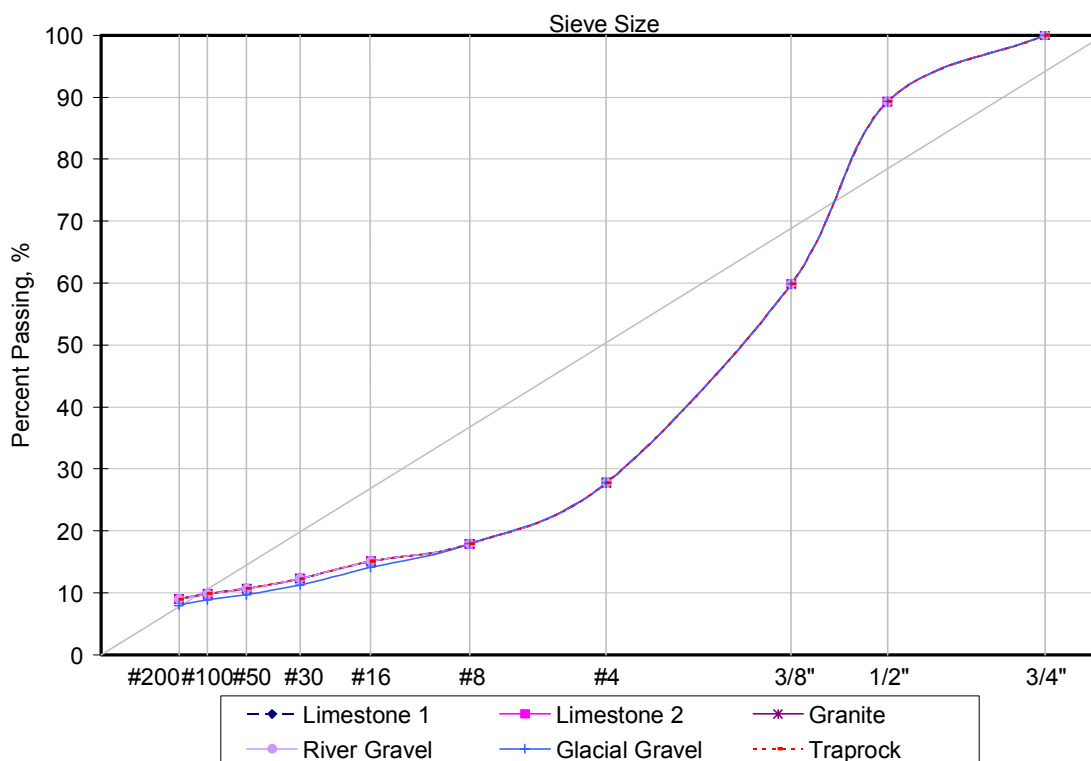
**Figure 3.1: Mixture Design Gradations.**

mixture to meet specifications. With several revisions to the gradation of the river gravel mixture, it was later decided that the original mixture design met closest to the mixture design specification. Three sets of mixture designs were made for the limestone 1 aggregate. The three mixture designs involved adjustments from lowering the mineral filler to adjusting the gradation of the coarse aggregate structure. Ultimately, the original mixture design for the limestone 1 met closest to specifications. Illustrations of the final gradations can be seen on Figure 3.1. This figure illustrates how the final gradations for the six aggregates are relatively the same with exception the glacial gravel mixture, which is a bit coarser than the other mixtures.

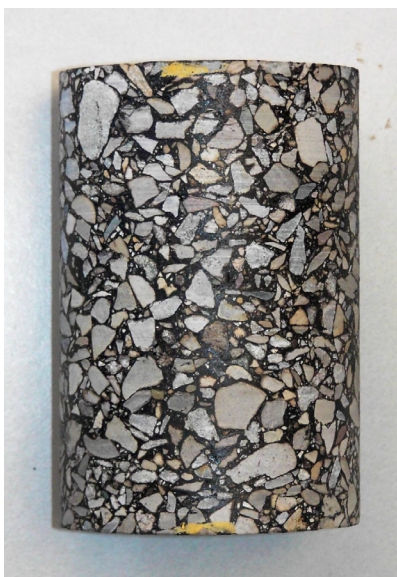
**Figure 3.3: Example of Trimmed Specimen for Flow Number Test (Glacial Gravel).****Table 3.6: Mix Design Results.**

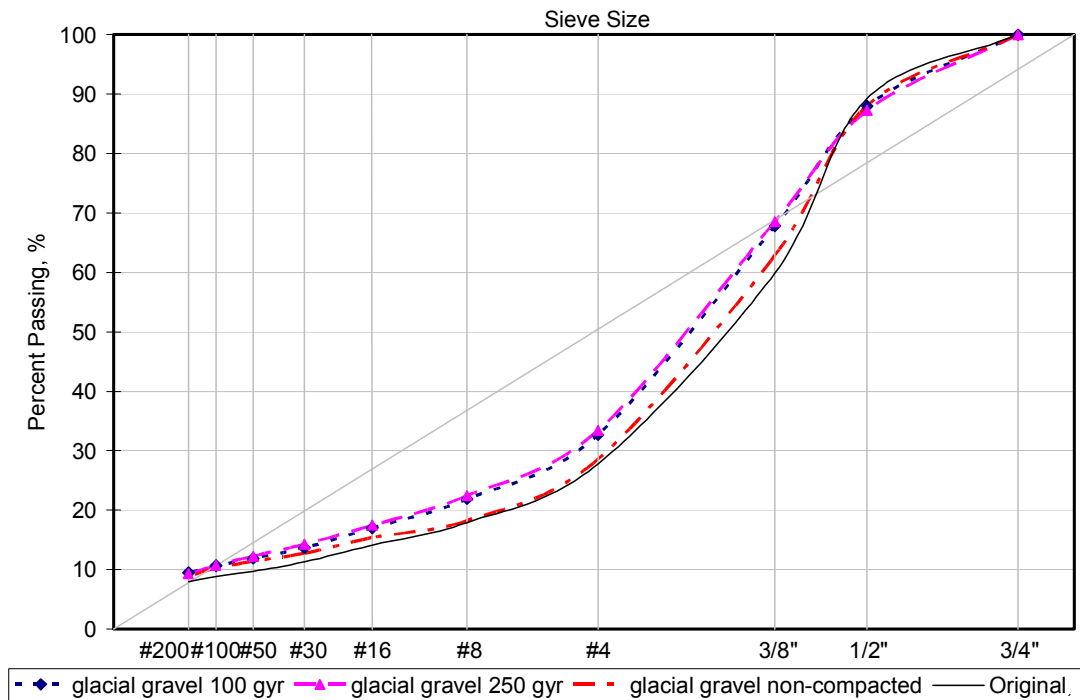
**Figure 4.2: Sieve Analysis Results for Glacial Gravel.**

Figures 4.2 to 4.7 show that aggregate breakdown did occur due to compaction. Breakdown is apparent within the first 100 gyrations of compaction with all mixtures; however the severity of breakdown varies. Glacial gravel exhibits a similar trend to limestone 2, where there is a small difference between the 100 gyration and 250 gyration curves as shown in Figure 4.2 and 4.7, respectively. The 12.5 mm (1/2 inch) sieve did not show a significant change in gradation; however, the gradations did become finer from the 9.5 mm (3/8 inch) sieve and smaller sieves.

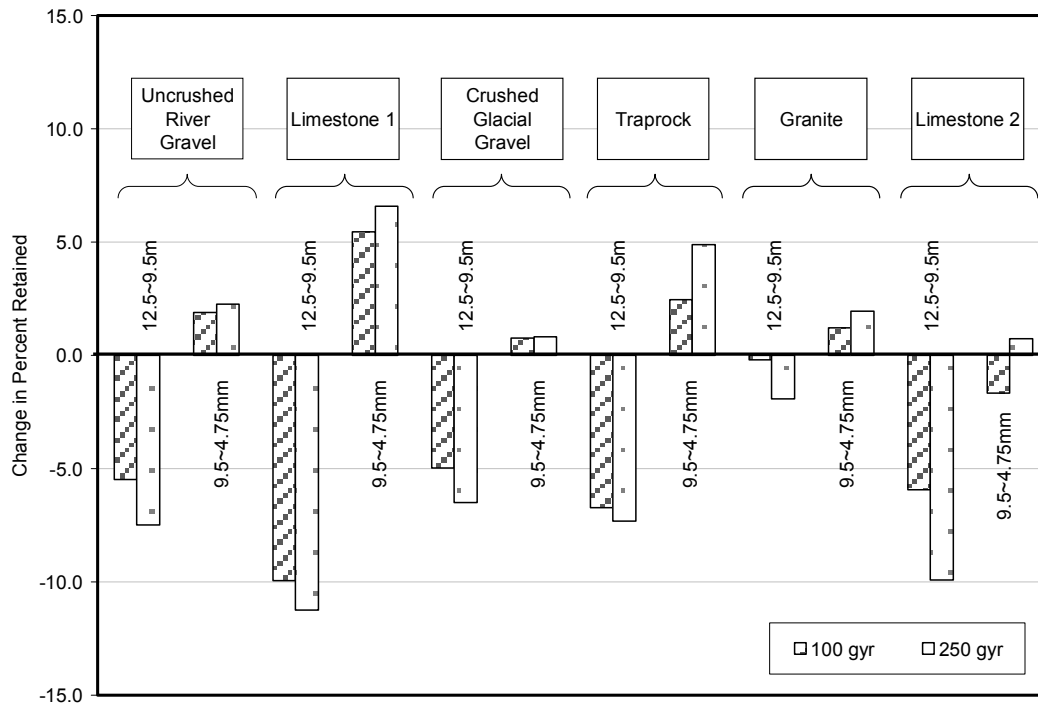
In order to better summarize aggregate degradation due to compaction, emphasis of the analysis pertained to the amount retained on the 9.5 mm (3/8 inch) and the 4.75 mm (#4) sieves. The results of the gradation analyses for all mixtures are shown on Figure 4.8. Ideally, a mix design gradation should not change from its design requirement after compaction. However, changes in gradations do occur to different extents after compaction. Once stone-on-stone contact is existent during compaction, the coarse aggregate is exposed to higher shear stresses due to the aggregate interaction. As a result, the coarse aggregate breaks down into intermediate-sized particles, which are further broken down into finer aggregate due to the shear stresses from compaction.

The graph shows the resultant change, with respect to the loose mix gradations, of the aggregates passing the 12.5 mm (1/2 inch) sieve and retained on the 9.5 mm (3/8 inch) sieve and aggregates passing 9.5 mm but retained on the 4.75 mm (#4) sieve for the six mixtures. The 9.5 mm and 4.75 sieve sizes experienced the most change when compared to the other sieve sizes. In fact, these two sizes comprise the majority of the coarse aggregates in addition to being a contributing factor in developing the coarse aggregate structure. Limestone 1 mixture had the most change, while the granite mixture had the least. Limestone 2 followed limestone 1 in terms of change in gradation; however limestone 1 had an increase of 5 percent in the amount retained on the 4.75 mm sieve as opposed to limestone 2, which showed very little change on the same sieve size. Each mixture showed a negative change in 12.5 – 9.5 mm aggregates and a small increase in the 9.5 – 4.75 mm aggregates at 250 gyrations.

**Figure 4.8: Percent Change in 9.5 mm and 4.75 mm Sieves Using Sieve Analysis.**

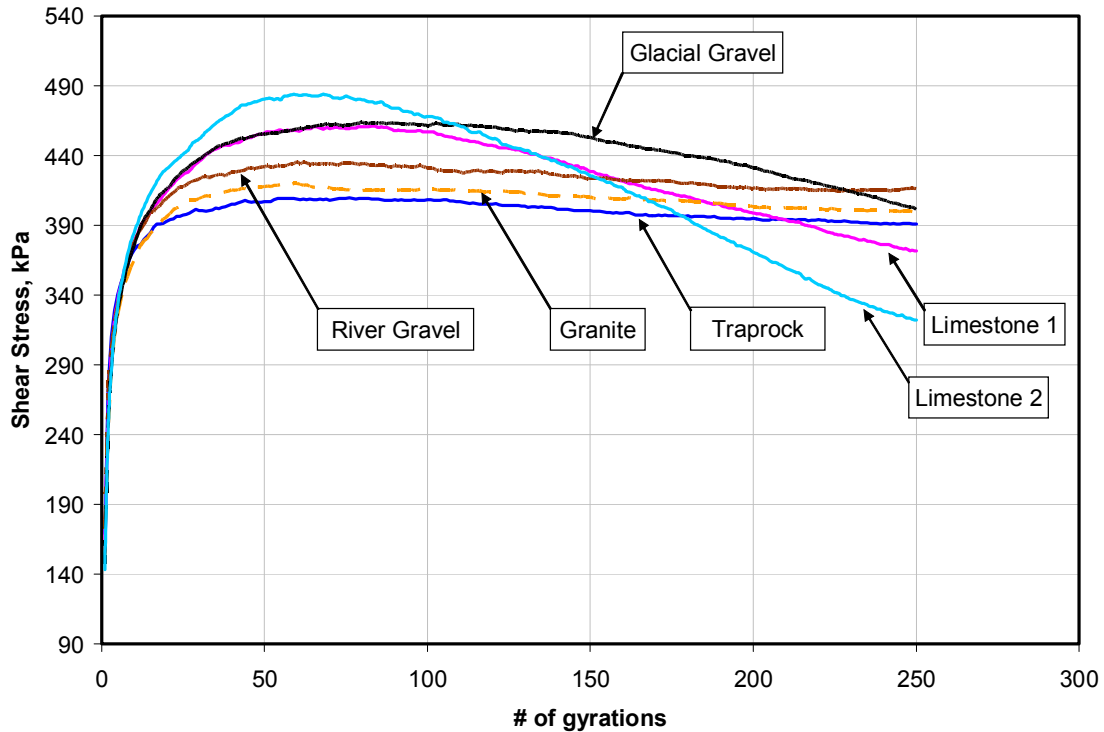
The shear stress recorded by the SGC is graphed with respect to the number of gyrations in Figure 4.9. A table of a sample of the data obtained from the SGC can be referenced in Appendix A3. The shear stress continued to increase until approximately 70 gyrations. From 70 gyrations to 250 gyrations, the traprock, granite, and river gravel mixtures either stabilized or showed a slight decrease in shear stress. The glacial gravel and the two limestone mixtures showed a decrease in the slope, where limestone 2 exhibited the most reduction in shear stress applied. Limestone 1 and the glacial gravel showed that both had similar shear stresses induced on the specimens, yet limestone 1 had a larger decrease of slope for shear stress applied.

**Figure 4.9: Recorded Shear Stress for Mixtures from the SGC.**

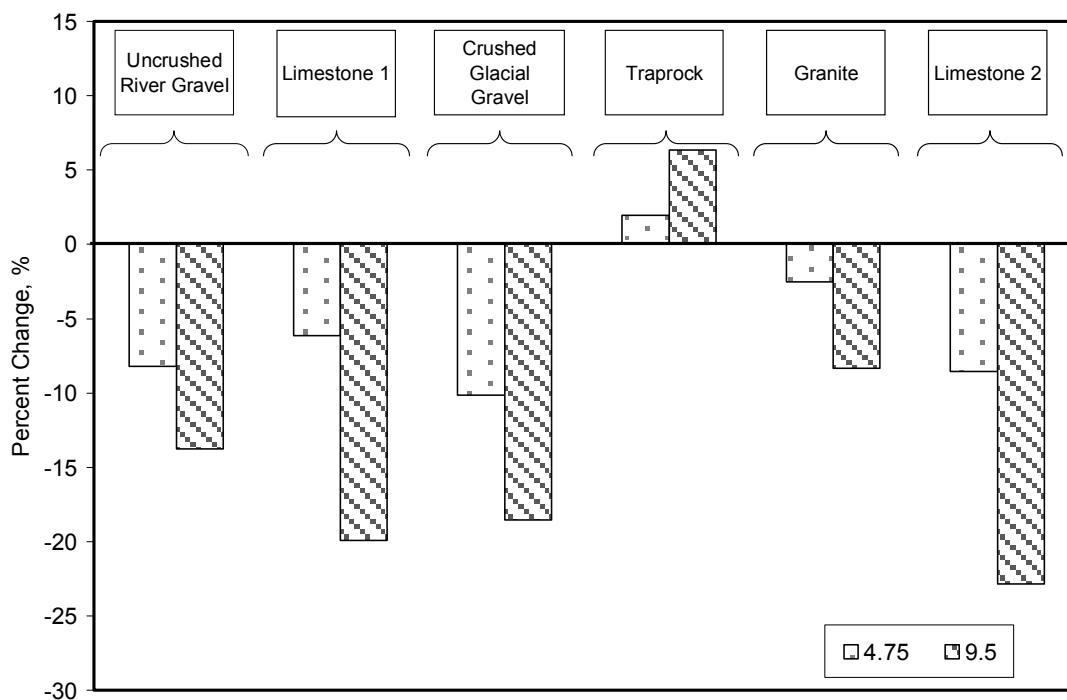
Looking at the plots in Figure 10, five out of six aggregates show negative changes. This is particularly the case for the aggregates retained on the 4.75 mm (#4) and 9.5 mm (3/8 inch) sizes. When focusing on the changes in the 9.5 mm, the results indicate that limestone 2 experienced the most change, followed by limestone 1, crushed glacial gravel, uncrushed river gravel, and then granite. The traprock actually showed an increase in aggregate size. This increase is attributed to the error in separating aggregate particles, as it was more difficult to separate particles at the 250 gyration level, due to the increase in contacts, than at the 100 gyration level. Particles that are in contact are considered as one large particle by image analysis techniques. The threshold values for the images obtained for the specimens compacted to 250 gyrations were increased by a value of five, which is approximately a 2 percent increase of filtration. This increase was needed to further separate the particles in contact because the aggregates in the 250 gyration specimens were more packed together as opposed to the 100 gyration specimens. As discussed earlier, particle separation was performed to minimize this error.

**Figure 4.10: Results of Change in Gradation Using X-Ray CT Imaging.**

The uncrushed river gravel, crushed glacial gravel and limestone 2 showed similar trends as the respective aggregate size decreased. All three exhibited a large amount of breakdown in the 9.5 mm (3/8 inch) sized aggregate and have moderate breakdown on the 4.75 mm (#4) sized aggregate. As a specimen is compacted, the aggregate come into contact with each other, causing friction, and eventually the aggregate begins to chip or break down. As a result of the aggregate breaking down, particle sizes become smaller.

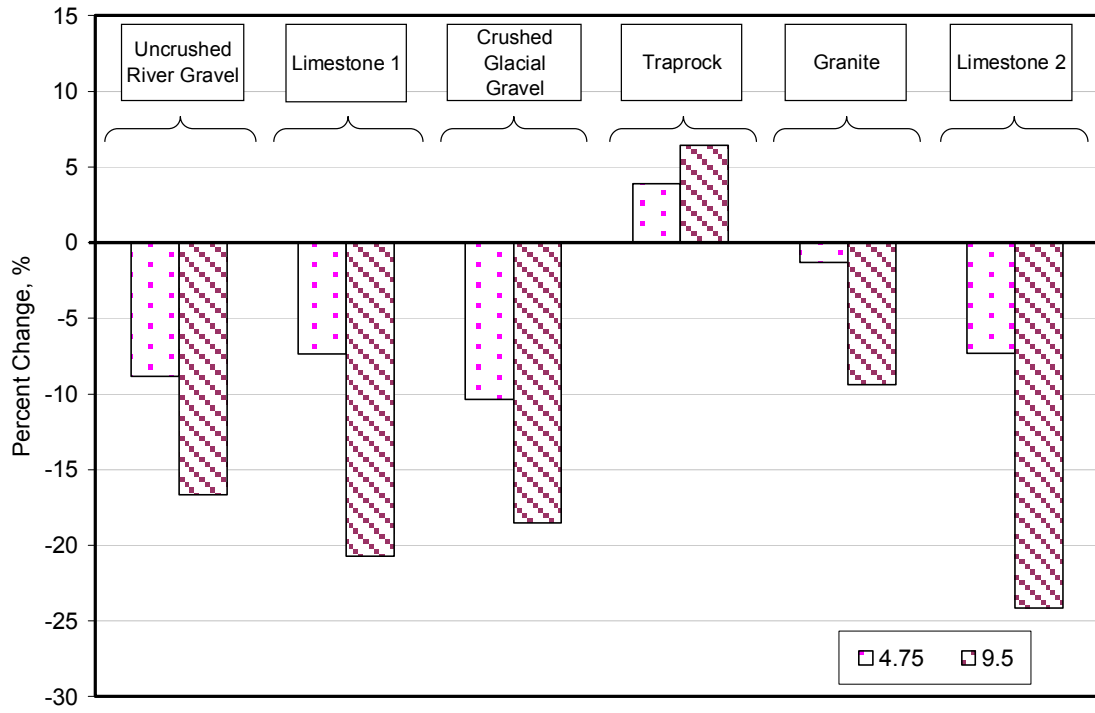
**Figure A4.1: 25<sup>th</sup> Percentile of Change in Gradation of X-Ray CT Analysis.**
