Saqib Mukhtar,
Kevin Wagner
and Lucas Gregory*

Technologies for *Reducing Nutrients* in Dairy Effluent

Two new technologies—a dewatering system and an electrocoagulation system—have proven effective in removing phosphorus and other constituents from the effluent being stored and treated in dairy lagoons.

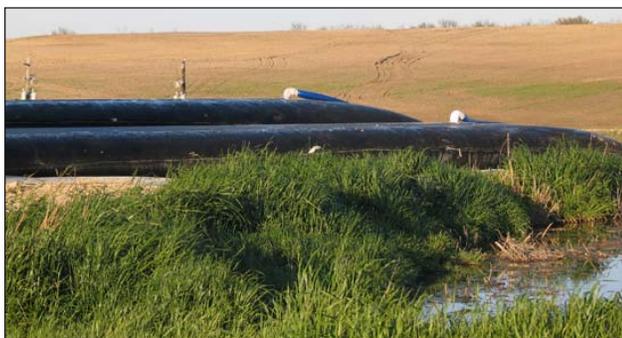
Figure 2: Filled Geotubes®.

1. Alum and a polymer are added to bind and precipitate (separate out) phosphorus in the lagoon effluent.
2. The lagoon effluent is pumped into the tubes (Fig. 2).
3. The pumping ceases and the tubes are left to dewater. The liquid leaves the porous tubes and returns to the lagoon or is used for irrigation; solids larger than the tube pore size are trapped.

Once the Geotubes® were filled with the mixture of slurry and chemical (Fig. 2) to a height of about 5 feet, the pumping ceased and the tubes were left to dewater for 6 months. The large geotextile filtration tubes retained the solids and allowed the liquid to weep from the pores in the fabric (Fig. 4).

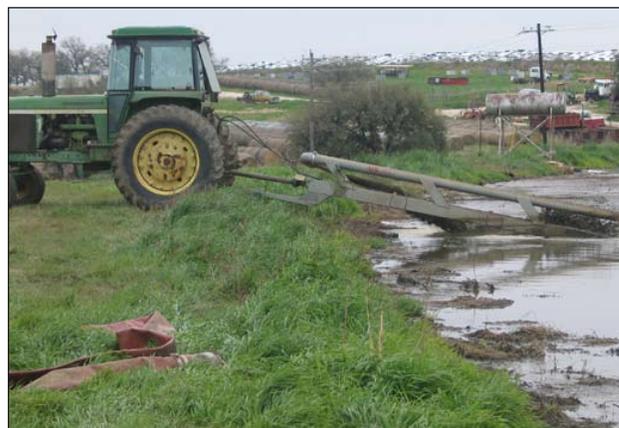
In the study, manure from the milking parlor at the demonstration dairy was flushed into the primary lagoon. Before treatment, the lagoon was agitated using a power-takeoff (PTO)-driven chopper pump (Fig. 3) for a minimum of 2 hours. Then the well-mixed, raw effluent was pumped into the tubes.

Figure 3: Chopper pump mixing the lagoon.

Concentrations of the liquid (mixed lagoon slurry) that were analyzed varied little between the two sampling events, indicating that the chopper pump effectively mixed the influent from the lagoon as it was pumped into the system.

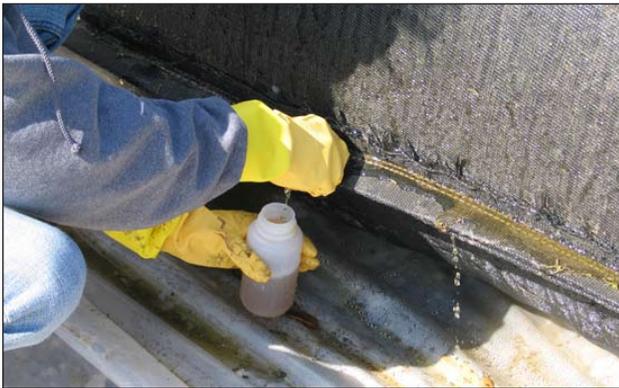
Figure 4: Sample collection from a Geotube®.

The effectiveness of the Geotube® system was evaluated based on liquid samples collected on March 30, 2005, as the Geotubes® were being filled and on April 6, 2005, after filling was completed (Fig. 4). Residual solids samples were collected October 3, 2005 (Fig. 5). The results

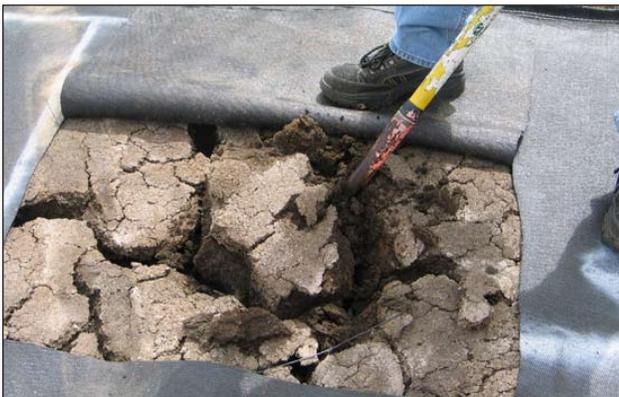
After the tubes were sufficiently dewatered, the residuals within the tubes (Fig. 5) were planned to be disposed of off-site.

Figure 5: Residual solids in dewatered Geotube®.

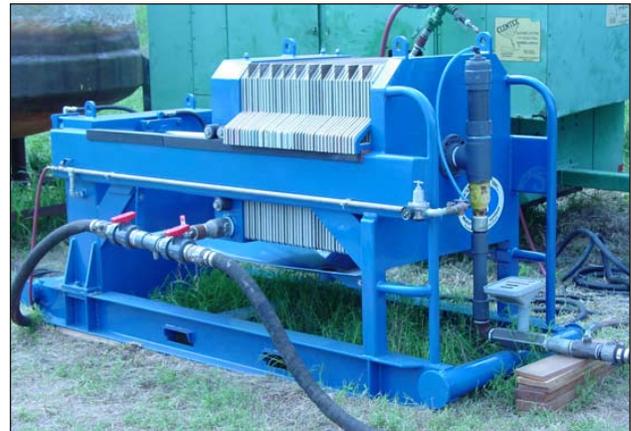
The focal point of the system is the EC unit. It contains positively charged electrodes that separate the negatively charged phosphorus and other metals from the liquid as it flows over the electrodes (Fig. 7).

Figure 7: EC unit with iron electrodes built on a filter press frame.

In the EC unit, the liquid was passed over charged electrodes that gave off ions, causing the phosphorus and metals to coagulate and precipitate (separate).

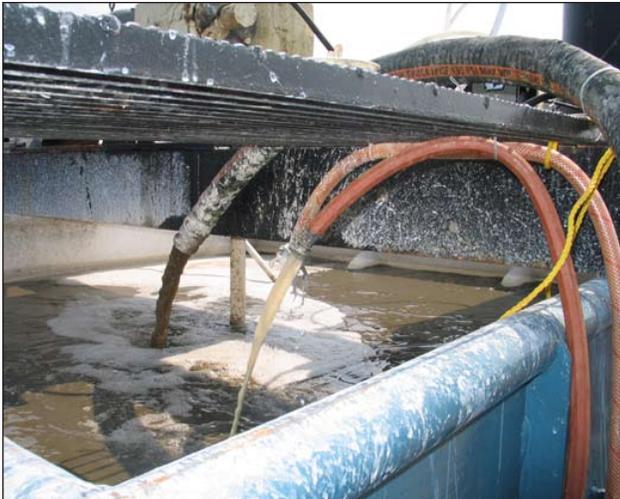
In the study, influent from the lagoon was pumped into a large mixing tank, where it was mixed with alum and an anionic emulsion polymer (Fig. 8) to help coagulate and separate the solids.

Figure 8: Mixing tank with chemical additions.

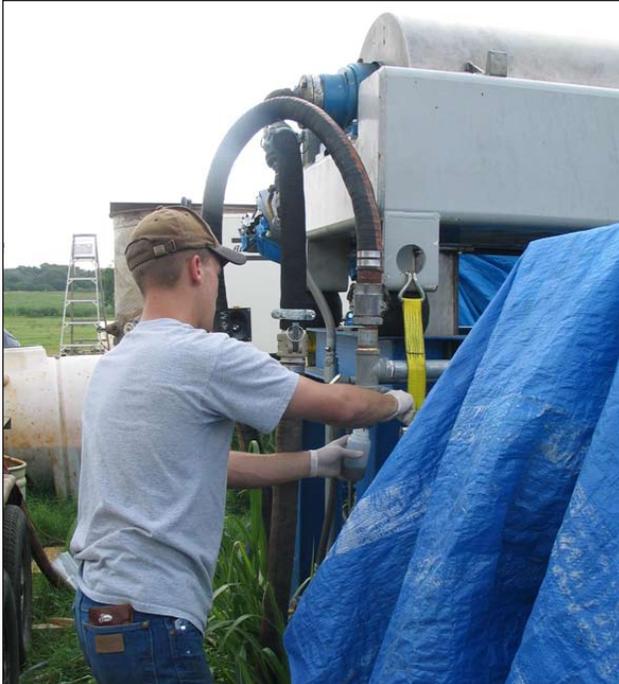
Effluent samples of liquid leaving the centrifuge (Fig. 9) indicated that the centrifuge was the most efficient component in the system, as it removed more total solids, total fixed solids, total volatile solids, total suspended solids, calcium, magnesium, manganese and copper than did any other component in the system. Most of the nitrate-nitrite nitrogen, total Kjeldahl nitrogen, soluble phosphorus and total phosphorus were removed in the large mixing tank, where alum and the polymer were added to influent from the lagoon.

Figure 9: Sample collection at the centrifuge.

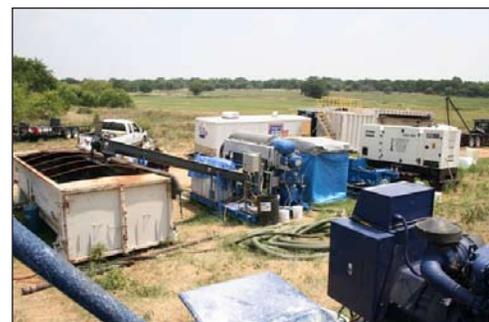
Figure 10: General layout of the EC system.

Cost estimates for the operation of the EC system (Fig. 10) were about \$0.12 per gallon of treated effluent. These costs include fees for system setup and operation by representatives from Ecoloclean Industries, Inc. This estimate does not include costs for residual material removal from the dairy.
