**DEVELOPMENT OF A COMPOSITE REPAIR SYSTEM
FOR REINFORCING OFFSHORE RISERS**

A Dissertation

December 2007

Major Subject: Mechanical Engineering

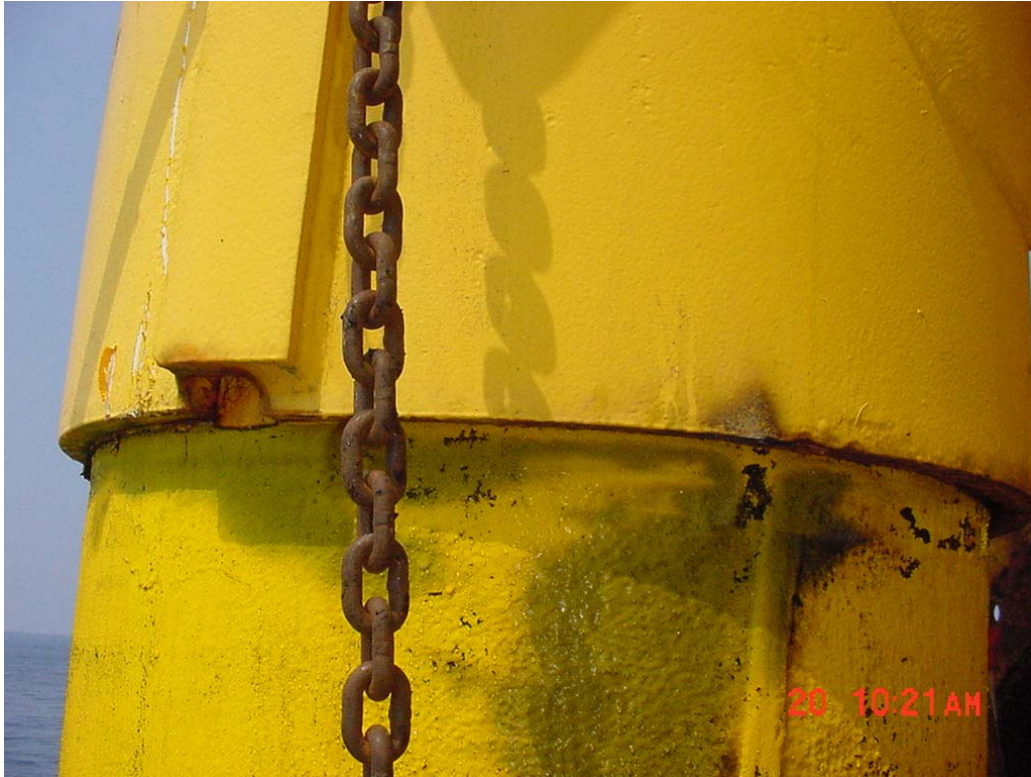
Figure 2 – A conventional riser repair involving a welded steel clamp

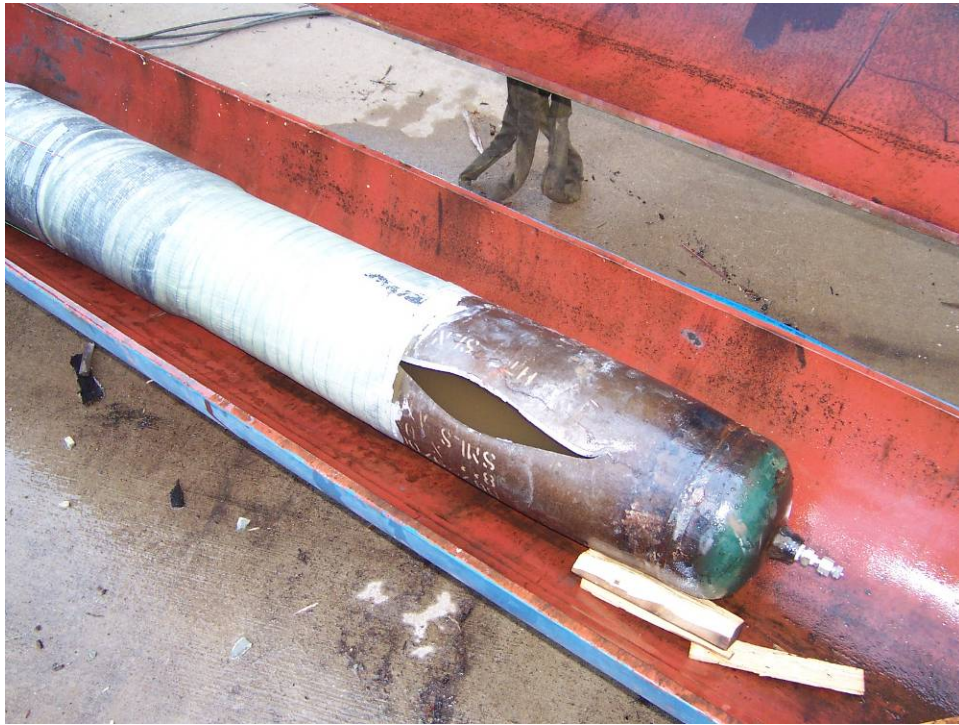
Figure 12 – Failure in burst sample using Product C

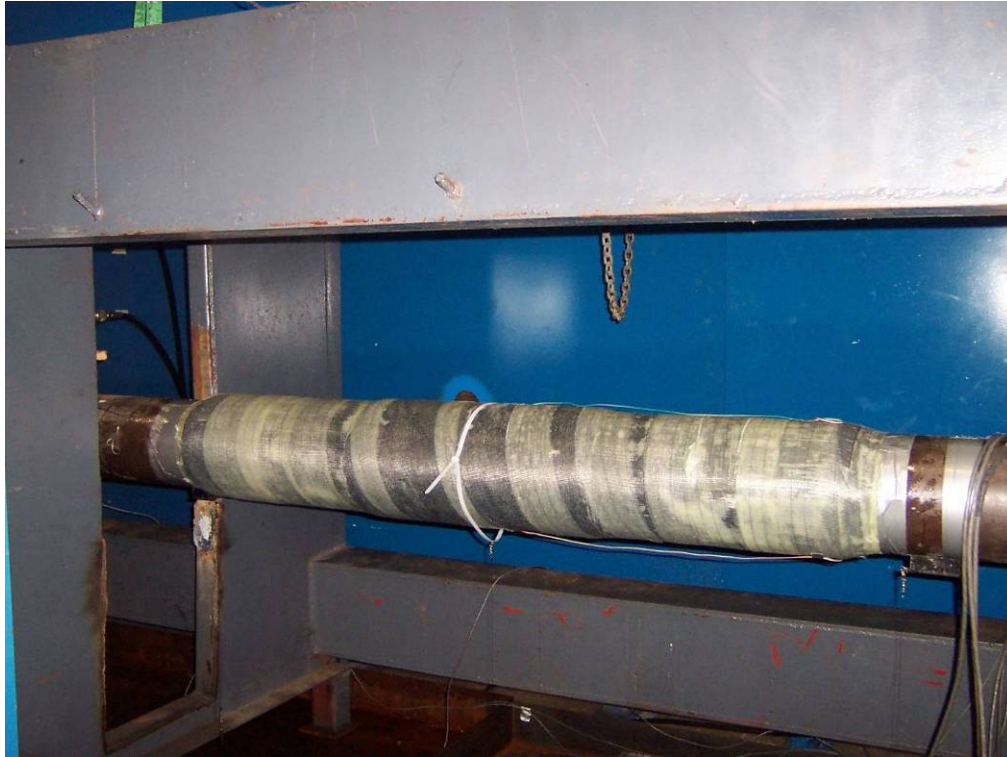
Figure 16 – Photo showing Product C prior to bend testing

Figure 16 is a photograph of the Product C repair in the load frame prior to bend testing.

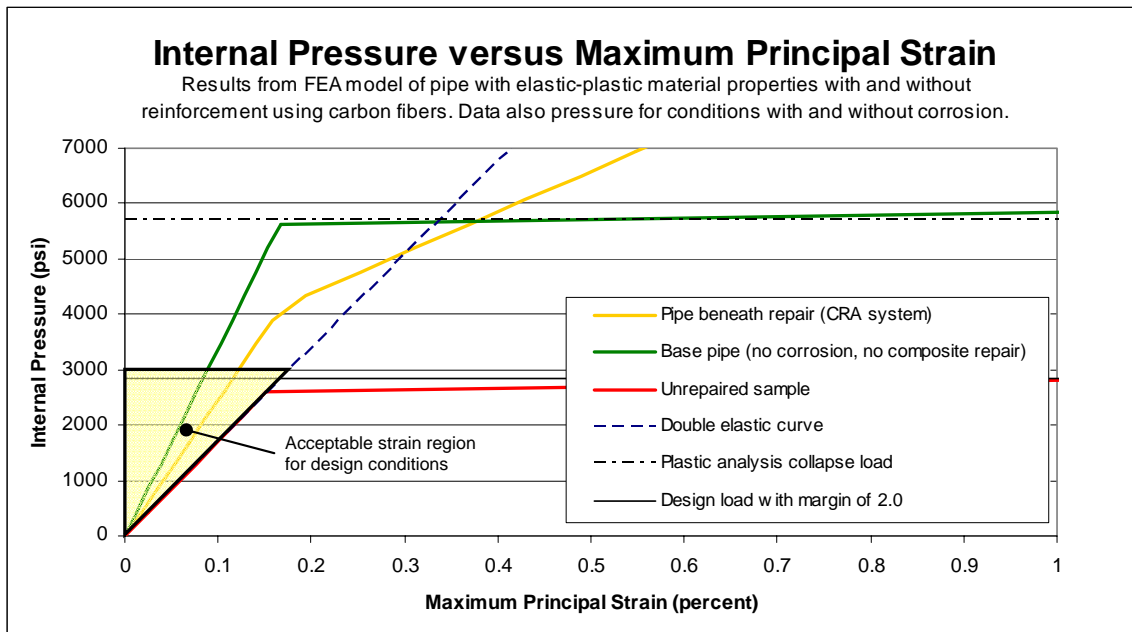
Figure 22 – Pressure loading versus maximum principal strain
(carbon repair with 0.200-inch thick hoop | 0.400-inch axial | 0.100-inch hoop layers)

The data set and curve that are of most interest are those pertaining to the pipe beneath the repair in the corroded region (gold curve). The acceptability of the design is based on whether or not the data fall within the acceptable range. As noted in **Figure 20**, the strains in the pipe beneath the carbon reinforcement are less than the maximum conditions permitted (as noted by the yellow translucent triangle region in this figure).

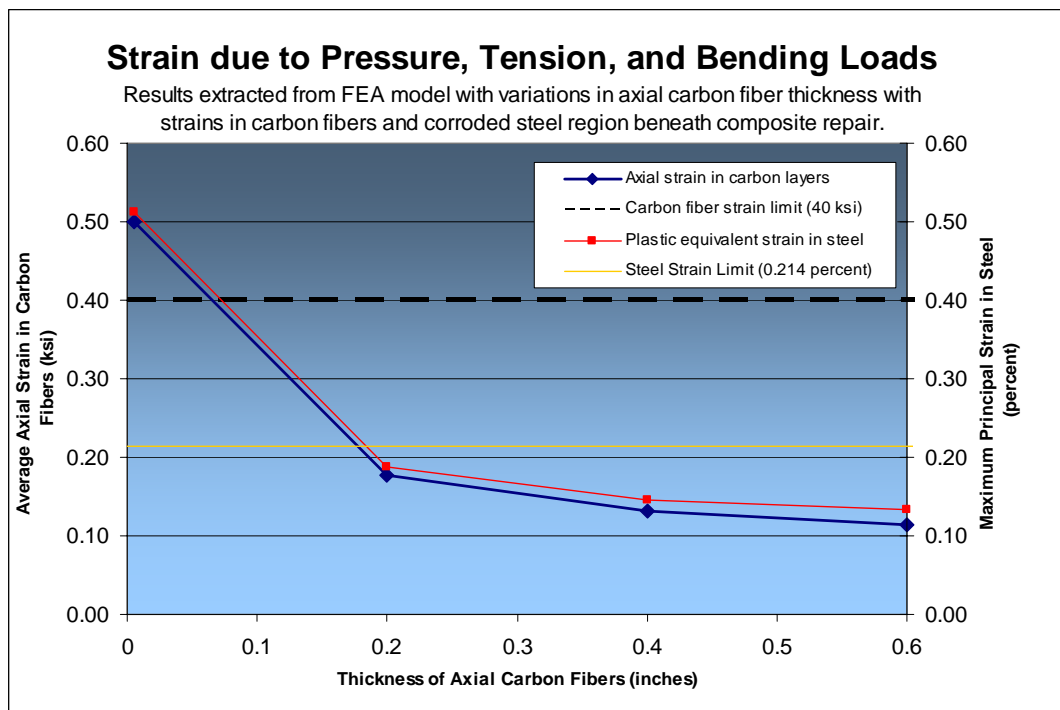
Figure 26 – Results for varying axial carbon thicknesses relative to design limits
(results for the four different FEA models at design conditions)

- From the above two bullets it is clear that the limiting case is the strain limit of the steel. Consequently, the thickness of the carbon half-shells should not be less than 0.20 inches.

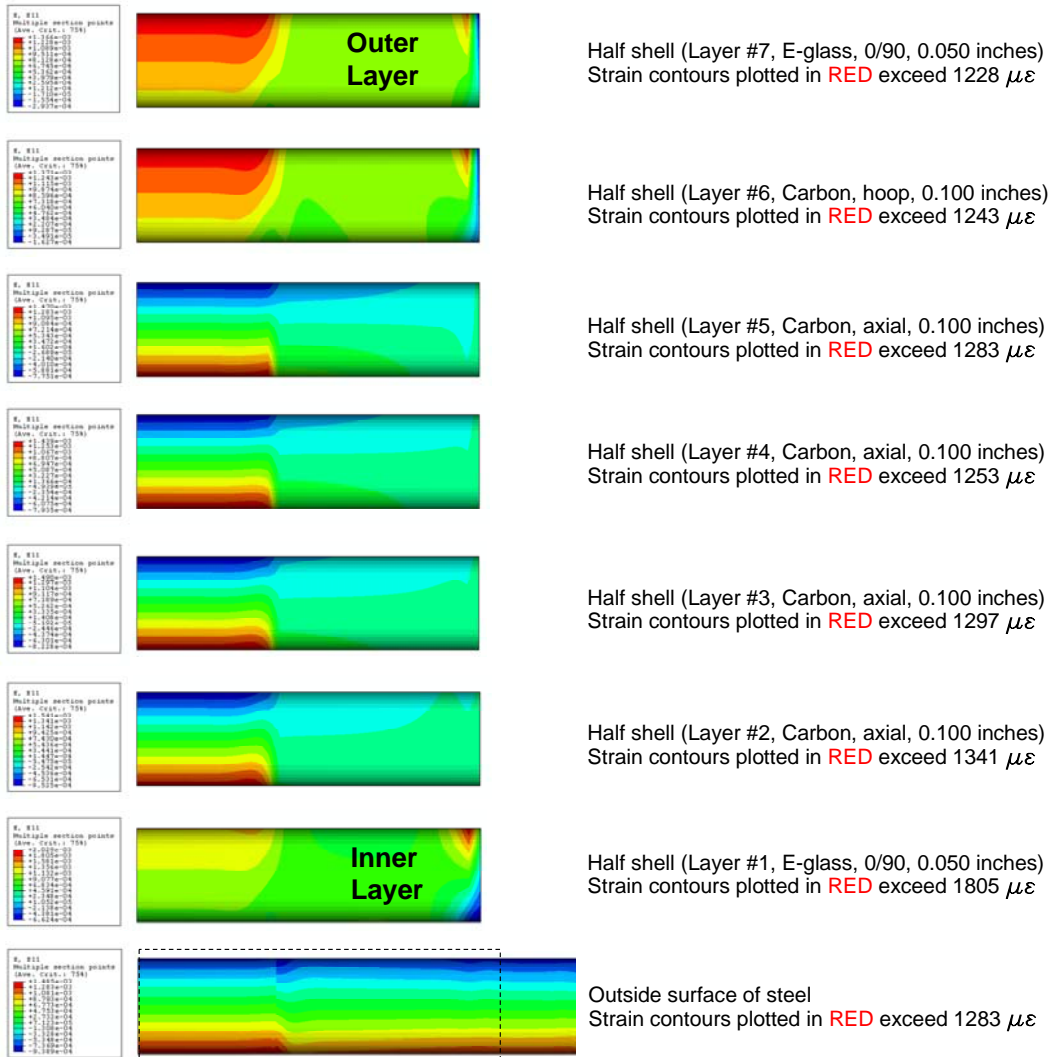
Figure 41 – Axial strain (E11) in composite layers at design condition (Case 1)
(2,887 psi, 145 kips axial tension, and 49.1 kip-ft bending)

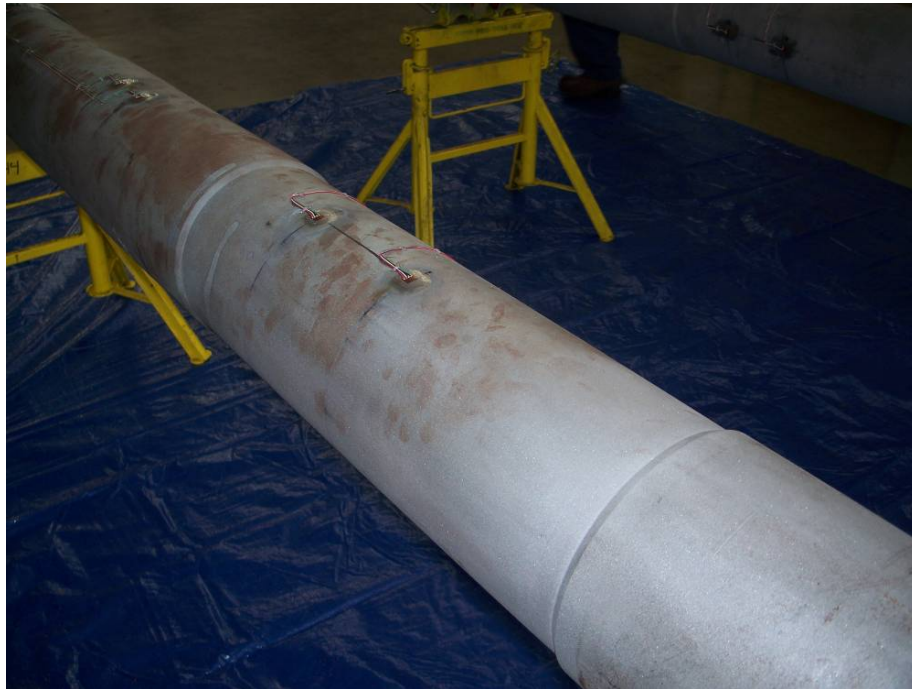
Figure 46 – Sandblasted surface of pipe prior to installed work

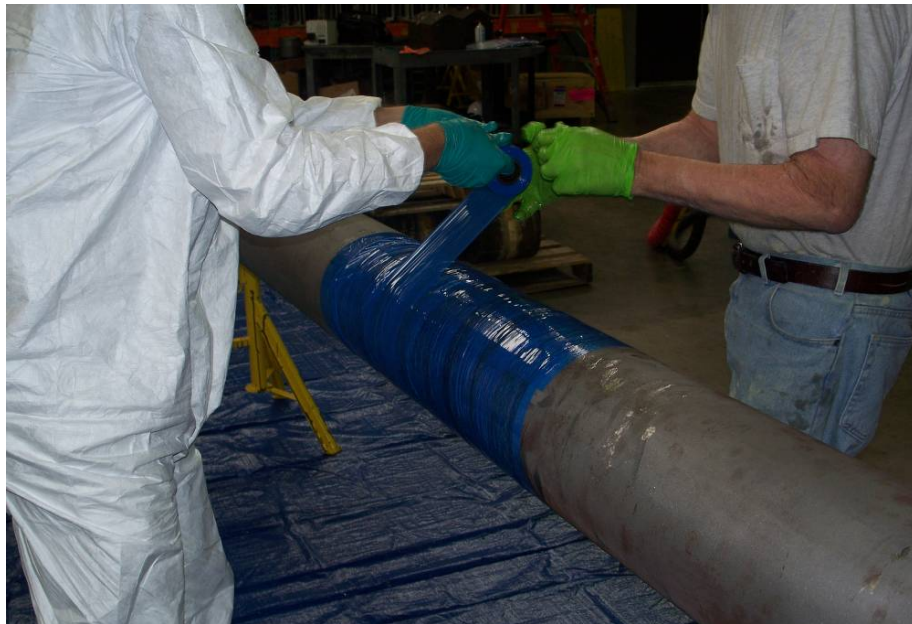
Figure 49 – Installing stricker wrap material around the outside of the repair

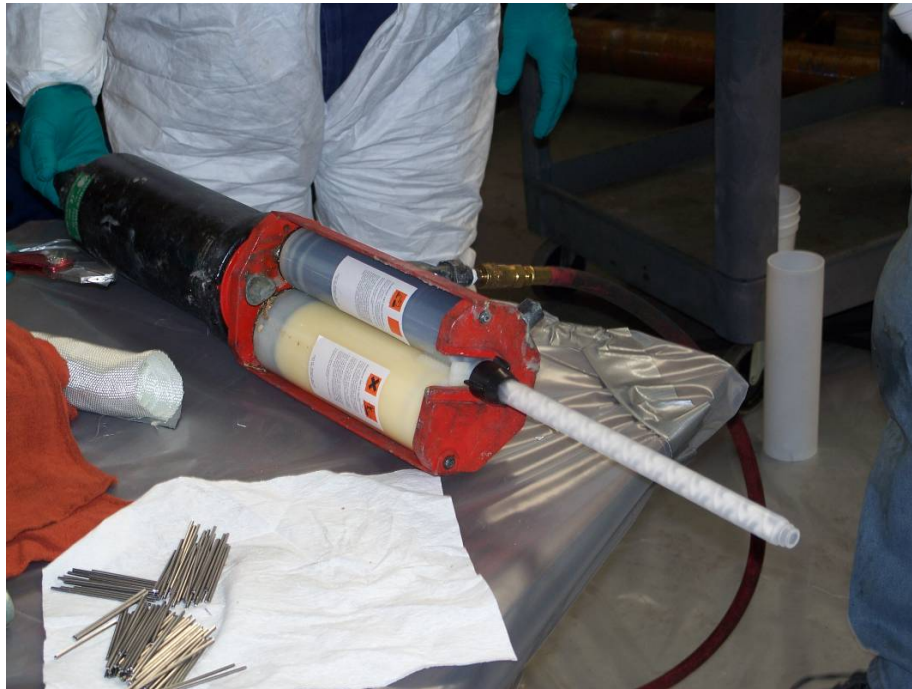
Figure 50 – Epoxy mixing gun used to mix the epoxy Spabond 340 adhesive

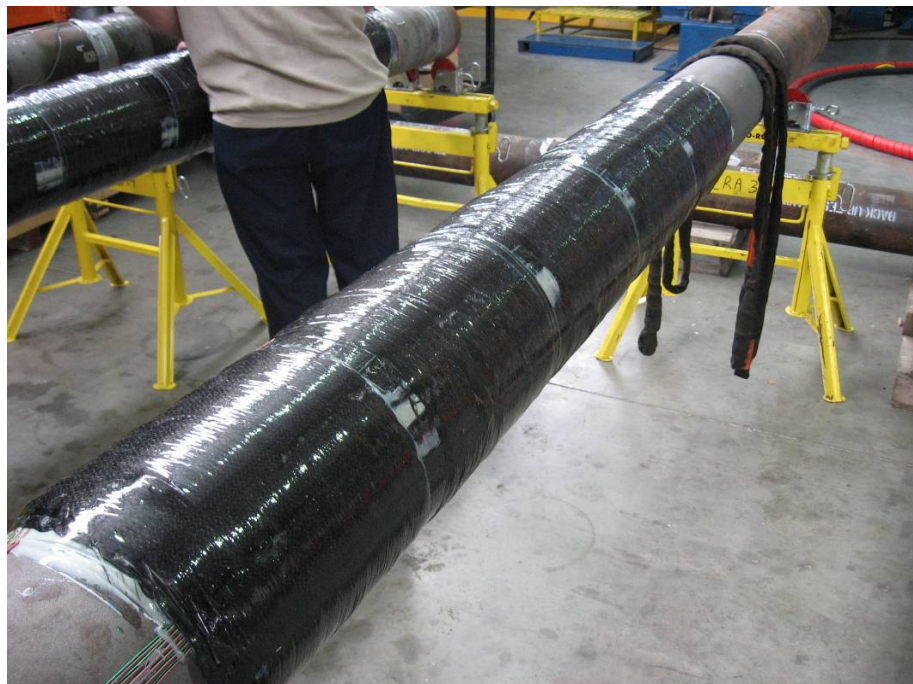
Figure 55 – Final view of cured repair prior to testing

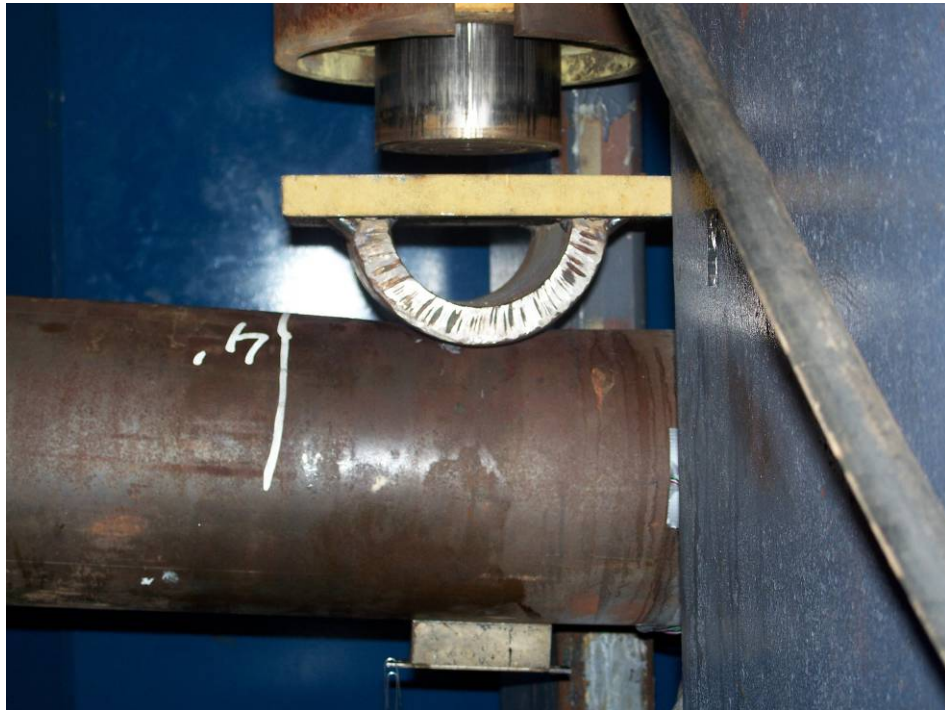
Figure 65 – Plastic deformation near the hydraulic cylinder point of contact

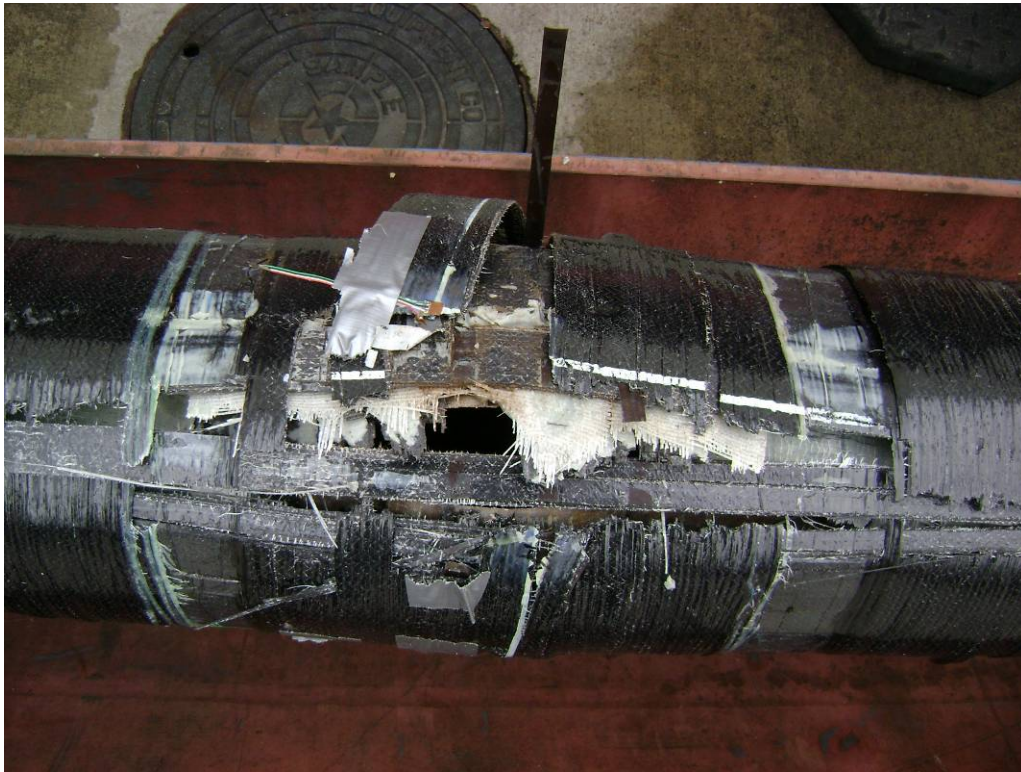
Figure 68 – Photo of burst test sample showing failure

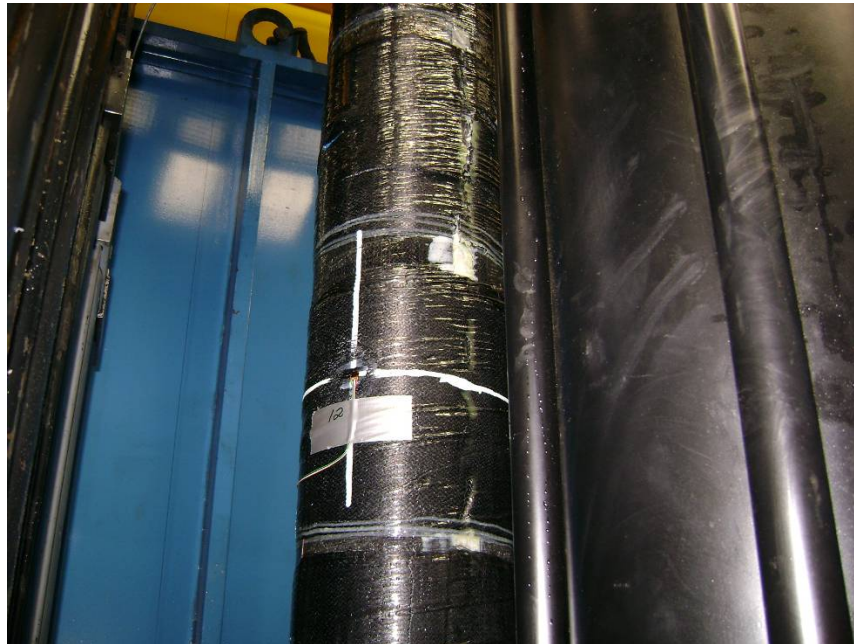
Figure 70 – Photo of tension test showing fracture

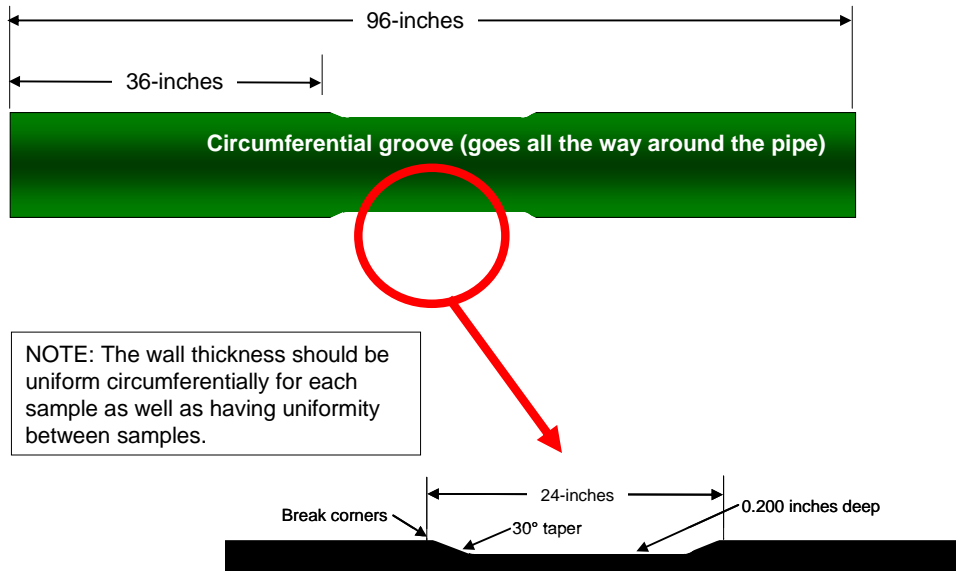
Figure A1a – Layout for Sample #1 and #2
(Pressure and Pressure plus Tension samples)

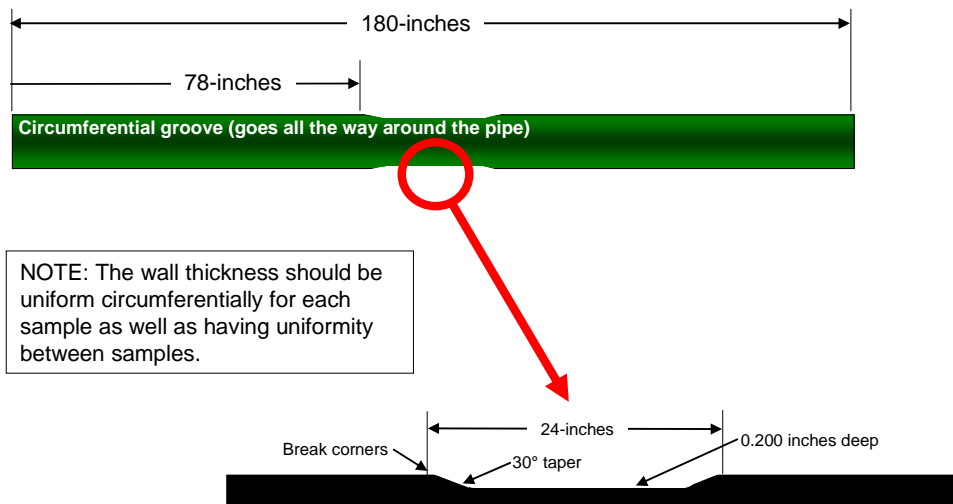
Figure A1b – Layout for Sample #3
(Pressure, Tension, and Bending samples)
