THE KITTEN SHIPWRECK:  
ARCHAEOLOGY AND  
RECONSTRUCTION OF A  
BLACK SEA  
MERCHANTMAN

A Dissertation

KROUM NICKOLAEV BATCHVAROV

August 2009

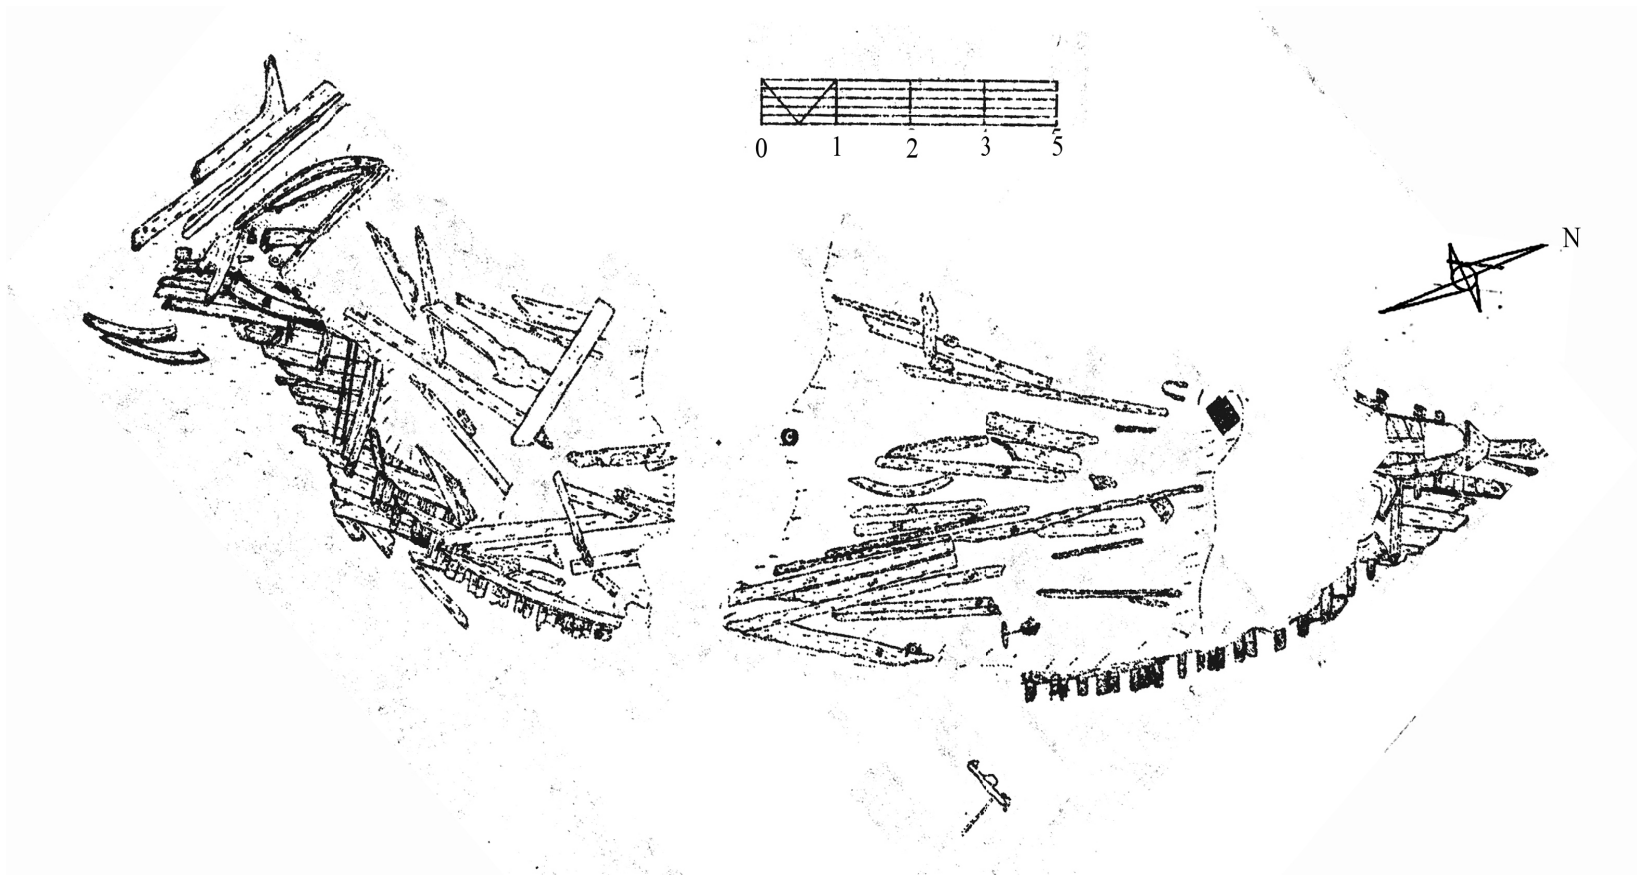
Fig. 6. Site Plan at the end of the 2001 season. Drawing: K. N. Batchvarov.

In the last week of the 2001 season, the archaeological excavation in area F started uncovering a heavy concentration of finds, beginning with a large marble mortar (fig. 6). By the end of the week, a decorated copper teapot and three plates (*sakhans*) were raised in addition to a sounding lead and a broken, but complete, ceramic plate. A few more copper utensils were observable, but left *in situ* to await the following season. Rows G, H, and I which corresponded to the central section of the ship yielded only the fragile remains of a treble block, a couple of sheaves from medium-sized blocks and large quantities of small softwood fragments that were too heavily eroded to yield any information. A close examination of the pieces suggested that they may be remains of deck beams and planking.

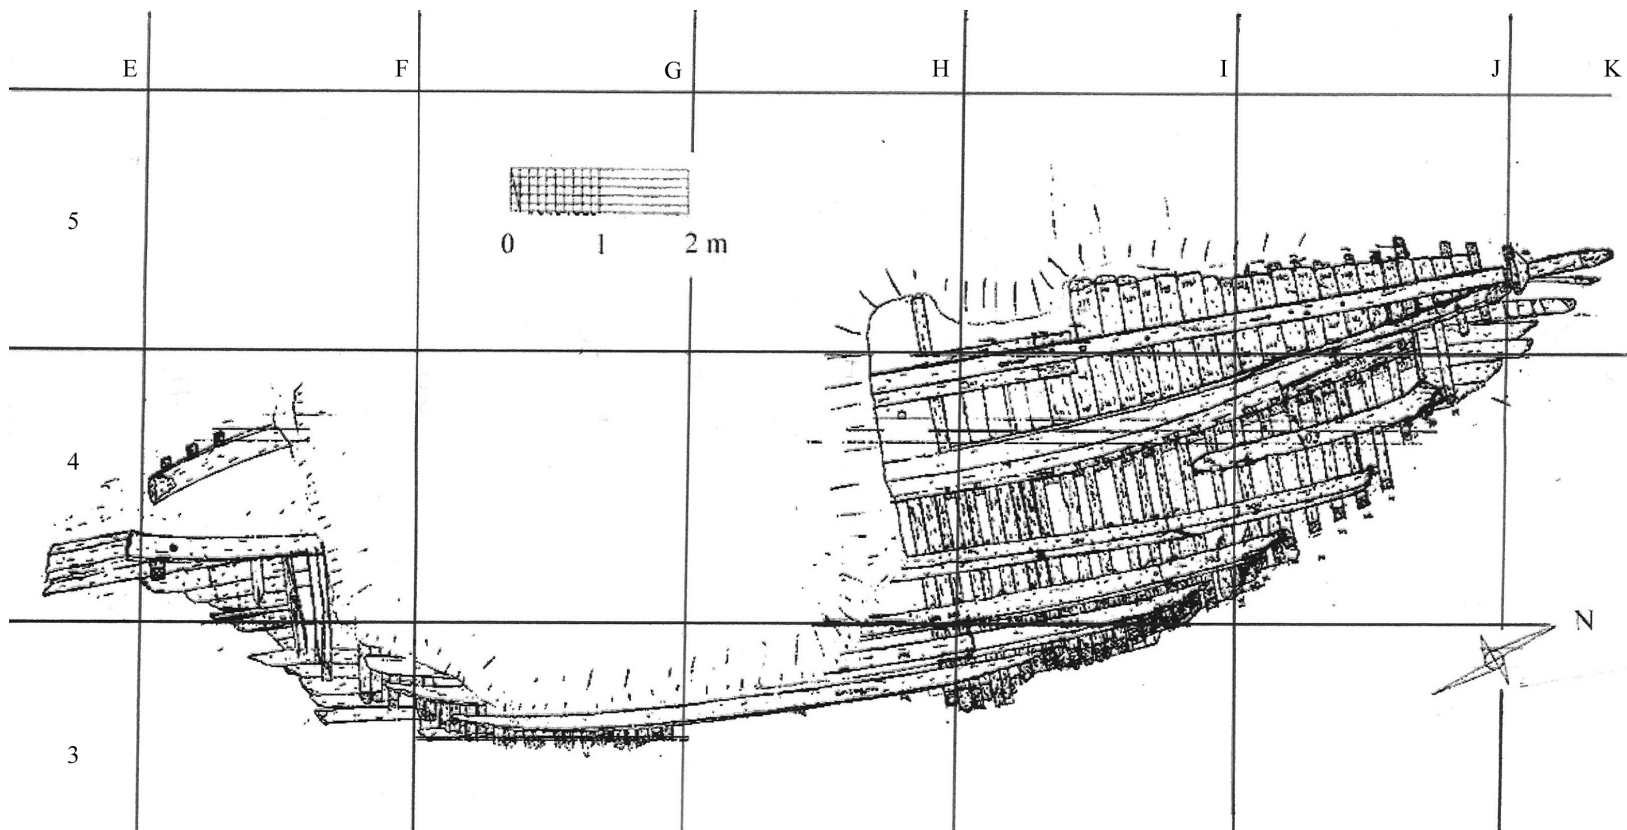
Fig. 7. Site plan, 2002. Drawing: K. N. Batchvarov.

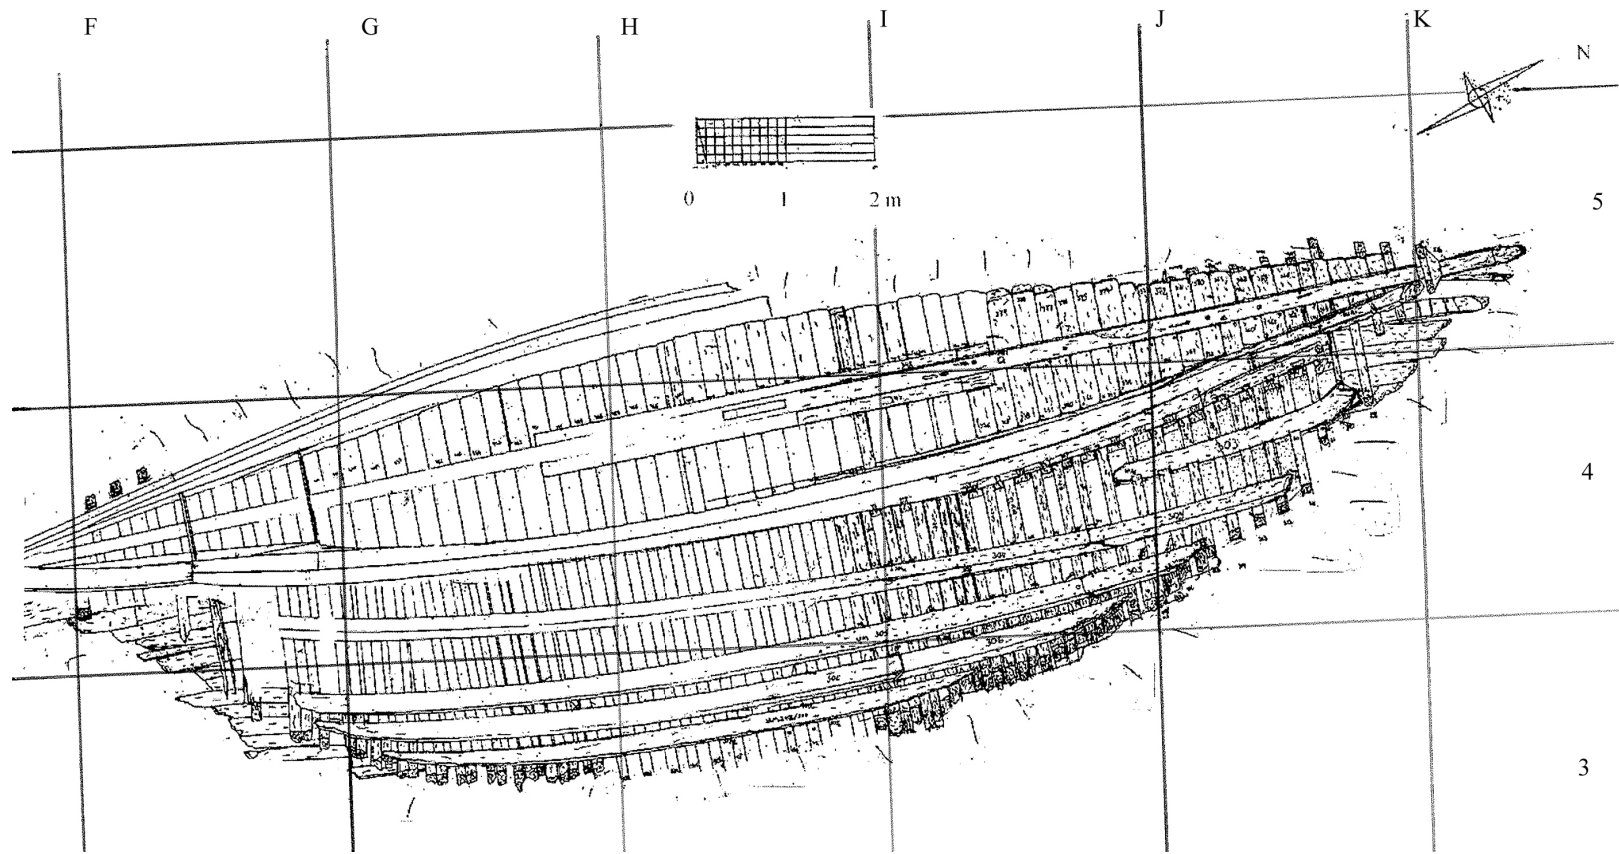
Fig. 8. The site plan at the end of the 2003 season. Drawing: K. N. Batchvarov.

During the fourth and final season, June 2003, the remainder of the site was excavated and numerous artifacts raised (fig. 8). At the very end of the season we also discovered the remains of the stern post, with the iron pintle still attached to it. Although the weather was mostly fine throughout the five weeks of the season, the water was unexpectedly cold; sometimes the temperature dipped to 5-6 degrees Celsius.

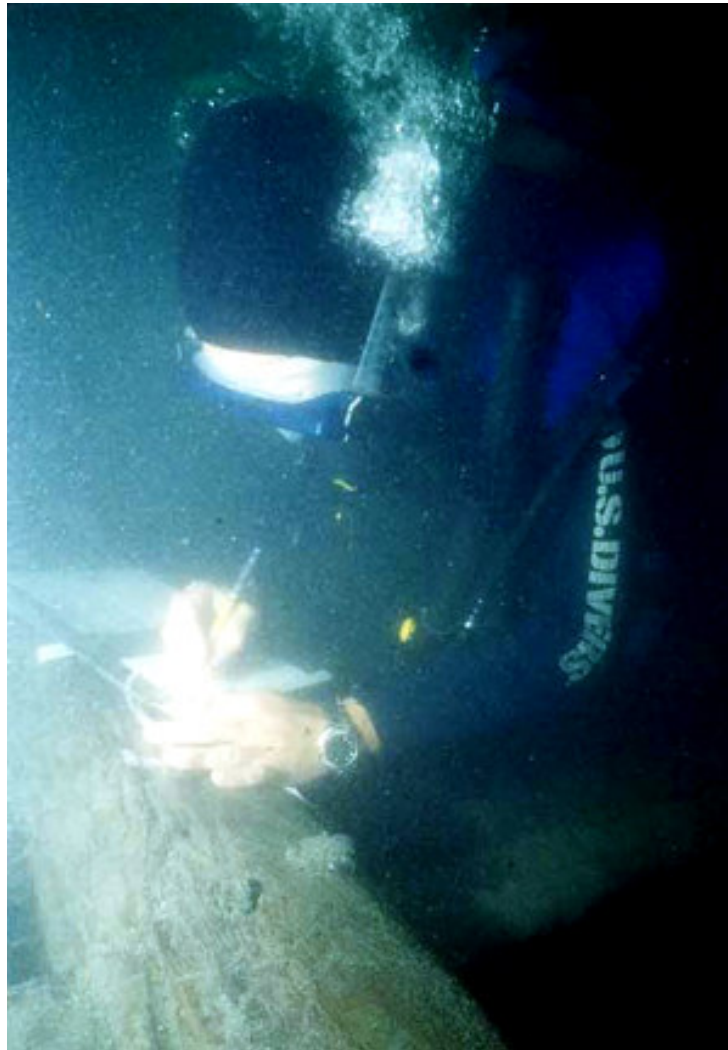
Fig. 9. Diver recording timber scantlings. Photo: L. Klissurov.

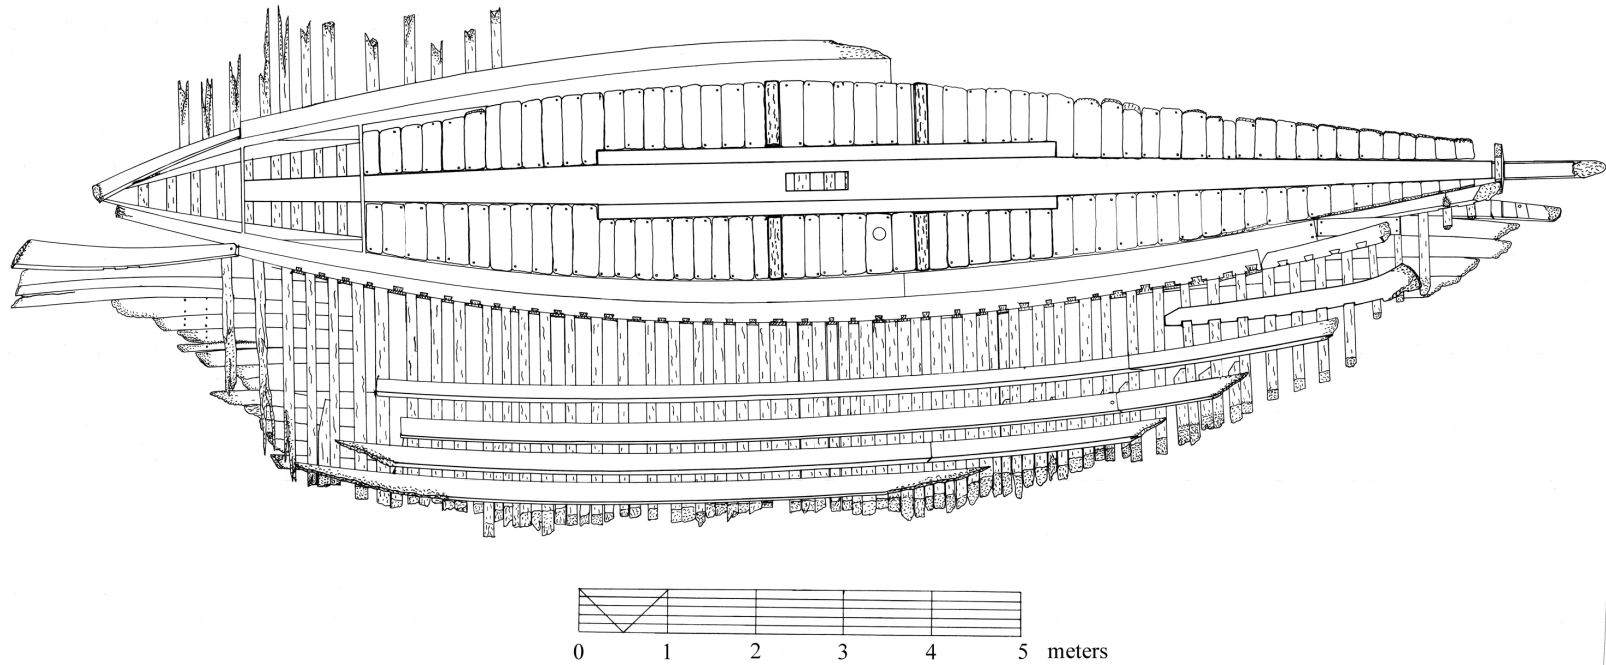
Fig. 11. Plan of the intact hull structure. Drawn: K. N. Batchvarov.

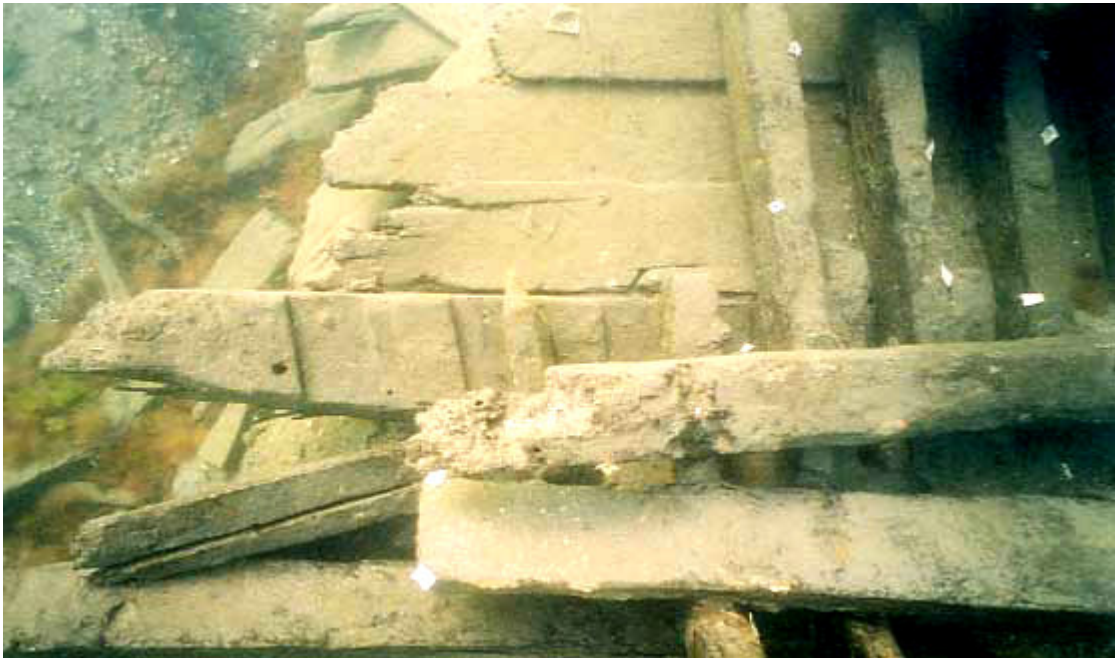
Fig. 12. External reinforcing timber, notched for the frame overlaps. Photo: K. N. Batchvarov.

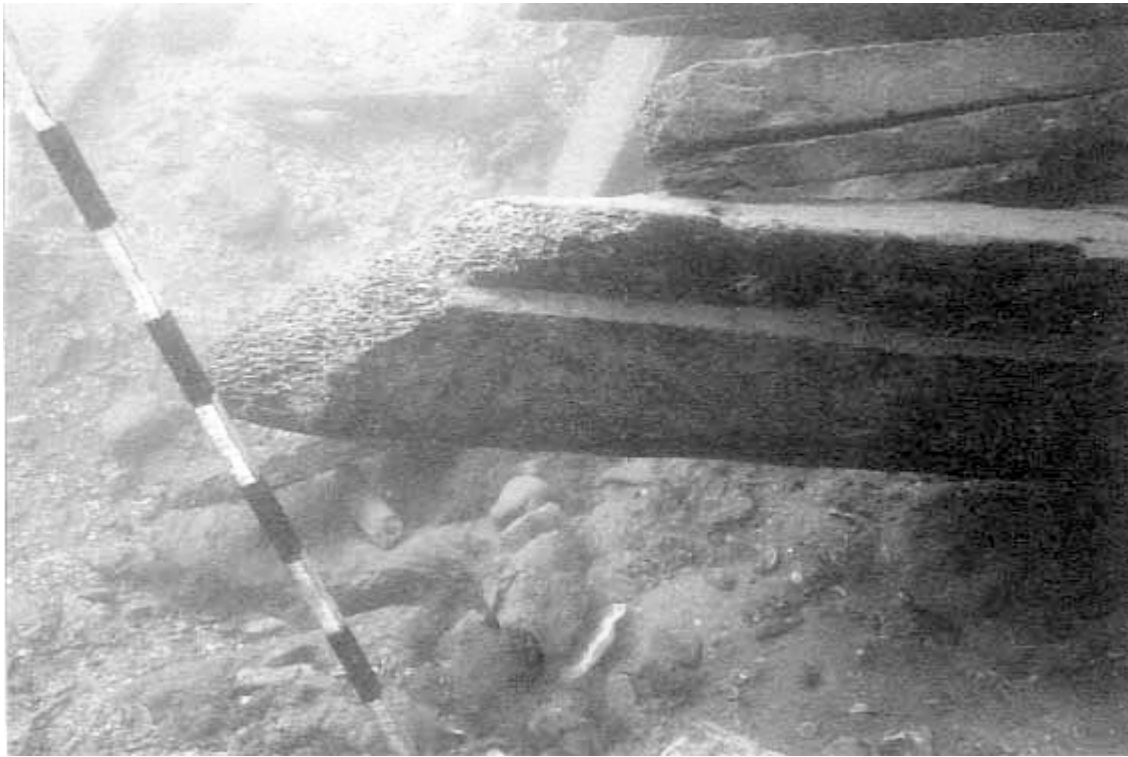
Fig.13. The remains of the stem with a deep rabbet along the side. Photo: K. N. Batchvarov.

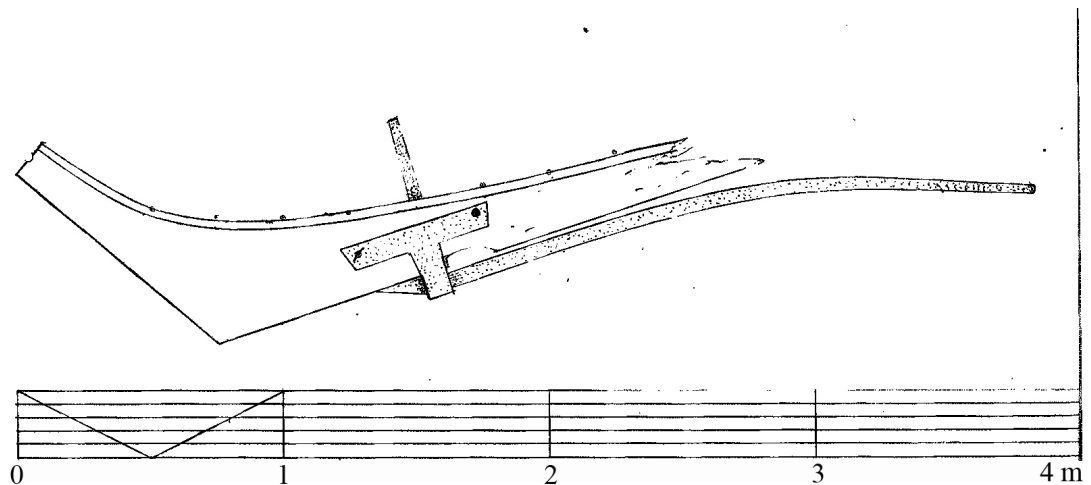
Fig.14. The Sternpost. Drawing: K. N. Batchvarov.

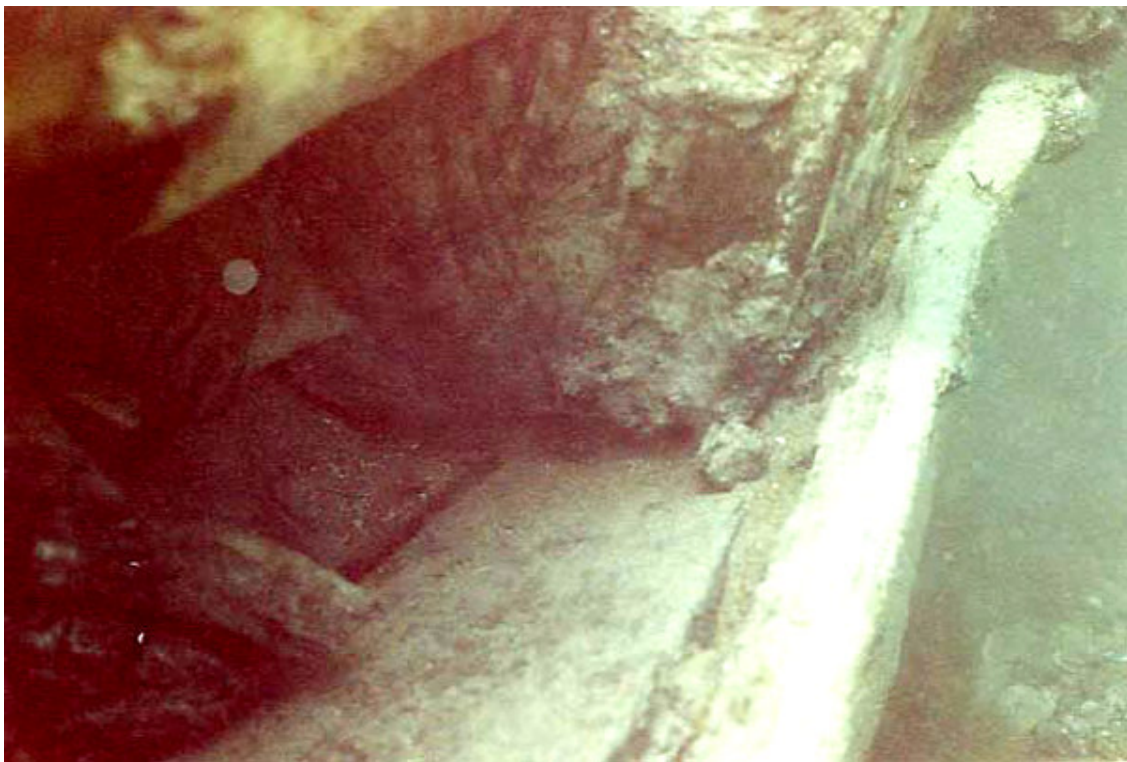
Fig. 15. Y-shaped floor timber in the bow. Photo: K. N. Batchvarov.

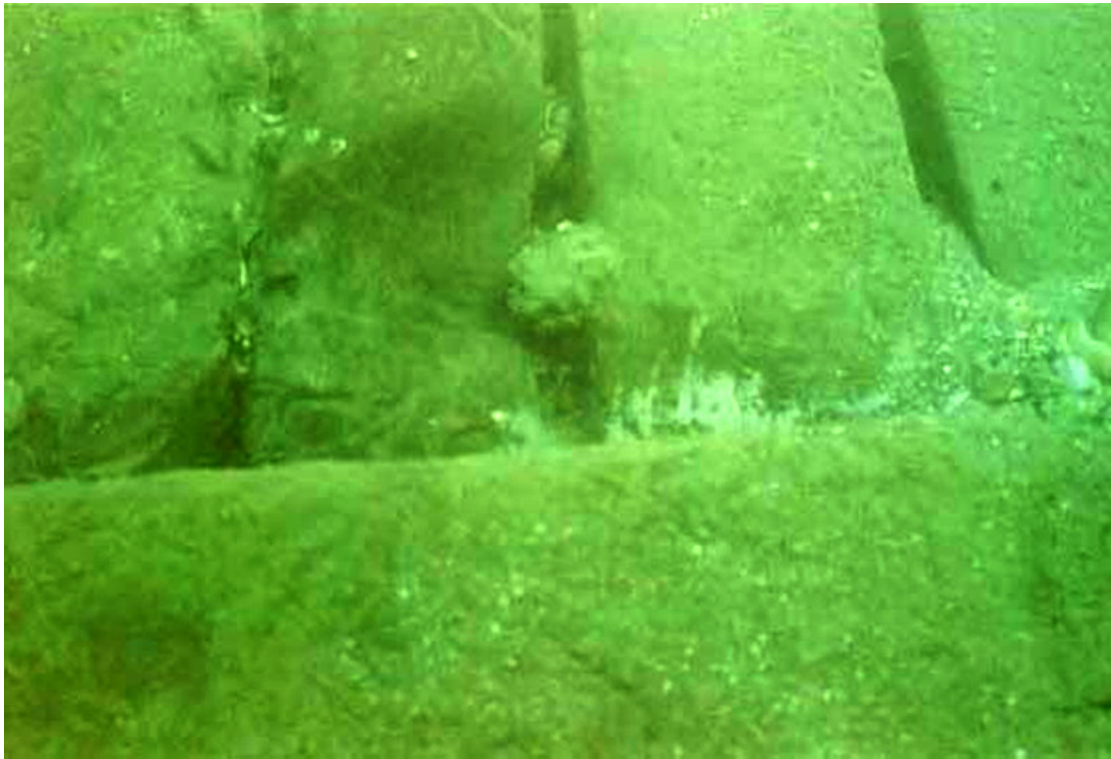
Fig. 19. Notch in adjacent timber for fastener of a toptimber. Photo: K. N. Batchvarov.

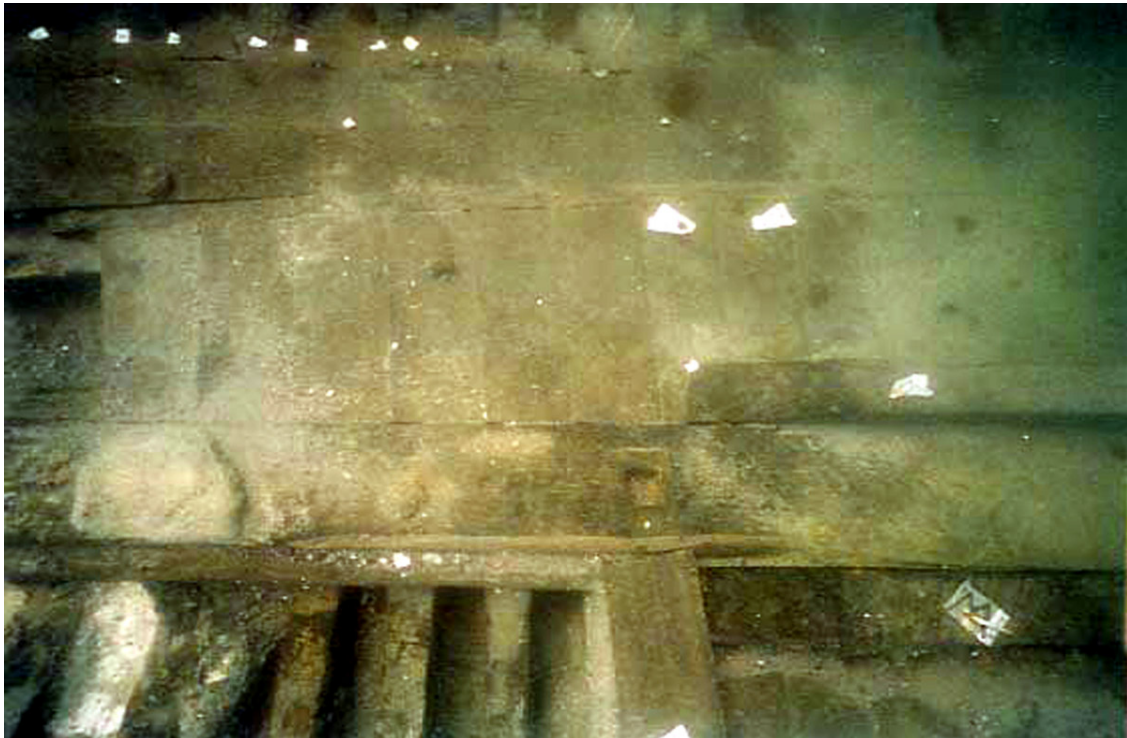
Fig. 21. Stanchion mortise with square imprint visible. Photo: K. N. Batchvarov.

Immediately forward of the sister keelsons a shallow square (c. 10 cm per side and 10 cm deep) mortise is cut into the upper face of the keelson. The mortise is surrounded by a square imprint, probably caused by the lower end of a stanchion (fig. 21). Neither the stanchion itself, nor any trace of it was found. This represents the only stanchion mortise found.

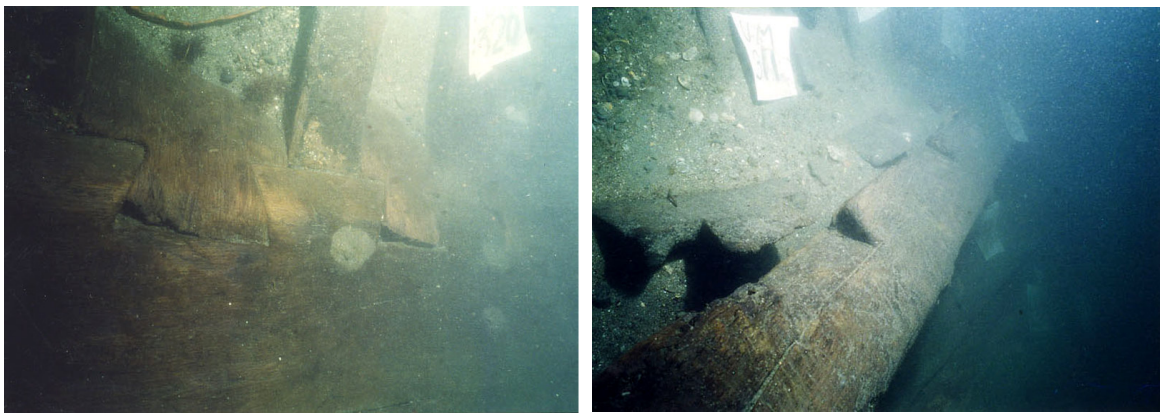
Fig. 23. Crenelated timbers with filling pieces between the futtocks. Photo: L. Klissurov.

The bilge stringer is partially covered by two thinner, but still massive strakes (c. 5-10 cm thick and c. 20 cm wide each) of footwaling extending from about the middle of the stringer outboard. Forward, the outer strake butts into a timber with nearly square section, which forms the continuation of the strake towards the bow of the vessel. Originally, it probably reached the stem or a breasthook. The timber was fastened to each frame, although most frames have now fallen off and the timber itself is in very poor condition. Nevertheless, dovetail mortises were clearly observable on its upper and outer surfaces, and some still contained the dovetails of filling pieces that covered the room between the futtocks. Aft, the outer of the two footwaling strakes is crenelated and notched around the futtocks, with dovetail-jointed filling pieces between the frames (fig. 23).

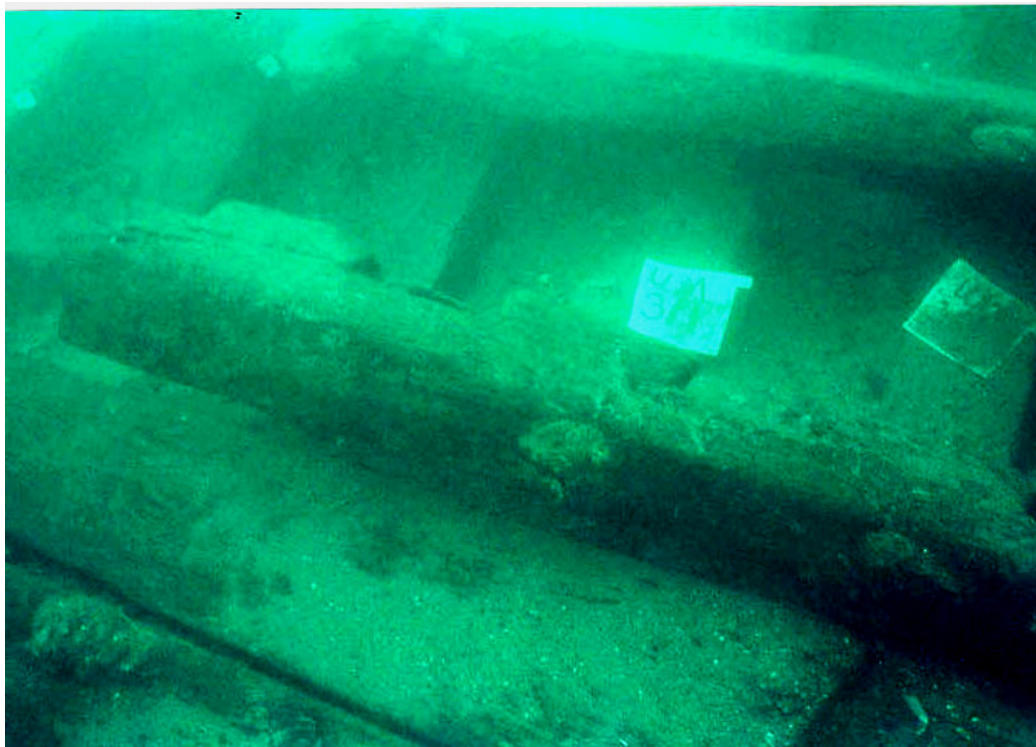
Fig. 25. A part of the outer footwaling strake which may have formed the arm of a breasthook. Photo. L. Klissurov.

In the bow, there is a timber, similar in scantlings to the heavier stringers, which butts into the outer strake of the footwaling and curves towards the stem, which it probably reached. It is likely to have been part of a breasthook (fig. 25). The timber is in very poor condition.

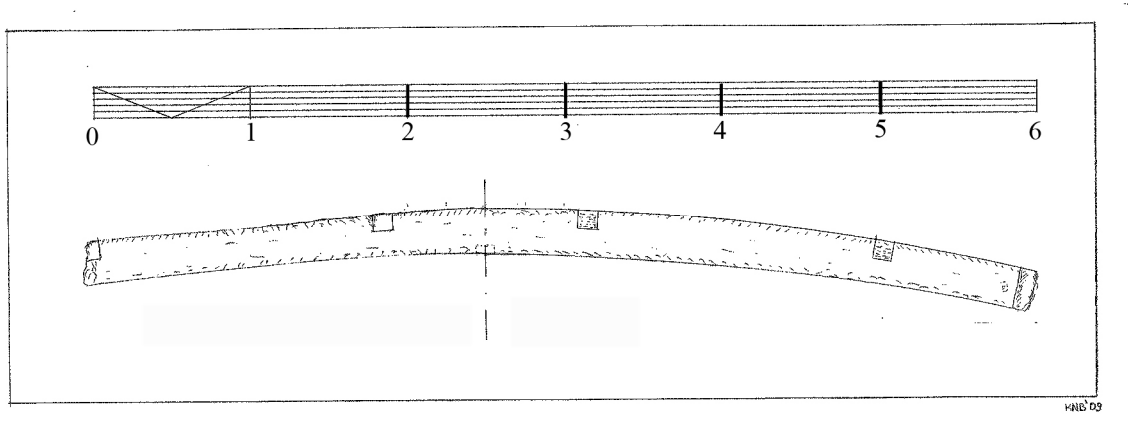
Fig. 27. Deck beam. Drawing: K. N. Batchvarov.

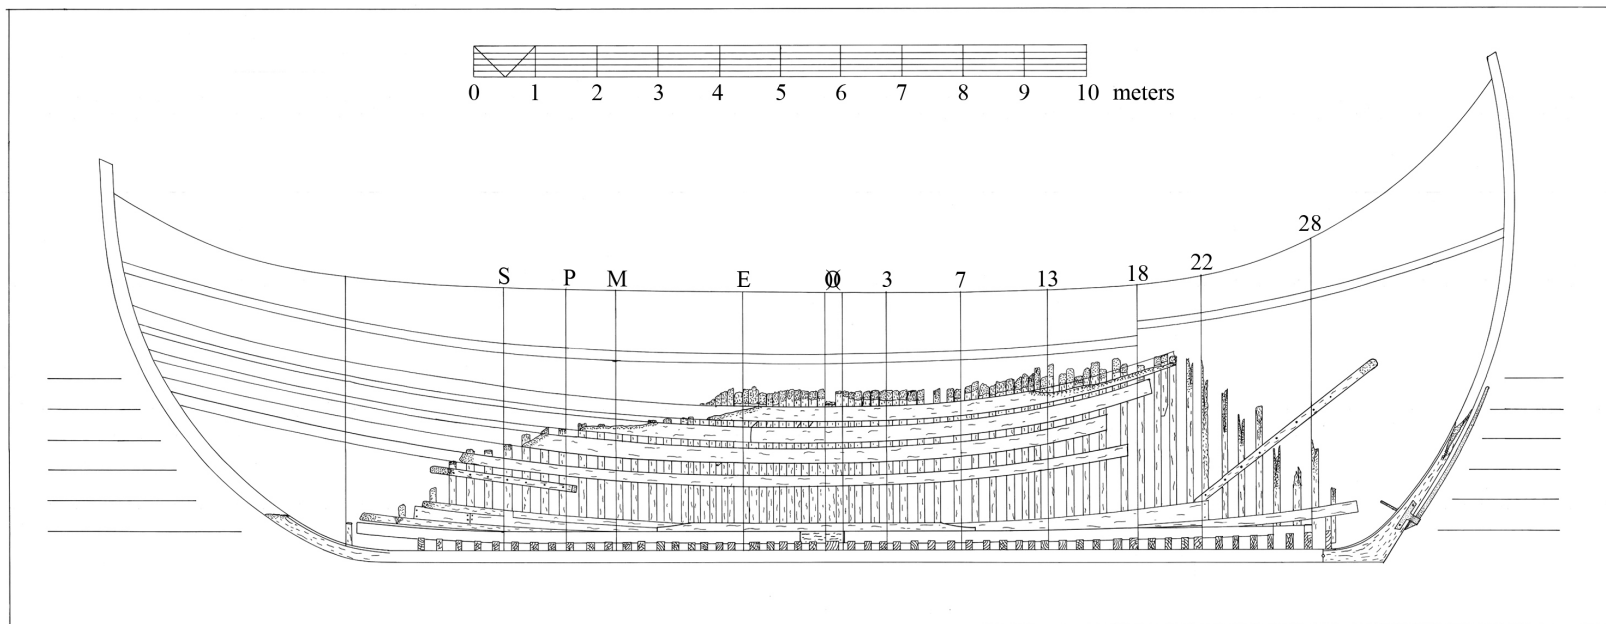
Fig. 29. Longitudinal section of the hull. The drawing shows the extent of hull preservation. Drawing: K. Batchvarov.

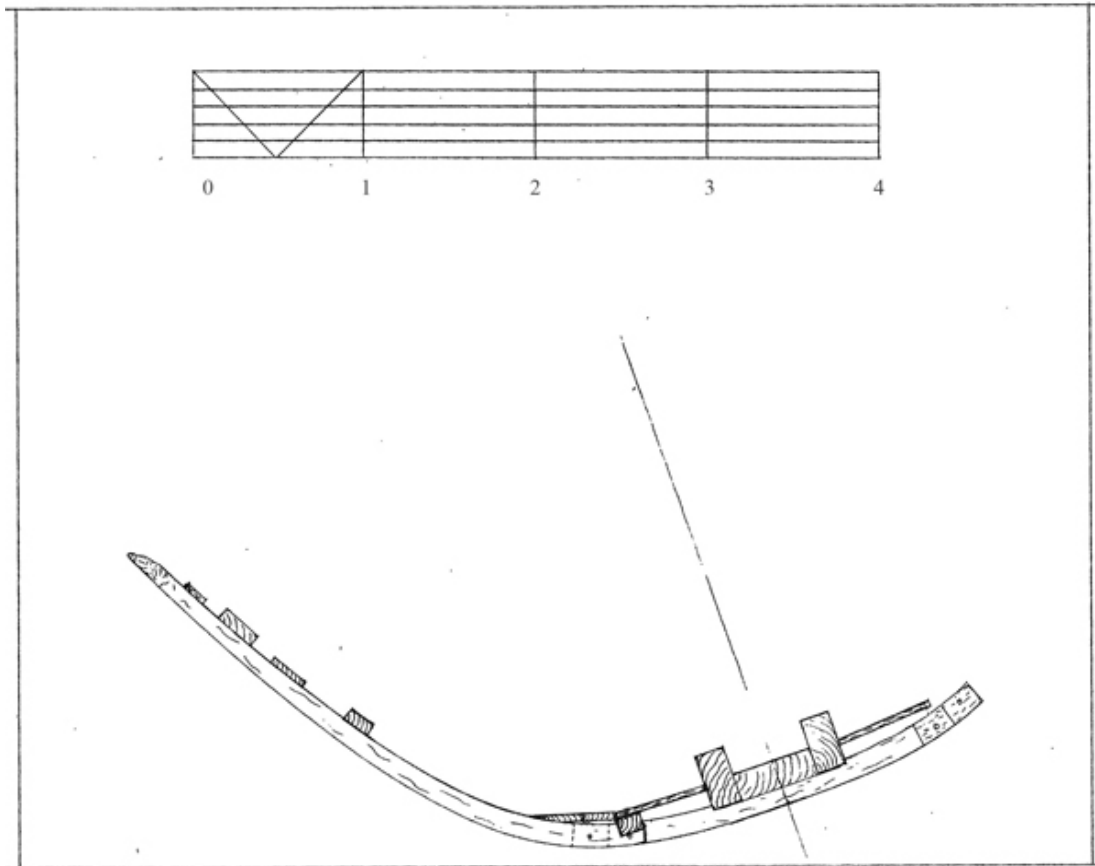
Fig. 31. Frame E as recorded. Drawing: K. N. Batchvarov.

concentration in the bow and stern areas where the shape of the hull changed more rapidly. The recorded sections include from the bow toward the stern S, P, M, E (fig. 31), the midship frame, 3, 7, 13, 18, 22 and 28 (fig. 28, 32).

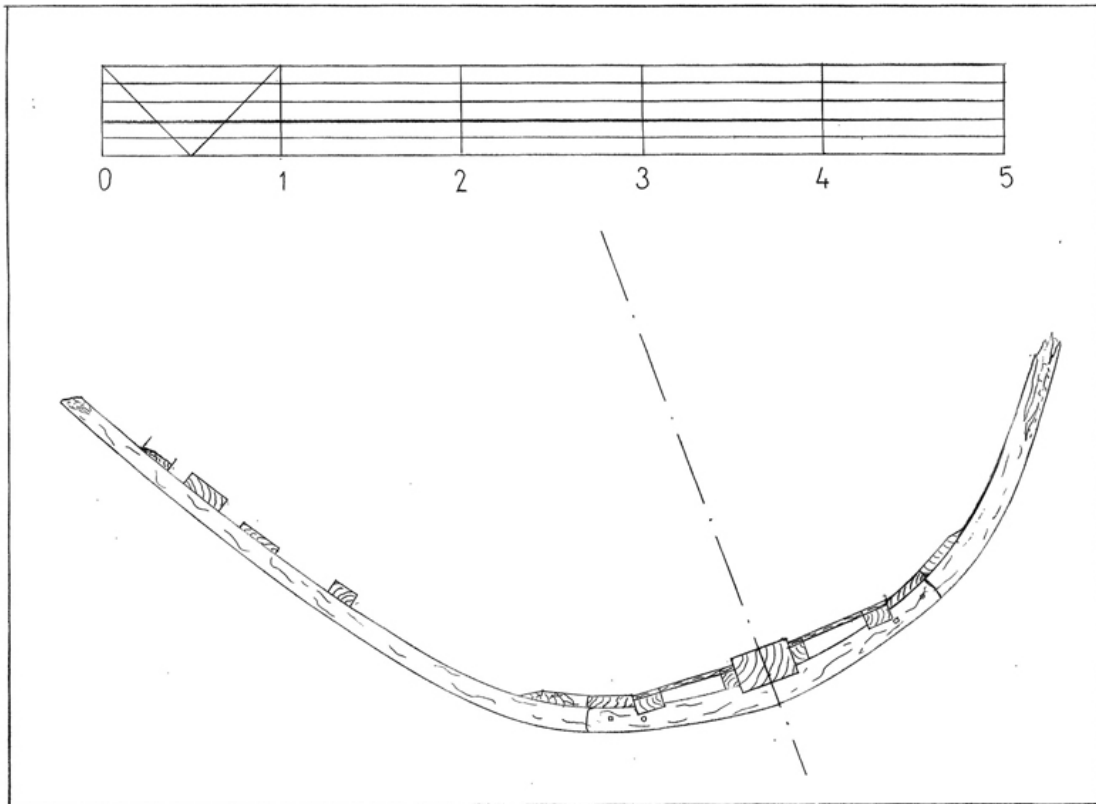
Fig. 32. Frame at section 13, as recorded. Drawing: K. N. Batchvarov.

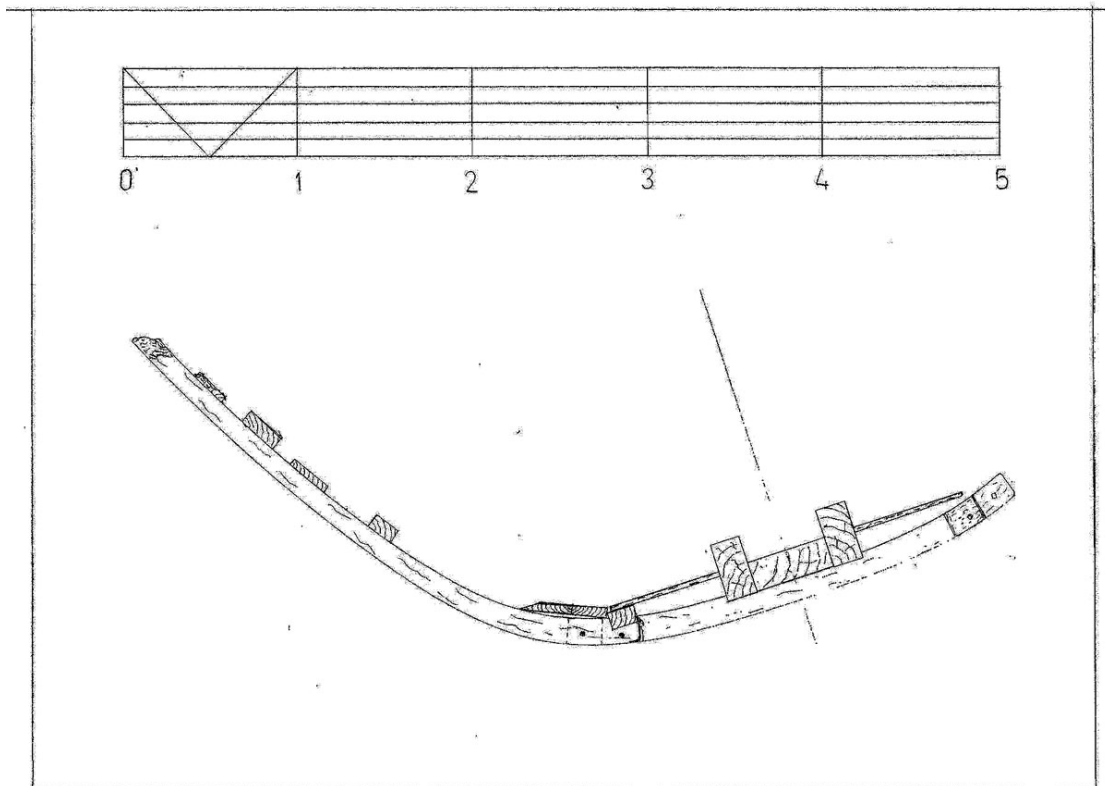
Fig. 33. Midship frame as recorded. Scale in meters. Drawing: K. N. Batchvarov.

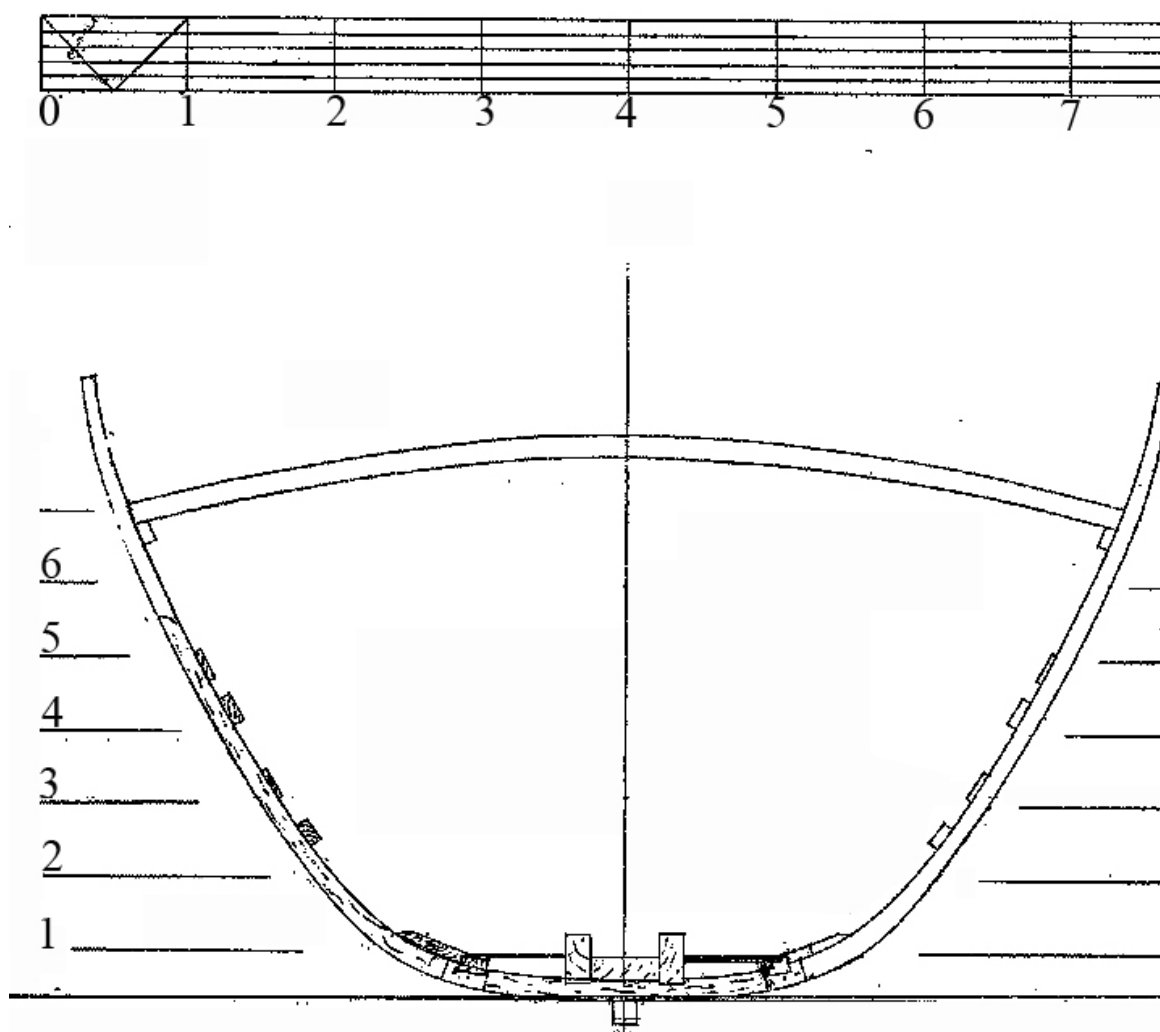
Fig. 34. Reconstructed midship frame. Drawing: K. N. Batchvarov.

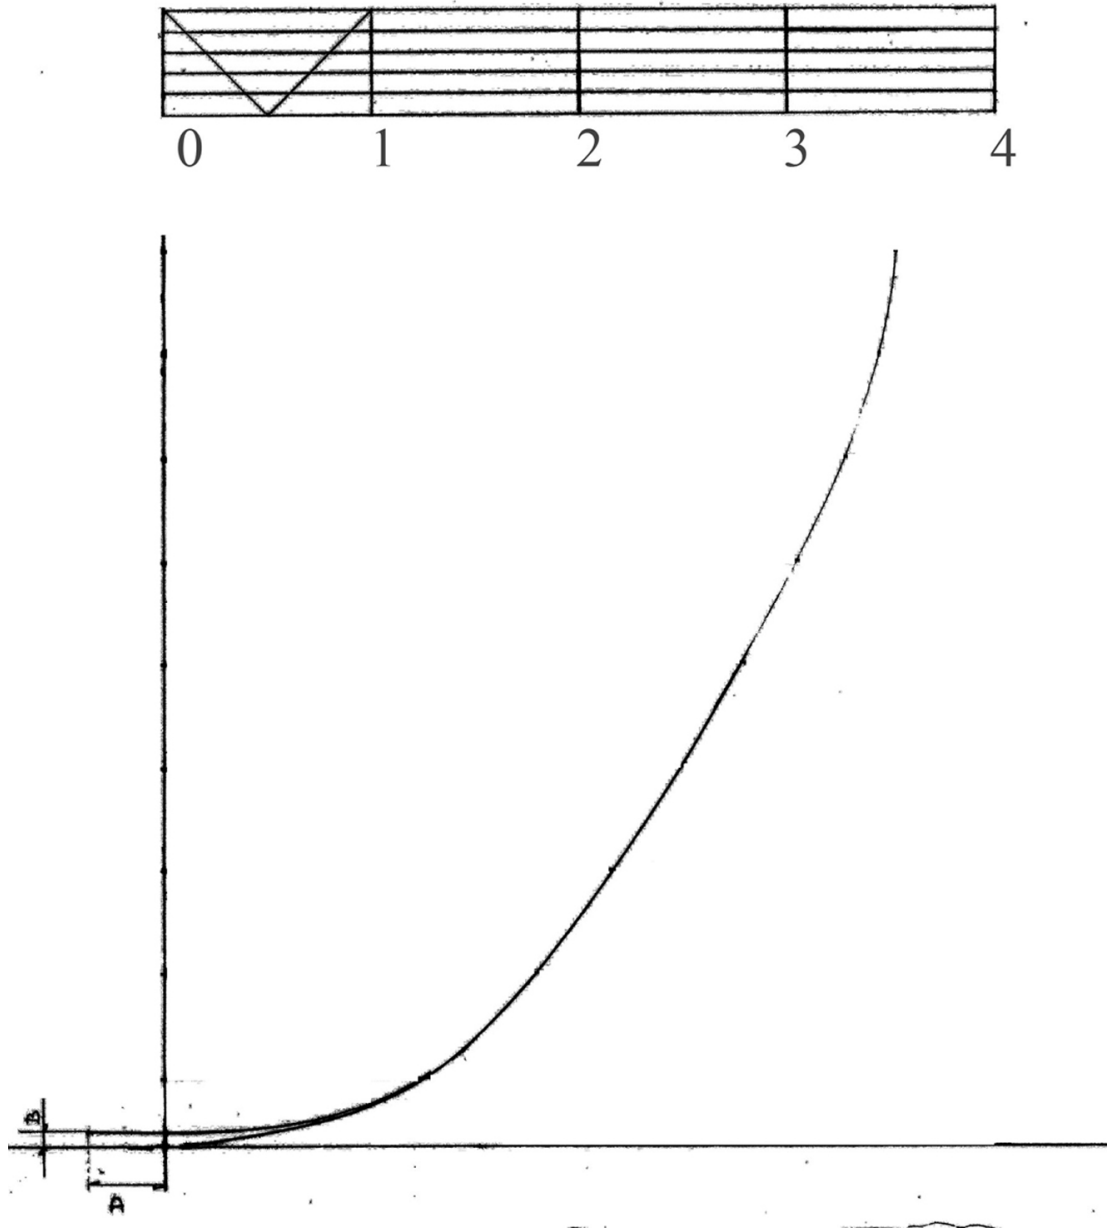
Fig. 35. Narrowing and rising of Frame M. Drawing: K. N. Batchvarov.

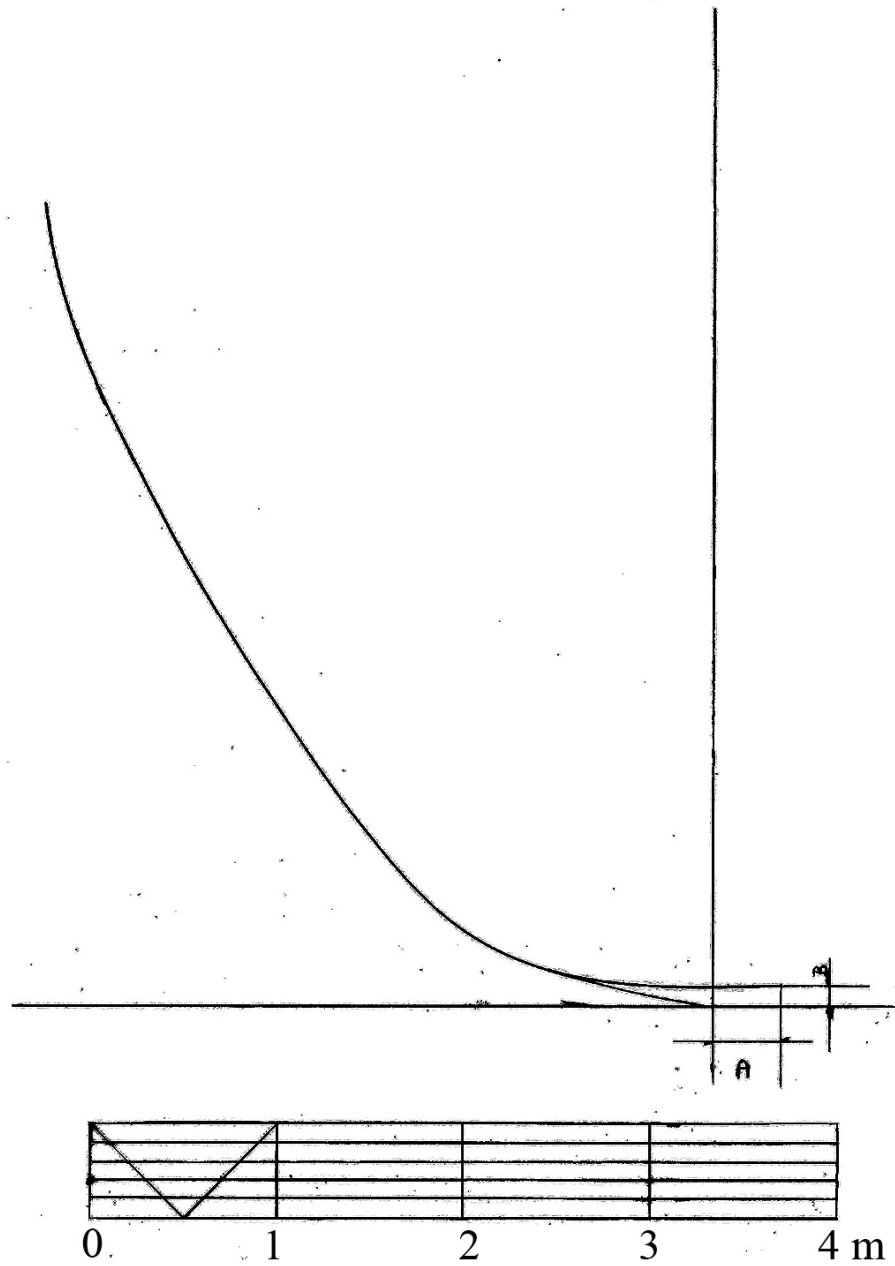
Fig. 36. Narrowing and rising of Frame 13. Drawing: K. N. Batchvarov.

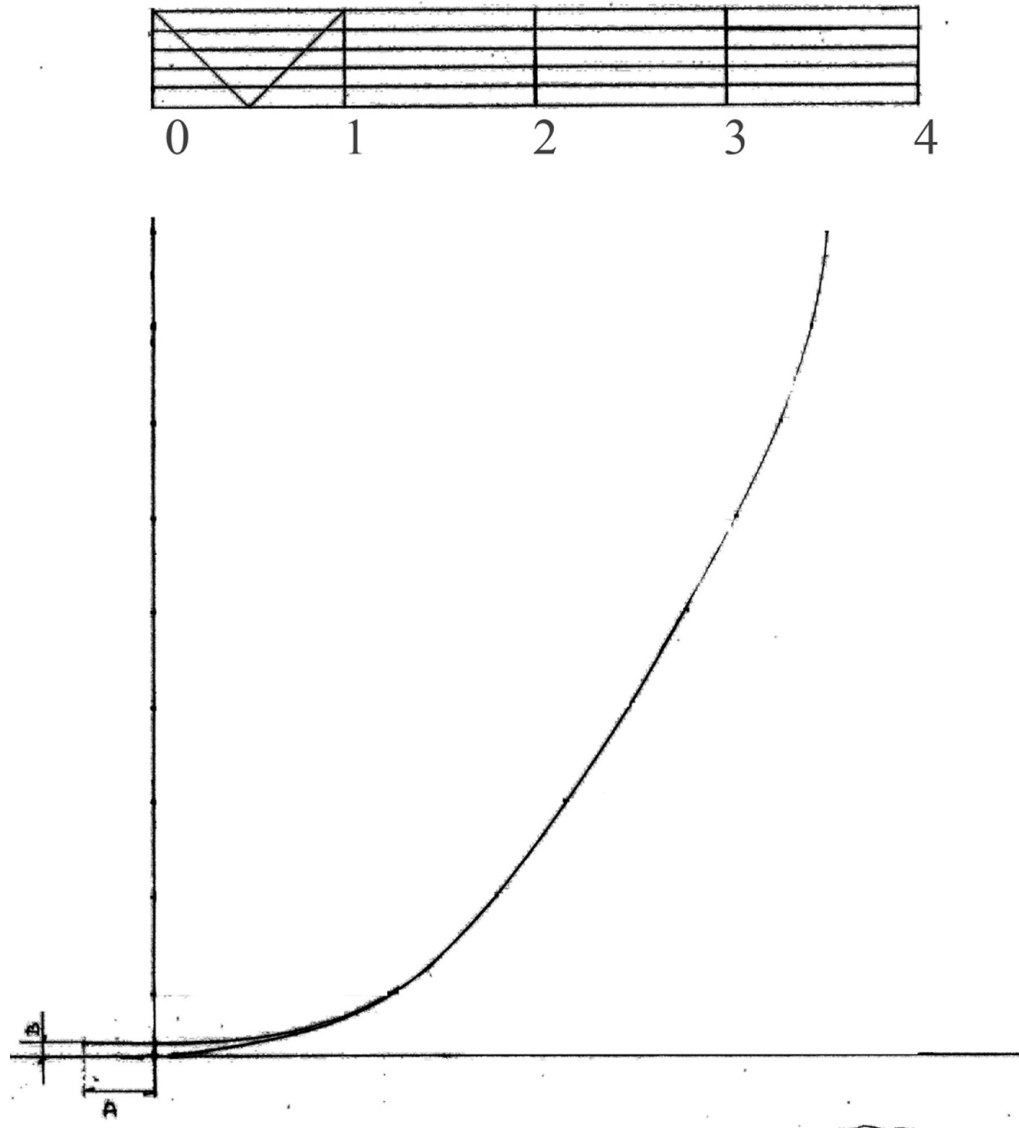
Fig. 37. Narrowing and rising at Frame E. Drawing: K. N. Batchvarov.

Forward, this was frame E (fig. 37). Aft, frames 3 and 7 were recorded, but 3 was so close in shape to the midship frame that the distinction would hardly be noticeable at the scale at which I worked and for this reason frame 7 (fig. 38) alone was used. Knowing the maximum narrowing or rising at the tailframes, I had to attempt to find a geometrical aid - mezzaluna, mezzarola or triangle - which would produce increments into which frames E and 7 would fit.

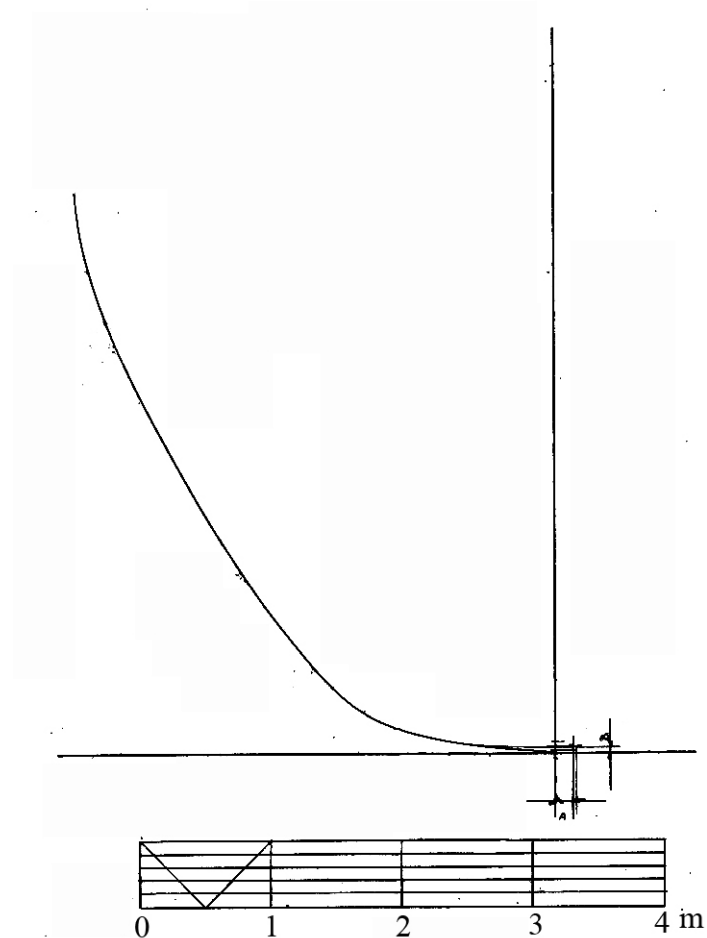
Fig. 38. Narrowing and rising at Frame 7. Drawing: K. N. Batchvarov.
