THE KITTEN SHIPWRECK:  
ARCHAEOLOGY AND  
RECONSTRUCTION OF A  
BLACK SEA  
MERCHANTMAN

A Dissertation

KROUM NICKOLAEV BATCHVAROV

August 2009

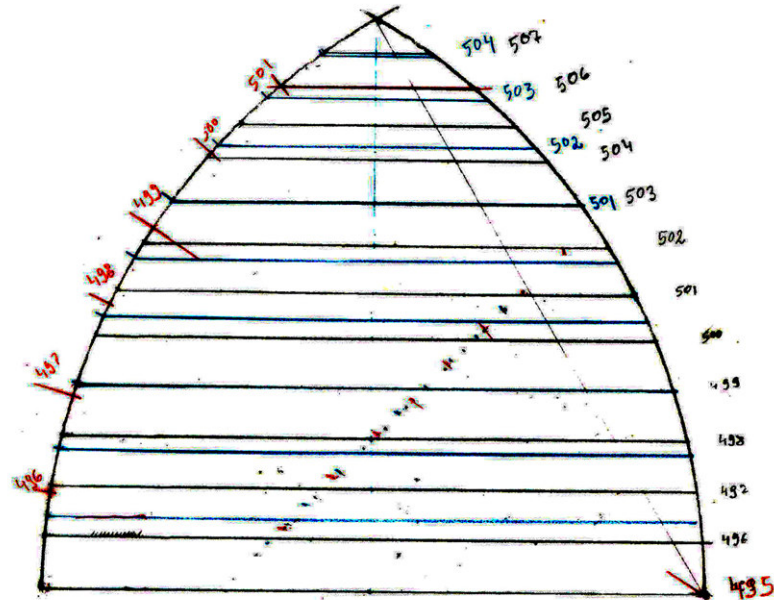
Fig. 40. Aft mezzarola. For comparison the different trial divisions were superimposed on the same drawing. Drawing: K. N. Batchvarov.

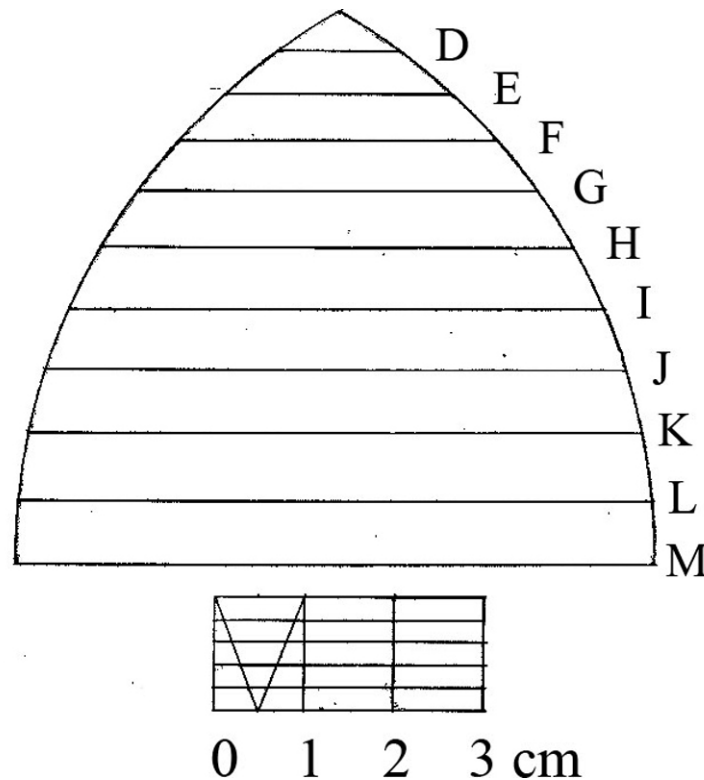
Fig. 41. This mezzarola fits the rising forward. Drawing: K. N. Batchvarov.

leaving the 3 frames fore and aft of the master with no rising, produce results that best match the recorded evidence.

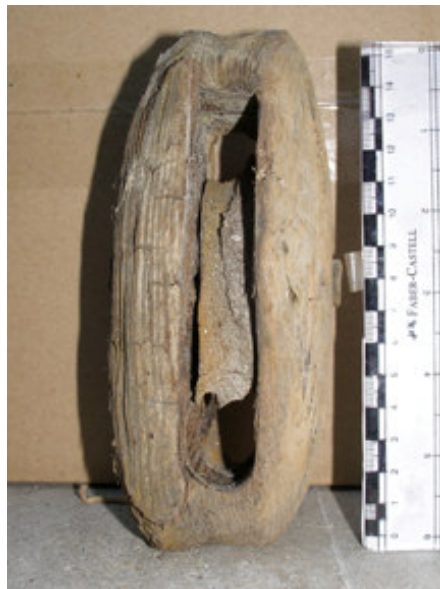
Fig. 42. One of the dried out blocks, recovered in the 1980s. Photo: K. N. Batchvarov.

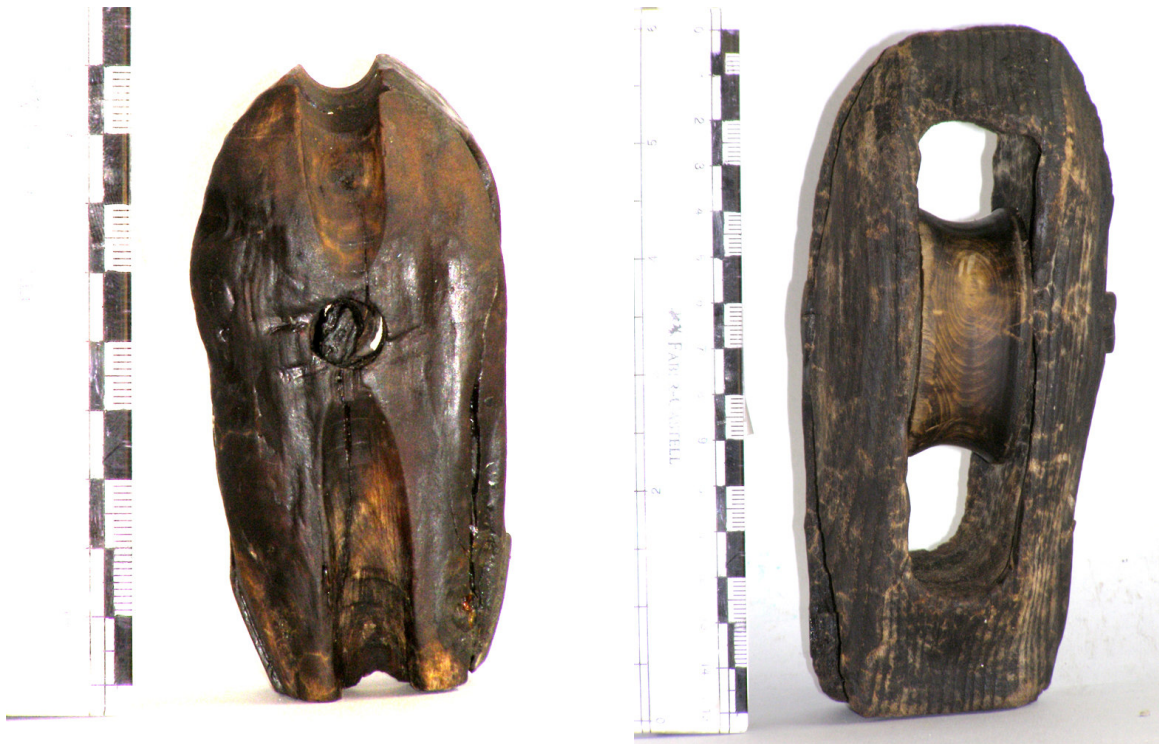
Fig. 44. Small block recovered from the Bow square in 2000. Photo: K. N. Batchvarov.

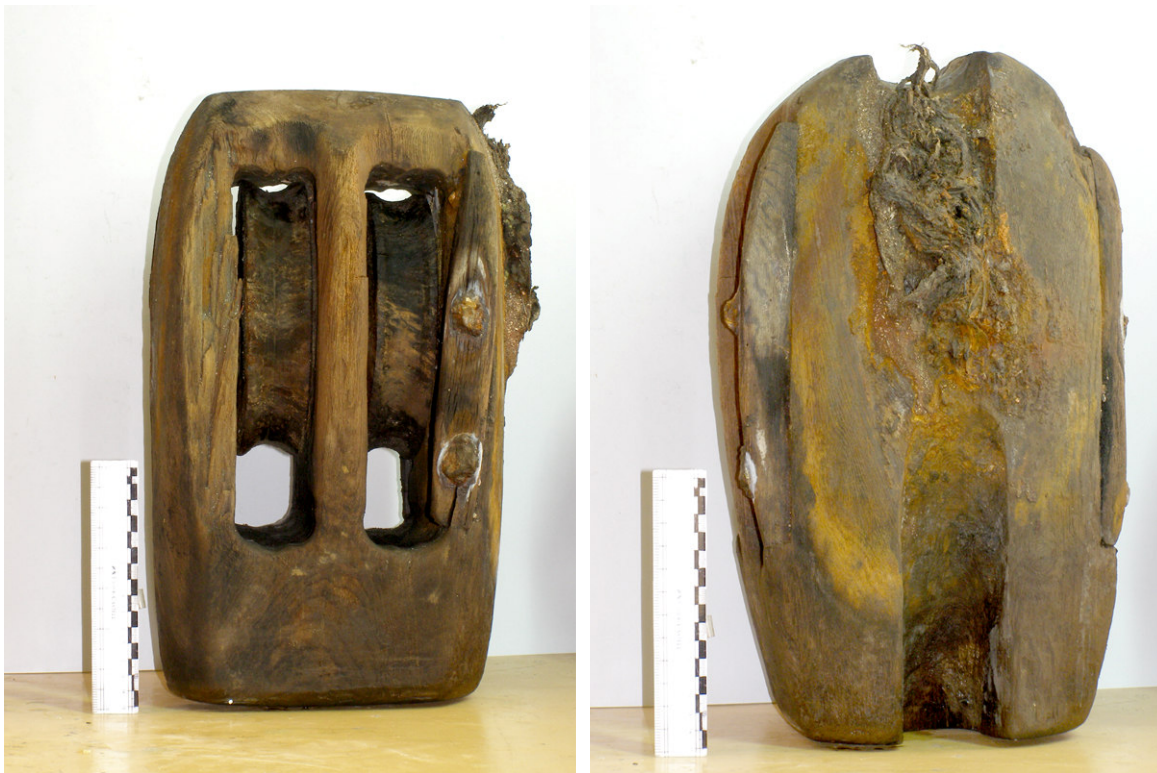
Fig. 45. Double block. Repairs to the shell are visible. Photo: K. N. Batchvarov.

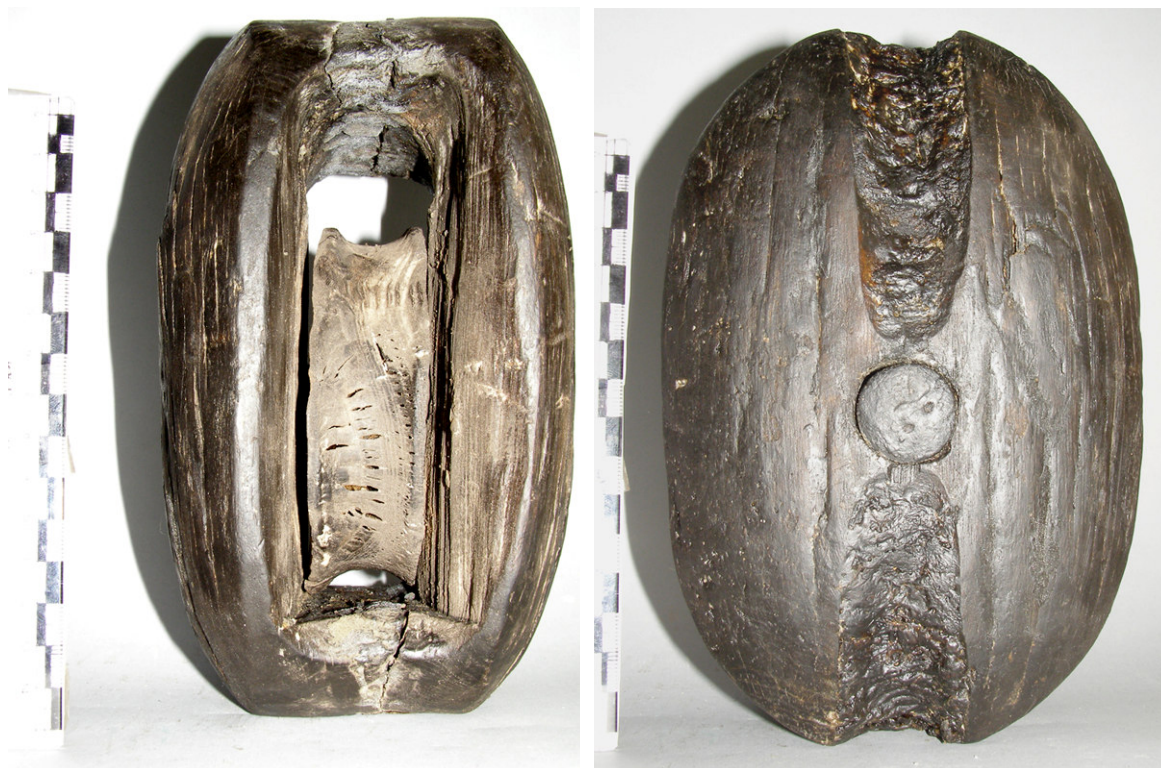
Fig. 46. One of the larger single blocks. Photo: K. N. Batchvarov.

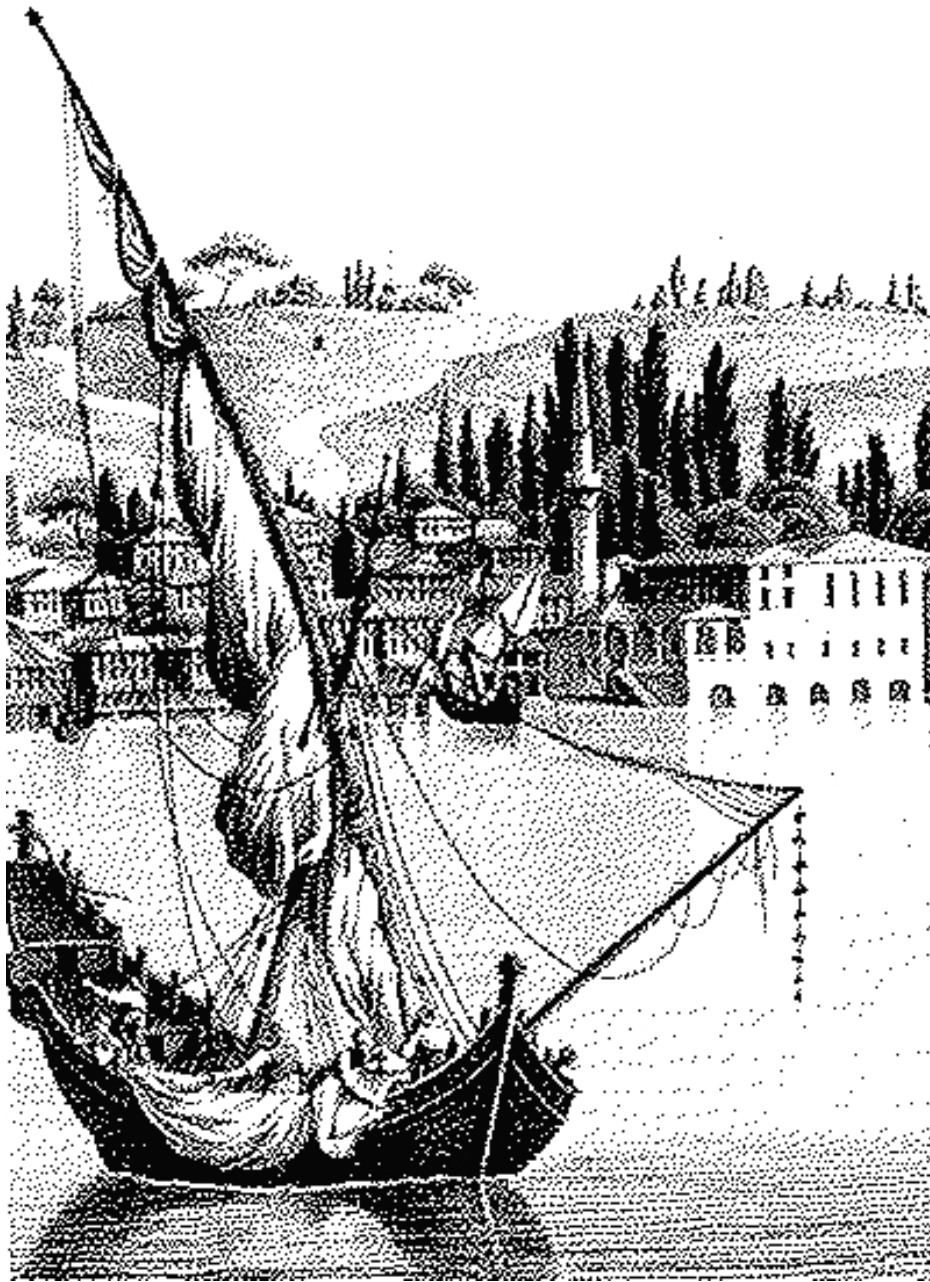
Fig. 53. A lateener with heavily raked mast. This vessel is probably very similar to the Kitten ship. Shrouds are set up with tackles. Detail from Melling, reprinted by Müller-Wiener in Plate 20.

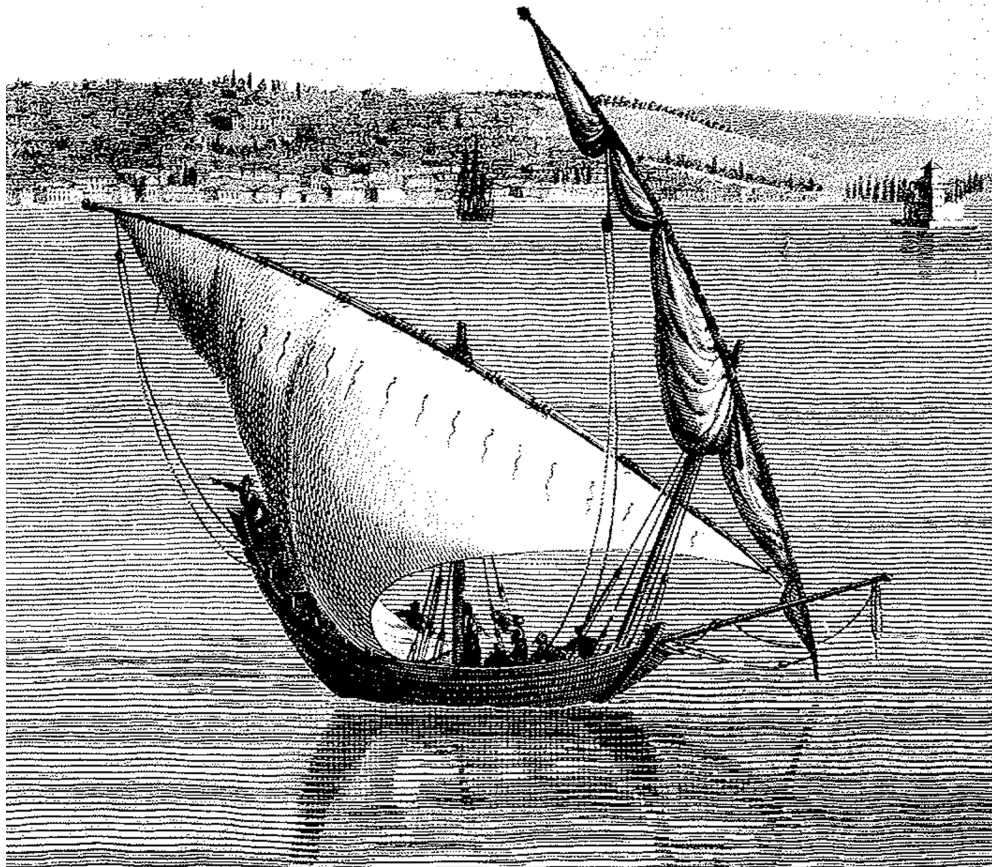
Fig. 54. Detail from an engraving by Melling, showing a two-masted lateener c. 1819. Republished by Müller-Wiener as Plate 36. Shrouds are set up with tackles, though the toggles are not visible.

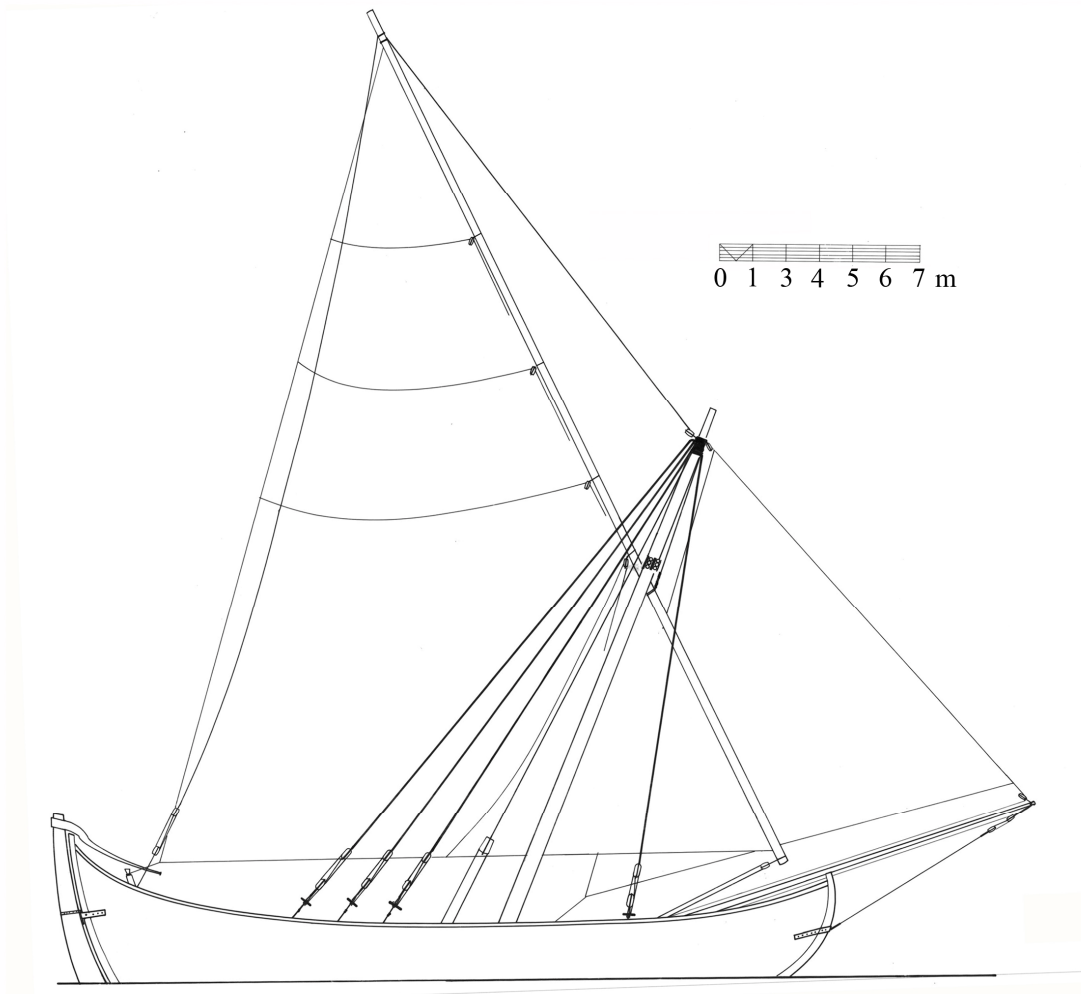
Fig. 56. Reconstruction of the Kitten vessel's rig. Drawing: K. N. Batchvarov.

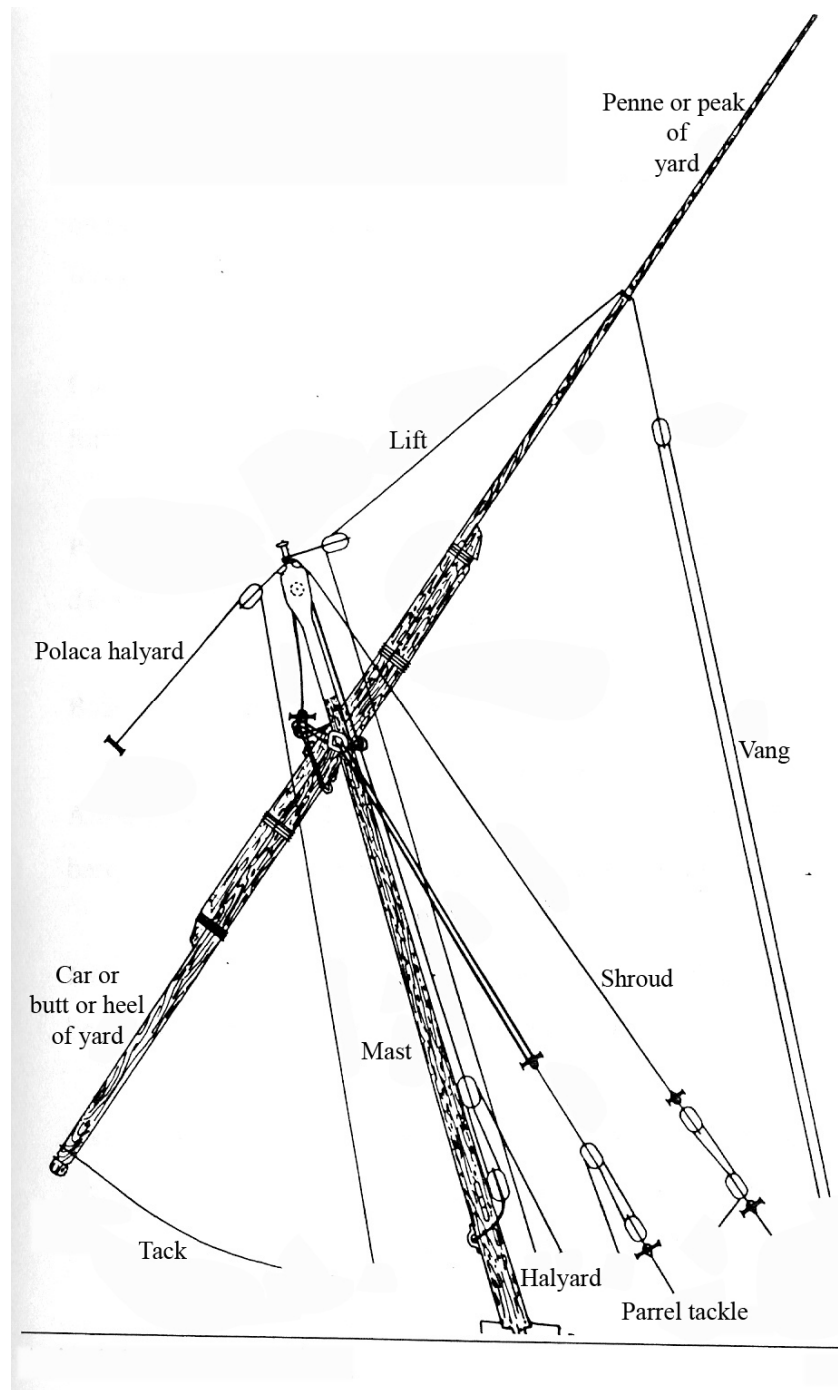
Fig. 58. Diagram of a lateen rig. Computer modified from the *Amics de la Mar Menorca* site.

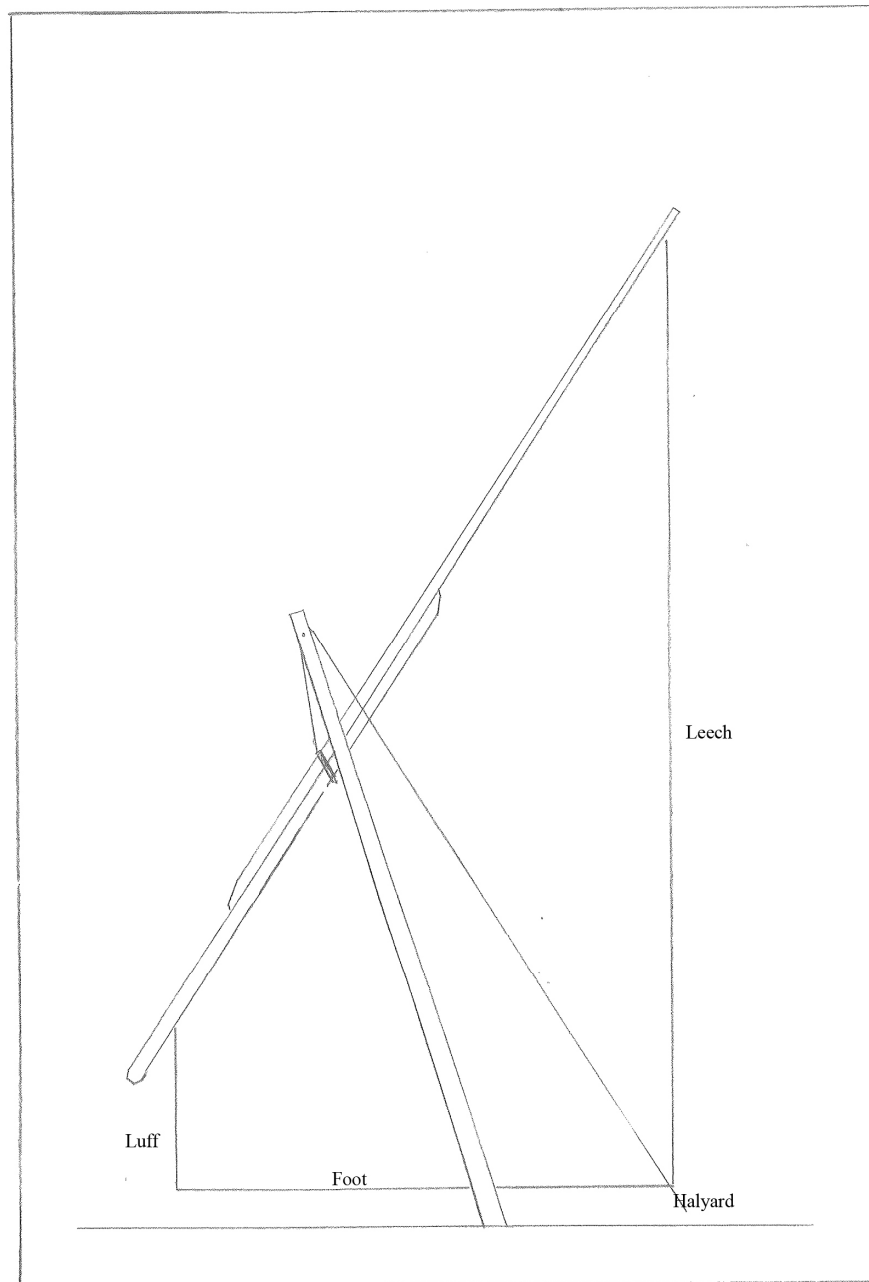
Fig. 59. Settee rig as carried by Alexandrian *feluccas*. The halyard leads aft and the yard swings forward of the mast in tacking. Drawing: K. N. Batchvarov.

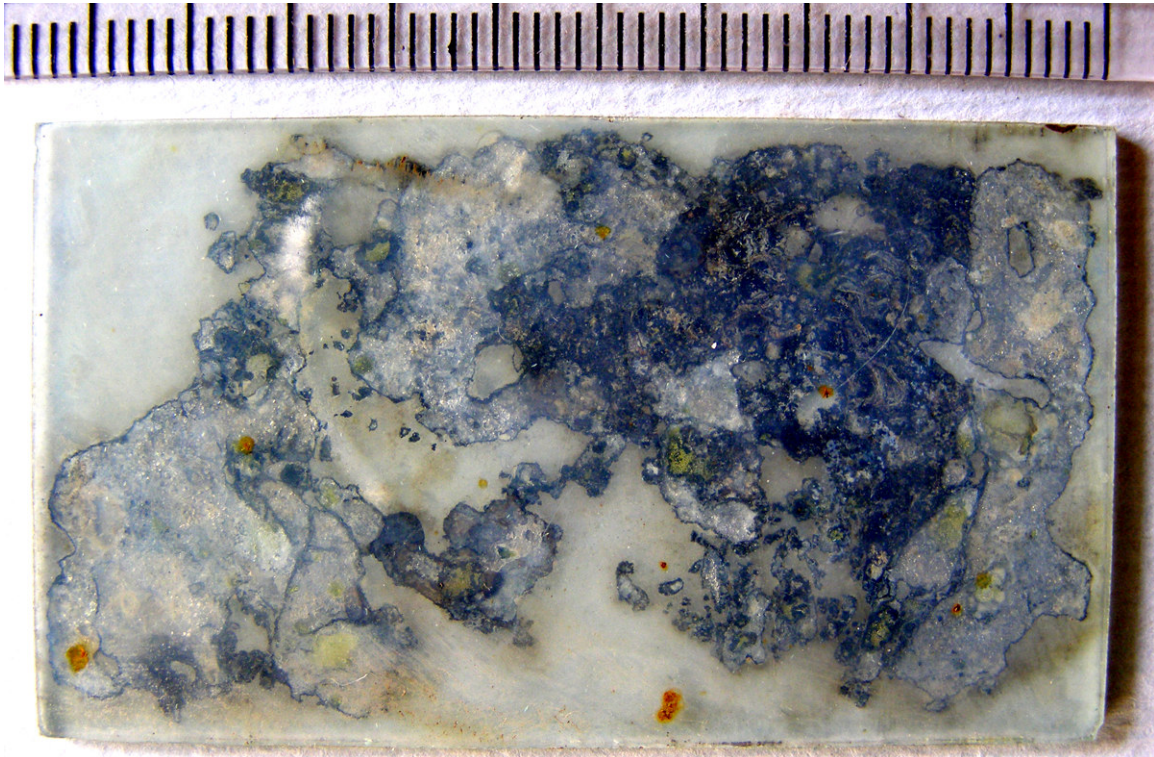
Fig. 100. KT117 Mirror from a navigational instrument. Photo: K. N. Batchvarov.

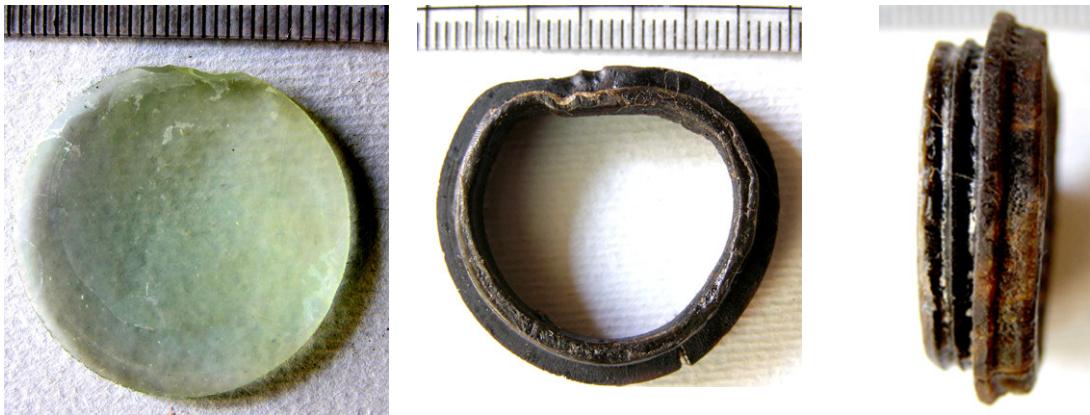
Fig.101. KT118 Possibly an ocular from the same navigational instrument as KT117.  
Photo: K. N. Batchvarov.
