**EXPERIMENTAL EVALUATION OF THE EFFECTIVENESS OF
ONLINE WATER-WASHING IN GAS TURBINE COMPRESSORS**

ABSTRACT

INTRODUCTION

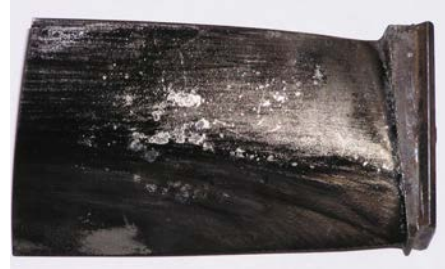
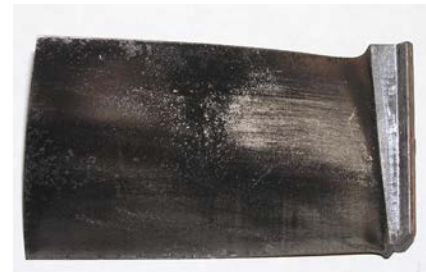
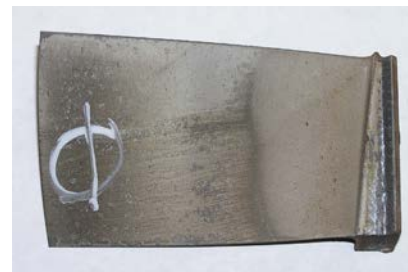
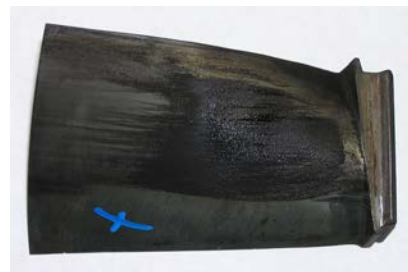
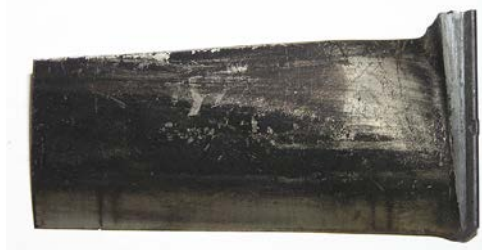
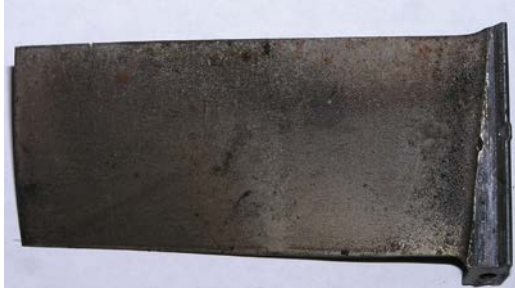
Pictures of representative blade samples are given in Figure 1 through Figure 6. The blades have varying degrees of contamination but have some common characteristics:

- deposit; however, other blades suggest that potential separation areas are less susceptible to having the dirt stick.
- Some of the deposits, like that shown for Blade 9, appear to have a substantial amount of hydrocarbon mixed in with the “dirt.”

Based on these blades, a decision was made to coat only the convex portion of the blades used for testing.

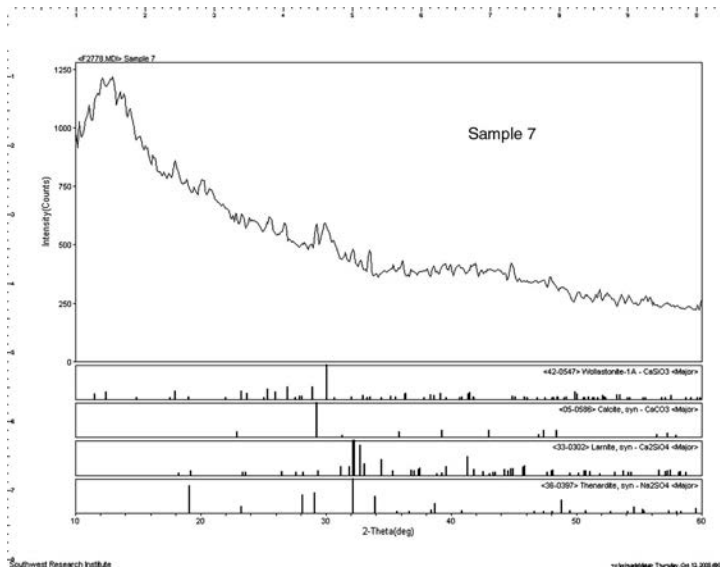
Figure 7. Example XRD Spectrum for Sample 7

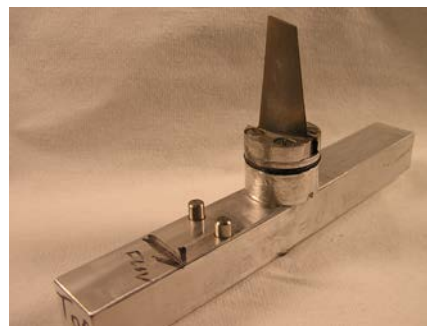
Five turbine blades were provided for use in these tests. Figure 11 shows one of the blades captured in the blade-mounting fixture. Note the pins in the bar section; these were used to provide positive position stops to allow the blade to be aligned with the base at 0 degrees relative to the flow, or with the base of the blade at 7 degrees relative to the flow direction. When the blade is installed at the 7-degree angle, the chord at the half-height location of the blade is approximately aligned with the flow direction. The use of the pins allowed for excellent repeatability of the test blade angle.

Figure 11. Blade Mounting Fixture with Blade Installed

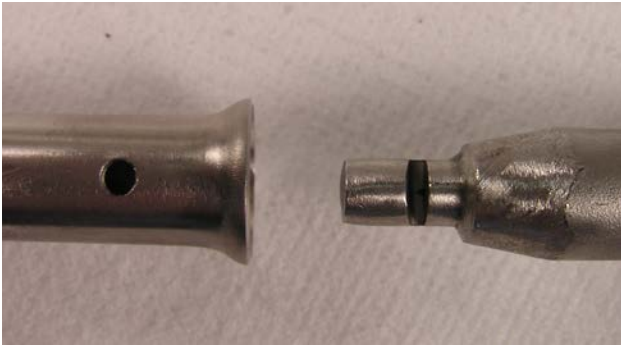
Figure 16. Flow Blockage Tube (Left) and Nozzle (Right)

The cleaning fluid was delivered into the plenum upstream of the test section (as shown in Figure 15) using a commercially available cleaning nozzle. The nozzle is reported to produce a cleaning spray with 120-micron droplets when sprayed at 120 psig. Because the nozzle was intended to be used to clean more than a single blade, part of the spray was blocked in order to produce an air-to-water ratio in the range of 200 to 1,000 based on values reported in the literature (Mund and Pilidis, 2004). The mass flow air/water ratio was measured to be roughly 200 for an airflow Mach number of about 0.6. The nozzle and the blockage tube are shown in Figure 16; when mated together, a portion of the spray leaves through the hole in the blockage tube and the remainder of flow travels down the tube.

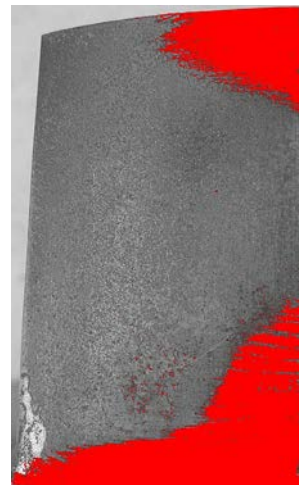
A public domain image-processing package named “ImageJ” (developed by the U.S. National Institutes of Health) was used for processing the images. The location of the blade in each picture was outlined manually as shown in Figure 19. A macro, developed using the image processing software, was then used to convert and threshold the image to determine the area of the outlined portion and to threshold the image to determine the amount of “dirt” remaining in the area of interest by assessing the total area of the blade and the area contained in the dark regions as shown in Figure 20 and Figure 21. This process was repeated on several independent images of each test result to assess the repeatability of the method.

Figure 19. Blade Image Outlined for Processing

Figure 20. Area of Interest with Threshold Area Indicated

Figure 21. Image of “Particles” Found in Area of Interest (22.9% of Projected Blade Area for This Example)

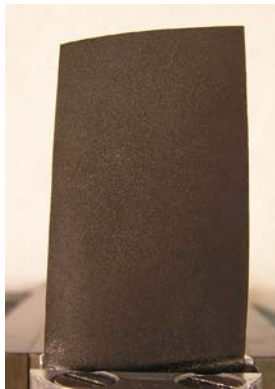
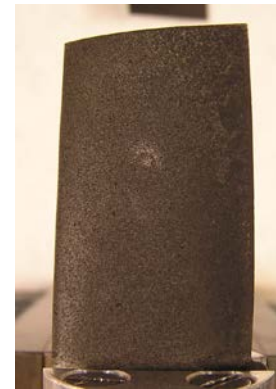
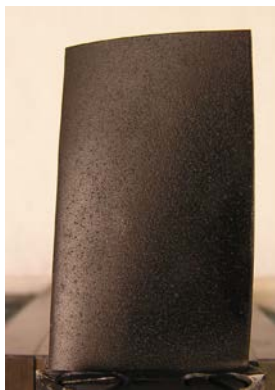
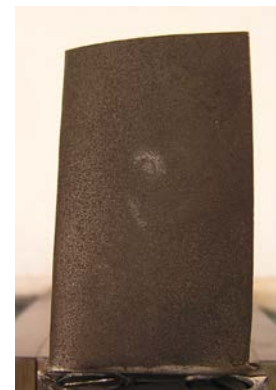
Figure 25. High Temperature Air Spray Tests

Figure 26. Blade Sprayed with Dirt/Tap Water Mixture in Heated Air Stream

Figure 27. Blade Sprayed with Dirt/High-Purity Deionized Water Mixture in Heated Air Stream

Figure 28. Blade Sprayed with Dirt/Commercial Detergent Mixture in Heated Air Stream

Figure 29. Blade Sprayed with Dirt/Gain/Deionized Water Mixture in Heated Air Stream

Tests were conducted by heating a mixture of dirt and water and injecting into the plenum upstream of the test section (in the same location used to spray cleaning fluid for the other tests). Clean blades were exposed to the dirt-contaminated water and flowing air stream for a period of about 30 minutes and then photo documented. Tests were conducted using both deionized water and high-purity deionized water and was performed at a very low flow velocity with “room temperature” air as well as at a mid-range velocity with heated air. The specific test conditions are given in Table 7.

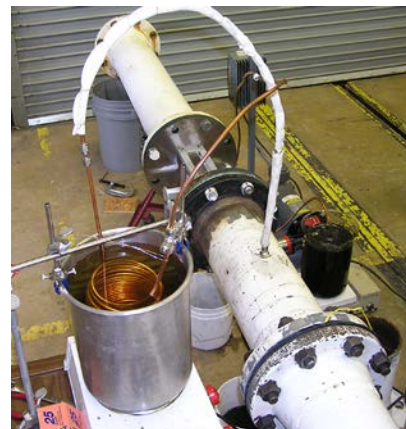
The dirt/water mixture was created using approximately 10 g of the “standard” dirt/PEG mix per 3,500 ml of water. This mixture was continuously stirred and was pumped through a copper tube heat exchanger immersed in oil heated in the range of 220°F to 290°F. A schematic of the setup is shown in Figure 30 and a picture of the physical setup is shown in Figure 31. A nozzle with an opening of about 0.032 inches was fabricated for the dirt injection tests. The opening was two to three times the opening size of the cleaning nozzle to avoid clogging the nozzle; however, clogging did occur occasionally during the tests, and the pump had to be stopped and started several times during a test to clear the nozzle and maintain flow.

Figure 31. Heated Dirt/Water Injection Setup
