TURBOMACHINERY PROBLEMS — LUBE AND SEAL SYSTEM REVISITED

Royce N. Brown
Consulting Engineer
Dow Chemical U.S.A.
Houston, Texas

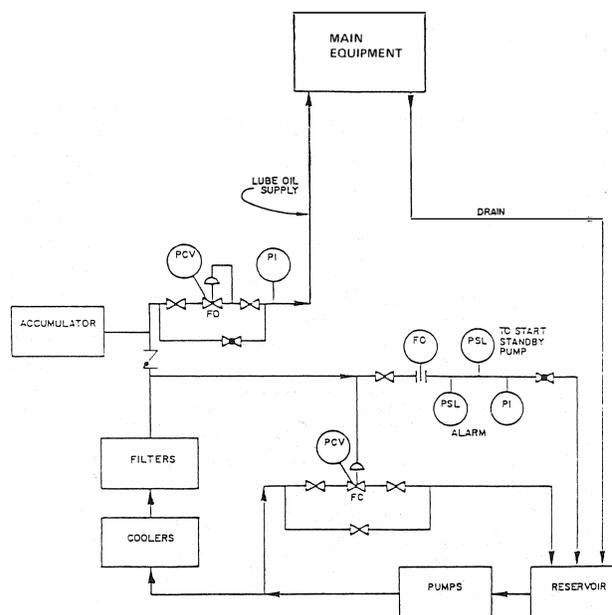
Figure 1. Lube Oil System.

As a review and to establish a base from which to communicate, refer to Figures 1, 2, and 3. These are block diagrams of lube or lube and seal systems of varying complexity, depending on the service in which they are used. Figure 4 shows a photograph of a large lube oil console. In common, they all include a source, consisting of multiple pumps, coolers, and filters. To keep the illustration simple, not all controls or control variations are shown. At first glance it would appear difficult that even in its basic form, such a simple string of equipment could be the source of problems.

Another problem was caused by one of several causes. The problem was the collapsing of filter elements. The time at which the filter elements collapsed was traced to that period of time during which both pumps were running. Further investigation showed that the bypass control valve was not as shown in Figure 1, but was located downstream of the filters. There are many pros and cons regarding this practice. The purpose of mentioning this particular failure is to point out the problem. The solution in the existing unit was to move the control valve to the position indicated in Figure 1. However, had the filters been checked for pressure drop with two pumps running, the initial position of the control valve would have been adequate.

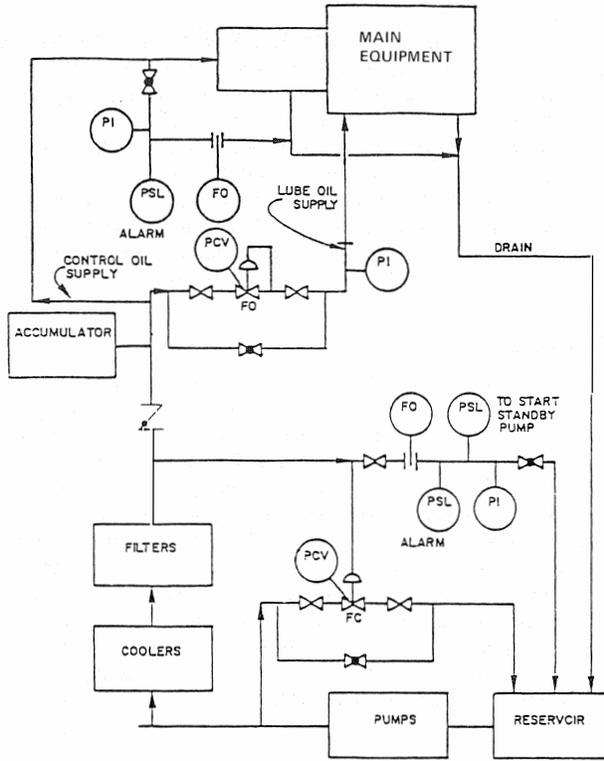
Figure 2. Lube and Control Oil System.

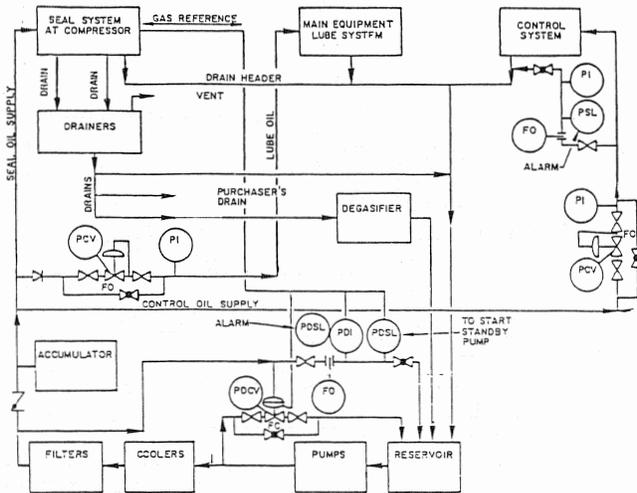
Figure 3. Combined Lube, Seal and Control Oil System for Contact Seals (No Overhead Tank).

One minor problem has occurred and is mentioned in passing more as a flag than a specific problem and solution. The problems encountered and the solutions thereto have not, in the author's opinion, been technically as sound as possible. The problem is one of control stability. When a system such as Figure 3 is commissioned, it consists of many control loops which may interact. Direct operated controllers are usually preferred for simplicity. Reliability, while it should go together with simplicity, is more elusive. Manufacturers usually offer direct operated controllers to be competitive, not reliable. The inherent intelligence of a direct operated controller is limited. Some problems have been solved using small accumulators to provide capacitance. Another solution is a more sophisticated controller such as a pneumatic or electronic multimode controller working into a valve positioner. A more comprehensive analysis at the time of design would probably save startup time and provide reliability.

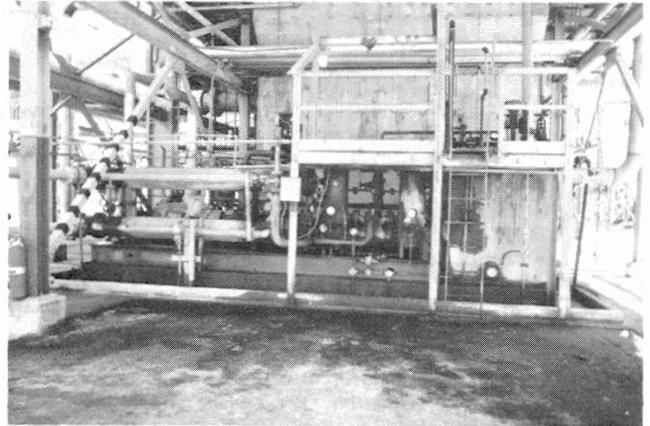
Figure 4. A Large Lube, Seal and Control Oil System.

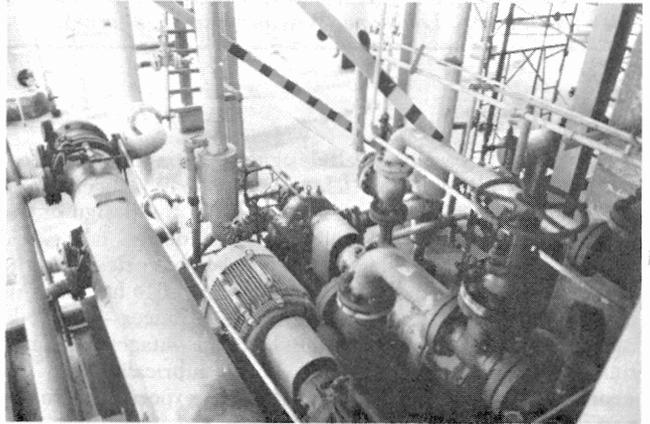
Figure 5. Steam Turbine Driven Main and Electric Motor Driven Auxiliary Pumps.

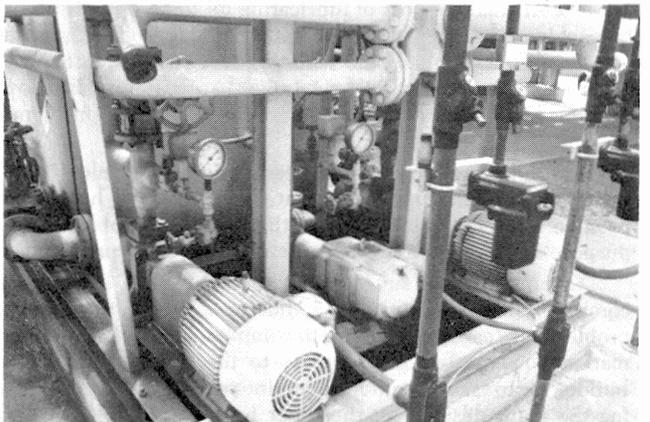
Figure 6. DC Motor Driven Coastdown Pump.

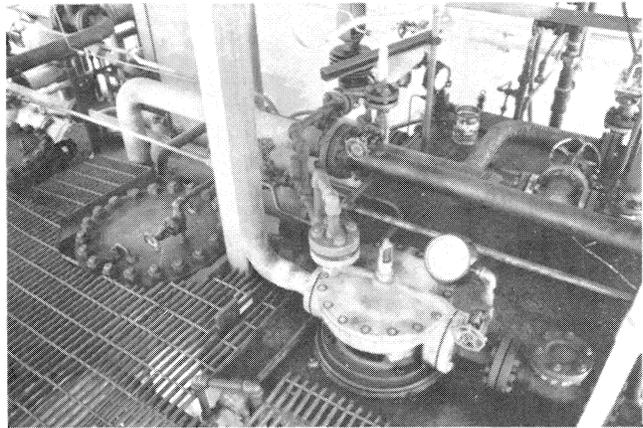
Figure 7. Steam Turbine Driven Coastdown Pump.

A vertical steam driven direct coupled pump was added to the system. Figure 7 shows such a pump. The steam turbine is a large clearance unit capable of operating on lower than normal steam. As the steam system decays, so does the output of the pump. The machinery train has slowed down to a point where less oil is required and the two pair rather nicely. This system works reasonably well on a large train and large steam system with a relatively large inherent storage capacity. This system did not function well at one of the smaller operating units where, when the systems went down, they were really down. Here another solution was used. A quite reliable source of pressure is gravity. By the addition of an overhead tank floating on the system, a rundown source of oil has been provided without any other outside power. Figure 8 shows an overhead lube oil coastdown tank. To avoid the use of a pressure vessel, the system piping as shown in Figure 9 is used. There are many alternatives to this. In fact, several different ones are used in the author's organization, but the one in the illustration appears to meet the need in most locations. The one primary requirement for this system is that the tank static head set by the elevation be less than the low oil pressure trip. This is necessary in order to use the entire contents of the tank after the unit has tripped for the coastdown. The size of the overhead tank is always a problem in that the time factor for coastdown is not exactly known nor is there an exact value established for quantity of oil to the bearings. Experience would indicate that the first minute is critical. Time and quantity become less critical thereafter because of the rate of deceleration of the turbomachine. A rule of thumb that works is to size for five minutes using the following relationship for quantity:

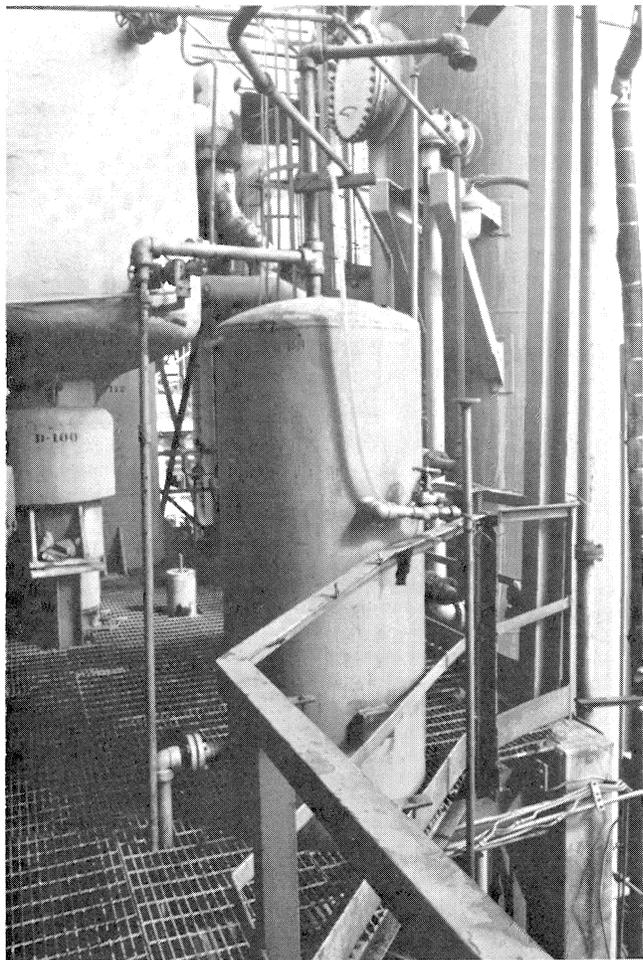
Figure 8. Overhead Lube Oil Coastdown Tank.

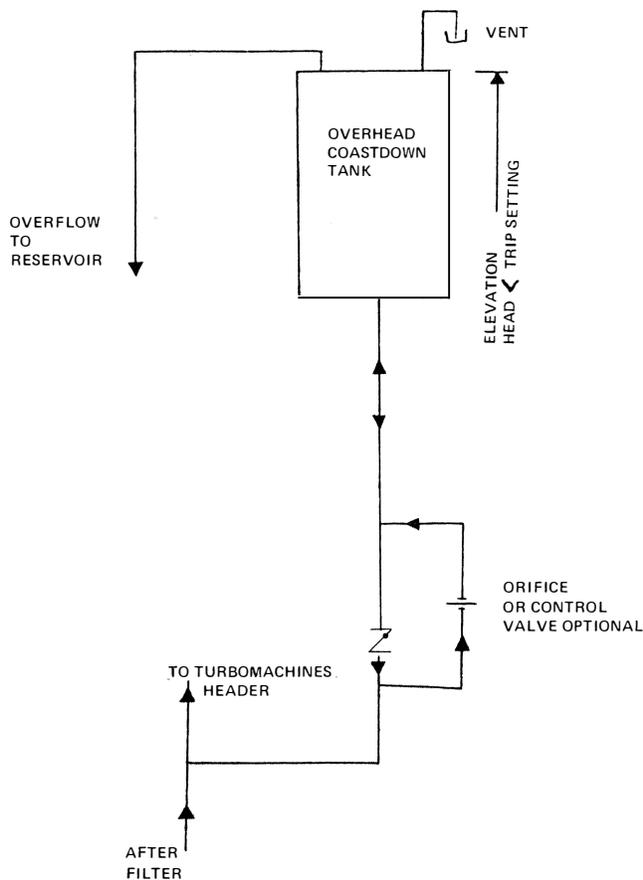
Figure 9. Overhead Coastdown Tank Piping.

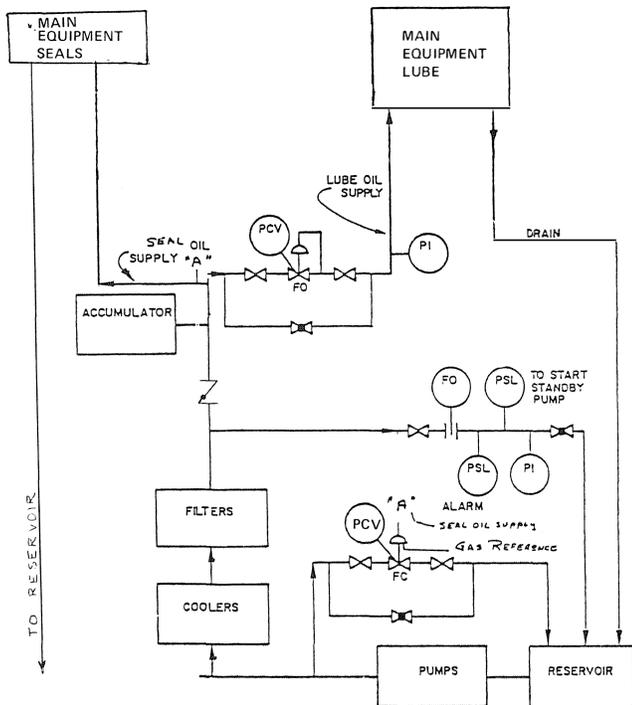
Figure 10. Combined Lube and Seal Oil System for a Refrigeration Compressor.

A scheme that can save pumping power on a refrigeration unit's combined lube and seal system is shown in Figure 10. The refrigeration unit seals normally run at relatively low pressure during operation and require high pressure at shutdown and startup. The controls in Figure 10 permit the pressure to pick up only when needed. The driver must be sized for the higher pressure, but if a careful selection for part load efficiency is made, energy can be saved. Figure 11 shows an overhead seal differential pressure tank. Such a tank is referenced to the compressor suction. It is used to maintain a constant differential seal oil pressure just above the suction pressure under all conditions of operation and shutdown.

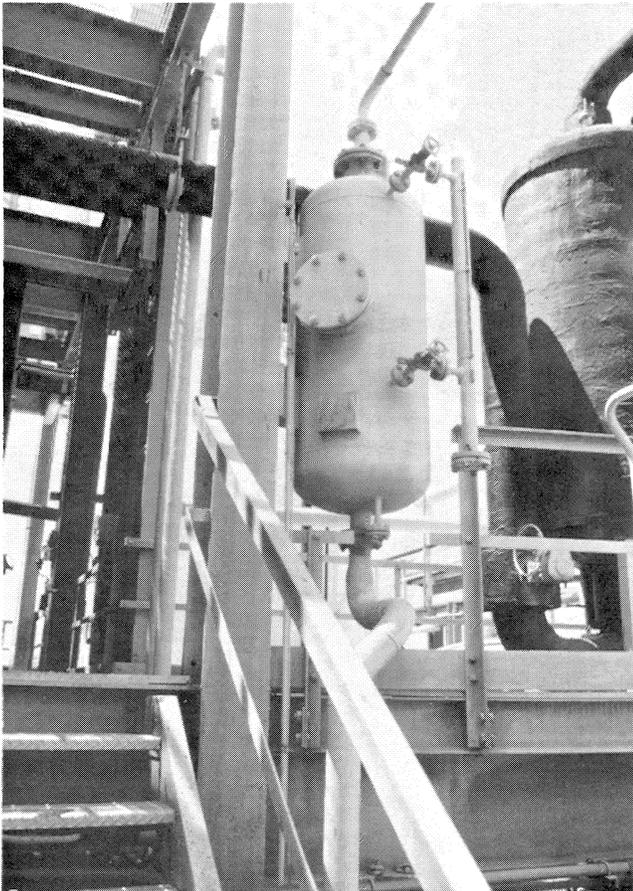
Figure 11. Overhead Seal Differential Pressure Tank.
