46TH TURBOMACHINERY & 33RD PUMP SYMPOSIA
HOUSTON, TEXAS | DECEMBER 11-14, 2017
GEORGE R. BROWN CONVENTION CENTER

Subsynchronous Shaft Vibration in an Integrally Geared Expander-Compressor due to Vortex Flow in an Expander

ABSTRACT

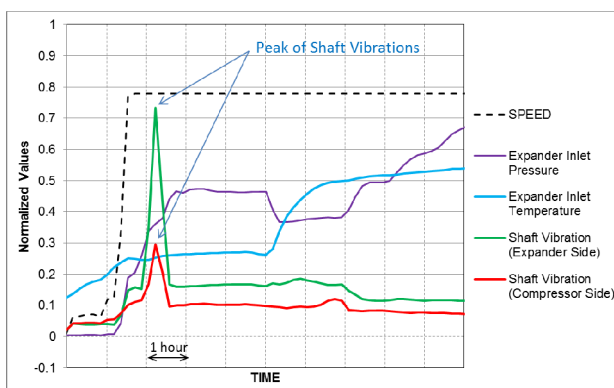
Fig.2 Time Trend Data of Operating Speed, Inlet Pressure/Temperature of Expander 2nd Stage and Shaft Vibration

In the course of plant start up, the no.1 pinion rotor faced a steep increase of shaft vibration when the operating parameters reached a particular condition, and immediately after such a condition was passed, the shaft vibration decreased [Fig.2]. The shaft vibration amplitude at the expander side of approx. 70 μm was much higher than that at the compressor side of 30 μm , and the dominant vibration frequency was subsynchronous component of 45~50 Hz (0.3 times operating speed) [Fig.3], which almost matched with one of natural frequencies of no.1 pinion rotor.

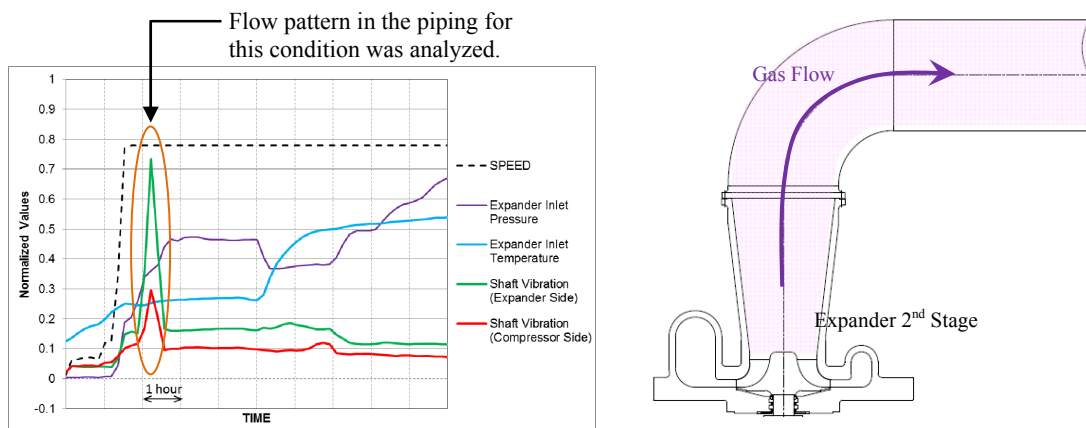
Fig.4 Condition and Objects for CFD Analysis for 2nd Stage Expander Wheel

Finally the flow induced excitation force from downstream piping was pointed out as one of the possible cause with reference to past experience of a hydraulic turbine ^[3]. In order to simulate the flow pattern in the piping downstream of the 2nd stage expander wheel, time transient CFD analysis was conducted. Boundary conditions for the CFD analysis were defined based on the recorded operating parameters, such as pressure/temperature of inlet/outlet and so on, at the timing when the steep increment in shaft vibrations was observed [Fig.4].

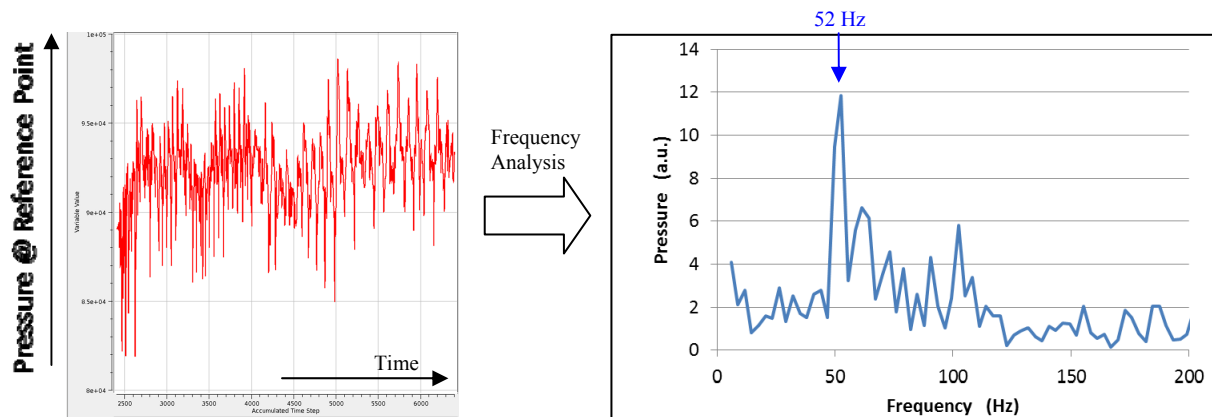
Fig.8 Pressure Pulsation at Reference Point in Downstream Piping from CFD

Additionally, the pressure pulsation at a point in the reference plane was examined by means of frequency analysis to the CFD result, and the spectrum showed a remarkable peak with 52 Hz as shown in Fig.8. This result suggests that 2nd stage expander wheel must be forced by the excitation force with frequency of 52 Hz. This frequency agrees with the dominant frequency (45~50 Hz) of the measured shaft vibration of no.1 pinion rotor.

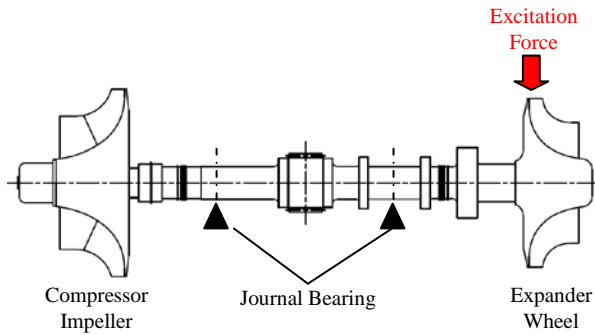
Fig.9 Rotordynamics Model for no.1 Pinion Rotor

Furthermore, rotordynamics for no.1 pinion rotor was studied with a consideration of the excitation force on 2nd stage expander wheel. That is ; the non-synchronous rotor vibration responses at rated speed were calculated by applying a unit external force with changing its frequency onto 2nd stage expander wheel in the rotordynamic model [Fig.9]. Fig.10 shows rotor vibration responses verses frequency of the unit excitation force, and it is confirmed that there are some peaks which are corresponding to the natural frequencies or the rotor at around 38 Hz and 50 Hz. As the predicted frequency of the excitation force from a vortex is 52 Hz, the second peak must be amplified by an interaction with the excitation force.
