47<sup>TH</sup> TURBOMACHINERY & 34<sup>TH</sup> PUMP SYMPOSIA  
HOUSTON, TEXAS | SEPTEMBER 17-20, 2018  
GEORGE R. BROWN CONVENTION CENTER

## Development of New Heat Treatment Method to impart high creep strength and high toughness to rotor material for condensing steam turbine

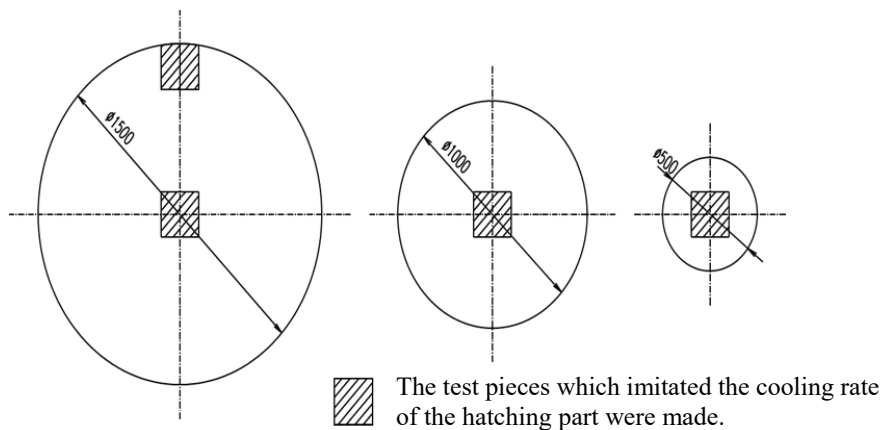
Figure 2: Lab test pieces

Lab simulations were conducted to determine quenching and tempering conditions. The conventional type heat treatment used blast cooling for HP section and water cooling for LP section as shown in Table 3. For rotors with small/medium bearing spans, drum diameter is less than 1000 mm so the cooling rate at center should be faster. FEM analysis was conducted to estimate the cooling rate distribution at core of rotor for different drum diameters and different heat treatment methods. For each cooling method, it was assumed that the surface of rotor for different drum diameter will have same cooling rate. The test pieces simulated the cooling rate at peripheral and core of rotor with varying drum diameter ( $\phi 500$ ,  $\phi 1000$ ,  $\phi 1500$ ) as shown in Figure 2.

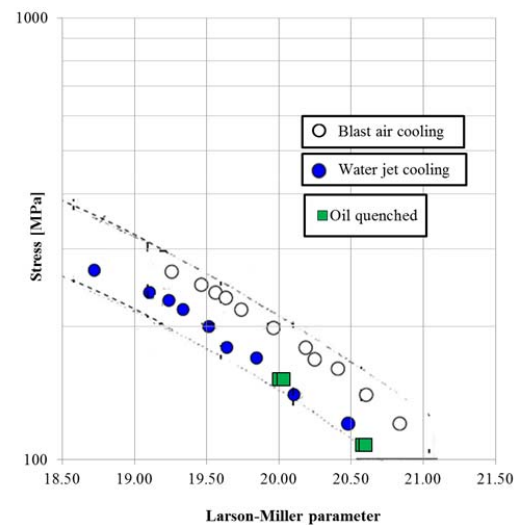
Figure 3: LMP for different quenching methods

Creep-stress rupture data for high-temperature creep-resistant alloys are often plotted as log stress to rupture versus a combination of log time to rupture and temperature. One of the most common time-temperature parameters used to present this kind of data is the Larson-Miller (L.M.) parameter. The Larson-Miller parameter (LMP) was used to predict the lifetime of the particular material for various heat treatment methods using a correlative approach based on the Arrhenius rate equation. The value of the parameter is:

The creep strength at peripheral of rotor for different heat treatment methods was predicted using hit and trial basis on lab test pieces which imitated the cooling rate at the peripheral for different quenching methods. Based on the lab test results, we were able to plot the LMP curve. Larson-Miller parameter for all quenching methods was larger than the minimum criteria [minimum rupture time based on 20 years lifetime excluding design margin]. It was concluded that all quenching methods satisfied the creep strength criteria although water cooling was very close to the limit. The summary for creep strength for conventional and new heat treatment is shown in Table 3.

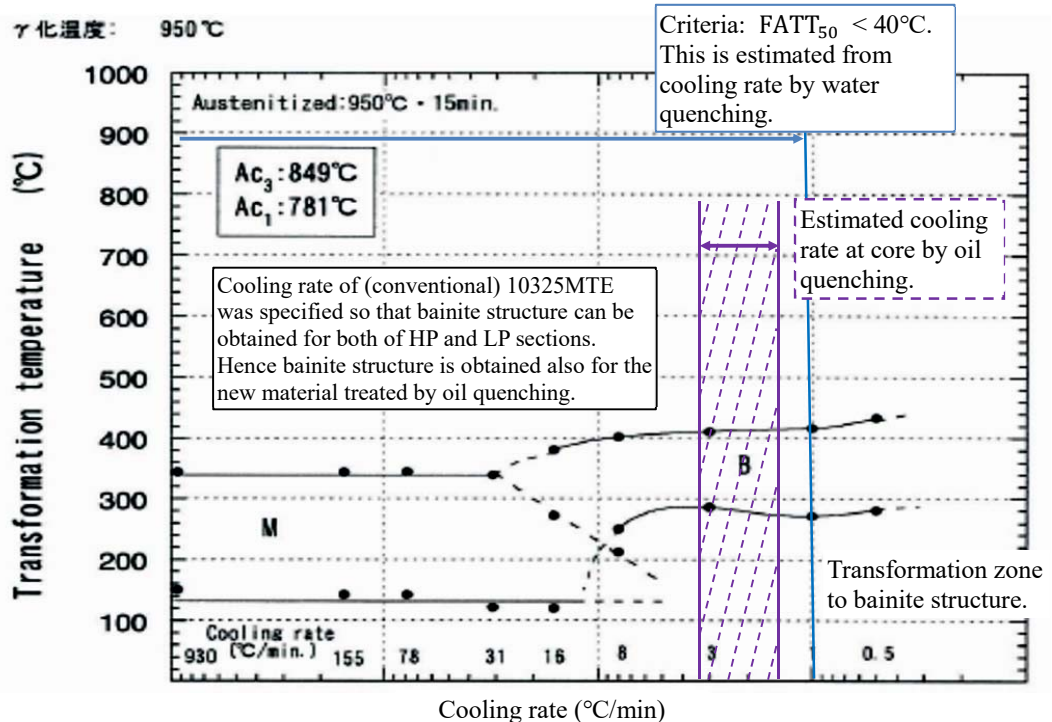
Fig 4: Continuous Cooling transformation curve for 10325MTE rotor material

Continuous Cooling Transformation (CCT) curve for 10325MTE material predicts the required cooling rate for transformation into Bainite structure with the target of  $FATT_{50} < 40^{\circ}C$ . Based on FEM result for different quenching method and estimated cooling rate from CCT curve, oil quenching which has a cooling rate between blast cooling and water cooling. For rotors with small diameter, the cooling rate at the center was faster so it was predicted that HP section and LP section of rotor can possess the required characteristics by oil quenching.

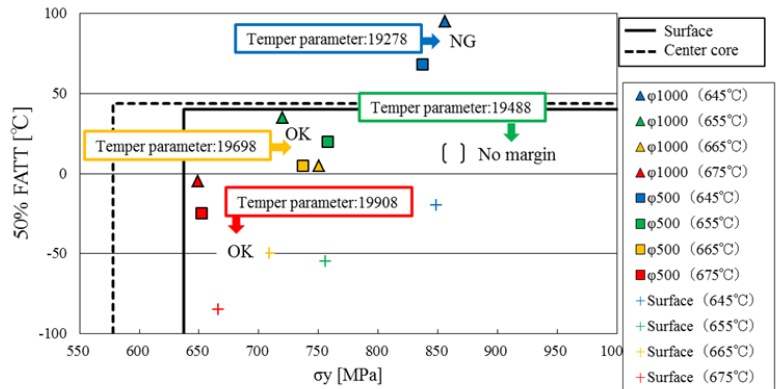
Figure 5: Allowable temper parameter values

The temperature was calculated to keep the temper parameter within the range of 19,698 and 19,908. The tempering conditions for different test pieces are shown in Figure 5.

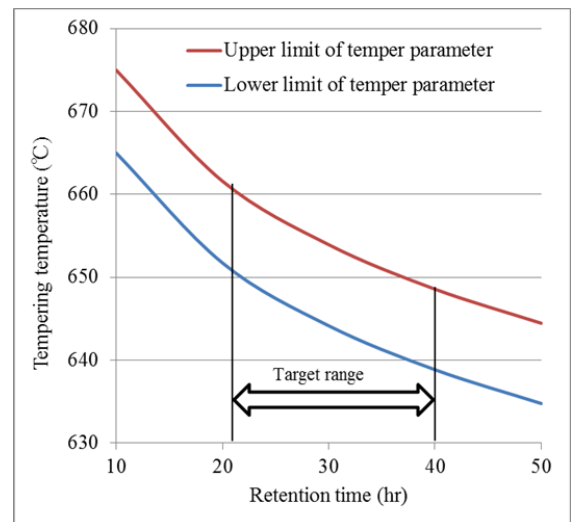
Figure 6: Tempering temperature vs retention time

Based on temper parameter range of 19,698 and 19,908, a curve depicting Tempering temperature and retention time was plotted to give an estimate of the available Tempering parameters.

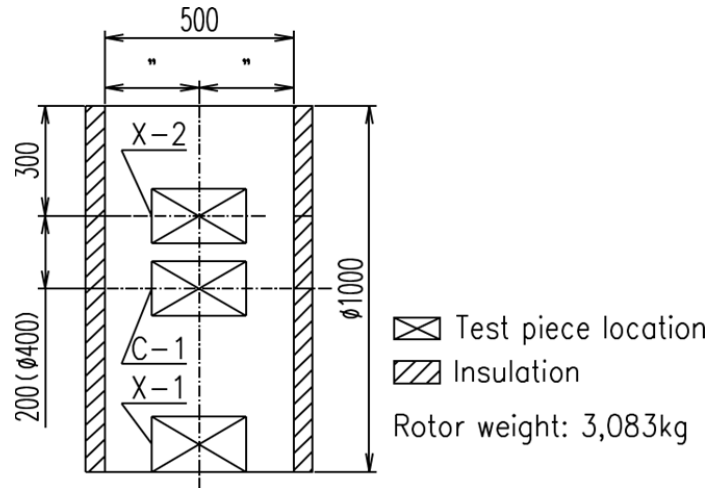
Figure 7: Location of Test pieces

To verify whether the heat treatment conditions determined by FEM and lab tests can be applied to the actual rotor, large test pieces were manufactured and various verification tests were carried out. Figure 7 shows the sampling position at the test piece. The test rotor simulates an infinite cylinder of diameter  $\phi 1000$  by affixing heat insulation material on the sides. Test pieces C-1 and X-2 taken from the core and  $\phi 400$  location of rotor were tested for low temperature toughness ( $FATT_{50}$ ) as the locations had lowest cooling rate. The centrifugal force is largest at  $\phi 400$  during operation (disc root equivalent position) so test piece X-2 was another critical point for toughness. Test piece X-1 was taken from the surface of the rotor and checked for creep strength. The cooling rate at surface is highest which makes it the critical point for creep failure.

The surface at the sides of this test piece is not cooled from the sides so the cooling rate is slower than actual rotor. It creates a favorable condition for high temperature creep rupture test. Another test piece from actual rotor was taken to verify the creep strength later.
