THE HISTORY OF H-CLASS SUBMARINES AND ARCHAEOLOGY OF THE
SUBMARINE USS *H-1*
(EX *SEAWOLF*) (1913-1920)

A Dissertation

RICHARD HANSON HENDREN

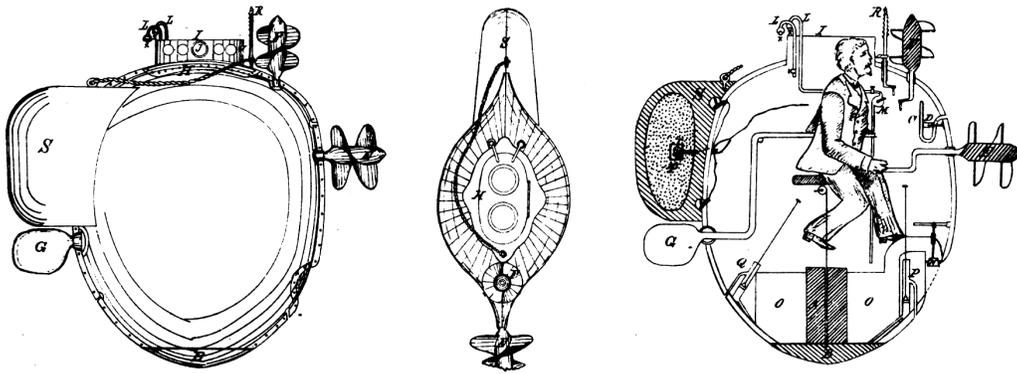
Figure 2. Bushnell's *Turtle*.

There are no extant design drawings from the construction of the original vessel. A drawing prepared in 1875 by Lt. Francis Barber USN follows the general description provided by Bushnell but has some inaccuracies (Figure 2).¹⁵ Barber incorrectly depicts the propeller as being of a helical design, instead of bladed, and shows enclosed ballast tanks which were not mentioned in any description of the vessel.

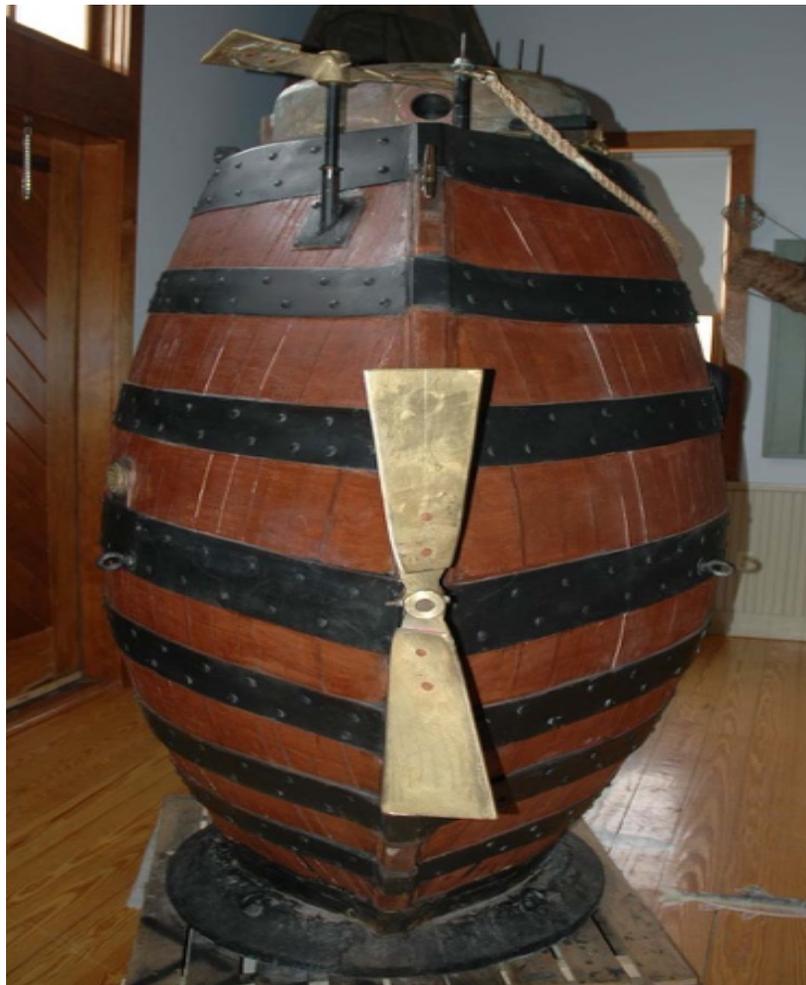
Figure 3. OSHS replica of *Turtle*.

and Roy Manstan and with the exceptions of a few modern safety improvements made to facilitate the vessel's in water testing is consistent with the historical descriptions (Figure 3).

Frese was the Industrial Arts teacher at OSHS and Manstan an engineer at the Naval Undersea Warfare Center (NUWC). This interpretation utilized period shipbuilding

practices resulted in a more hydrodynamic hull than others replicas reviewed. The project began in 2003 and culminated with operational testing in 2008 (Figure 4). The construction and testing of replicas faithful to the description of Bushnell and Lee proved that *Turtle*, while likely slower than described, functioned as described.

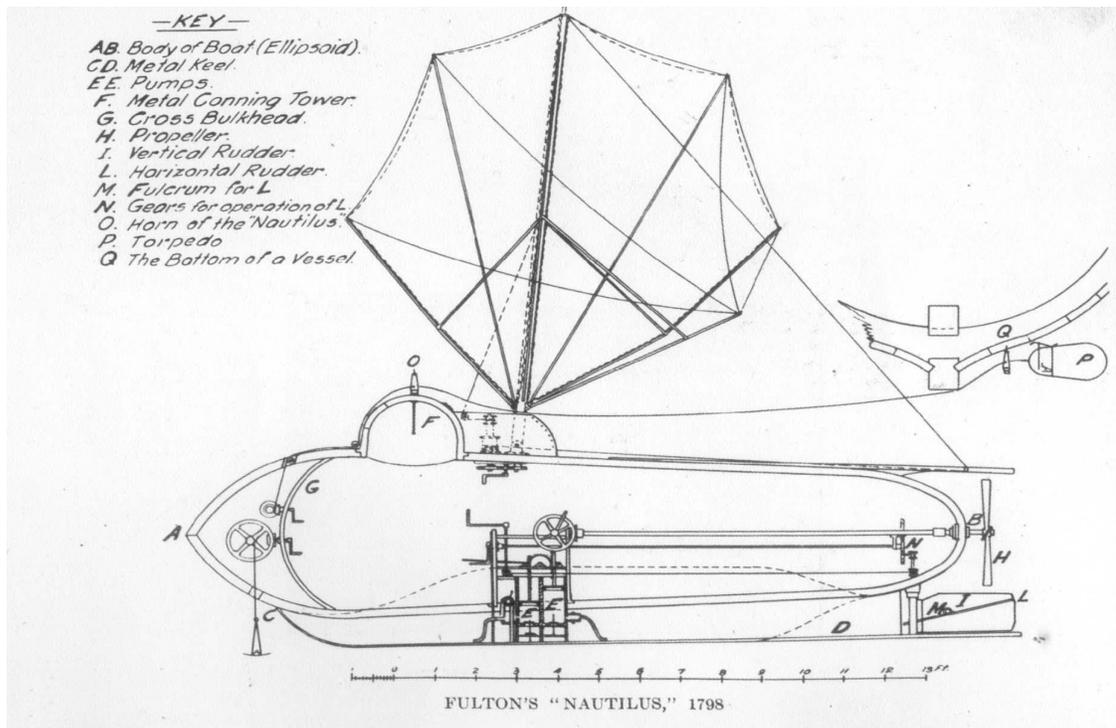
Figure 5. Drawing of *Nautilus*.

Nautilus initial design and major components are illustrated in Figure 5. The submarine was a composite vessel, with components of iron, lead and cupreous metal as well as wood.²⁸ It was at least partially fastened in iron as Fulton later noted the fasteners caused rust damage.²⁹ Like *Turtle*, *Nautilus* had a metal conning tower mounted atop the hull fitted with an access hatch and deadlights. Submerged propulsion was provided by a human-powered propeller. New in *Nautilus* was a separate method of

surface propulsion: it was fitted with collapsible mast and sail. Hull dimensions were 21.3 feet (6.5 m) in length and 6.6 feet (2 m) in beam.

Diving, or plunging as Fulton referred to it, was accomplished by flooding the ballast tanks, located in the metal keel. Once slight negative buoyancy was achieved, the bow was driven down by utilizing forward motion and stern-mounted diving planes. Surfacing was accomplished by pumping the water out of the ballast tanks with a manual forcing pump while driving the bow up in the same manner. Directional control was via a stern-mounted vertical rudder. Fulton proposed to attach an explosive charge (that he referred to as the torpedo) to the hull of an enemy ship by employing the “Horn of the *Nautilus*” (Figure 5, detail O). This method was much the same as the concept Bushnell used in *Turtle*, but it employed a spike instead of a screw to fix the charge to the target and the torpedo was towed behind instead of mounted directly on the vessel.

Fulton made several modifications to the plan shown in Figure 5, adding a wooden deck for the crew to stand on while sailing, a jib to improve sailing capability, a vertical propeller to improve depth control and altering the horizontal propeller to improve submerged speed.³² The designer's concept of a vertical propeller is seen in plans by Fulton (Figure 6, detail B) for an improved submersible that was not constructed.

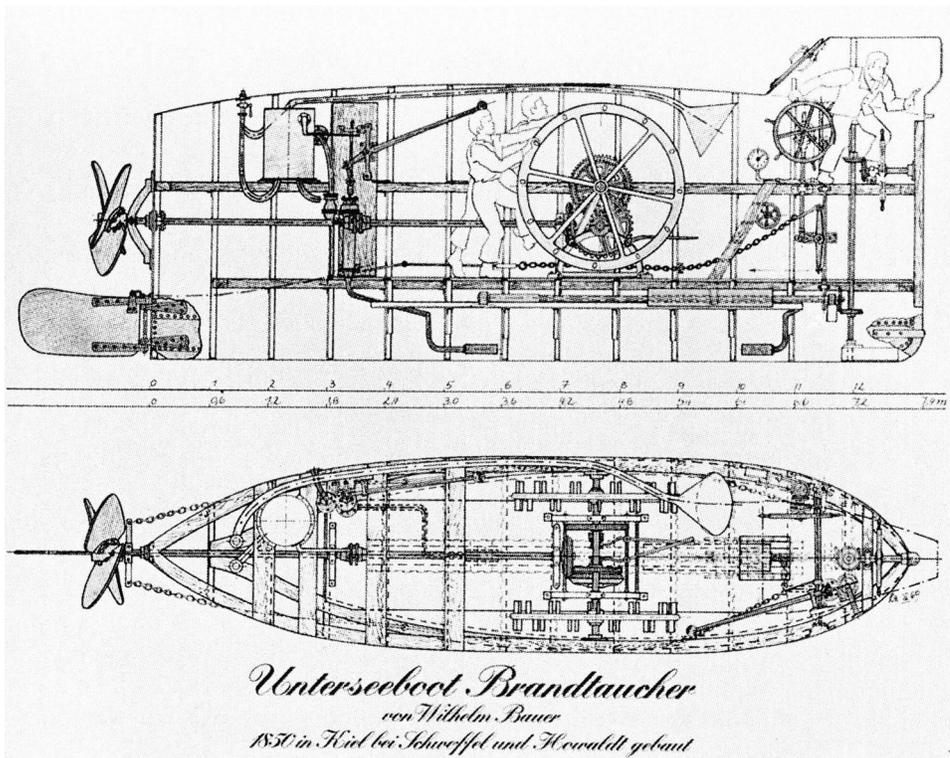
Figure 9. *Brandtaucher* drawings.

During the conflict, the Danish government imposed a naval blockade of the ports of Schleswig-Holstein. Sebastian Wilhelm Bauer (1822-1875), a Bavarian artillery engineer, designed and constructed a submersible with which he hoped to break the blockade (Figure 9).

The submersible was 26 feet (8 m) long, had a beam of 6 feet (2 m), a submerged displacement of 30.5 tons, and was constructed in iron at the Machine Factory and Foundry of Schweffel & Howaldt in Kiel. Named *Brandtaucher* (*Incendiary Diver*), the vessel, like its predecessors, was human powered, uniquely with a treadwheel. Much like *Turtle*, surface draft was adjusted with metal weights to achieve slight positive

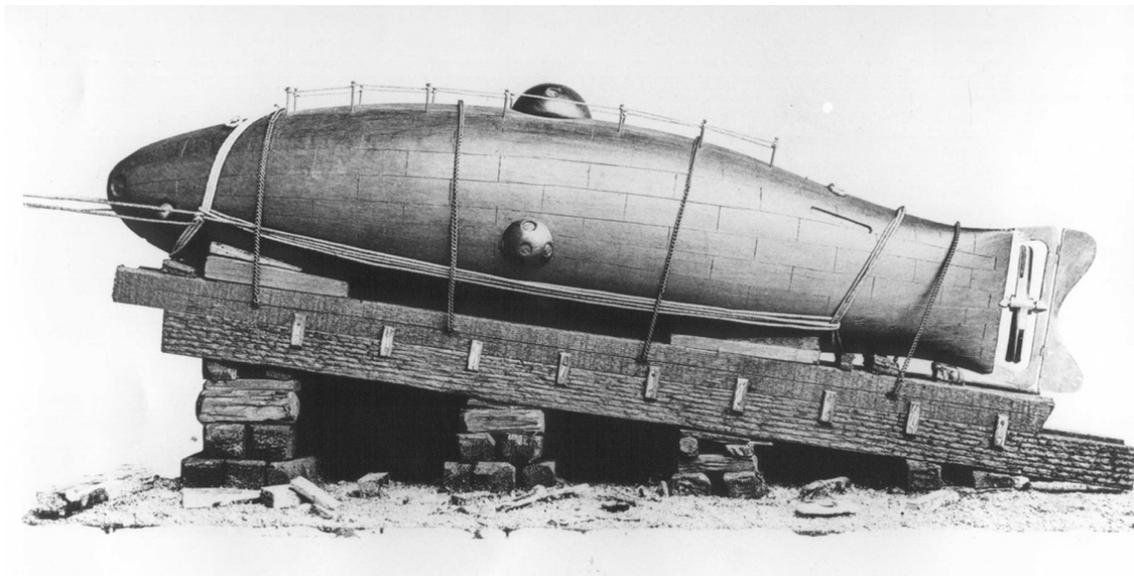
Figure 13. *Ictíneo*.

Ictíneo was 23 feet (7 m) long and displaced 10 tons, designed for a crew of six and, like its predecessors, was human-powered and slow; nevertheless, it represented a large leap forward in submarine development (Figure 13). The most important of these developments was the inventor's use of a double hull. The inner hull, constructed of olive wood and clad in copper, was designed as the pressure vessel, while the outer hull, also of olive wood, was designed to be as hydrodynamically efficient as possible. Other innovative features incorporated in *Ictíneo* included ballast tanks located in the interstitial space between hulls and an atmosphere control system for removal of carbon dioxide and the enrichment of oxygen. *Ictíneo* operated successfully at depths up to 20 meters and achieved a submerged duration of four hours.⁴⁵ In January 1862, a freighter collided with *Ictíneo*, sinking it at its berth.

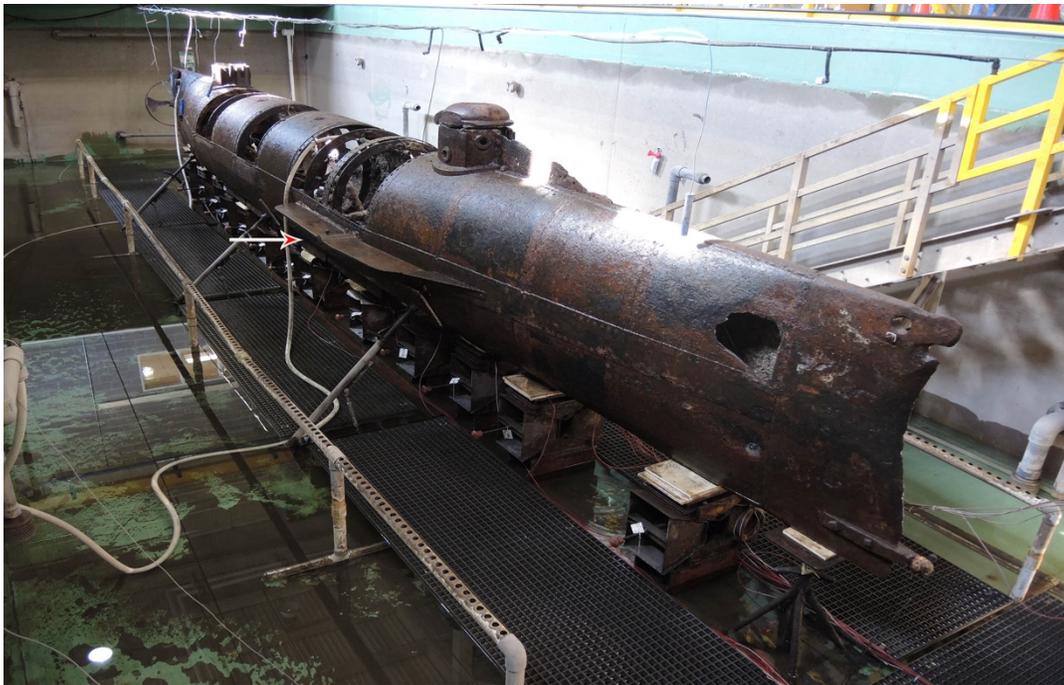
Figure 15. *H. L. Hunley*.

The most significant of these vessels is the Confederate vessel *H. L. Hunley* (Figure 15). It made history as the first submarine to sink an enemy combatant when, on the night of 17 February 1864 under the command of Lt George Dixon CSA, it sank *USS Housatonic* off Charleston, South Carolina. *Hunley* also sank during the engagement with the loss of all eight souls aboard.

Built of boiler iron and propelled by seven men turning a three bladed screw via a hand crank, the vessel, uniquely, was controlled in the vertical axis with large hydroplanes mounted forward of the center of buoyancy, the control rod for which is mounted slightly abaft the forward conning tower. The planes are remarkable in size and location. An analysis of the diving planes suggested that the length of the planes may have been excessive, exacerbating depth control challenges.⁴⁷

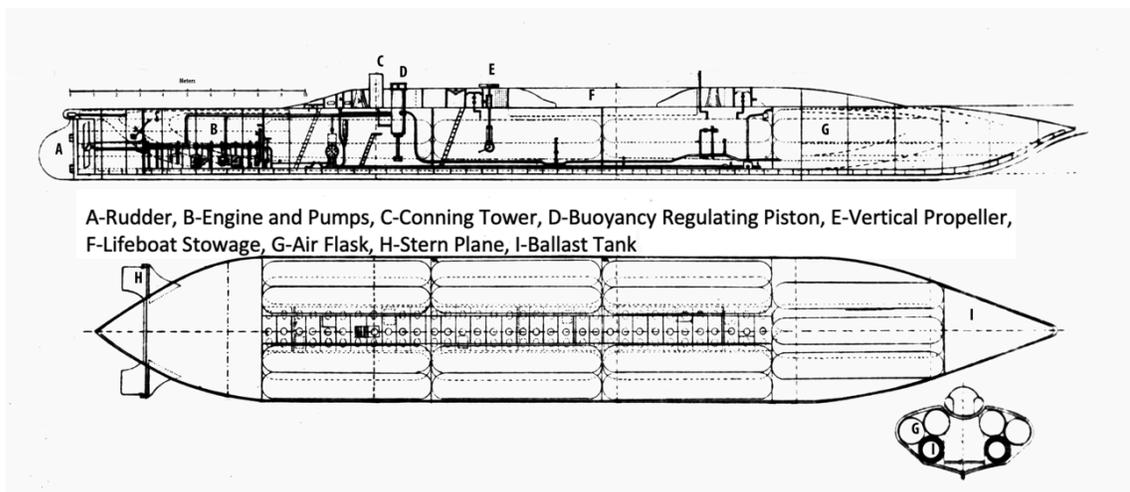
Figure 16. *Le Plongeur*.

In 1863 a new submarine designed by Captain Siméon Bourgois and the engineer Charles Brun was launched in Rochefort, France. *Le Plongeur* was the first submersible to be powered by mechanical means (a piston and cylinder engine) driven not by steam but by compressed air (Figure 16).

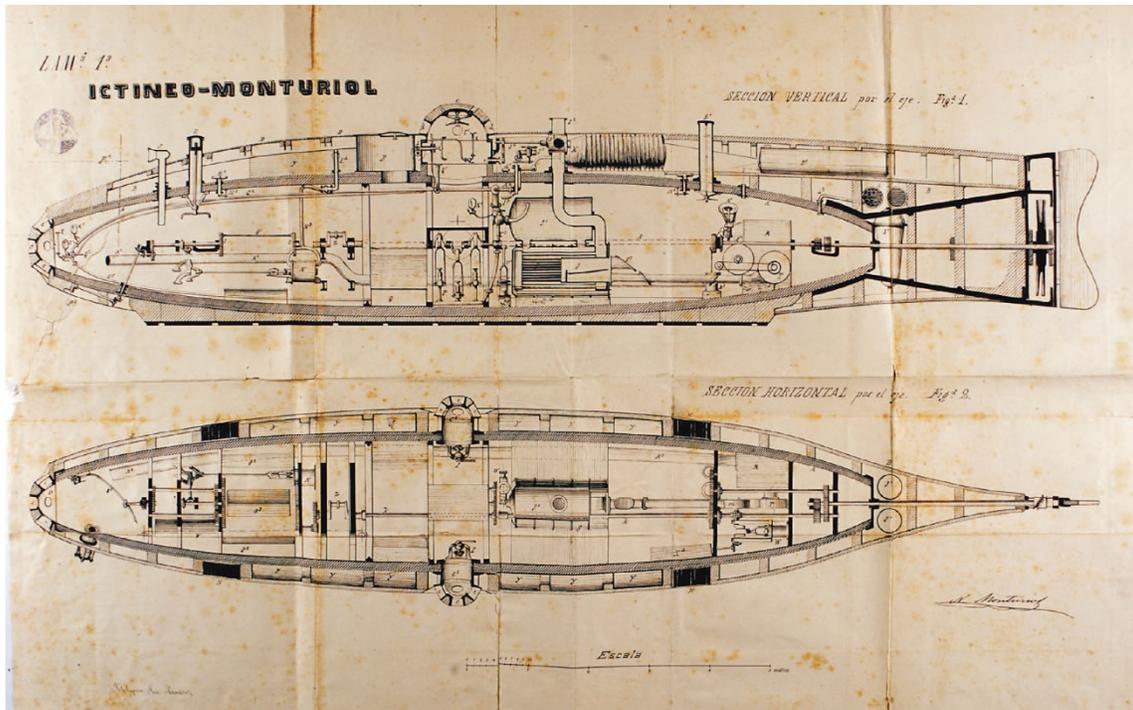
Figure 17. *Ictíneo II* fitted with steam engines.

The first steam powered submersible was developed by Narcis Monturiol as a modification to his human powered *Ictíneo II* (Figure 17). In his quest for mechanical power, he focused his attention on developing a steam propulsion system that utilized a mix of chemicals whose interaction safely generated heat while not contaminating the enclosed atmosphere of *Ictíneo II*. He found that a mixture of zinc, manganese dioxide, and potassium chlorate controllably produced heat with byproducts of oxygen and zinc oxide.⁵⁰

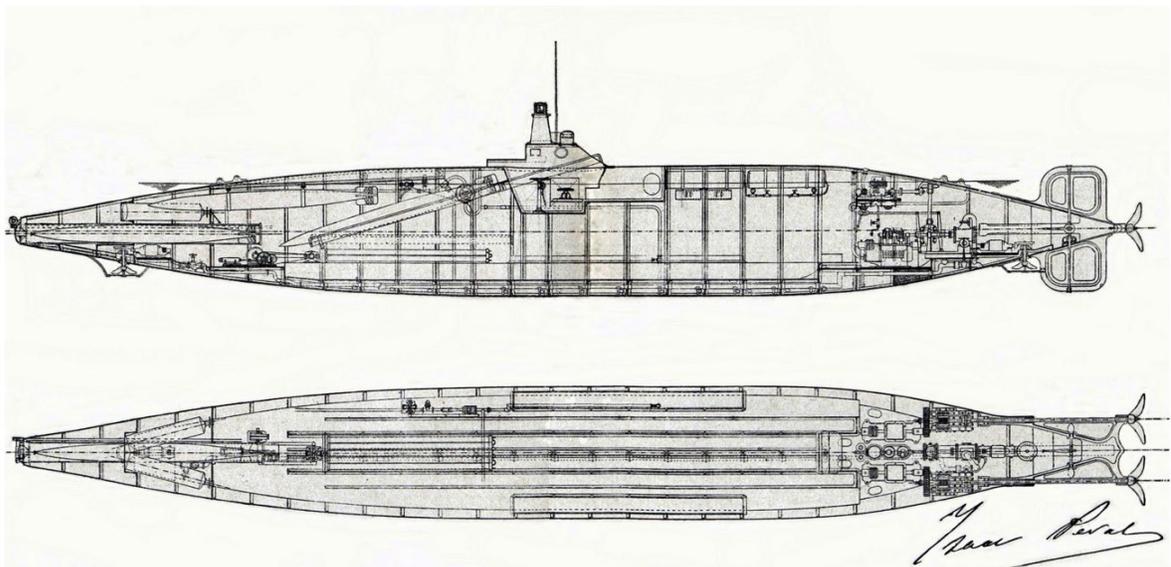
Figure 21. *Peral* plan and profile drawings.

Peral was built of steel plate on frames; it was approximately 72 ft (22 m) in length, had a beam of 9.5 ft (2.9 m) and displaced 77 tons surfaced and 85 tons submerged. *Peral* was powered by two 30-horsepower electric motors driving independent propellers. *Peral* lacked hydroplanes, instead relying on five-horsepower electric motors driving two vertical-thrust propellers, the forward of which was located below the torpedo tube while the aft thruster was placed just forward of the rudder.

Peral's drawings show the machinery layout and torpedo storage but lack details regarding location of the storage battery, described as the largest of its day, nor can the location of ballast tanks be discerned (Figure 21).

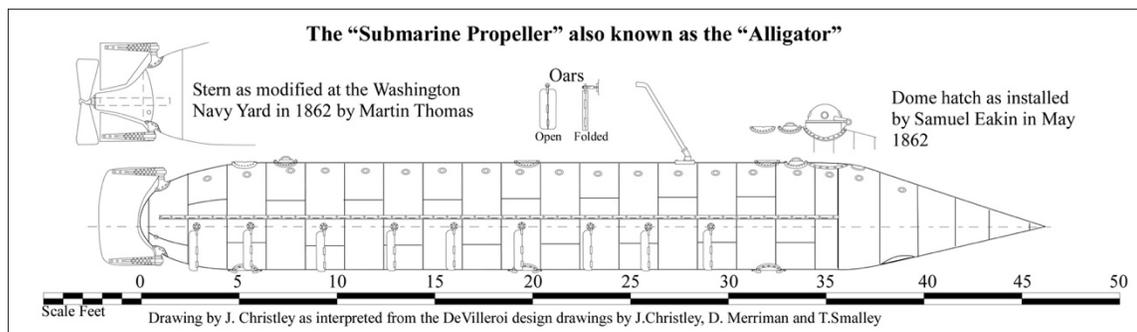
Figure 24. *Alligator*.

The U.S. Navy began experimenting with submersibles early in the Civil War. The French inventor Brutus de Villeroi (ca. 1797-1875) designed, and the Philadelphia shipbuilders Neafie and Levy built, the Navy's first submersible, launched on 1 May 1862. Dubbed *Alligator*, the boat was approximately 47 ft (14.3 m) long and was human powered, utilizing oars which feathered on the forward stroke and opened on the catch (Figure 24). *Alligator* was to deliver explosive charges by a diver deployed through its lockout chamber, the sole innovation of this craft. *Alligator* sank on 2 April 1863 while being towed to Port Royal, South Carolina. It was never employed in combat.

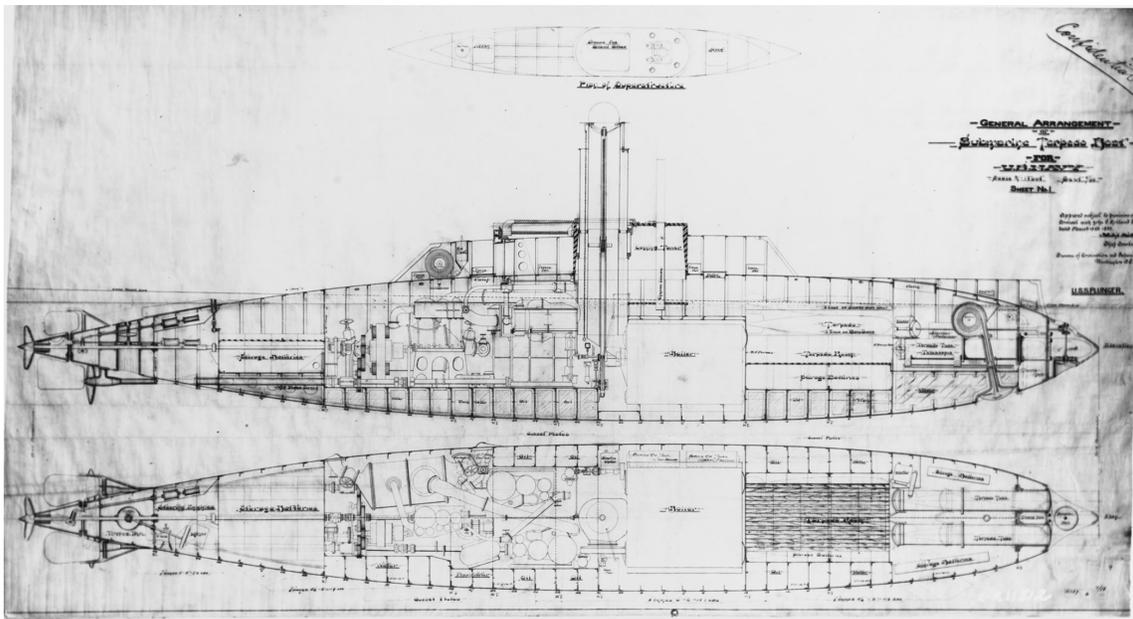
Plunger was the largest and most complicated boat Holland had attempted; built in the yard at Columbian Iron Works in Baltimore, MD, it was 85 feet (25.9 m) in length, 12 feet (3.7 m) in beam and displaced 168 tons. *Plunger* did not follow Holland's previous designs except in the most general of terms. Holland boats were single hull vessels, meaning that the pressure hull contained the entirety of the vessel's tanks, equipment, and personnel. The interiors of Holland's early boats were not divided into separate watertight compartments, exposing the entire crew to the same environmental hazards and the boat to catastrophic flooding. While *Plunger* was drawn by Holland it was essentially designed by committee (Figure 26).

Figure 26. *Plunger* drawings.

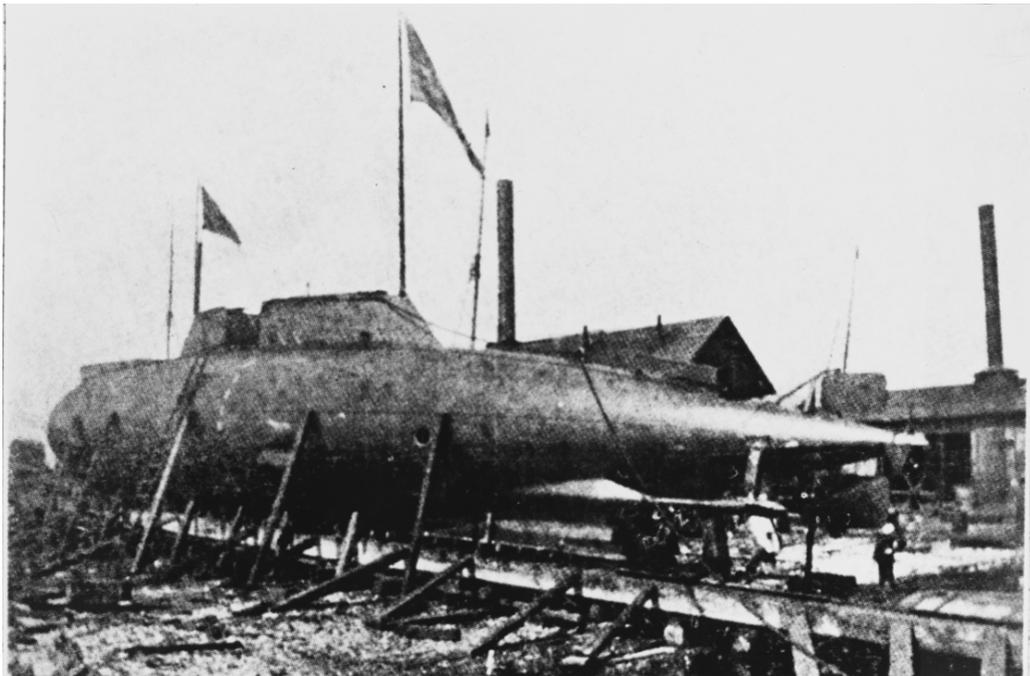
Figure 27. *Plunger* on the ways.

The triple screw configuration appears in the photo below (Figure 27). The outboard screws which provided surface propulsion were driven by steam engines, each generating roughly 810 horsepower at 400 revolutions per minute. The centerline screw, provided submerged propulsion and was powered by a 70-horsepower electric motor.⁸³

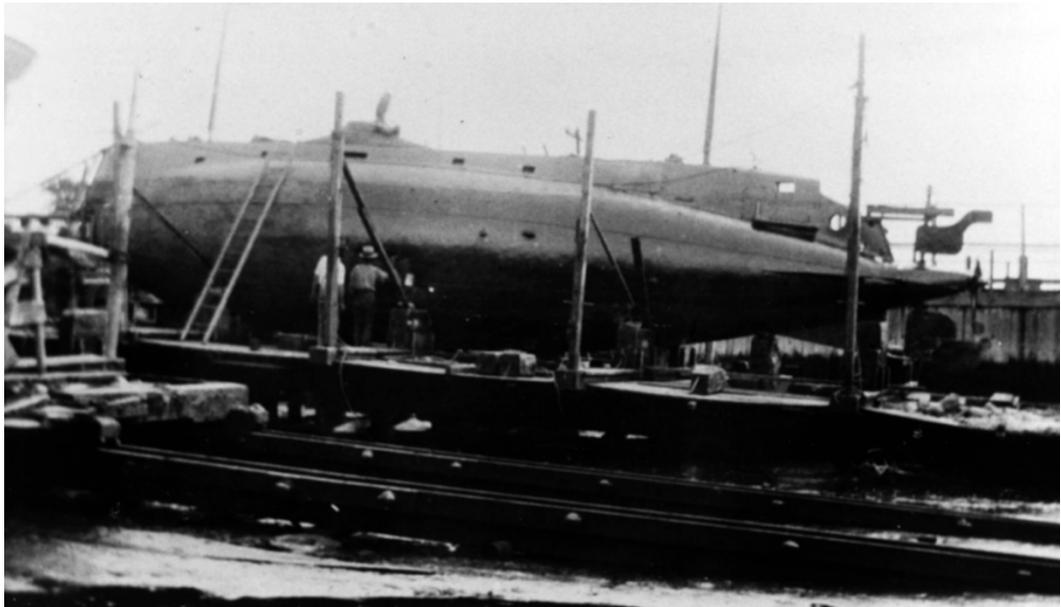
Figure 28. *Holland VI* circa 1898.

Holland VI was launched on 17 May 1897, three months before *Plunger*. The image above shows *Holland VI* in its original configuration; note that the rudders and diving planes are mounted forward of the propeller (Figure 28). On 13 October 1897 while undergoing alterations dockside, a sea valve was accidentally left open allowing the boat to flood and sink; it was photographed on the dock being repaired following the incident.

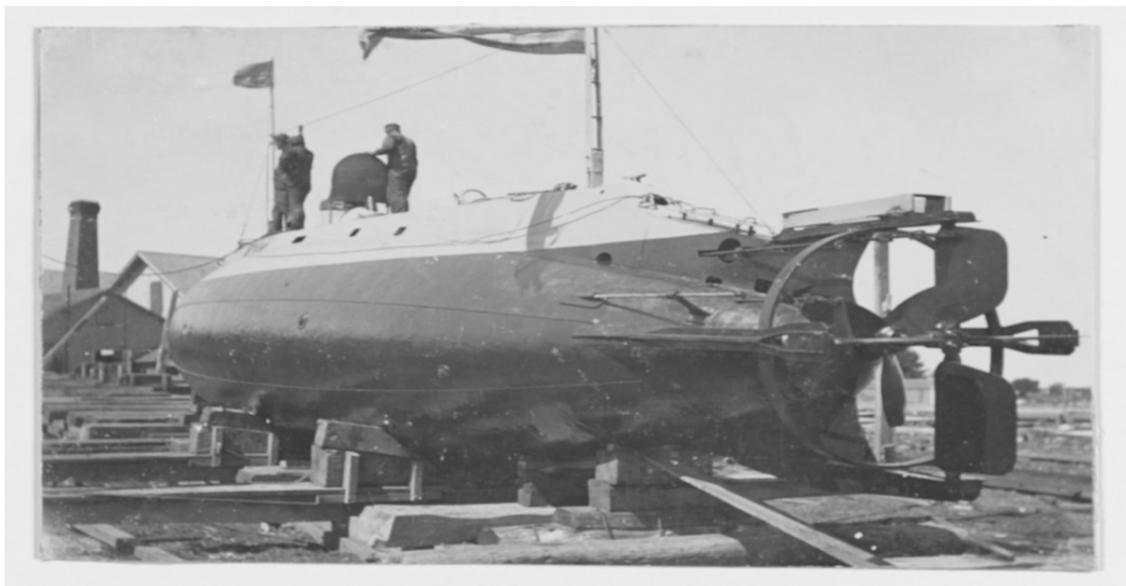
Figure 29. *Holland VI* circa 1899.

gear, removing the aft dynamite gun, and designing and constructing a compensating system to deal with the change in buoyancy resulting from the launch of a torpedo. The design changes were a time and resource consuming evolution that nearly bankrupted the Holland Torpedo Boat Company. The image below shows *Holland VI* awaiting launch following Cable's modifications and displaying a fresh coat of paint (Figure 29).

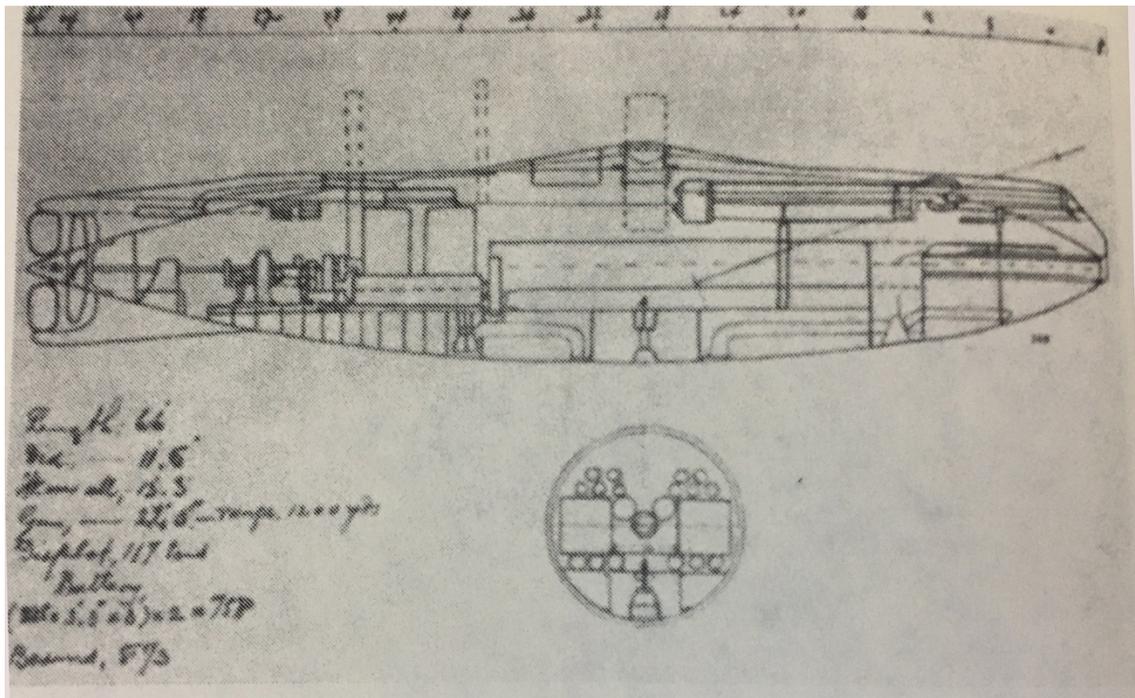
Figure 30. J. Holland's 1899 advanced *Holland* plan.

The improved design provided to the Navy in 1899 by John Holland was envisioned as larger, deeper diving, version of USS *Holland* with some significant improvements (Figure 30).

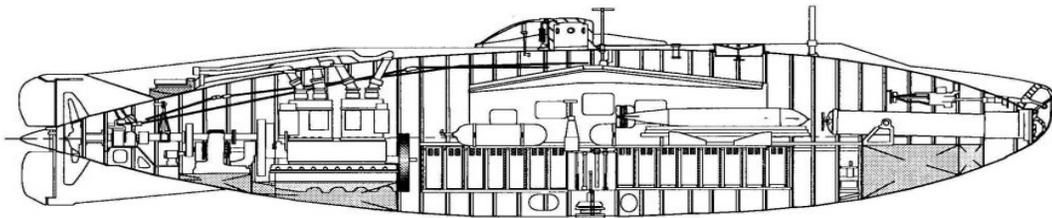
Figure 33. A-Class.

As with Holland's previous designs no periscope was originally fitted on the A-Class boats; neither were they equipped with atmosphere control equipment, nor with adequate berthing, messing, and sanitation facilities (Figure 33). The conning tower on each vessel was only 2 feet (0.6 m) tall, affording little protection from winds and waves. These design factors clearly indicate a vessel best suited to submerged operations of short duration in support of harbor defense.

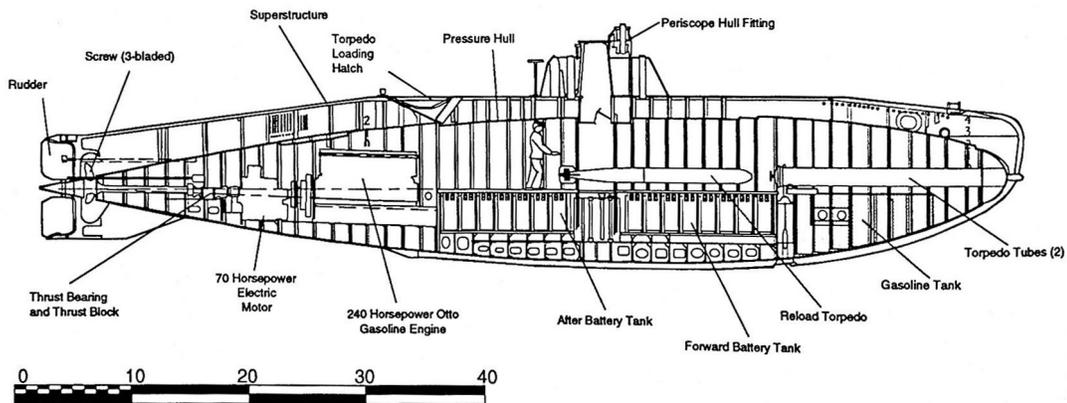
Figure 36. B-Class profile.

The B-Class boats were a larger and improved version of the A-Class boats, equipped with more powerful propulsion systems, increased cruising radius, and more formidable armament. The new boats were designed with a range of 600 nautical miles (1111 km) and were operated with a ten-man crew. At 81 feet 5 inches (24.8 m) in length with a beam of 12 feet 6 inches (3.8 m) and displacing 173 tons submerged, they were significantly larger than their predecessors. Their 240-horsepower gasoline engine

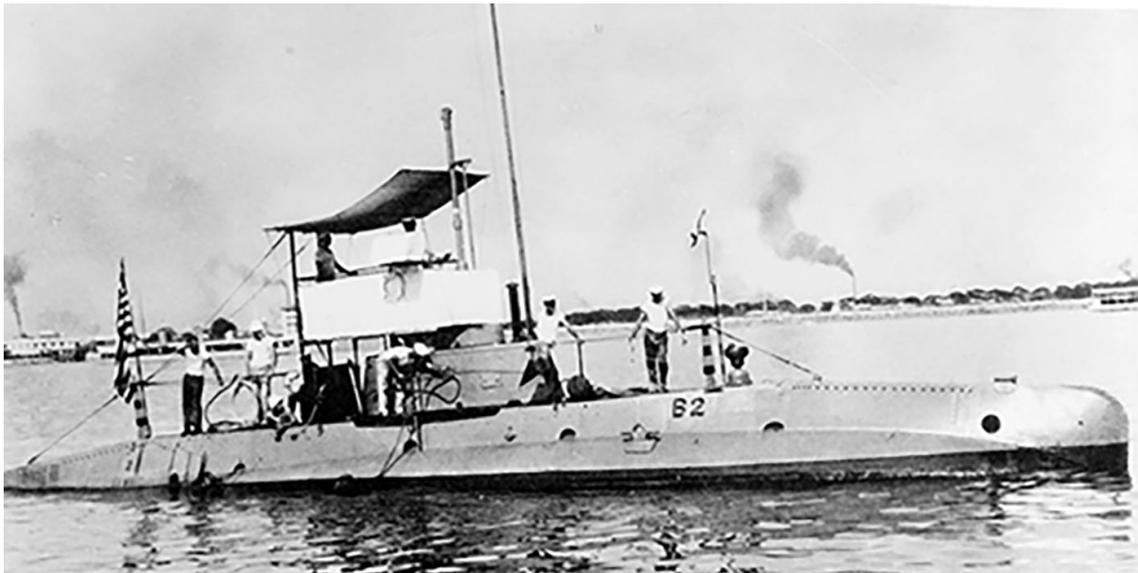
Figure 37. USS *B-2*.

gave the boats a surface speed of 9 knots (17 kph) and the 70-horsepower electric motor propelled the boat at 8 knots (15 kph) while submerged. The propeller pitch could be changed (while stopped) to improve efficiency, with a finer pitch for the electric motor and a greater pitch for the lower RPM gasoline engine. An expanded conning tower was fitted for safer surface operations, a trend which would continue as submarine missions began taking them further to sea and away from the safety of the harbor.¹²² The larger superstructure and conning tower improved the safety and comfort of surface watchkeeping. The temporary canvas bridge and awning seen in the photograph of *B-2* exemplify the adaptive nature of submariners (Figure 37).

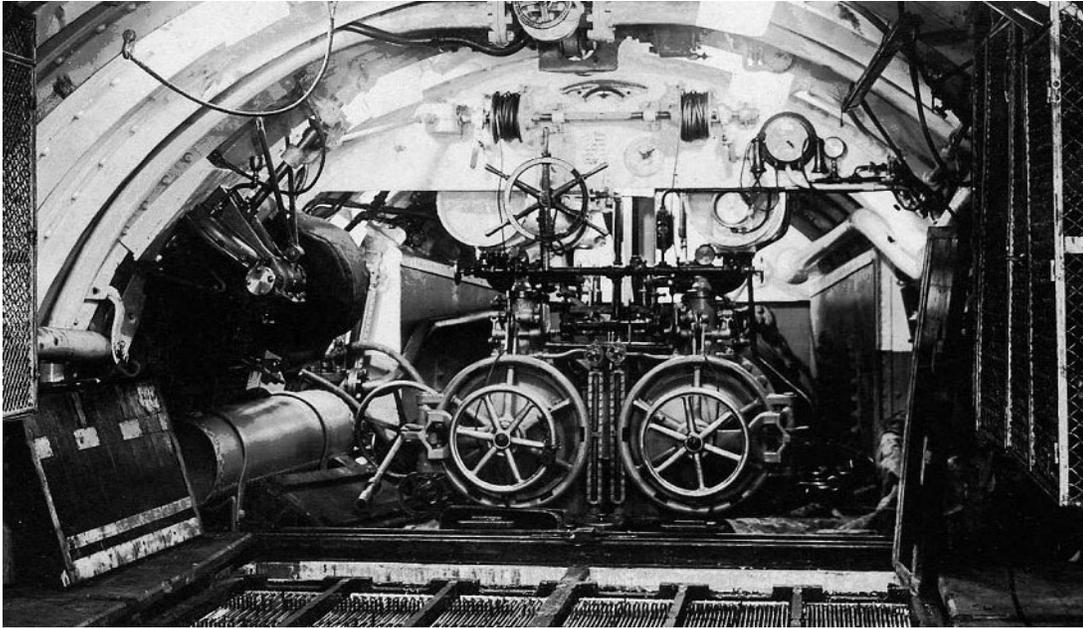
Figure 38. USS *Octopus* Torpedo Room.

Perhaps the most important upgrade was the increase in armament from a single torpedo tube to two 18-inch (457mm) torpedo tubes (Figure 38); four torpedoes could be carried, two stowed in the tubes and two reload torpedoes in the torpedo room.

The muzzles of the tubes were covered with a rotating bow cap, which flooded both tubes when rotating it open, consequently wetting both torpedoes. If the torpedoes were not fired, they required cleaning and maintenance before re-use. The large spoked handwheel in the upper center of Figure 38 operated the bow cap, the large handwheels on each torpedo tube operated the breech door, and the two winches located above the bow cap operating gear were used for moving torpedoes in and out of the tubes. Figure

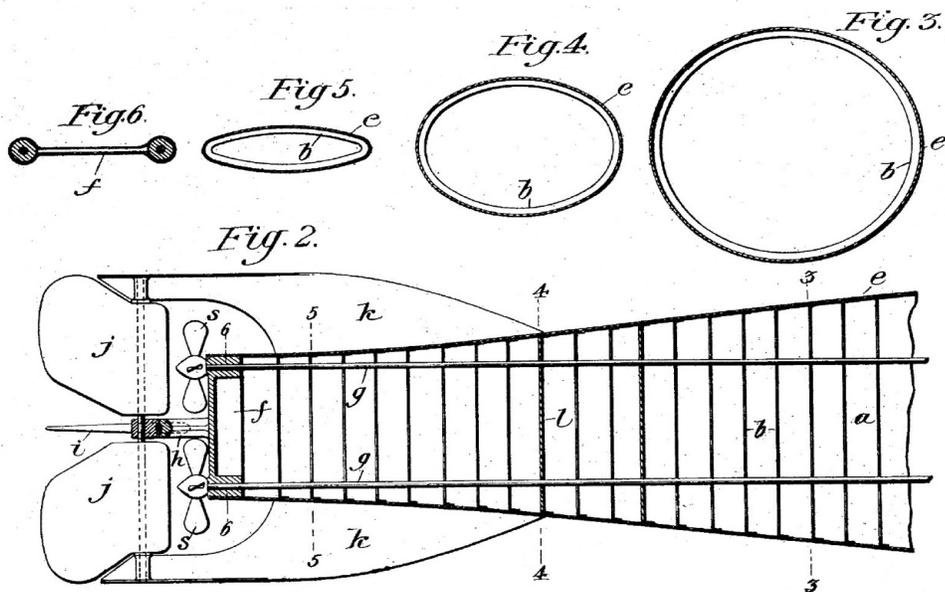
Figure 39. Twin-screw submarine design.

In addition to the B-Class boats, a new type of submarine was laid down by Electric Boat in the Fore River Yard in August of 1905. This improved design (EB17) was the brainchild of naval architect L.Y. Spear and it would change the shape of submarines hulls for the next 45 years, abandoning Holland's cigar shaped form in favor of a circular midships tapering forward and flattening aft into an oval stern section facilitating twin screws. This configuration, patented by Spear, began Electric Boat's transition from an underwater vessel with limited surface capabilities toward a submarine optimized for submerged operation while possessing enhanced surfaced capability (Figure 39).¹²⁷

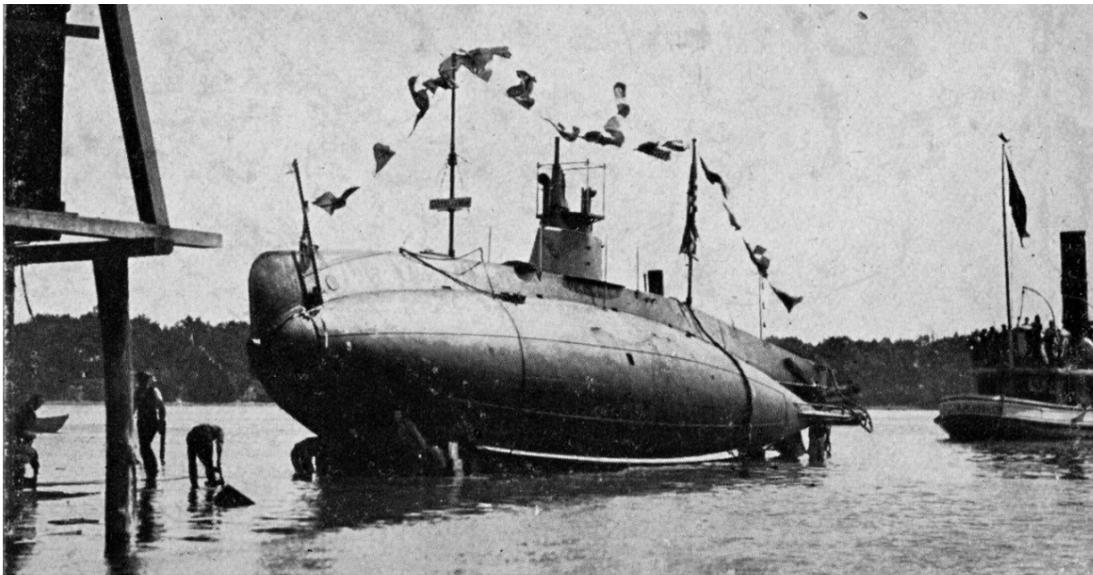
Figure 40. USS *Octopus* launching

Octopus was, at its launching in 1906, the largest submarine yet built by Electric Boat (Figure 40). It measured 105 feet 4 inches (32 m) in length, 14 feet (4.2 m) in beam and displaced 238 tons surfaced and 275 tons submerged. *Octopus* was designed for a maximum safe depth of 200 feet (61 m) and had a range of 776 nautical miles (1437 km). Operated by a crew of 15 officers and men, it was armed with four torpedoes to be launched via two 18-inch (457mm) torpedo tubes arrayed in the same side-by-side configuration as the B-Class. Its twin screws were powered on the surface by two gasoline engines each rated at 250-horsepower giving it a design speed of 10.5 knots (19 kph); when submerged, two storage batteries of sixty cells each powered two electric motors each rated at 150-horsepower designed to achieve 9 knots (17 kph).¹²⁸

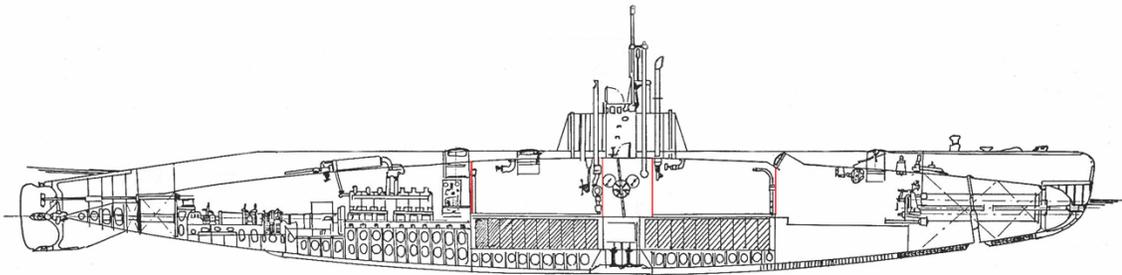
Figure 41. *Narwhal* watertight bulkheads in red.

Narwhal and *Grayling* were subdivided into a torpedo room, forward battery, control room, after battery, and an engine room (Figure 41); in *Salmon* the bulkheads separating the control room from the forward and after battery compartments were not installed, to facilitate installation of second periscope with an integral torpedo director.

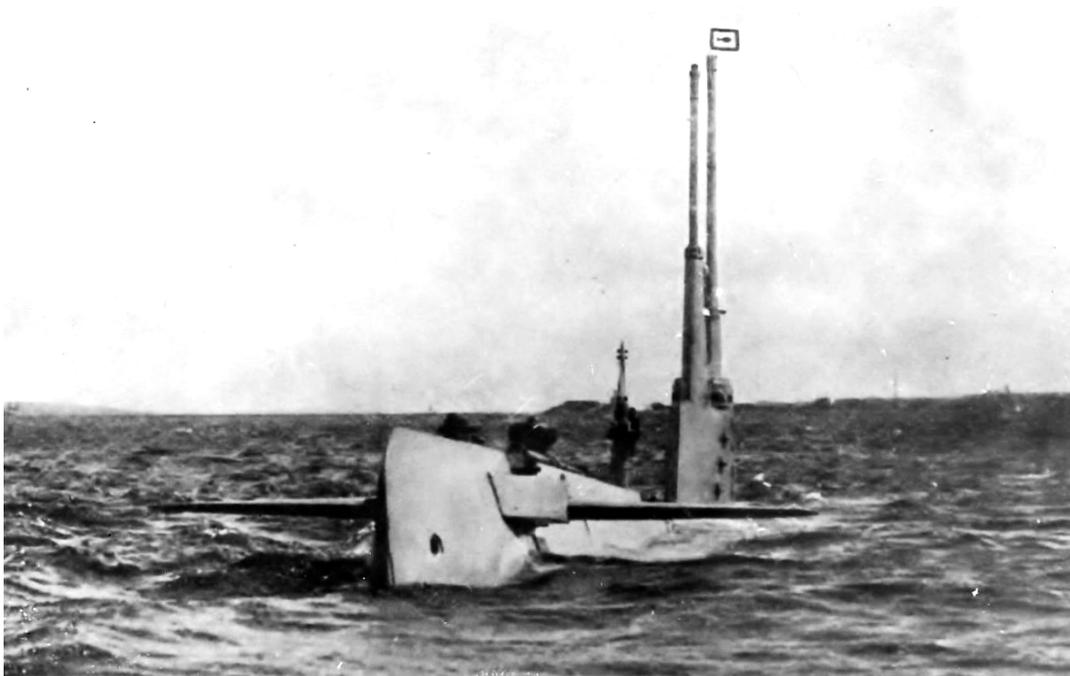
Figure 43. USS *E-1*.

rigged out when preparing to dive. The stern planes' primary function remained controlling the up or down angle of the boat or the "bubble" in the parlance of submariners, while the bow planes were effective at fine depth control. Several foreign navies were already using bow planes on their submarines, and America's slow acceptance can likely be attributed to the design traditions of Electric Boat, the single supplier. In the image below the bow planes of *E-1* are visible in their rigged-out position and the boat appears to be surfacing as it is down by the stern (Figure 43).

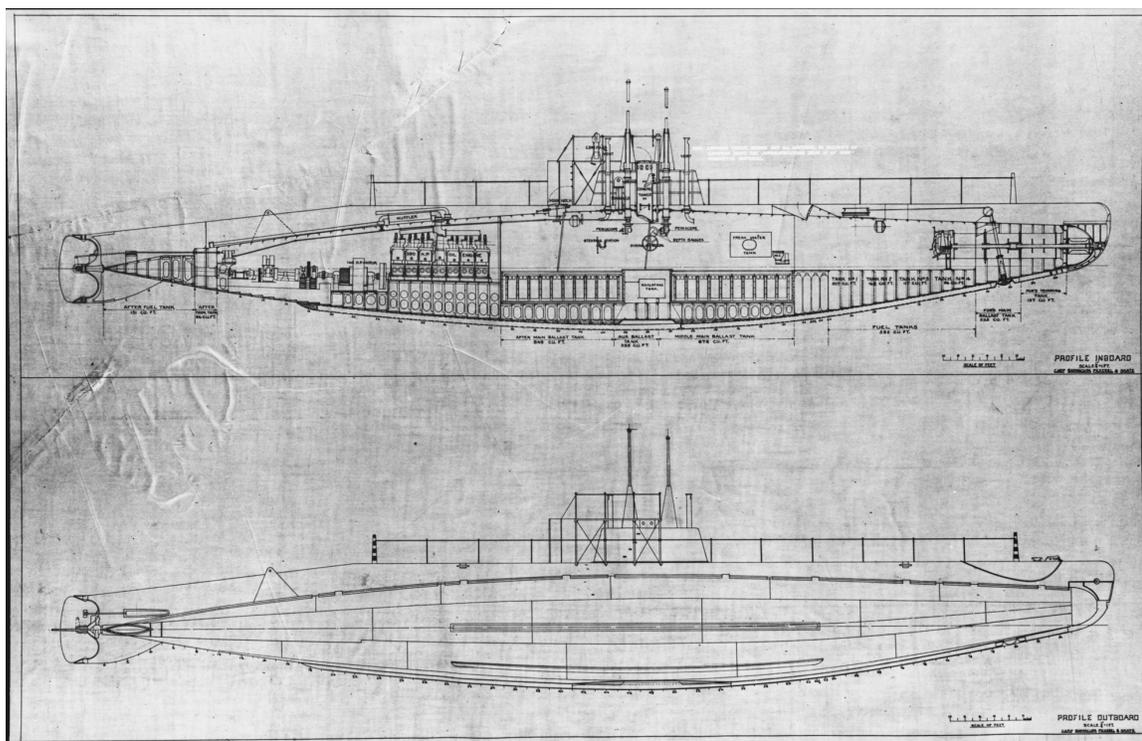
record group 19 of the National Archives (Figure 44). It should be noted that the drawing does not depict bow planes. The F-Class were actually laid down before the E-Class and as both the E-Class and F-Class boats were built with bow planes, their absence in this plan, as well as the other views within the set, could indicate that bow planes were a late addition to the design.

Figure 44. F-Class profile.

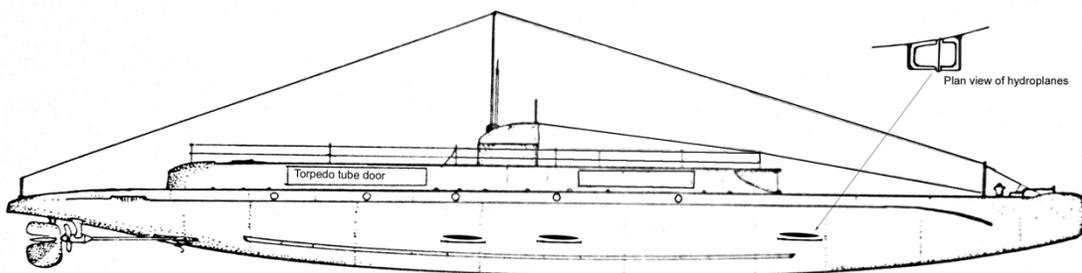
Figure 45. USS *G-1*.

G-1 was laid down in February 1909 as *Seal* at Newport News Shipbuilding and Drydock Company (Figure 45). It was 161 feet (49 m) in length, had a beam of 13 feet (4 m), displaced 400/516 tons surfaced/submerged, and was manned by one officer and 23 enlisted men.

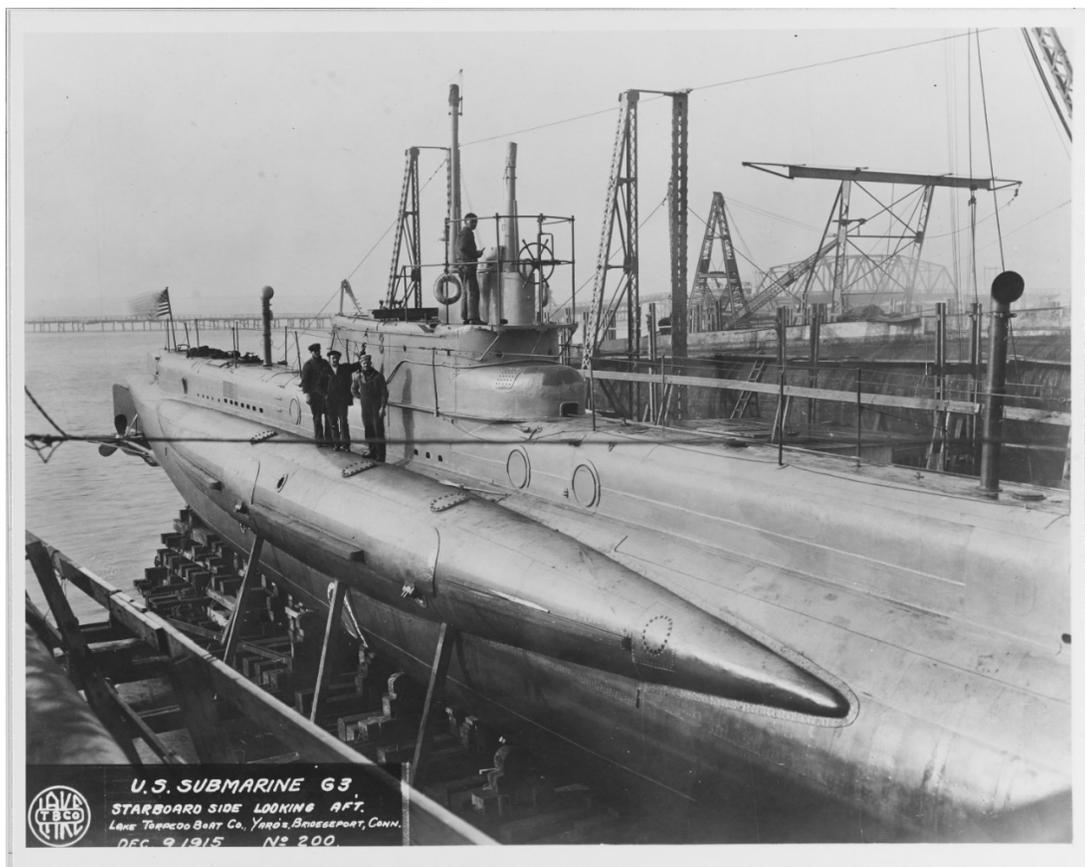
price.¹⁴⁷ None of the boats were completed on time and consequently Lake's one-way cash flow resulted in the closure of the Bridgeport plant before *G-2* and *G-3*'s final acceptance by the Navy. The Navy had them finished in the Brooklyn Navy Yard, under Lake's supervision. Commissioned in March of 1915, *G-3* was found to have significant stability problems requiring that sponsons be fitted to each side of the hull to remedy the problem (Figure 46).

Figure 46. *G-3* on the ways showing sponson.
