THE HISTORY OF H-CLASS SUBMARINES AND ARCHAEOLOGY OF THE
SUBMARINE USS *H-1*
(EX *SEAWOLF*) (1913-1920)

A Dissertation

RICHARD HANSON HENDREN

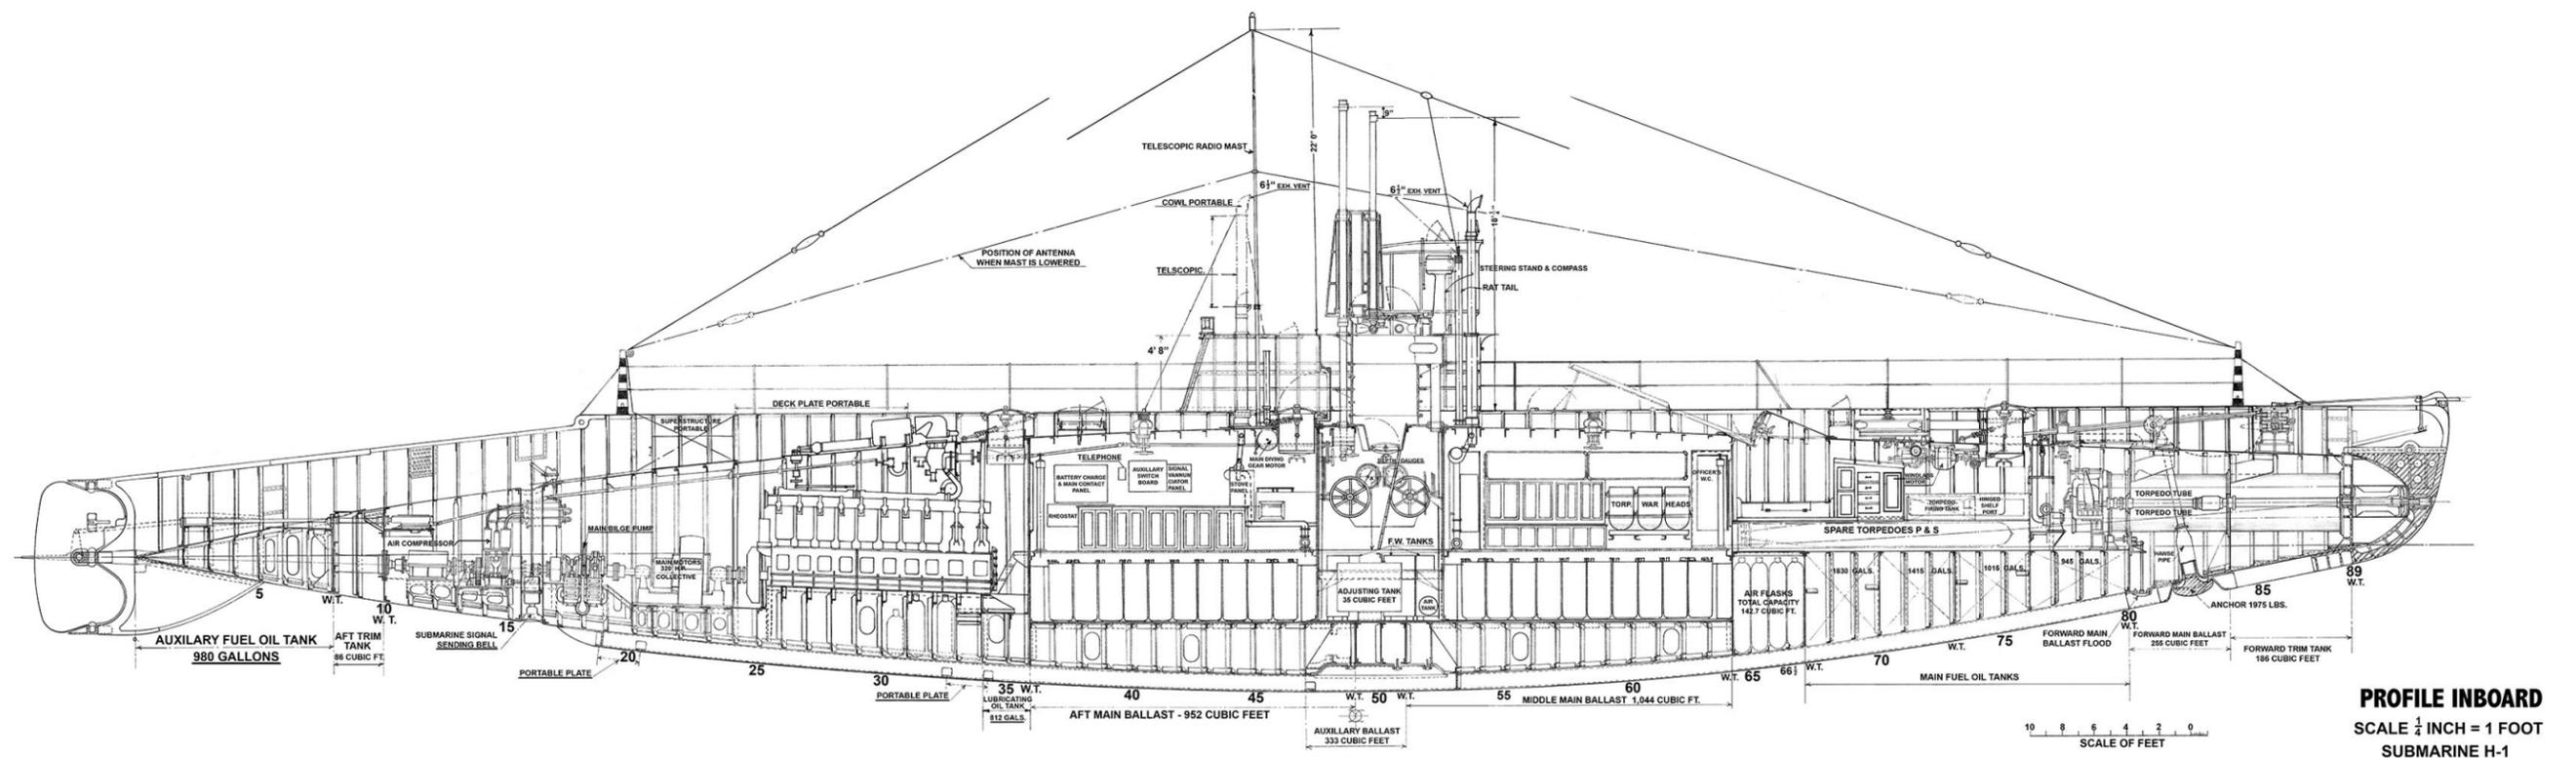
Figure 48. USS H-1 inboard profile 1918. Design EB-26.

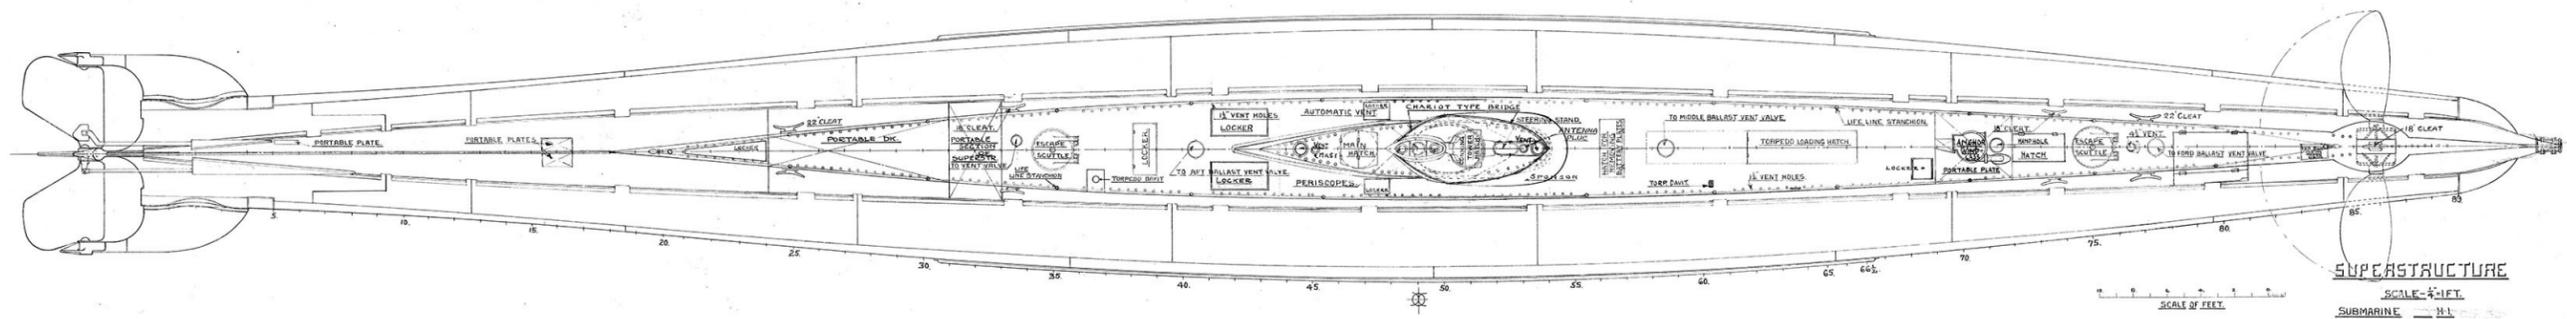
Figures 48, 49 and 50 provide the reader with visual frame of reference for the descriptions of the vessel.

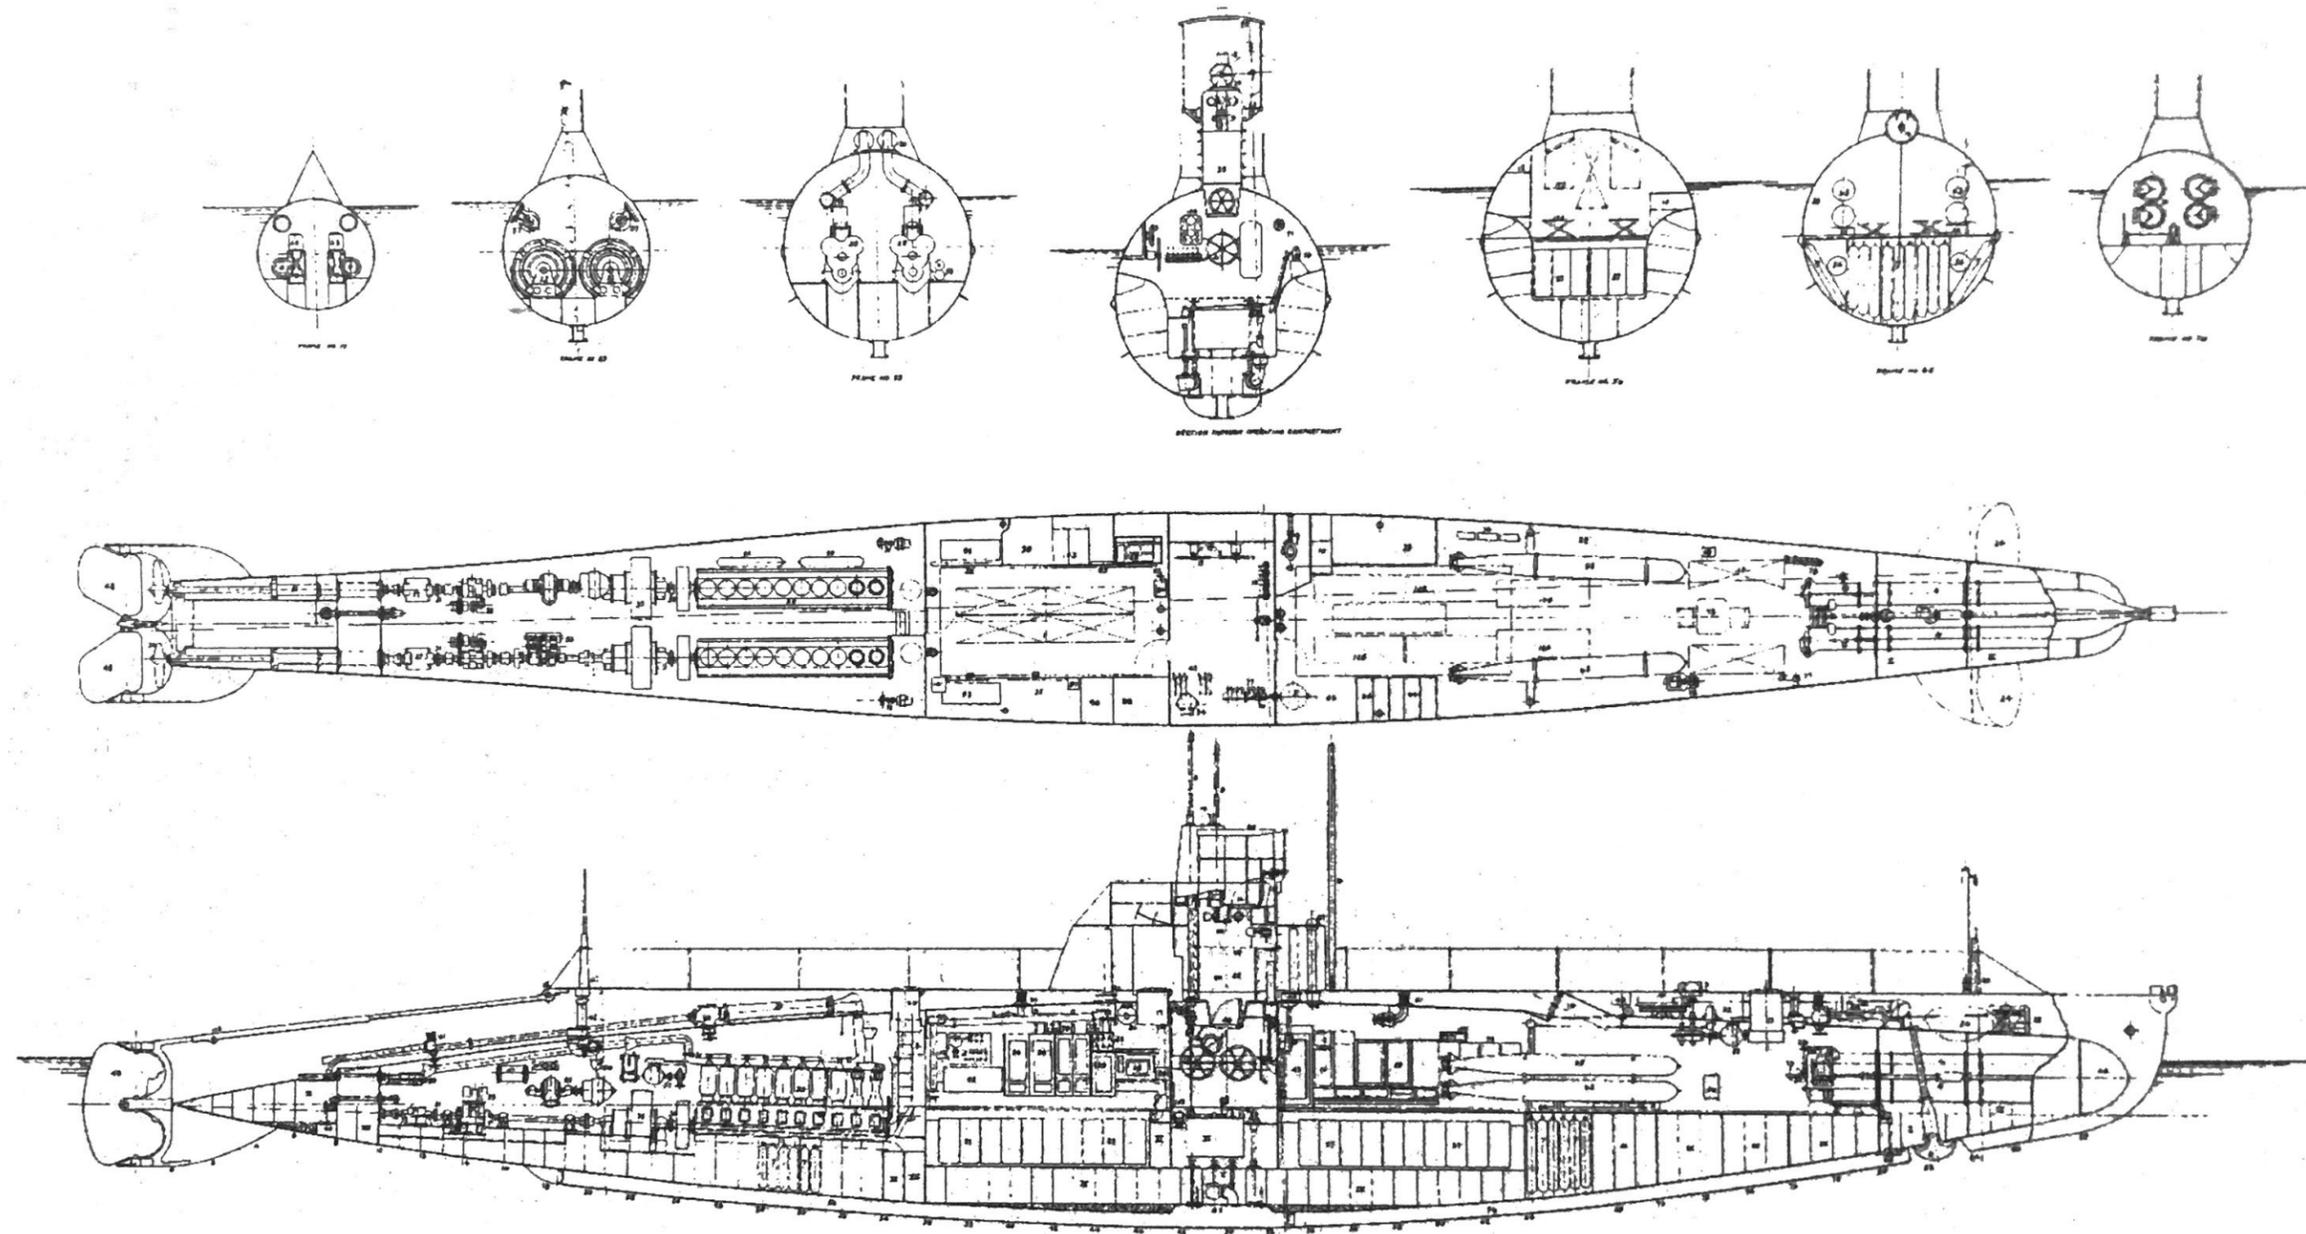
Figure 50. Design EB-602 longitudinal sections.

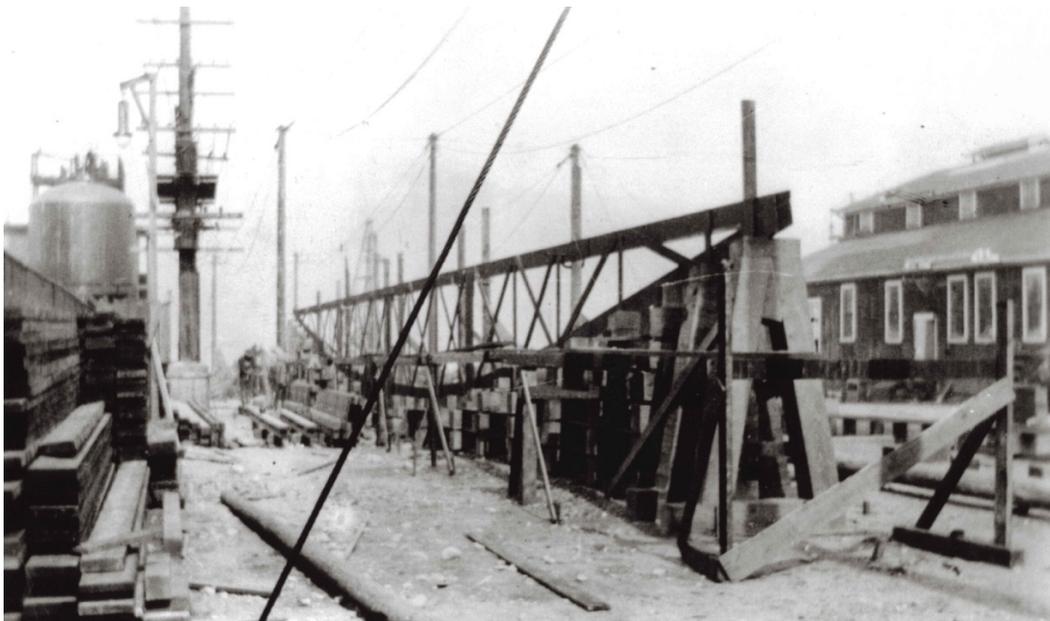
Figure 51. Barnet building ways.

The hulls of H-Class boats were constructed by riveting steel plate on structural frames, a process resembling the wooden plank on frame construction method utilized in shipbuilding for centuries. Construction began with the erection of building ways; these wooden structures provided the foundation upon which the vessel was built (Figure 51). The timber supported above the building ways appears to be a skeleton mold of the bottom of the hull.

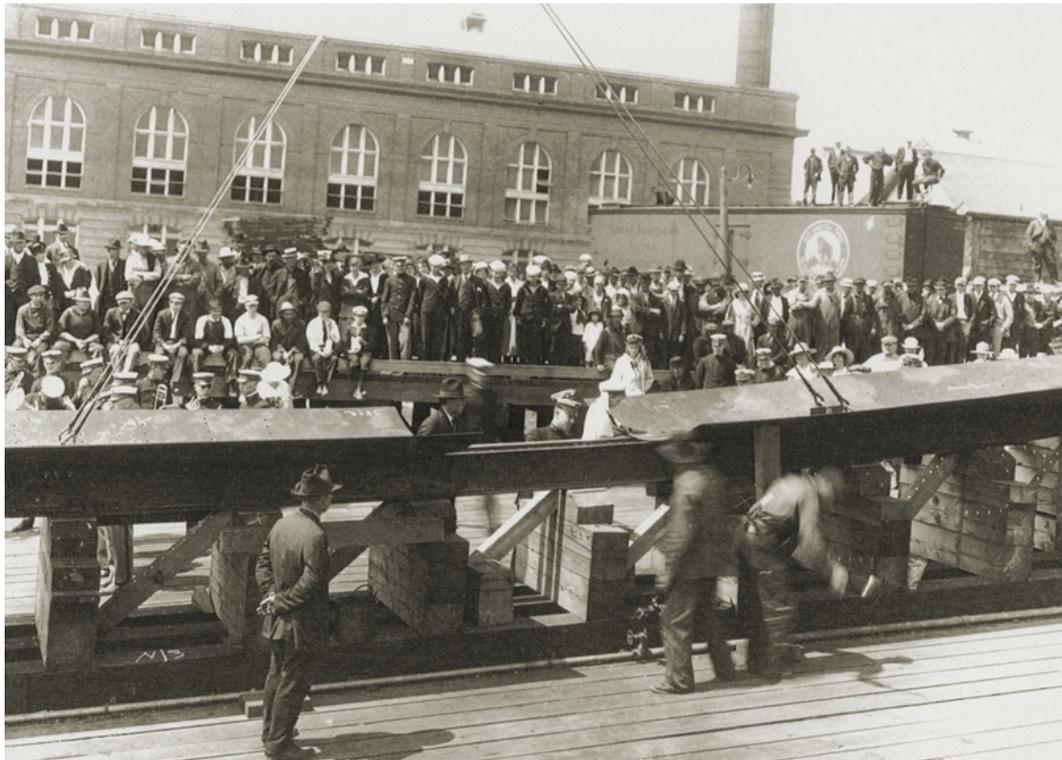
Figure 52. *O-2* keel laying.

The dimensions for the mold were taken off the plans by a loftsmen and laid out in timber; once constructed the mold could then be erected, plumbed, and leveled to establish the appropriate height and positioning of the keel blocks. Pre-assembled keel sections were then placed on the blocks. The image below shows the same process with the keel of USS *O-2* being laid at Puget Sound Naval Shipyard in 1917 (Figure 52).

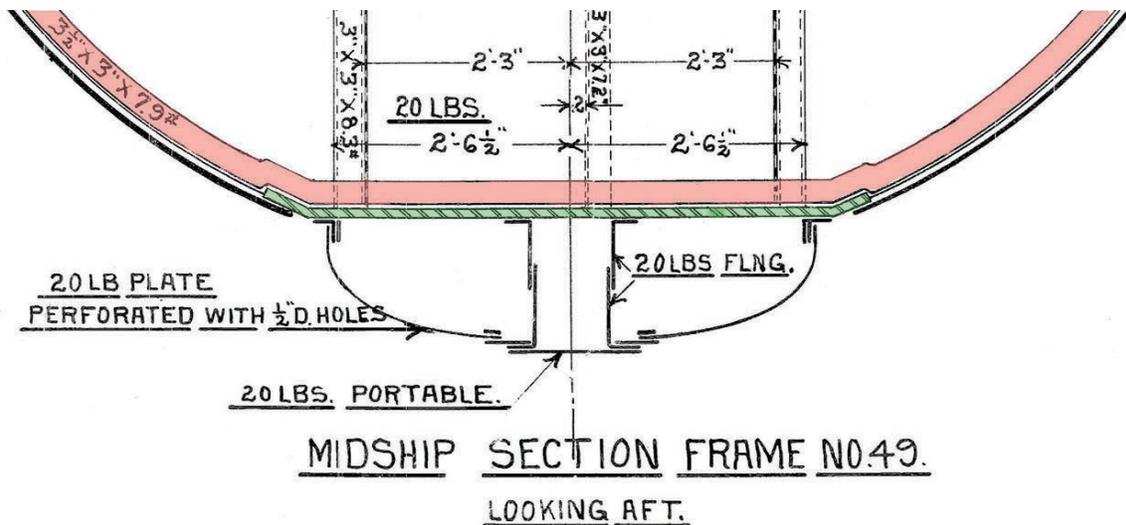
Figure 53. *H-1* keel plate and duct keel.

H-Class submarines lacked a traditional solid keel running from stem to stern. Instead, they were constructed with a heavy keel plate which provided longitudinal rigidity and a duct keel which contributed additional longitudinal stiffening but did not run the full length of the hull (Figure 53). The keel plate, shown here in green, was approximately 1.5 inches (3.8 cm) thick and 6.8 feet (2.1 m) wide at the midships frame, the width tapering fore and aft as the hull diameter decreased. The components annotated ‘20LBS FLNG’ and ‘20LB PORTABLE’ make up the stiffening structure of the duct keel which spanned from frame 19 aft to its abutment with the stem at frame 89 (Figure 48). The hollow structure duct keel, patented by L.Y. Spear in 1906, provided communication between the ballast tanks, ballast pump, and the sea.¹⁵⁴ The fairing labeled ‘20LB PLATE PERFORATED WITH ½” D. HOLES’ was located under the valves which controlled flooding and draining of the main ballast tanks at frames 47-53; the perforated plate provided free communication with the sea while protecting the critical valves. The watertight section of the duct keel could also be flooded to improve stability.

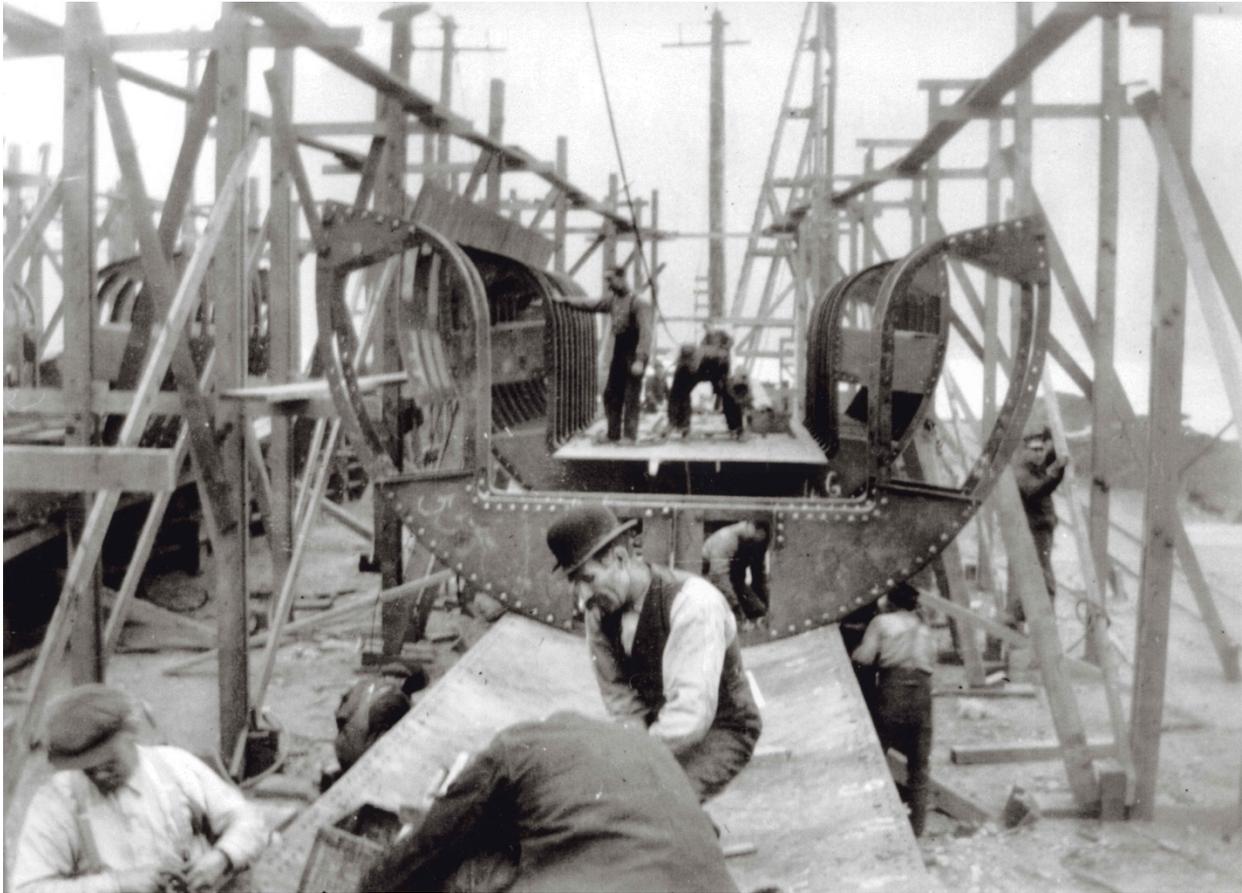
Figure 54. Framing in progress.

Once the keel structure was in place, the boat was framed and plated. Frames were fabricated and installed in sections, with the distance between the frames being approximately 18 inches (457 mm). This close frame spacing and thick hull plating gave the boats a 200 foot (61 m) maximum operating depth. Lower frames, seen in the foreground of the image below, were set on the keel plate and riveted in place (Figure 54).

Hull plating is shown attached to the section aft of frame 46. This manner of construction fitting plates to frames early in the assembly sequence both stiffened the assembled frame sections and provide additional structure upon which to secure the upper frames. Hull plates were identified by letter, with the A strakes adjacent the keel plate, and the B and C strakes continuing up the sides of the hull, finishing with the D strake at the top of the hull.

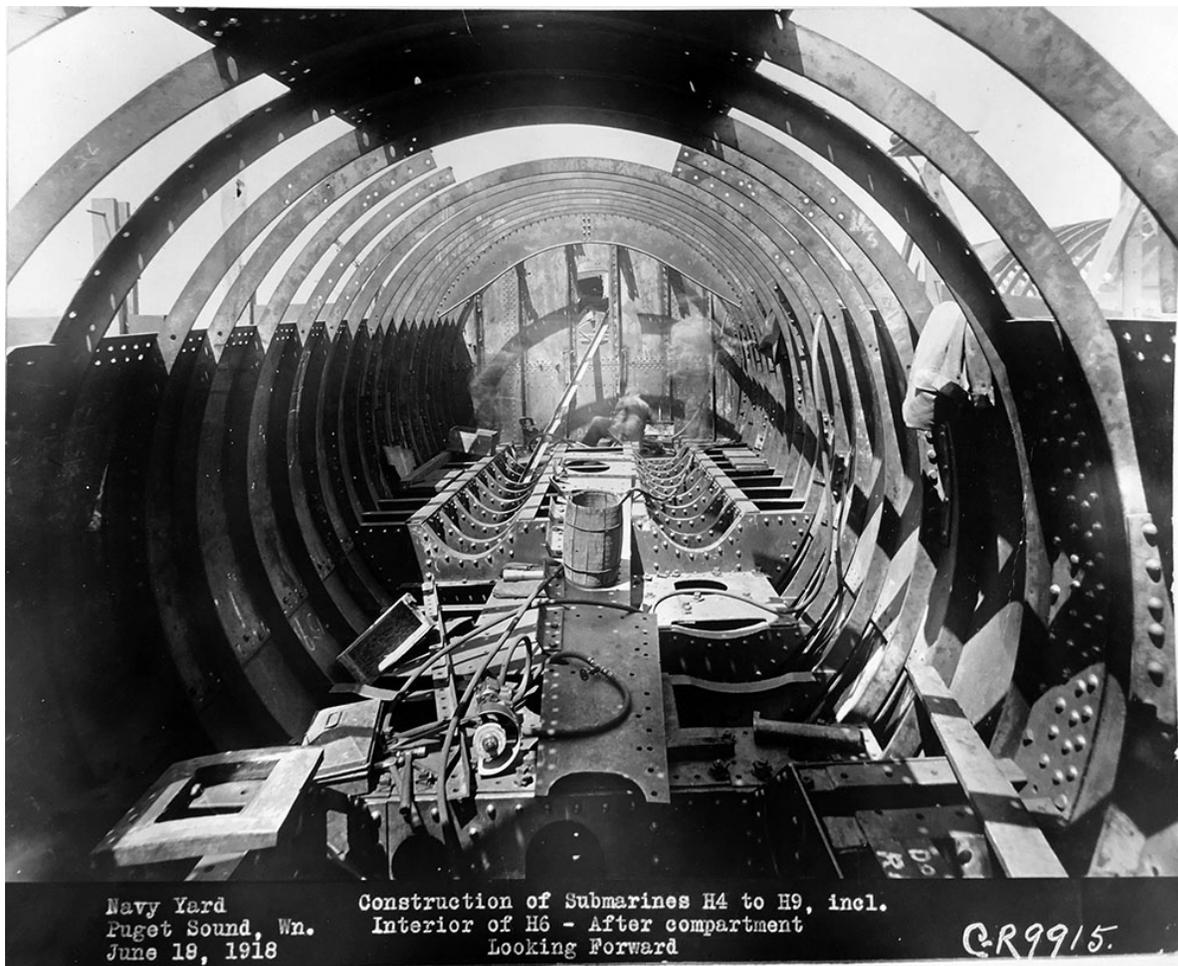
Figure 55. *H-6* Engine Room.

Installation of the upper frame sections and the C and D strakes of hull plating likely proceeded in an interrupted fashion to facilitate installation of major equipment (Figure 55). This image shows two types of upper frames; those in the foreground form an uninterrupted arch supporting the D strake, while the partial frames, located above the foundations for the diesel engines, are drilled for rivets to facilitate installation of an upper section to close the arch, presumably following the installation of major engine room equipment.

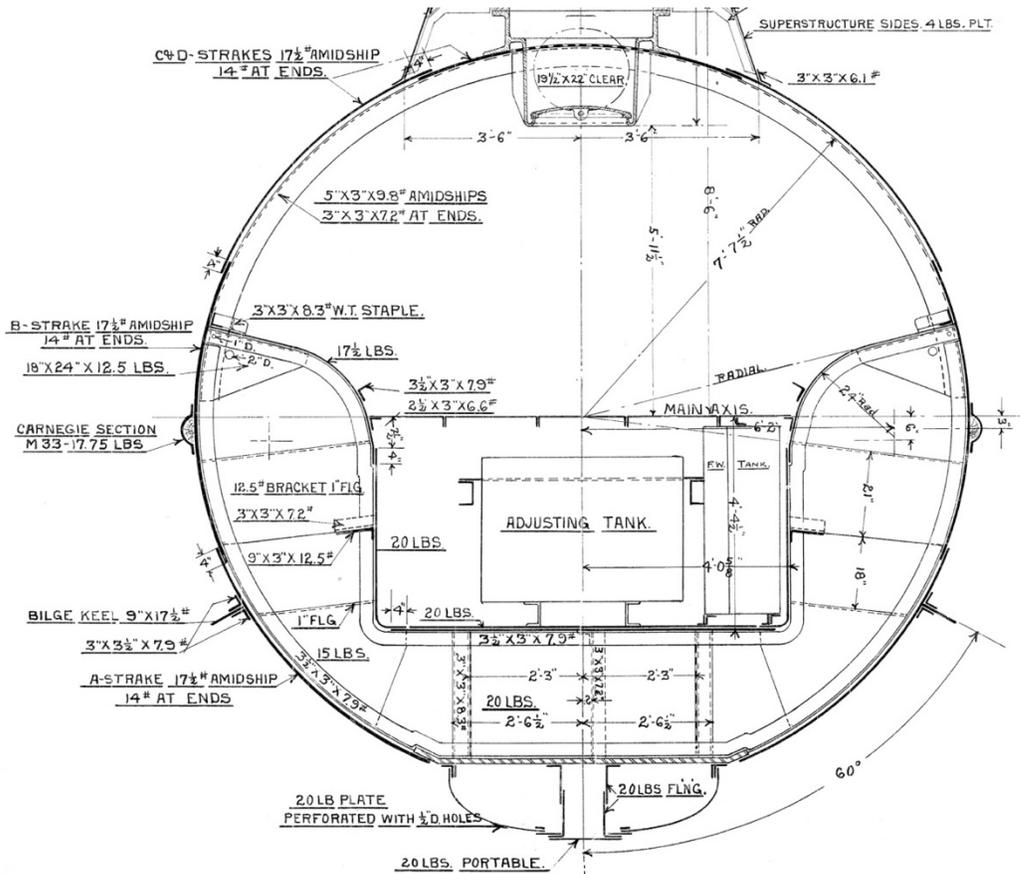
The overlapping horizontal join of hull plates and the sequencing of hull plate installation can be deduced by observing which plate overlaps which (Figure 56). The B strake, overlapped by both the A and C strakes, was the first to be installed and was likely followed by the A strake to enclose the bottom. The C strake could not be installed until the D strake was in place as it overlaps both the B and D strakes. Both the C and A strakes would have required a filler strip, called packing, be installed between the frame and plate as neither the frames nor the plates appear to have been joggled.¹⁵⁶

Figure 56. H-1 midships section.

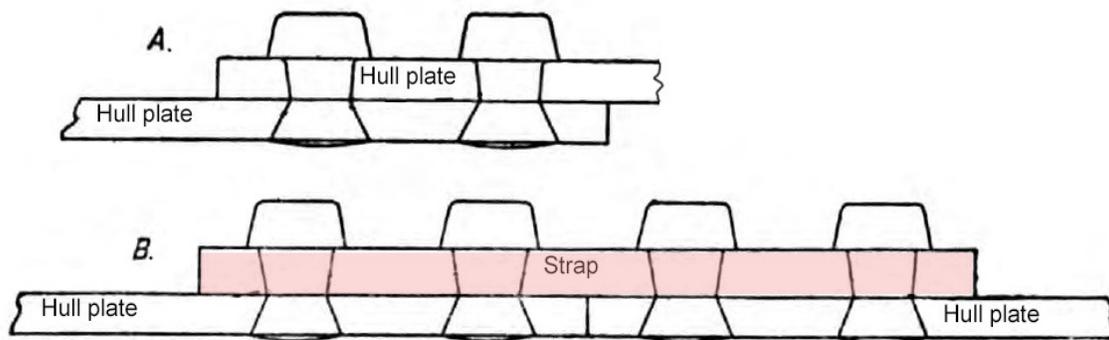
Figure 57. Butt lap and butt strap connections.

The types of joints used to join the hull plates were the double riveted butt lap (detail A below), joining horizontal edges of adjacent hull strakes, and the double riveted butt strap (detail B), joining vertical edges of sections of hull strake (Figure 57).¹⁵⁸ The strap was affixed on the internal surface of the hull strakes. Both riveting patterns are visible in Figure 55, the double riveted butt strap (image lower right) appears to use a zig-zag pattern, improving the strength of the join.

Rivets were used to mechanically join the plates. A red-hot rivet was inserted through holes in the plates to be joined, the rivet was then compressed until it both filled the holes and had a mushroom-like shape on the point. Unfortunately, the details of riveting process are not known. Hand riveting was time consuming and was not appropriate for large rivets or pressure tight applications. Hydraulic riveting presses, in use in large shipyards at the time, were too large to be effective in the cramped interior of the submarine hull. Pneumatic riveting hammers, in common use in shipyards, better fit in the confines of the submarines, making them the most plausible option.¹⁵⁷

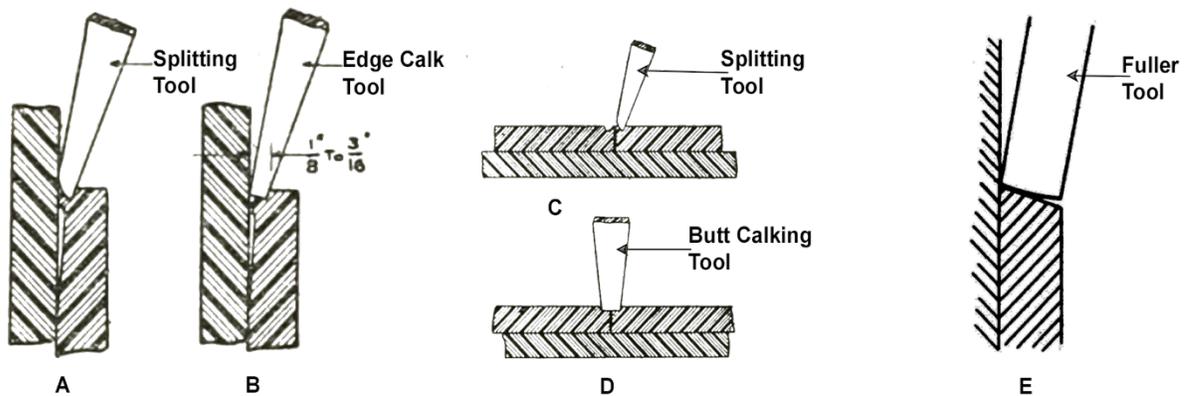
Figure 58. Caulking and fullering.

Riveting alone would not always produce a watertight seam; this was typically accomplished by caulking or fullering, these finishing methods are illustrated below (Figure 58). In the context of finishing methods used in the assembly of H-Class submarines, caulking refers to the practice of striking the edge of the steel, first with an angular faced splitting tool which nicked the edge of the plate, followed by striking the same surface with a flat faced edge calk tool or butt calking tool, the resulting distortion creating a watertight seam.¹⁵⁹ Fullering, a similar practice, used an iron of comparable width to that of the plate, developing a smoother edge.¹⁶⁰

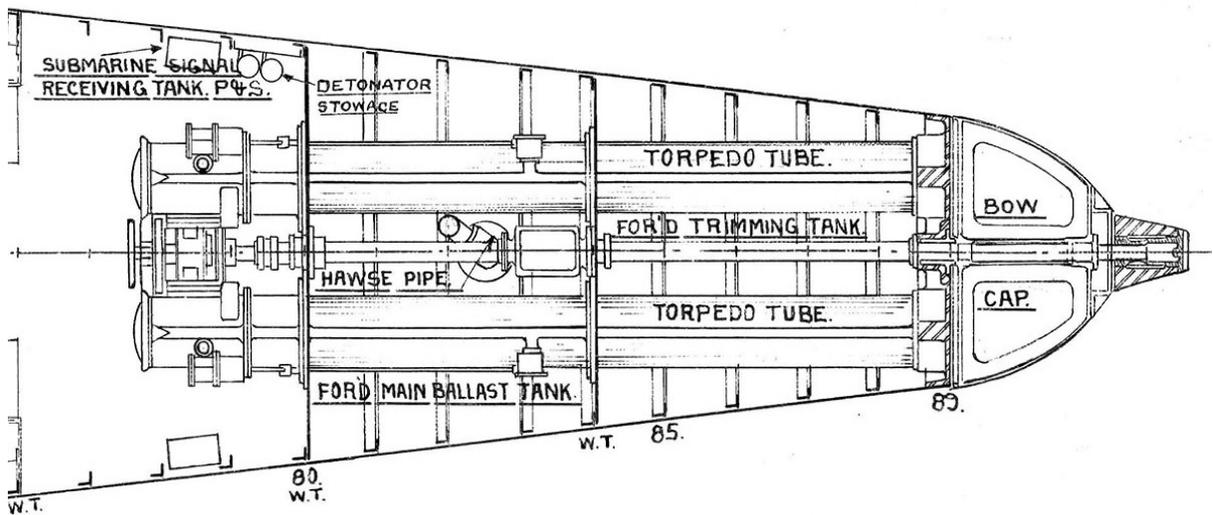
Forward and aft watertight bulkheads at frame 10 and frame 80 closed the ends of the habitable section of the pressure hull but framing and plating continued fore and aft, incorporating the tanks and castings which finished the bow and stern. The bow was composed of a bow casting at frame 89, a rotating bow cap through which the torpedoes fired, and stem pieces (Figure 59).

Figure 59. Plan view of H-1 bow section.

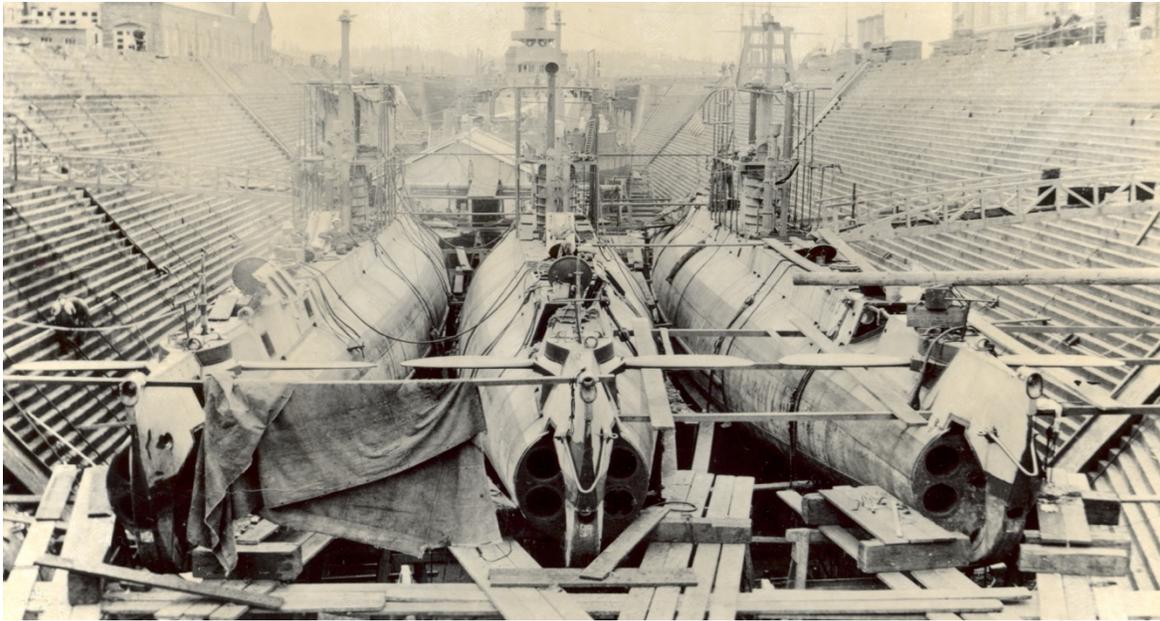
The bow caps have been removed from the H-Class boats in the image below, leaving the stem pieces and bow casting visible (Figure 60). The bow casting supports the forward ends (muzzles) of the four torpedo tubes and the operating shaft for the bow cap which runs through the center penetration visible on *H-3*, the submarine to the right.

Figure 60. H-Class drydocked in Puget Sound Naval Shipyard.

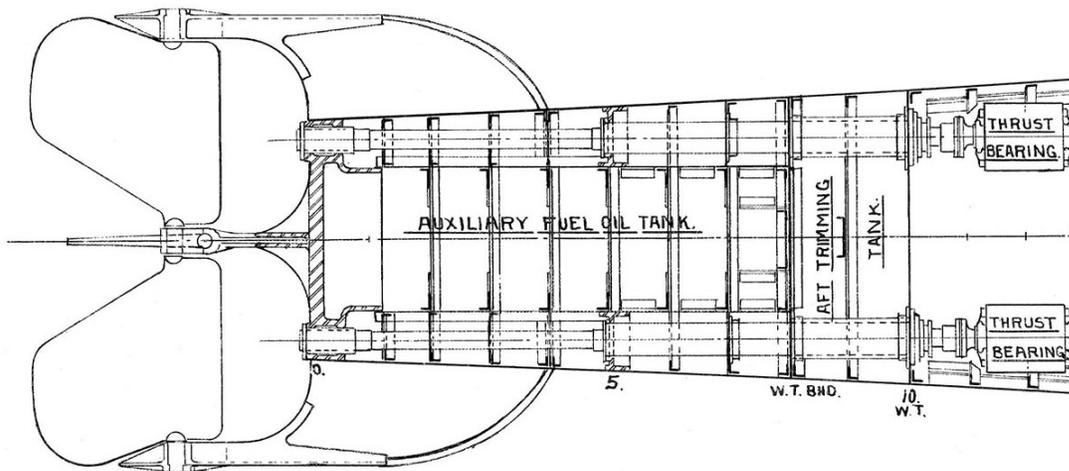
Figure 61. Plan view of *H-1* stern section.

The figure above shows the stern castings which supported the stern tubes (frame 5) and cutlass bearings (frame 0), through which the propulsion shafts passed, and provided strong mounting surfaces for the rudder and stern planes (Figure 61). The vertical section of casting shown below provides an indication of the size of the rudder and its position relative to the ship's screws which mounted on the propulsion shafts nearly flush to the stern tube through which the shafts pass (Figure 62).

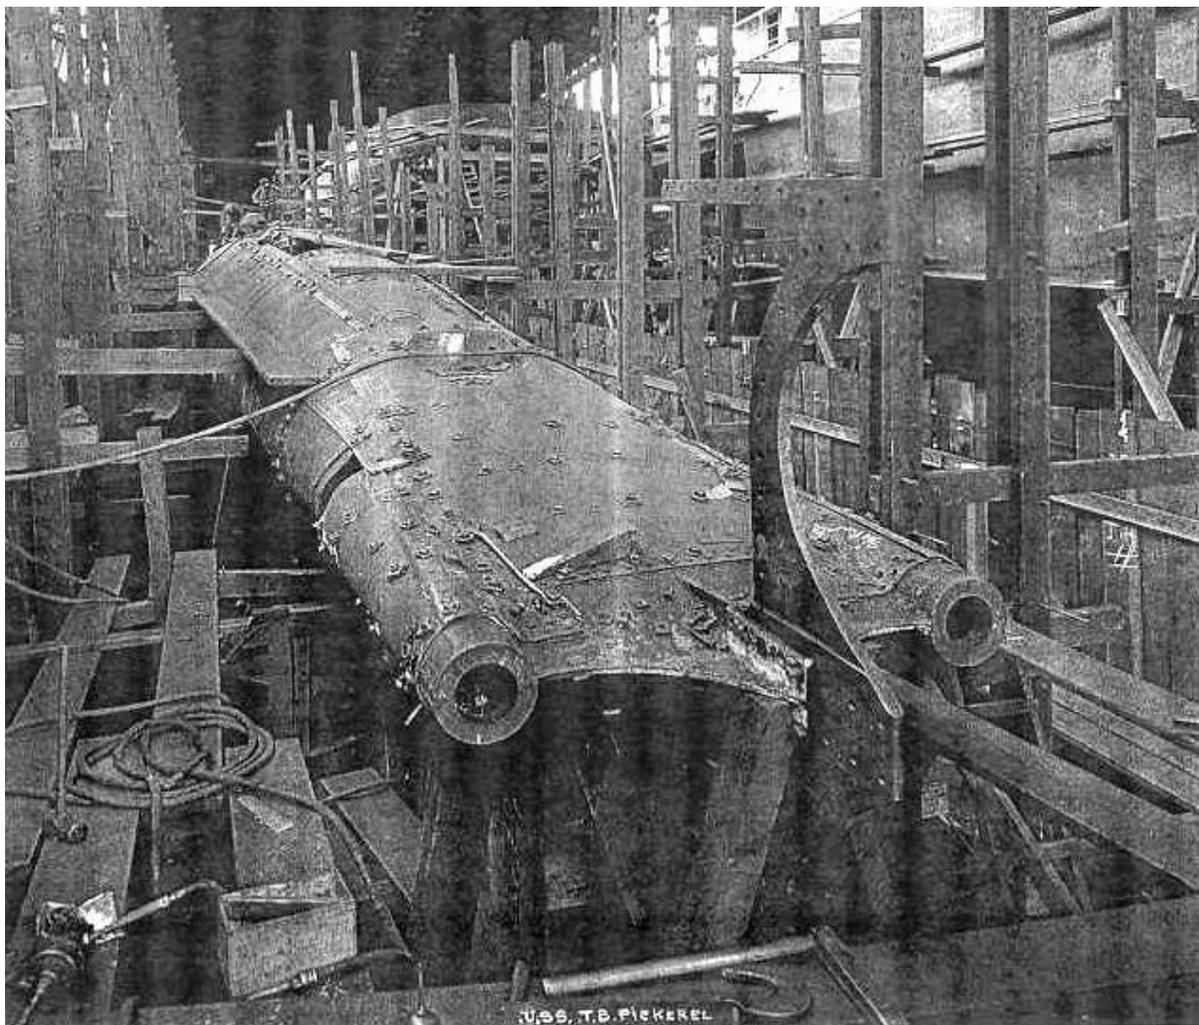
Figure 62. Stern view of *Pickerel* in Union Iron Works.

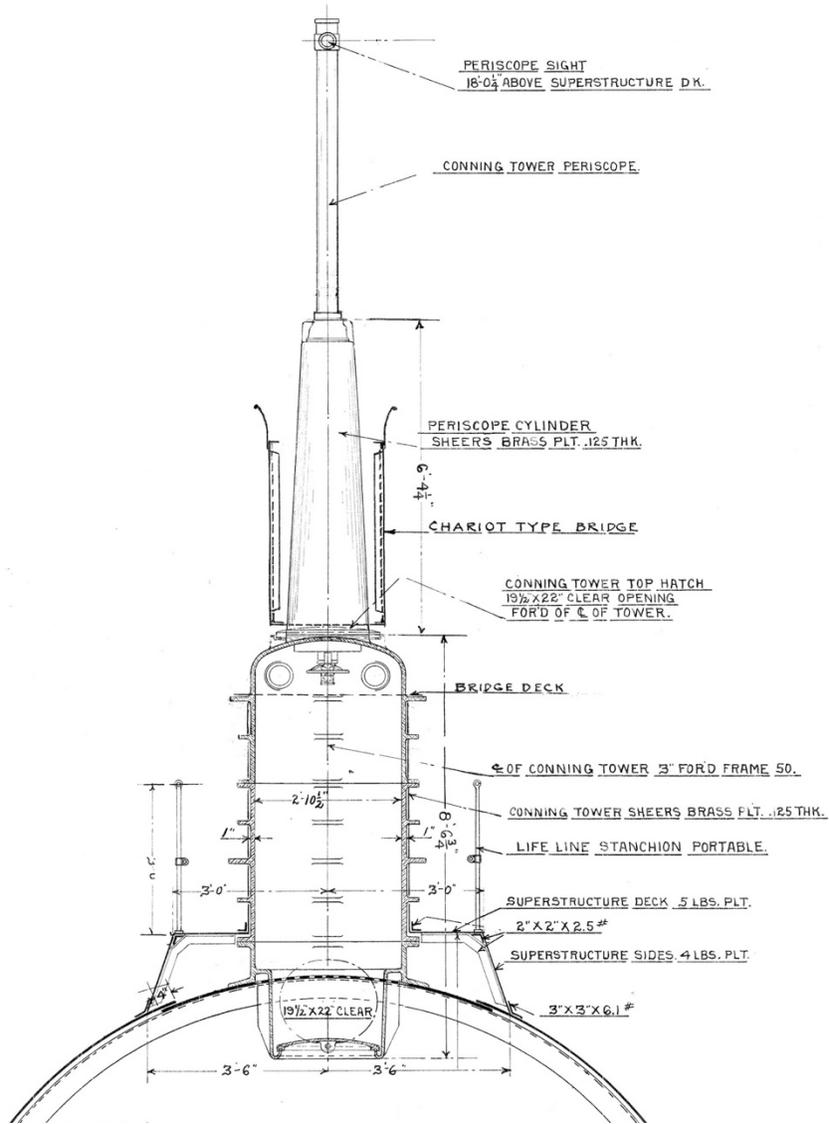
The conning tower, an isolated pressure tight space, was made of non-ferrous metal (brass) 1 inch (2.5 cm) thick; the choice of material improved the performance of the magnetic compass. Ship's drawings show it cast in three segments: a lower section which provided a flanged interface to the hull and contained the control room access hatch, a middle section, and a top section which contained glass deadlights and the upper hatch (Figure 63).

Figure 63. H-1 conning tower detail.

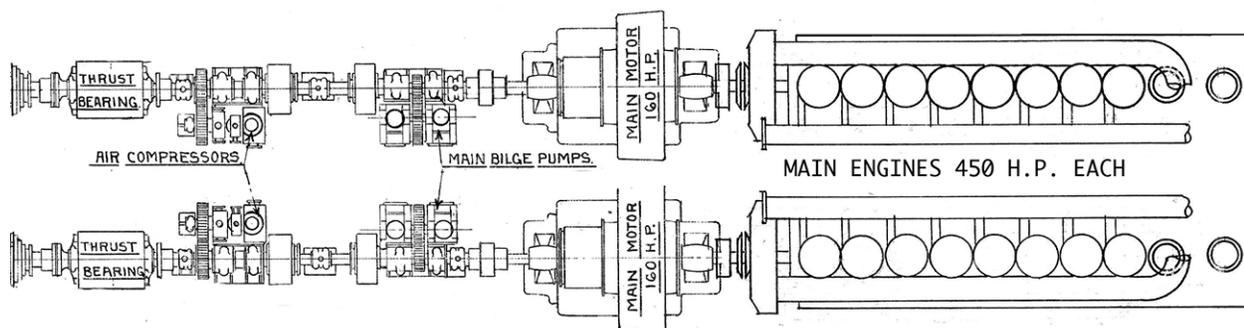
Figure 64. *H-1* propulsion system, batteries not shown.

The propulsion and auxiliary system was comprised of four subsystems: main engines, direct current motor generators, storage batteries, and auxiliary shaft line components (figure 64).

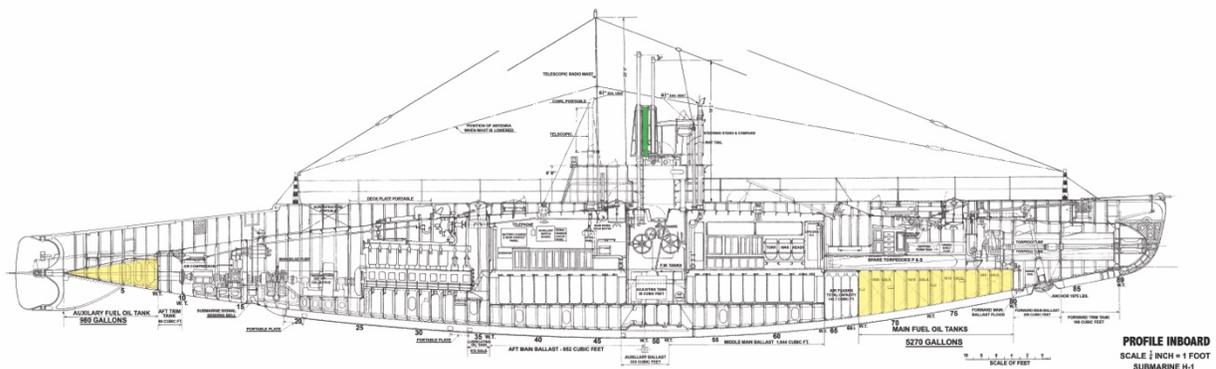
Diesel fuel for the main engines, totaling 6250 gallons (23,659 l), was stored in five tanks located within the pressure hull. The four forward Main Fuel Oil Tanks' total capacity was 5270 gallons (19,949 l) and the aft Auxiliary Fuel Oil Tank capacity was 980 gallons (37,10 l); in the figure below, fuel tanks are highlighted in yellow.

Figure 65. *H-1* ventilators and fuel oil tanks.

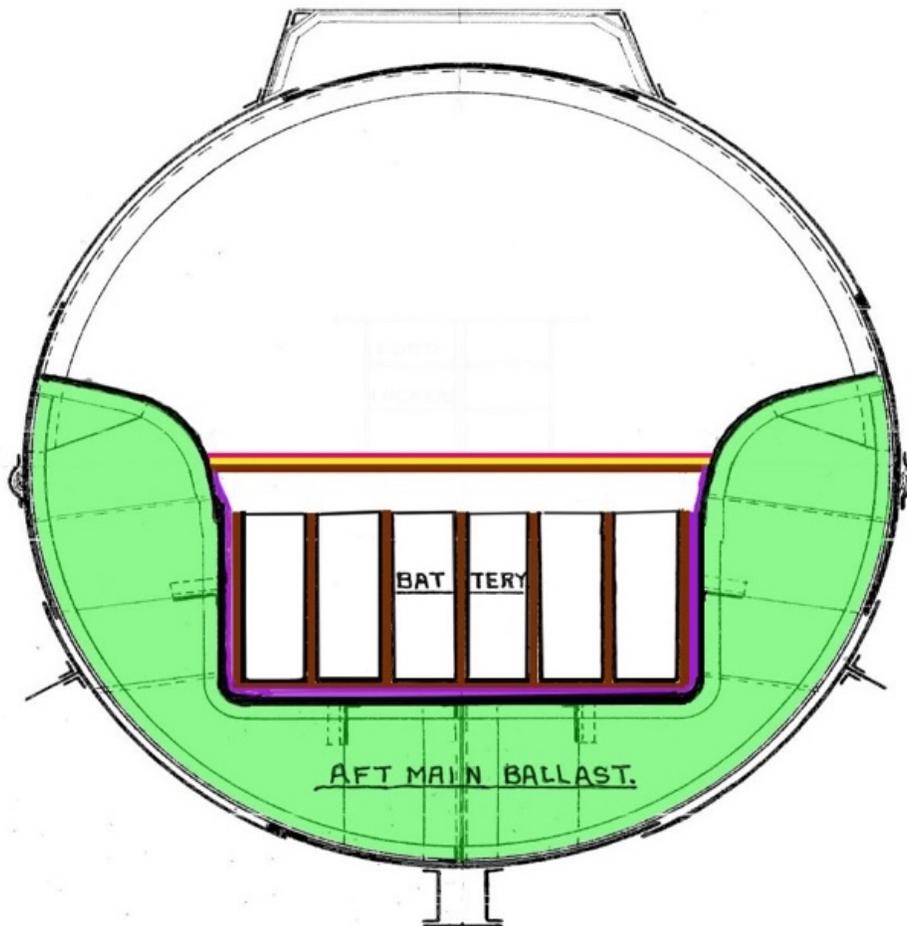
Figure 66. H-1 aft battery well.

In an effort to manage these risks the batteries were installed in tightly sealed tanks, called battery wells, under the decks in the forward and aft battery compartments (Figure 66).

The outer boundary of each well, which also comprised the inner wall of the main ballast tank, was of steel plate coated with bituminous composition (coal tar). Lining the steel, as shown in Figure 66, was a layer of lead (purple); wood (brown) was used to separate the cells from each other, the tank walls and deck, and provide a structural deck above the well. This wooden deck

was covered in sheets of rubber (yellow) and a layer of shellacked canvas (magenta).¹⁶⁹ This construction worked under normal circumstances but failed to prevent seawater intrusion in cases of flooding, resulting in fires due to catastrophic battery failure and the release of chlorine gas.

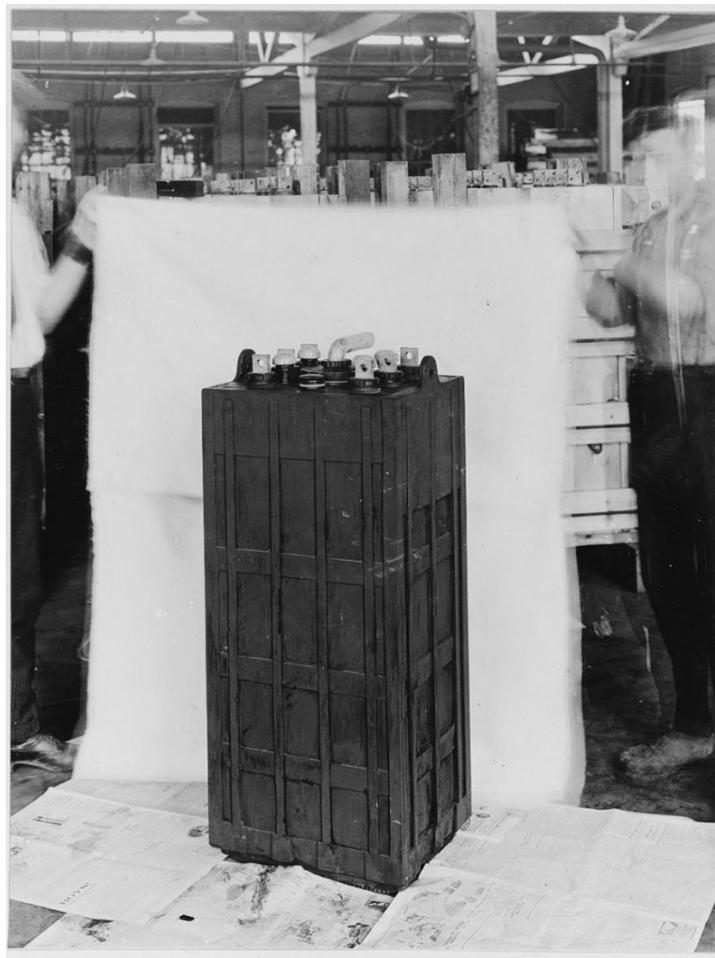
The forward and aft batteries were each composed of sixty lead acid cells (Figure 67). The cells are best described as large rectangular jars made of hard rubber. Each cell contained positive plates, made from lead peroxide, and negative plates of purified lead.

Figure 67. *H-1* battery cell.

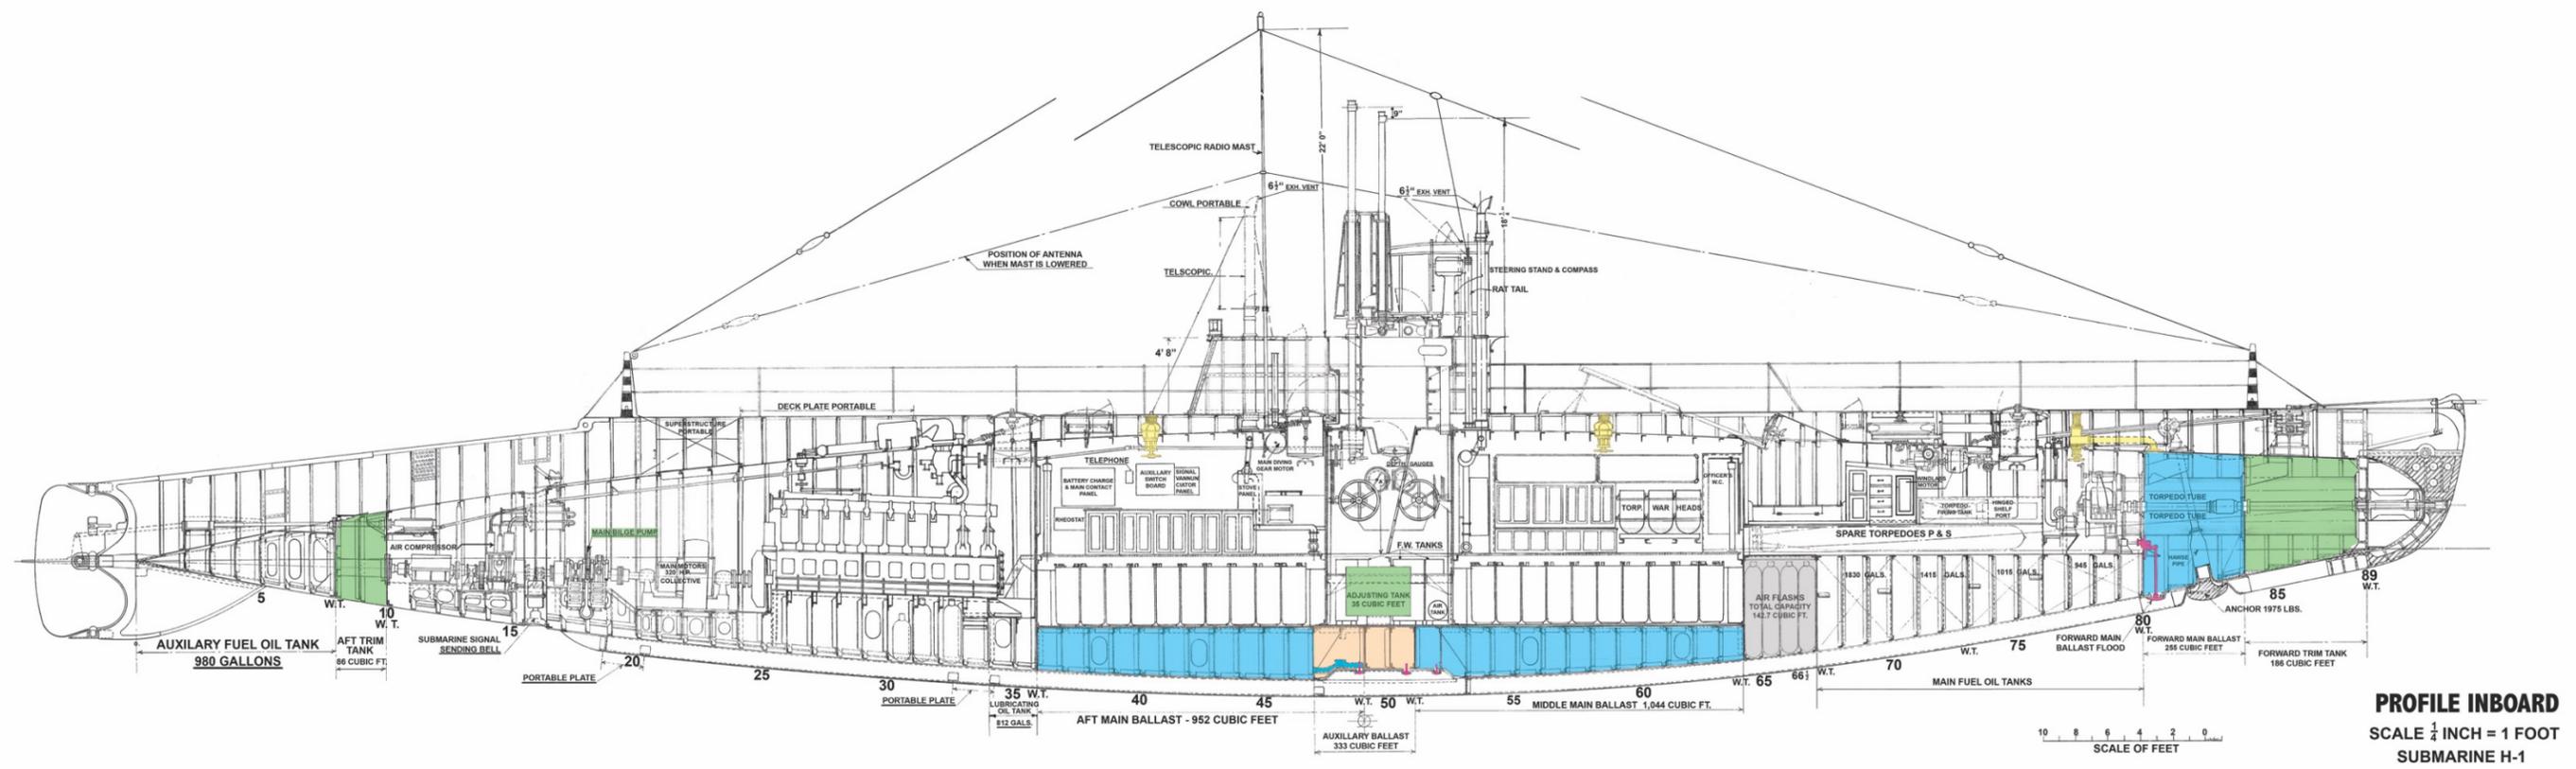
Figure 68. H-1 ballast and trim.
