THE HISTORY OF H-CLASS SUBMARINES AND ARCHAEOLOGY OF THE
SUBMARINE USS *H-1*
(EX *SEAWOLF*) (1913-1920)

A Dissertation

RICHARD HANSON HENDREN

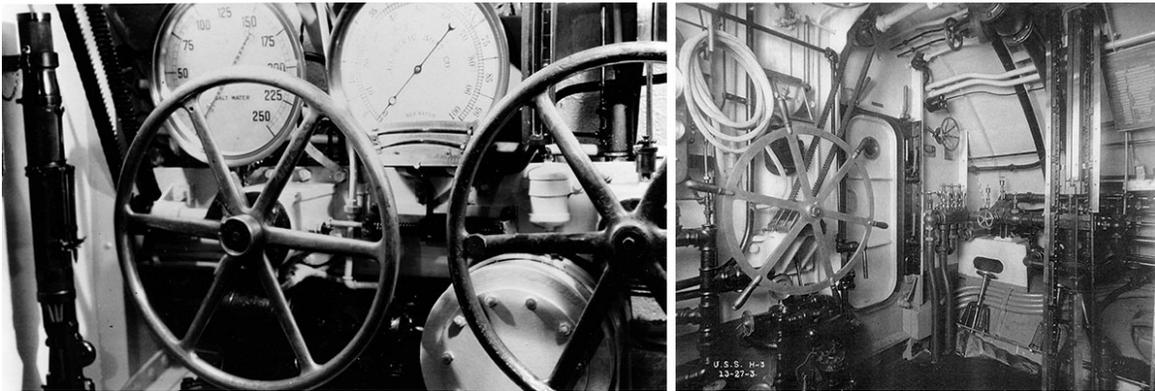
image shows the diving station of *H-5*, located on the port side of the control room; the hand wheels control the bow and stern planes. Between the wheels are coarse and fine clinometers measuring the inclination of the boat, referred to as the bubble in submarine vernacular, and deep and shallow water depth gages. The right image shows the helm of *H-3*. A drive chain can be seen going from the wheel to the rudder shaft in the overhead, and the steering motor lies aft of the visible shaft. The mirror mounted on the bulkhead, just above the wheel, allowed the helmsman to view the compass.

Figure 70. H-Class diving and steering stations.

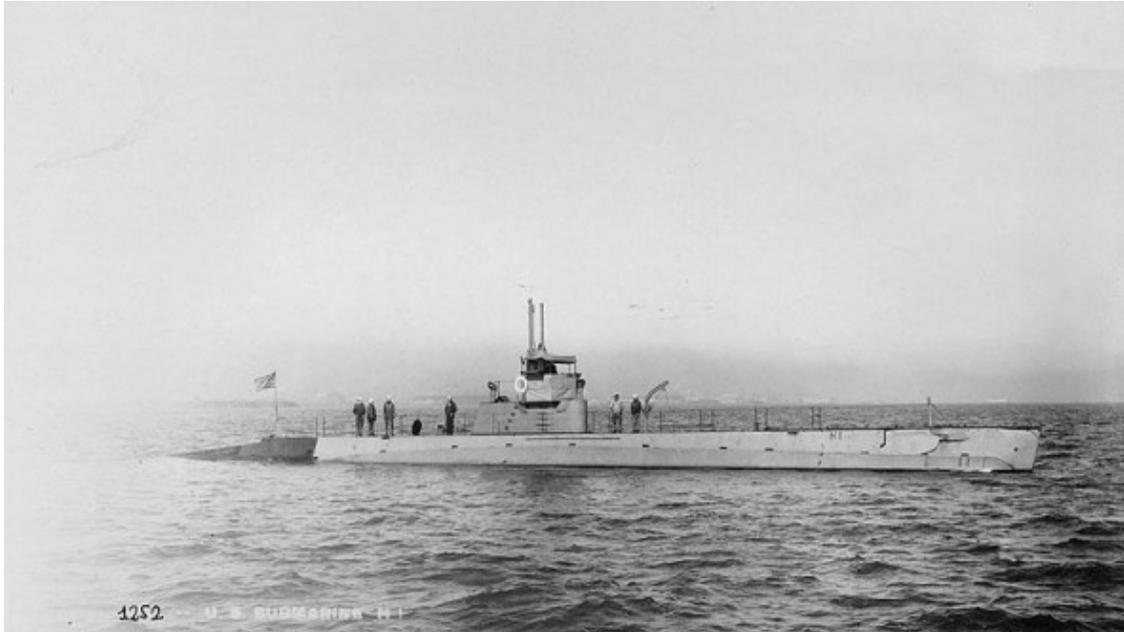
Figure 71. *H-1* canvas bridge.

were equipped with a large pole awning and canvas bridge skirts to protect the men on watch and reduce the possibility of taking water down the open hatch (Figure 71).

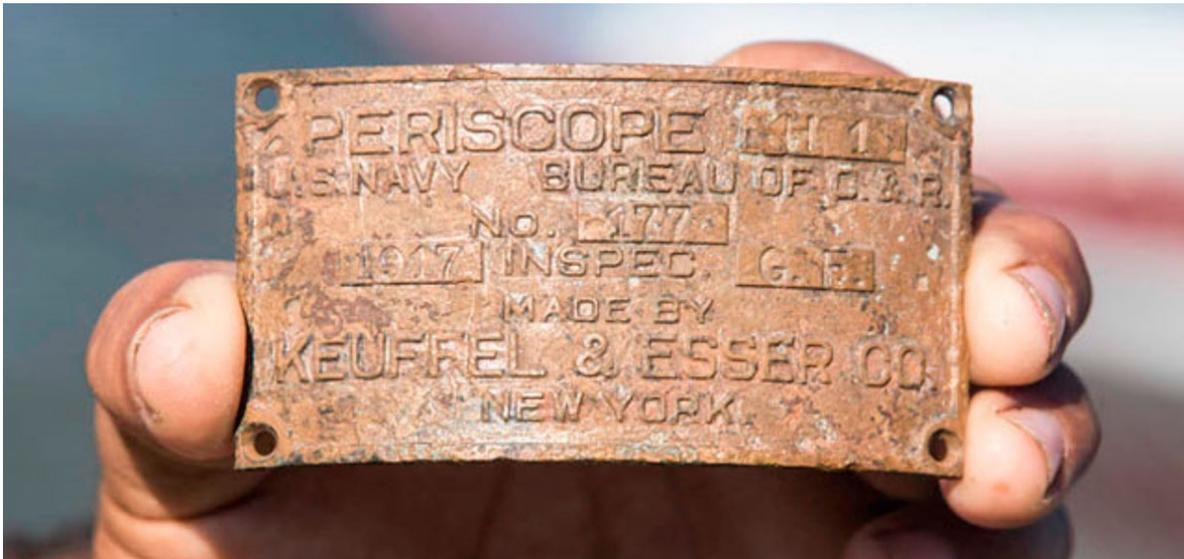
Figure 72. *H-1* periscope name plate.

A name plate, recovered by fishermen in Mexico indicates that one of the periscopes in *H-1* was manufactured by the Keuffel and Esser Company of New York was a retrofit dated 1917, (Figure 72).

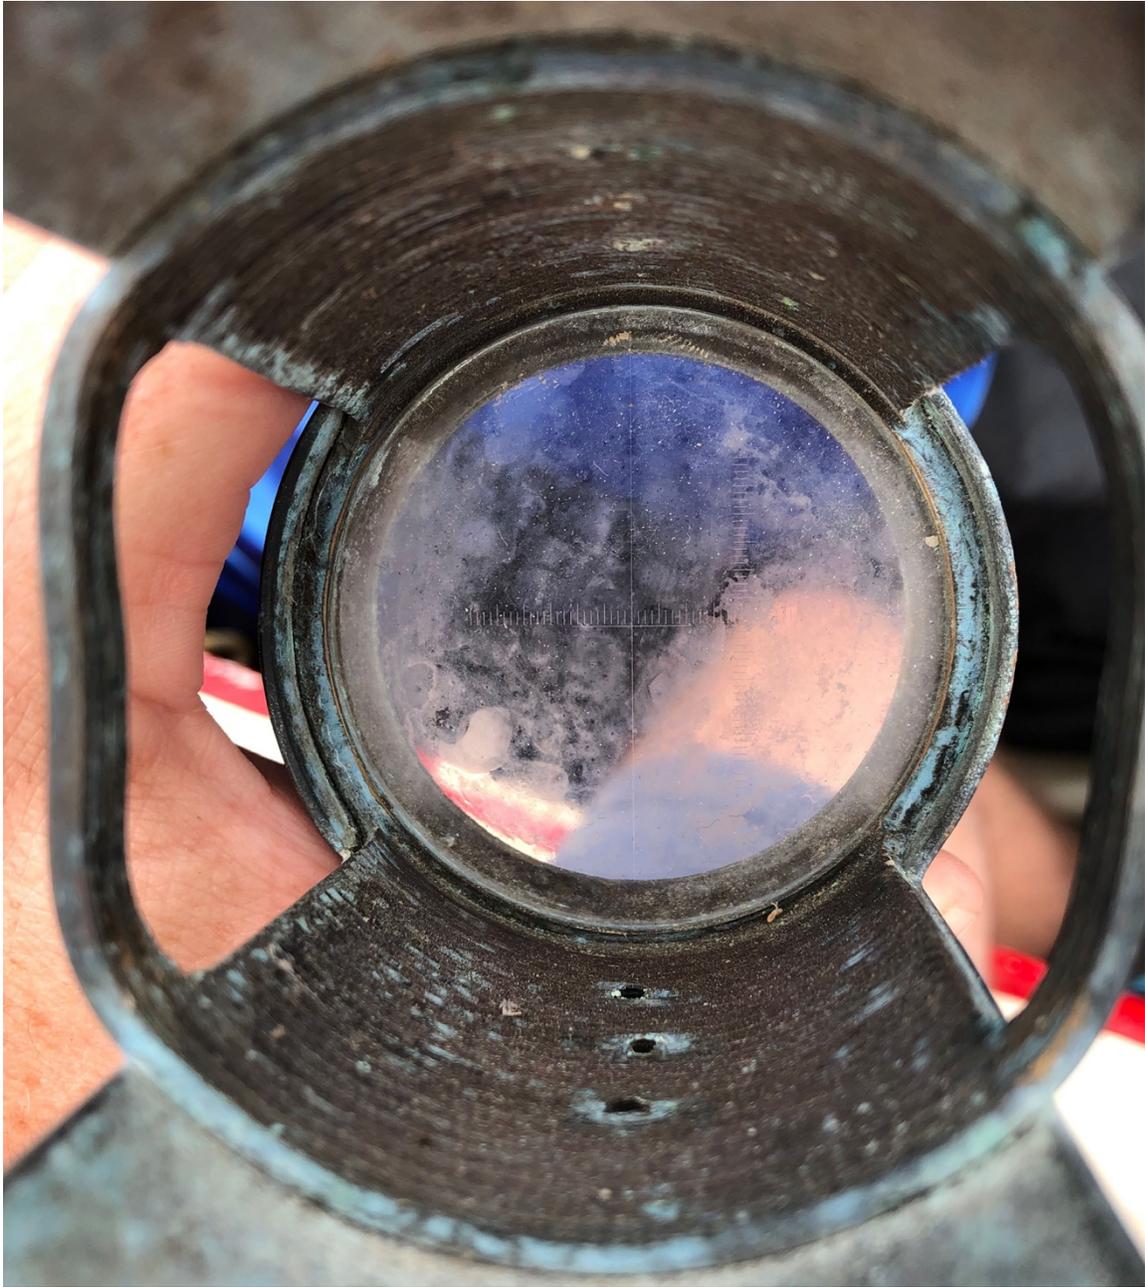
Another *H-1* periscope artifact, the portion of the periscope tube containing the telemeter lens etched with vertical and horizontal gradations, was returned by local fishermen in Mexico. The gradations indicated degrees of true field (Figure 73). Range to an object was critical both in navigation and weapons employment and the telemeter allowed submariners to estimate the range to a ship or structure based on the number of degrees of field occupied by the object, if the target object's height or length were known. It also provided a method of measuring bearings to terrestrial objects; these bearings could be referenced to either the magnetic or gyrocompass, and could then plotted on the navigation chart, to establish or "fix" ship's position.

Figure 73. *H-1* telemeter lens.

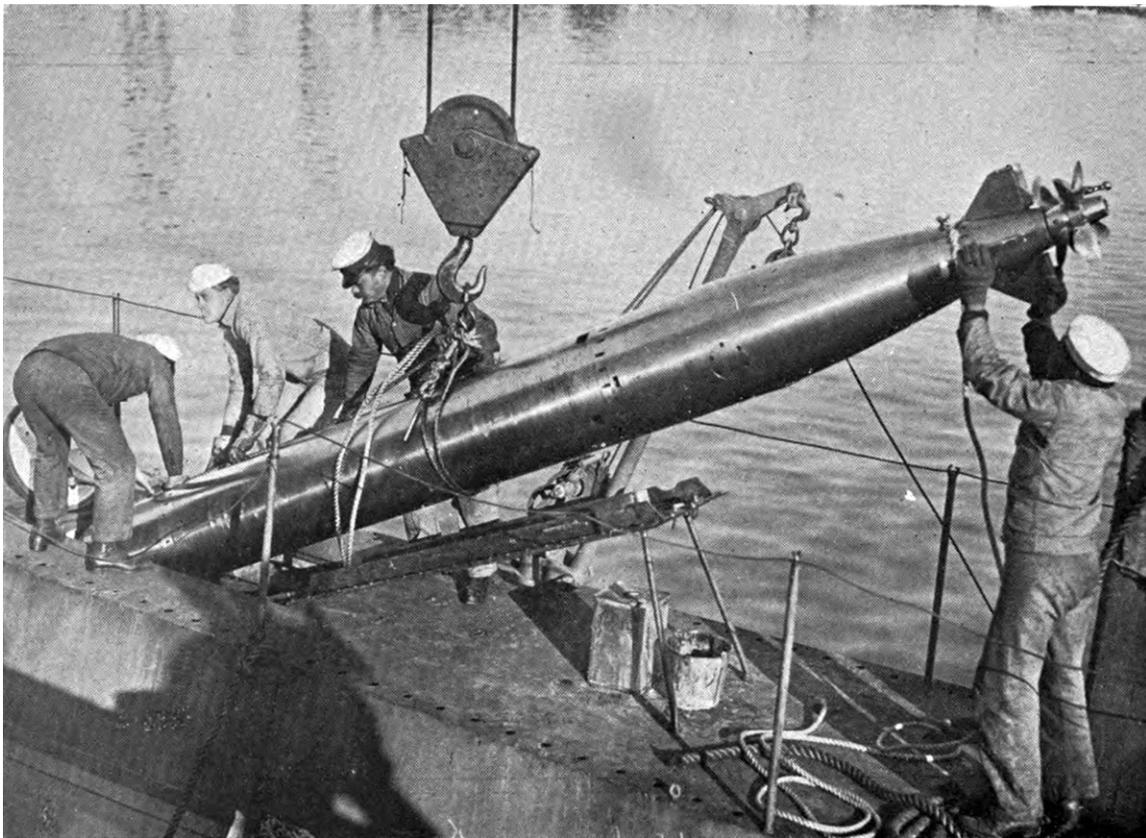
Figure 75. K-5 loading torpedo.

Torpedoes were loaded into the boat via the torpedo loading hatch located forward of the sail. In preparation for loading torpedoes, a temporary skid was mounted in the hatch. A crane was used to lift the torpedo onto the skid where it would be secured by straps. A strap would then be wrapped around the back of the torpedo and the handling crew would lower the torpedo into the torpedo room, using the deck mounted davit and block and tackle (Figure 75).¹⁸¹

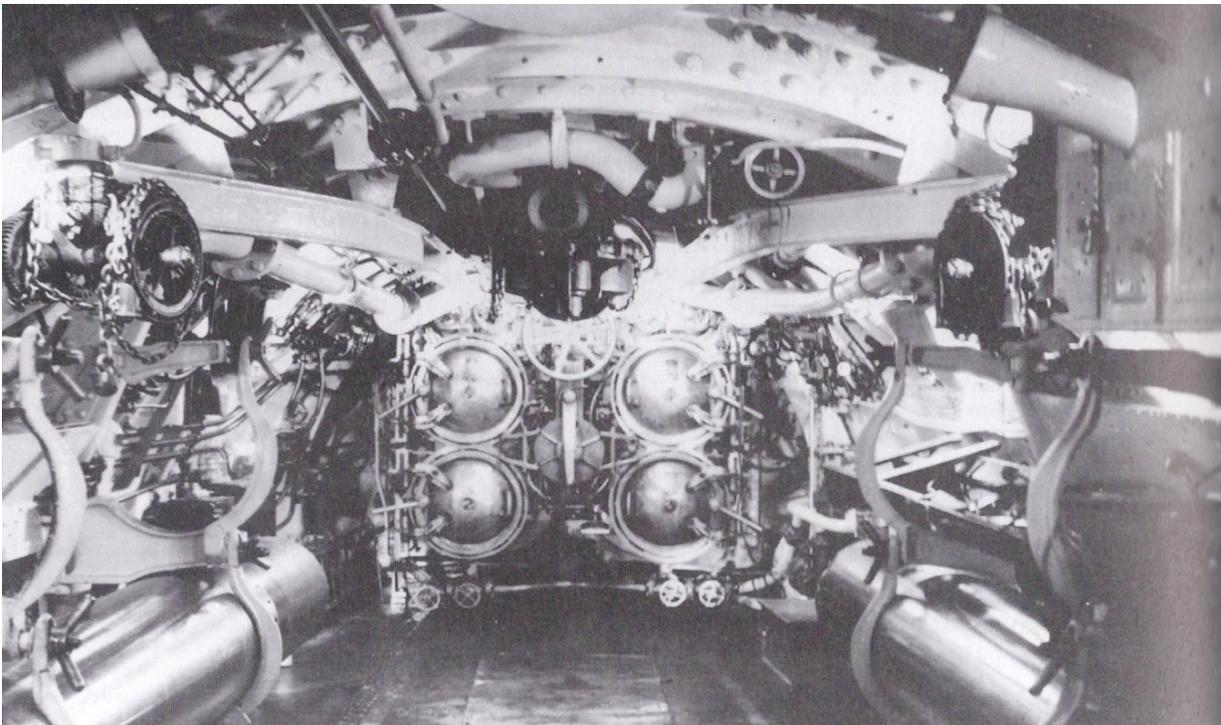
If eight torpedoes were to be carried, four were loaded into the tubes using the chain falls and rails seen in the upper part of the image (Figure 76). Prior to loading either an exercise or explosive warhead would be fitted, maintenance checks conducted, and the torpedo coated liberally with grease to protect it. Depending on circumstance (war or peacetime) spare torpedoes could be stowed, with or without warheads installed, in the cradles seen at the bottom of Figure 76.

Figure 76. *H-5* Torpedo Room.

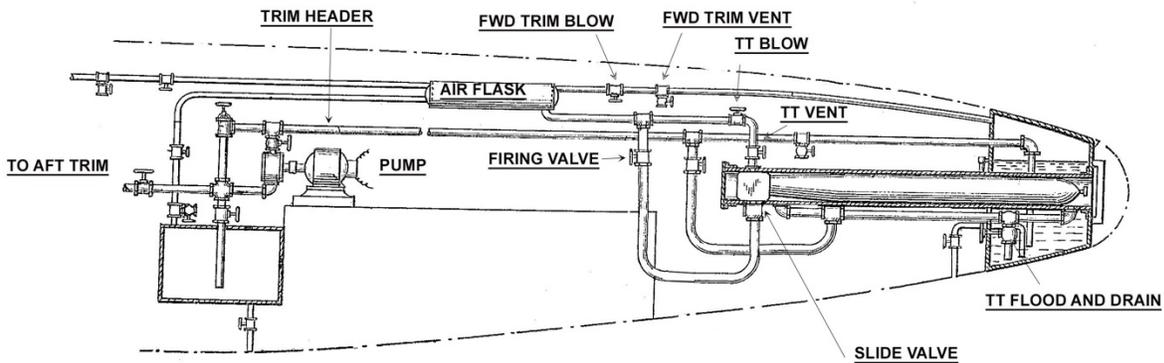
Figure 78. Torpedo tube plumbing schematic view.

Figure 78, developed using L.Y. Spear's 1911 patent # US997713A, is provided to illustrate the torpedo tube firing cycle. This illustration presents a simplified schematic depiction of a single tube and the associated plumbing for air and water.

The torpedo tubes functioned much like a breech-loading smooth-bore cannon. Both cannon and torpedo tube were crew-served weapons, requiring a dedicated team to load and fire them. They differed in the stored energy used to impulse the projectile; cannons used gunpowder, and torpedo tubes used compressed air. Lastly the torpedo after firing was self-propelled, whereas the cannon ball was not. A significant concern for a submarine firing a torpedo was the necessity to manage the post-launch environment of the torpedo tube for the sake of maintaining diving trim.

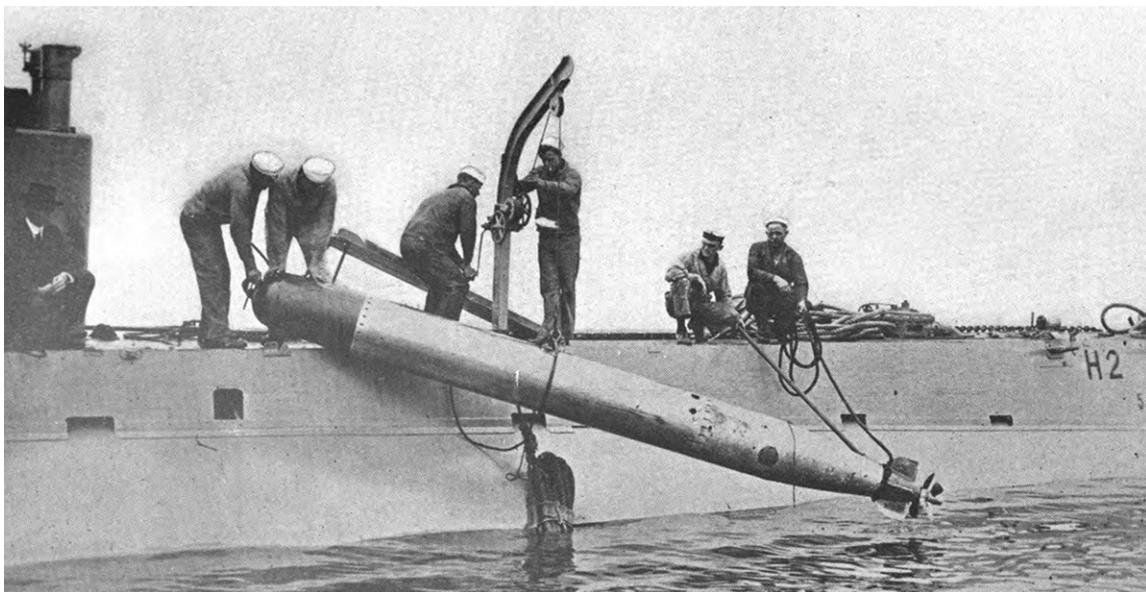
Figure 79. *H-2* retrieving exercise torpedo.

The boats were often responsible for recovering their own exercise torpedoes at sea. Just as with loading torpedoes in port, the davit and strap method was used to recover exercise torpedoes after their use. Once the torpedo was located, and if no boat was available from the target ship, an able swimmer jumped into the water with a rope to lasso the torpedo, a task which was likely complicated by the well-greased state of the torpedo. Once captured, the torpedo was lifted aboard using the hand-cranked winch on the torpedo loading davit where it was either lashed to the deck or returned to the torpedo room (Figure 79).

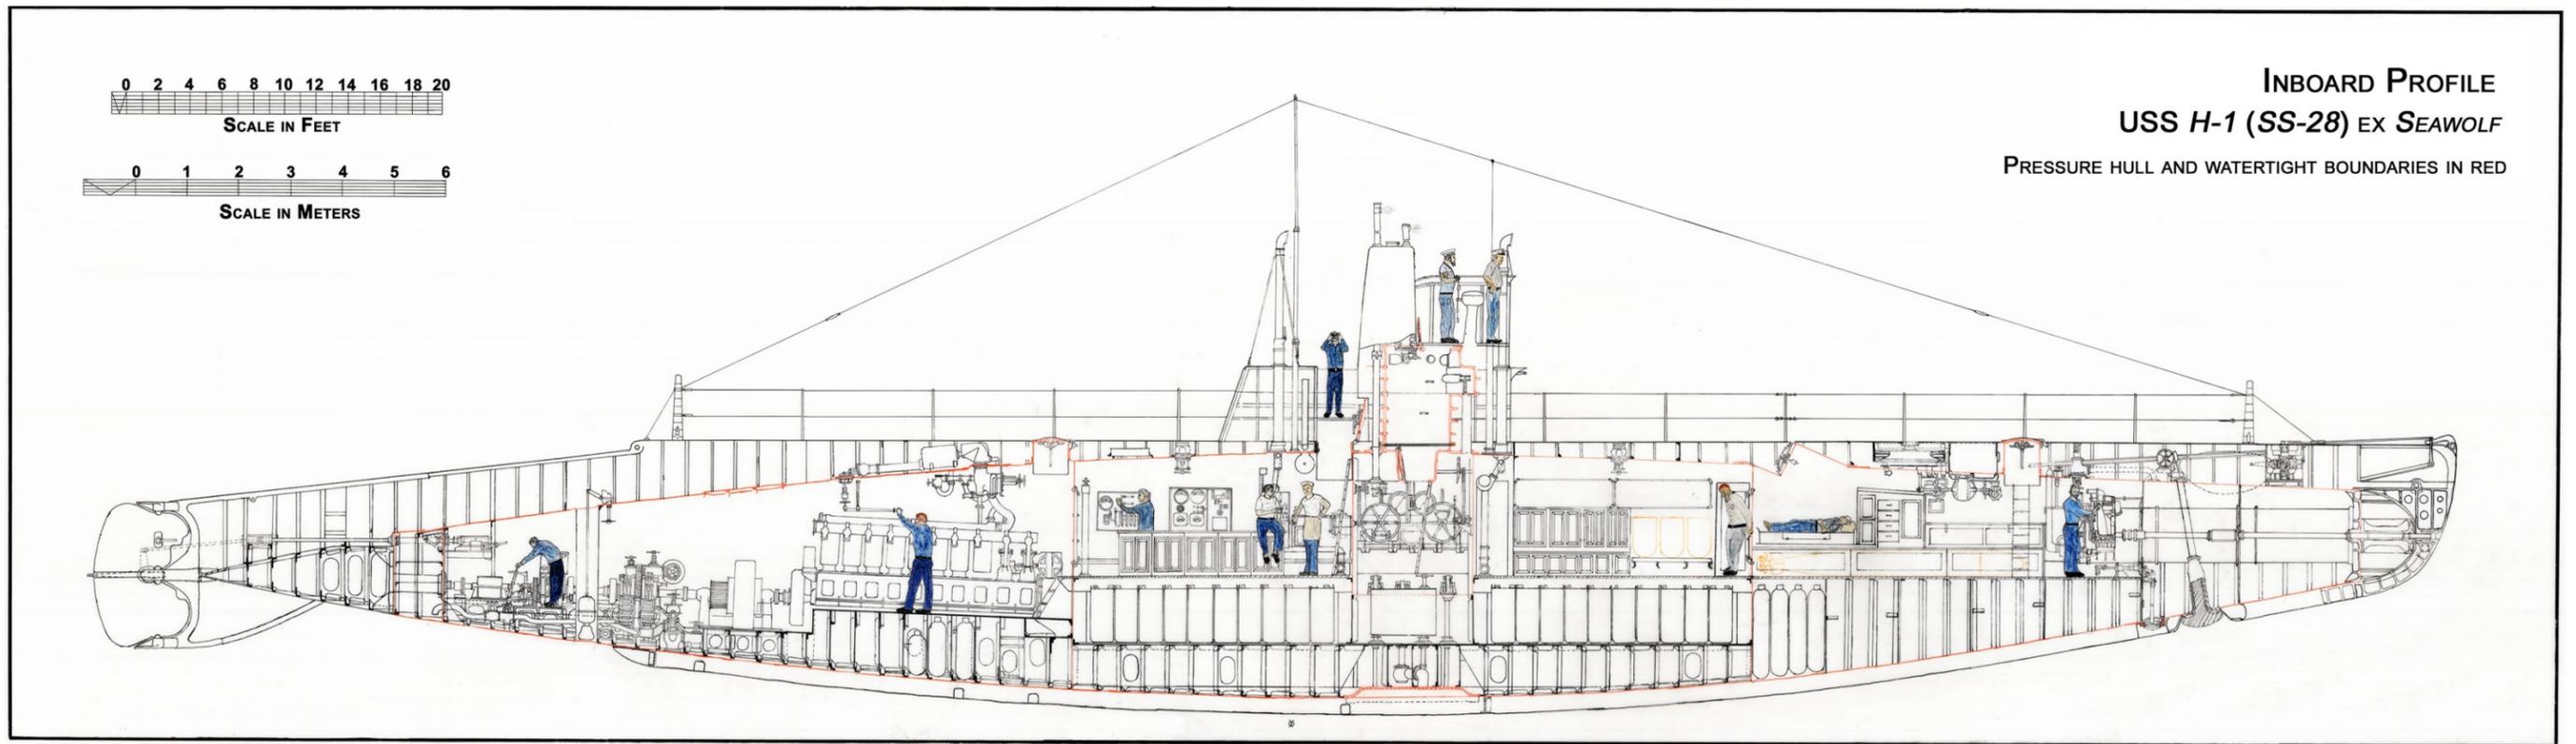
Figure 80. Life aboard USS *H-1*.

Habitability on submarines was apparently the least concern of naval architects. Although propulsion, navigation, weapons, and communications systems are meticulously fit into the boat naval architects seemed to overlook the reality that the people needed to operate the boat also needed to live on board. Consequently, crew accommodations were so spartan that the early classes of submarines came to be known as “pigboats.” Figure 80, on the following page, depicts the cramped life aboard the boats.

The H-Class boats typically sailed with a crew of 25, comprised of a Commanding Officer (CO), Executive Officer (XO), and 23 enlisted men. The officers each had their own bunks, with privacy curtains, located in the aft part of the torpedo room, and they shared a lavatory, mounted on the aft port bulkhead. The enlisted hands slept primarily on pipe-and-canvas bunks in the forward battery compartment. The boat was issued 18 mattresses when it was built, with the CO and XO each having their own; this left 16 mattresses for the 23 enlisted men to share.¹⁸⁸ When underway the crew was broken up into watch sections, with part of the crew sleeping or attending other tasks while the section on watch operated the boat. At watch change, the oncoming watch was awakened, ate a meal, and relieved the men on watch. The men going off watch ate their meal and crawled into the still-warm beds of the men who relieved them, a practice known as “hot racking”. The Chief Petty Officers (CPOs) may have had their own bunks and it is likely that some of the men slung hammocks where they could.

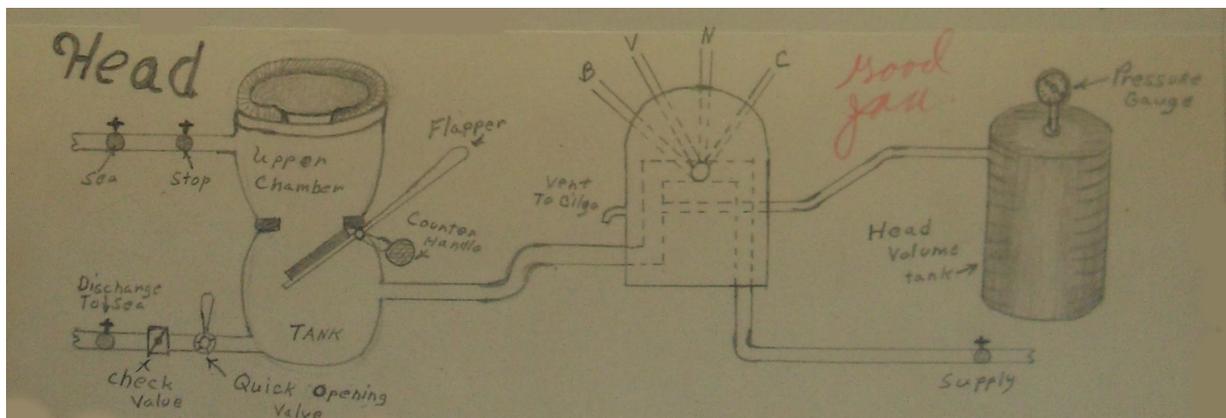
Figure 81. USS *O-1* Head.

The head on a submarine is a necessarily complex device that must perform the function of a toilet, flushing waste overboard, while keeping the sea from flooding in (Figure 81).

Research has thus far failed to uncover a drawing of an H boat head; however, a drawing from the qualification book of Robert E. Fretz details the head on USS *O-1* and is considered comparable. Flushing the head required the skillful manipulation of the valves in proper sequence, and failure to follow the procedure exactly could result in the operator wearing the contents of the bowl or water coming into the boat.

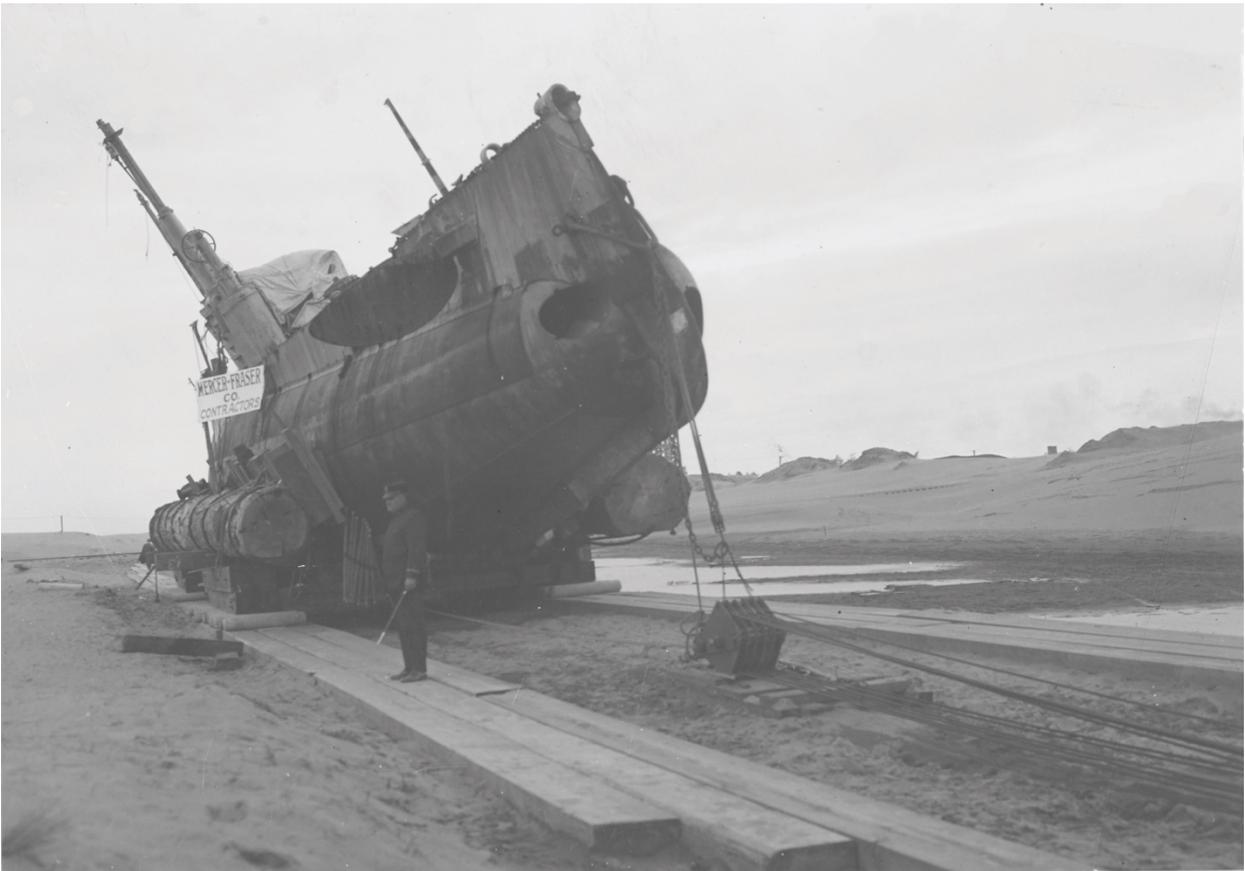
Figure 86. *H-3* overland transit.

H-3 was still stranded on the beach. James Fraser, a principal of the Mercer-Fraser Company, a local salvor of good repute, submitted a proposal to salvage *H-3* for the sum of \$18,000. Fraser proposed transporting the boat across the beach on log rollers, a distance of approximately .5 mile (.8km) and launching it into the protected waters of Humboldt Bay. The Navy accepted the bid and Fraser went to work, first lifting *H-3* which was partially buried in the soft sand and then laying a plank road and shifting it across the spit on rollers (Figure 86). *H-3* was decommissioned with a small crew assigned to look after the Navy's interests during the salvage.

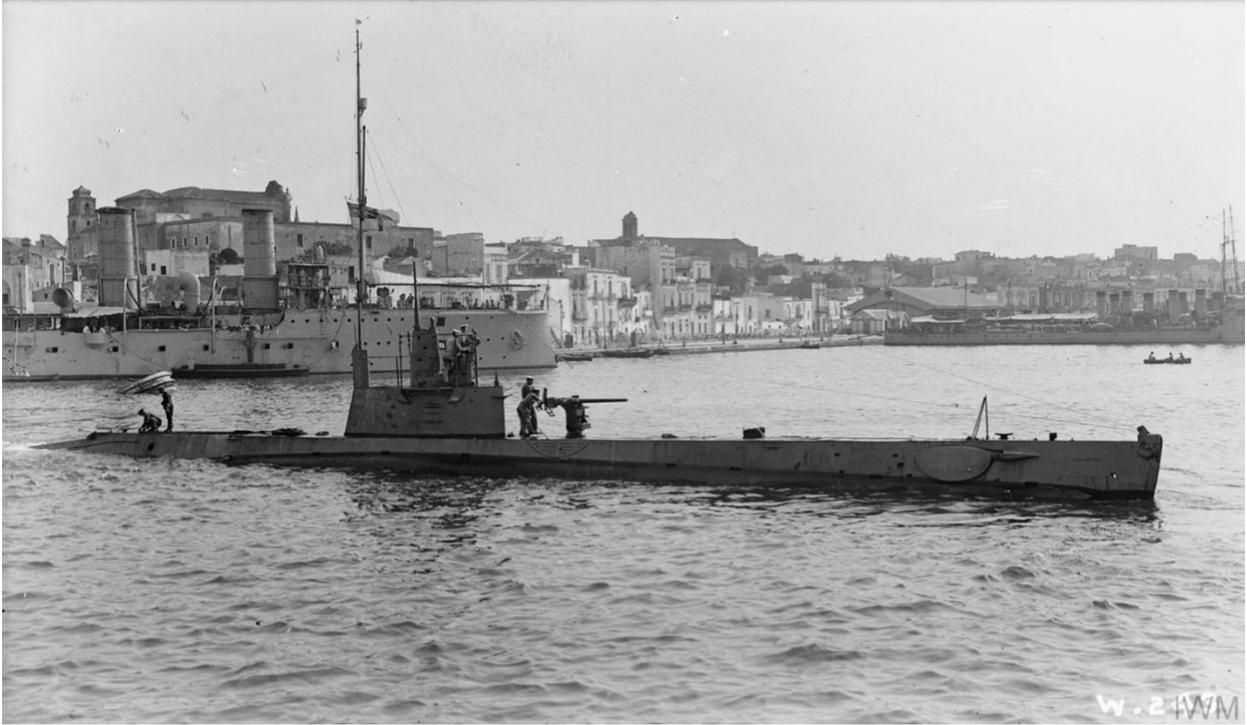
Figure 88. HMS *H-4* with six-pound gun Brindisi, Italy 1916.

The boats sailed for Malta after ten days of maintenance in Gibraltar. In Malta each boat was fitted with a quick firing six-pounder gun (57mm), wireless radio, and jumping wires (Figure 88). Jumping wires were heavy cables allowed a submarine to penetrate submarine nets, one of the few anti-submarine warfare tools of the day. The jumping wires were attached at the bow, led tightly above the periscopes and attached at the stern, reducing the chances that the submarine would become entangled in a net. When the work was complete *H-1* sailed for Mudros on the Greek island of Lemnos and then on to Kephalos harbor, on the east side of

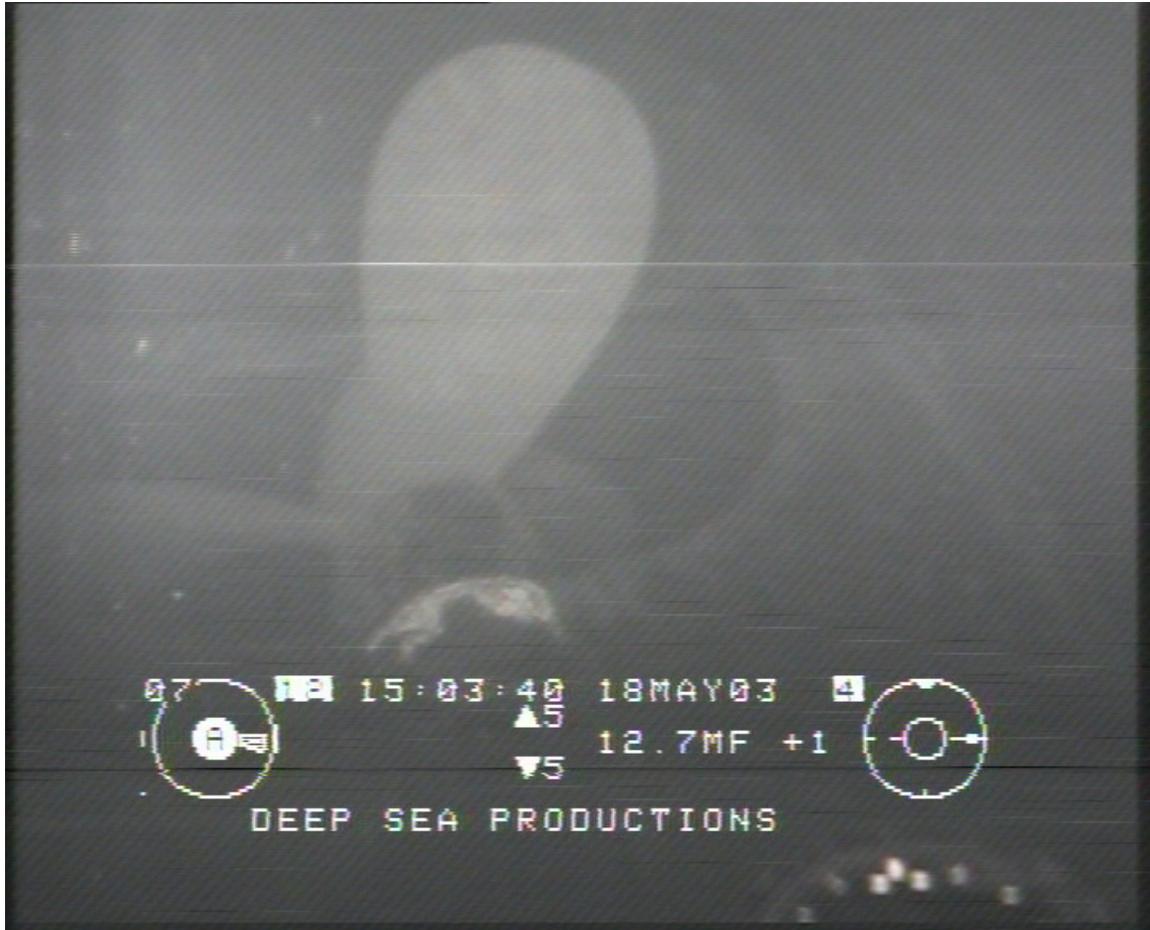
Figure 94. Propeller believed to be from *AG-14*.

Images provided by Mr. Carl Douglas of MMT, the firm which conducted the search, supports classification of the wreck as an early submarine. The design of the propeller aperture is visually consistent with that of an H-Class submarine (Figure 94).

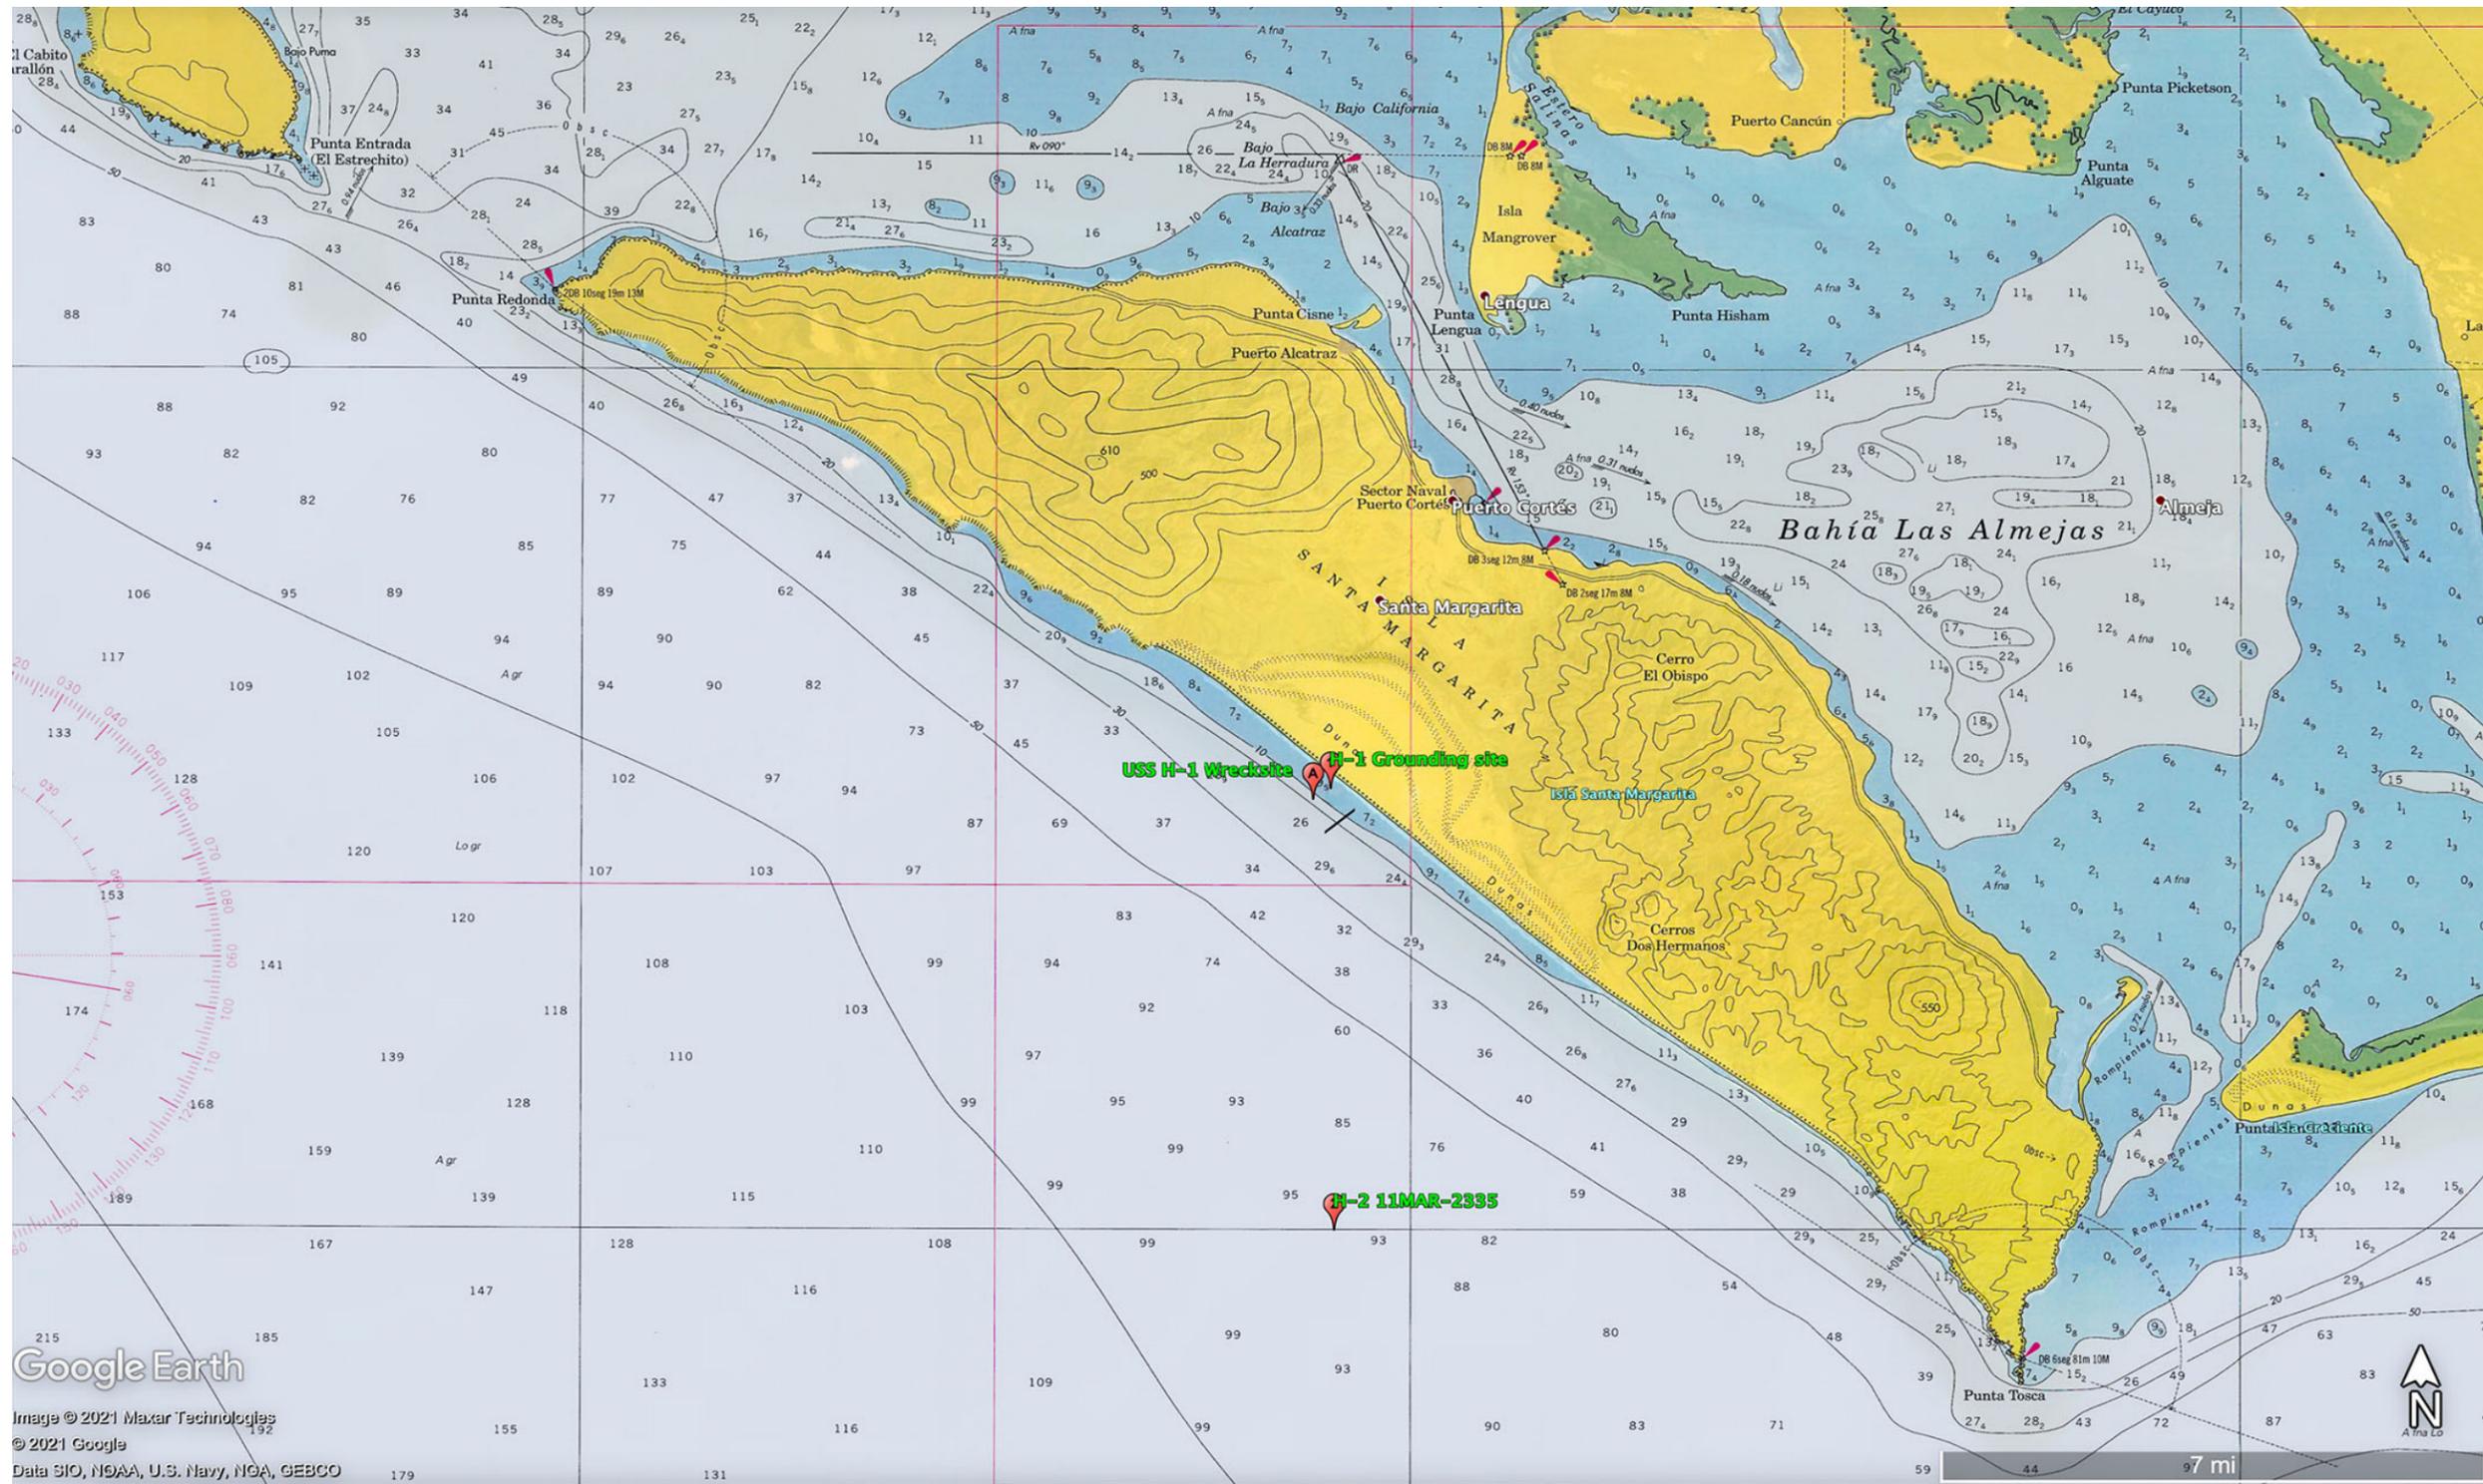
Figure 101. Isla Margarita wreck site.

The chart that follows shows *H-2*'s approximate position where it loitered awaiting *H-1*'s arrival and shows the current position of *H-1*'s wreckage. The actual grounding site is estimated to be approximately .3 nautical miles shoreward (Figure 101).

Isla Margarita has a very low central section that looks deceptively like an entrance; the topography of the island (Figure 101) shows that there is in fact high ground on either side of a gradually sloping plain. The 1915 Coast Pilot notes that on earlier charts the area was named "Pequena Bay" (Pequena translates to 'small' or 'little') and the northern promontory was called "Cape Judas".²⁷⁴

H-1's wreck lies on a sandy bottom under 60 feet (18 m) of seawater in close proximity to the position where it sank (Figure 101). The 13-year mean salinity and temperature, calculated from 1950-1962 at 33 feet (10 m) of seawater in the area of Isla Margarita were 34.4 ppt. and 70 degrees (21 C) respectively.²⁹² The average level of dissolved oxygen in the area of the wreck is currently unknown. Levels of dissolved oxygen in seawater can vary significantly from the anoxic Black Sea to as high as 12 ppm. Cold water with low salinity can hold the most dissolved oxygen; raising either the temperature or salinity of the water reduces its oxygen carrying capacity. Other factors which affect dissolved oxygen are water movement and the presence of marine organisms that either generate oxygen (plant life) or consume oxygen (animal life). Considering the abovementioned factors, it is probable that the environment surrounding *H-1* has a higher carrying capacity for dissolved oxygen. Higher dissolved oxygen levels result in higher corrosion rates in steel.²⁹³

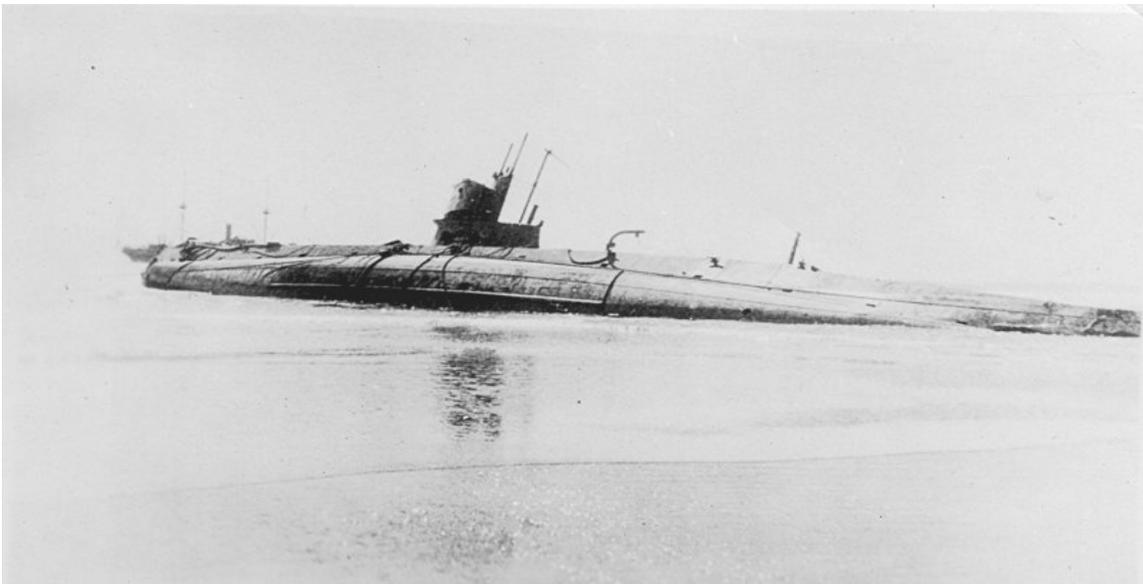
Figure 103. *H-1* aground with USS *Vestal* to seaward.

On 12 March *Sinclair*, under the command of Cmdr. F. McCrary, was in transit from the Panama Canal to its new homeport of San Diego, California. The ship was steaming in formation with USS *Doyen* (DD-280) and USS *Meade* (DD-274) and *Sinclair*'s deck log reflects that it split off from them during the 0400-0800 watch on 13 March, increasing speed and altering course toward Magdalena Bay. *Sinclair* sighted *H-1* at approximately 16:00 that afternoon (Figure 103).

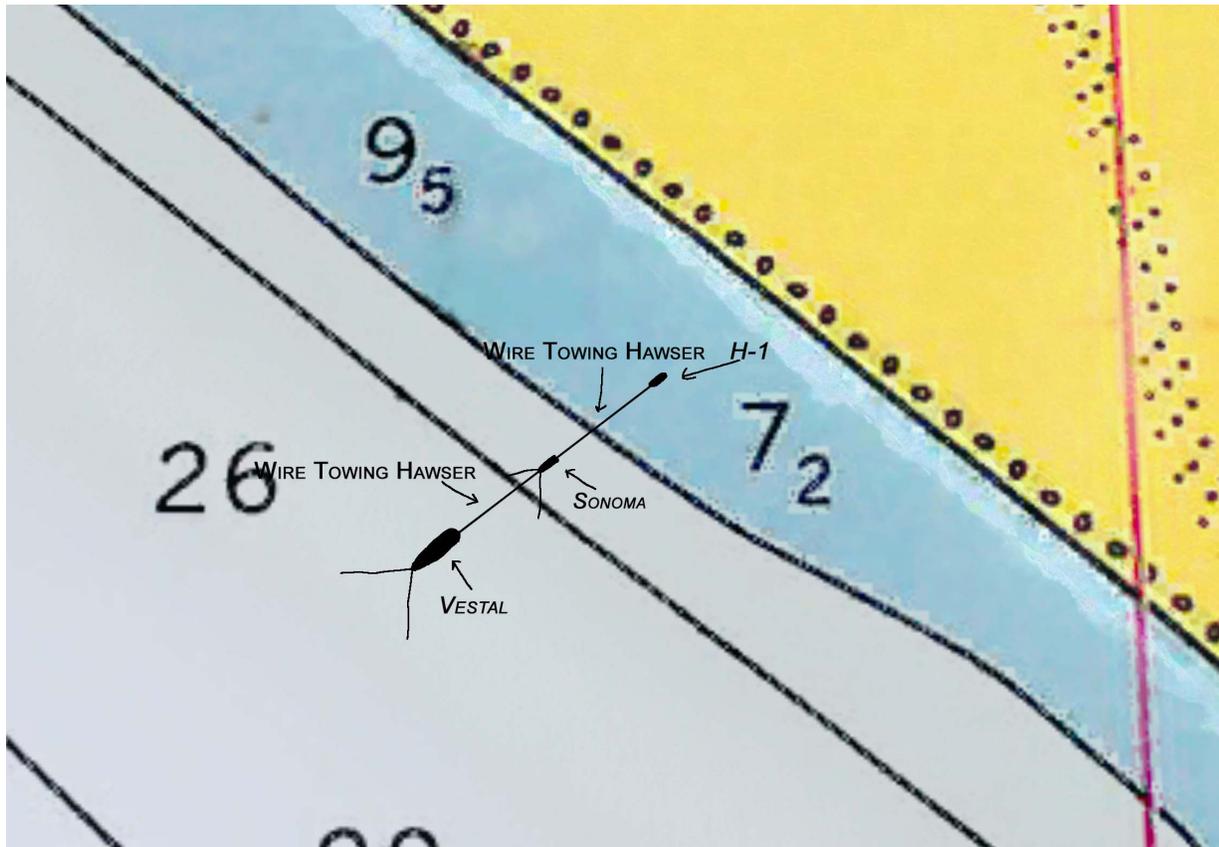
Figure 104. Initial towing configuration (Position is approximate and vessels are not to scale).
Author after Searle and Curtis.

At 0830 *Sonoma* repositioned such that *Vestal* was anchored seaward and to windward. *Sonoma* took *Vestal*'s steel towing wire, secured it to its bow and backed toward *H-1* where it anchored. *H-1* was rigged with a towing bridle of 4.5-inch (11 cm) wire rope wrapped twice around its conning tower. Once secure on both anchors, *Sonoma* floated its steel towing wire to *H-1* using empty gasoline drums where it was secured to the bridle (Figure 104). A strain was

successfully taken on the towing rig during the early hours of the 1600-2000 watch. The strain was slackened during the falling tide and taken up again.

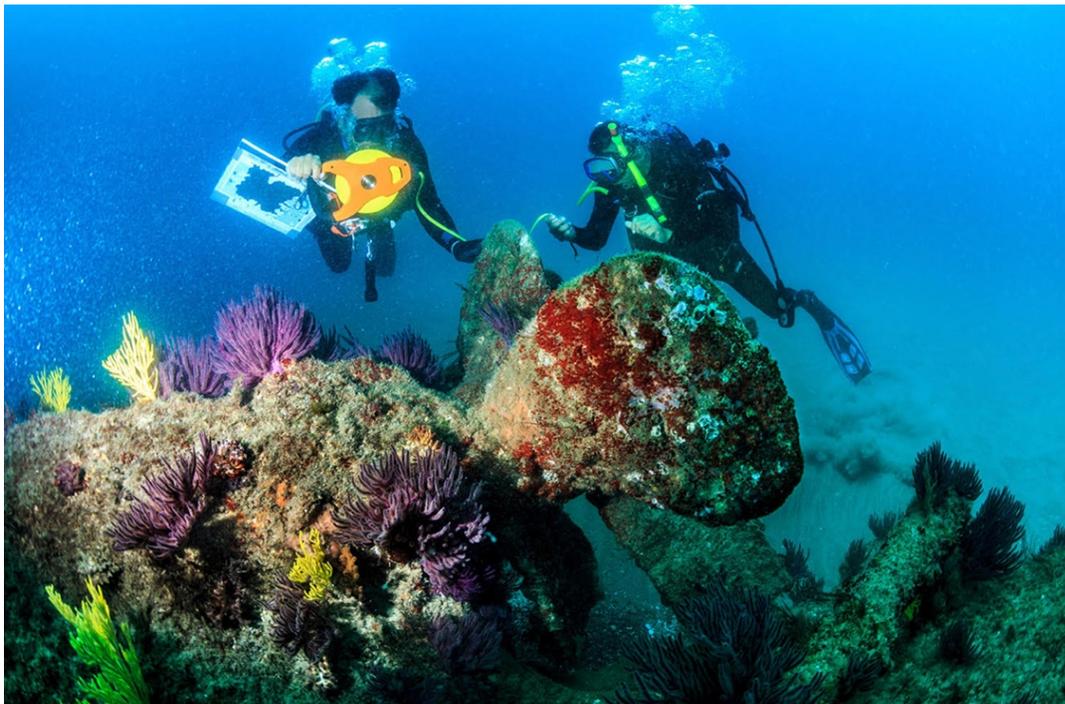
Figure 105. *H-1*'s coral garden.

In the century that *H-1* has lain on the seafloor it has become part of a vibrant ecosystem. It is covered with marine organisms including sea anemones, colorful soft corals and common barnacles, and its hull is developing a layer of concretion that appears almost fur-like with marine growth. Voids within the hull are also rich in aquatic life, including lobsters, octopi, eels, and many species of fish making their homes among the machinery (Figure 105).

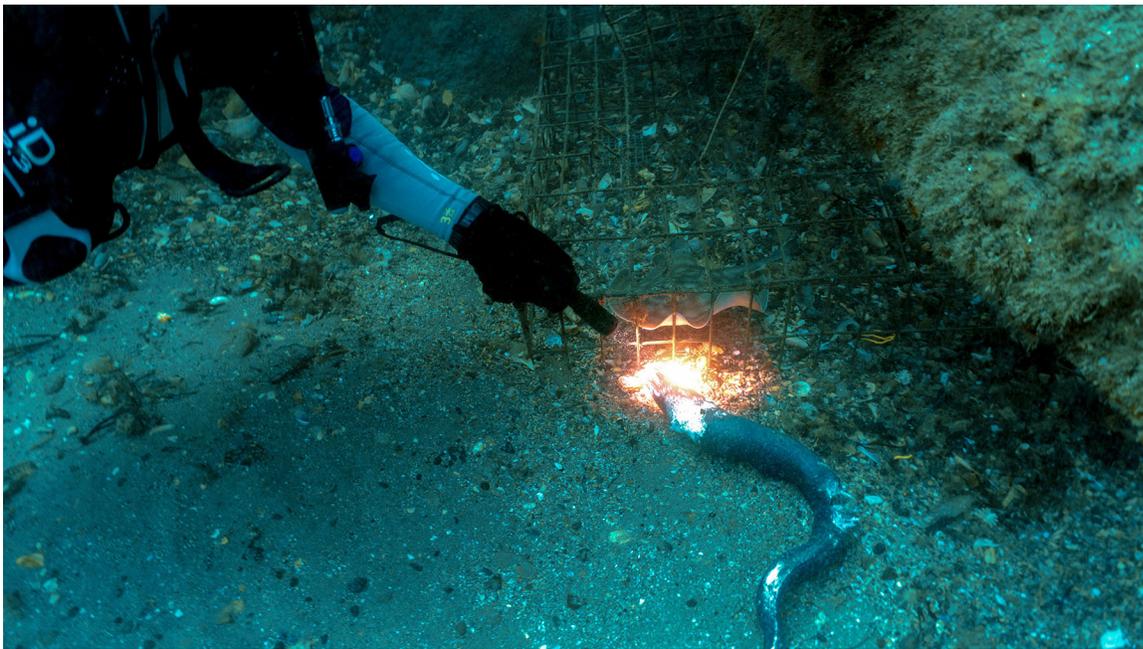
Figure 106. Entangled Moray eel.

Fishing activity has adversely impacted the wreck. Local fishermen typically anchor their boats to the wreck using a grapnel anchor. No anchors suitable for anchoring in sand were observed during the author's visit to the island. The wreck is littered with fishing equipment, lines, and anchors, as well as lobster and fish traps. This derelict equipment is damaging to both the site and the marine life as the gear continues to kill animals post abandonment (Figure 106).
