THE HISTORY OF H-CLASS SUBMARINES AND ARCHAEOLOGY OF THE
SUBMARINE USS *H-1*
(EX *SEAWOLF*) (1913-1920)

A Dissertation

RICHARD HANSON HENDREN

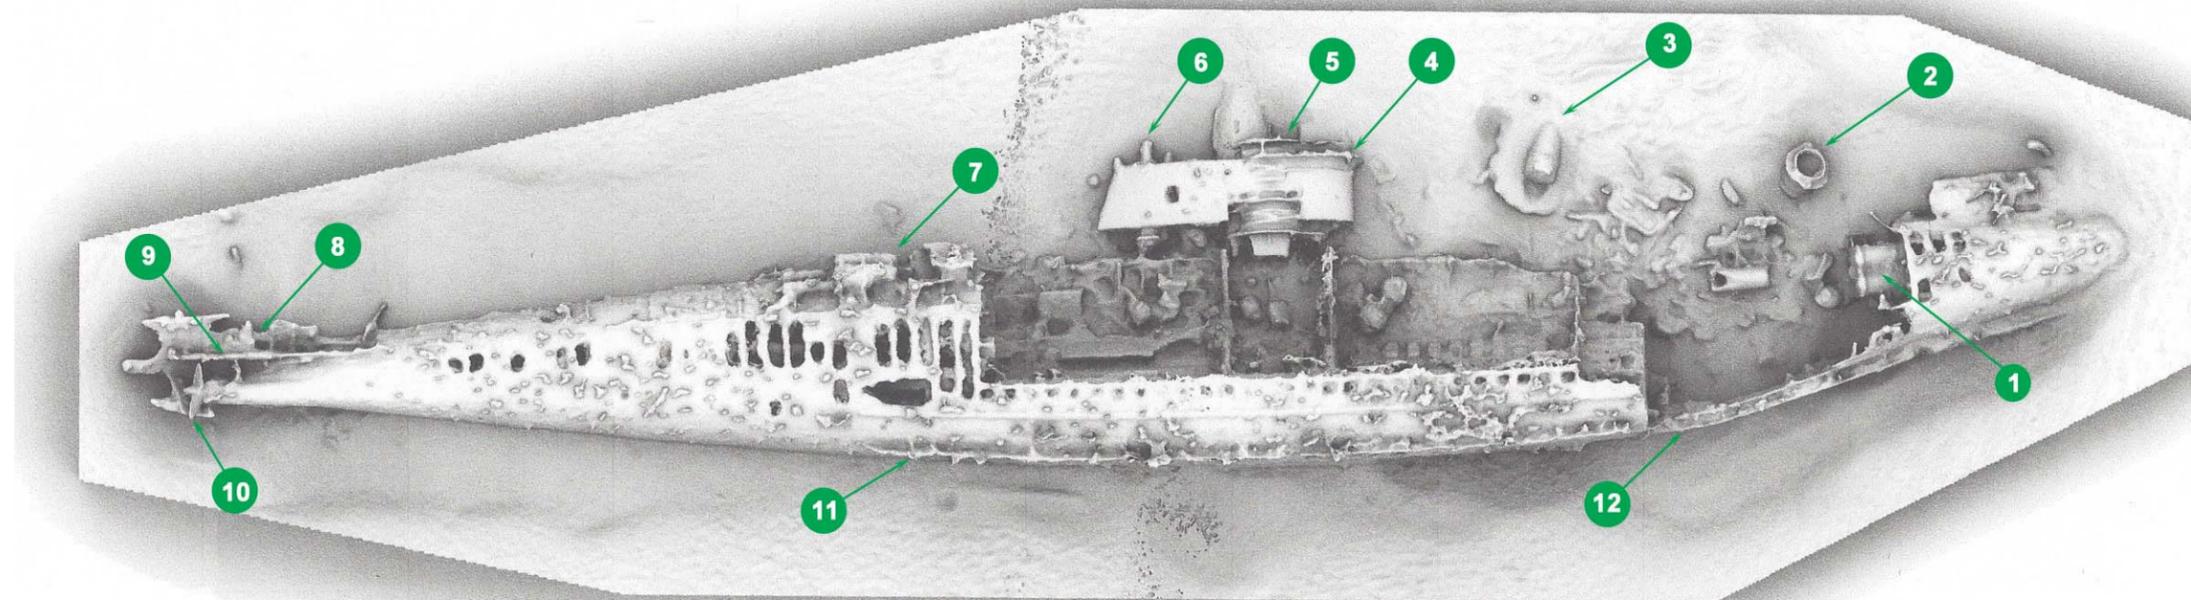
Figure 107. *H-1* site plan.

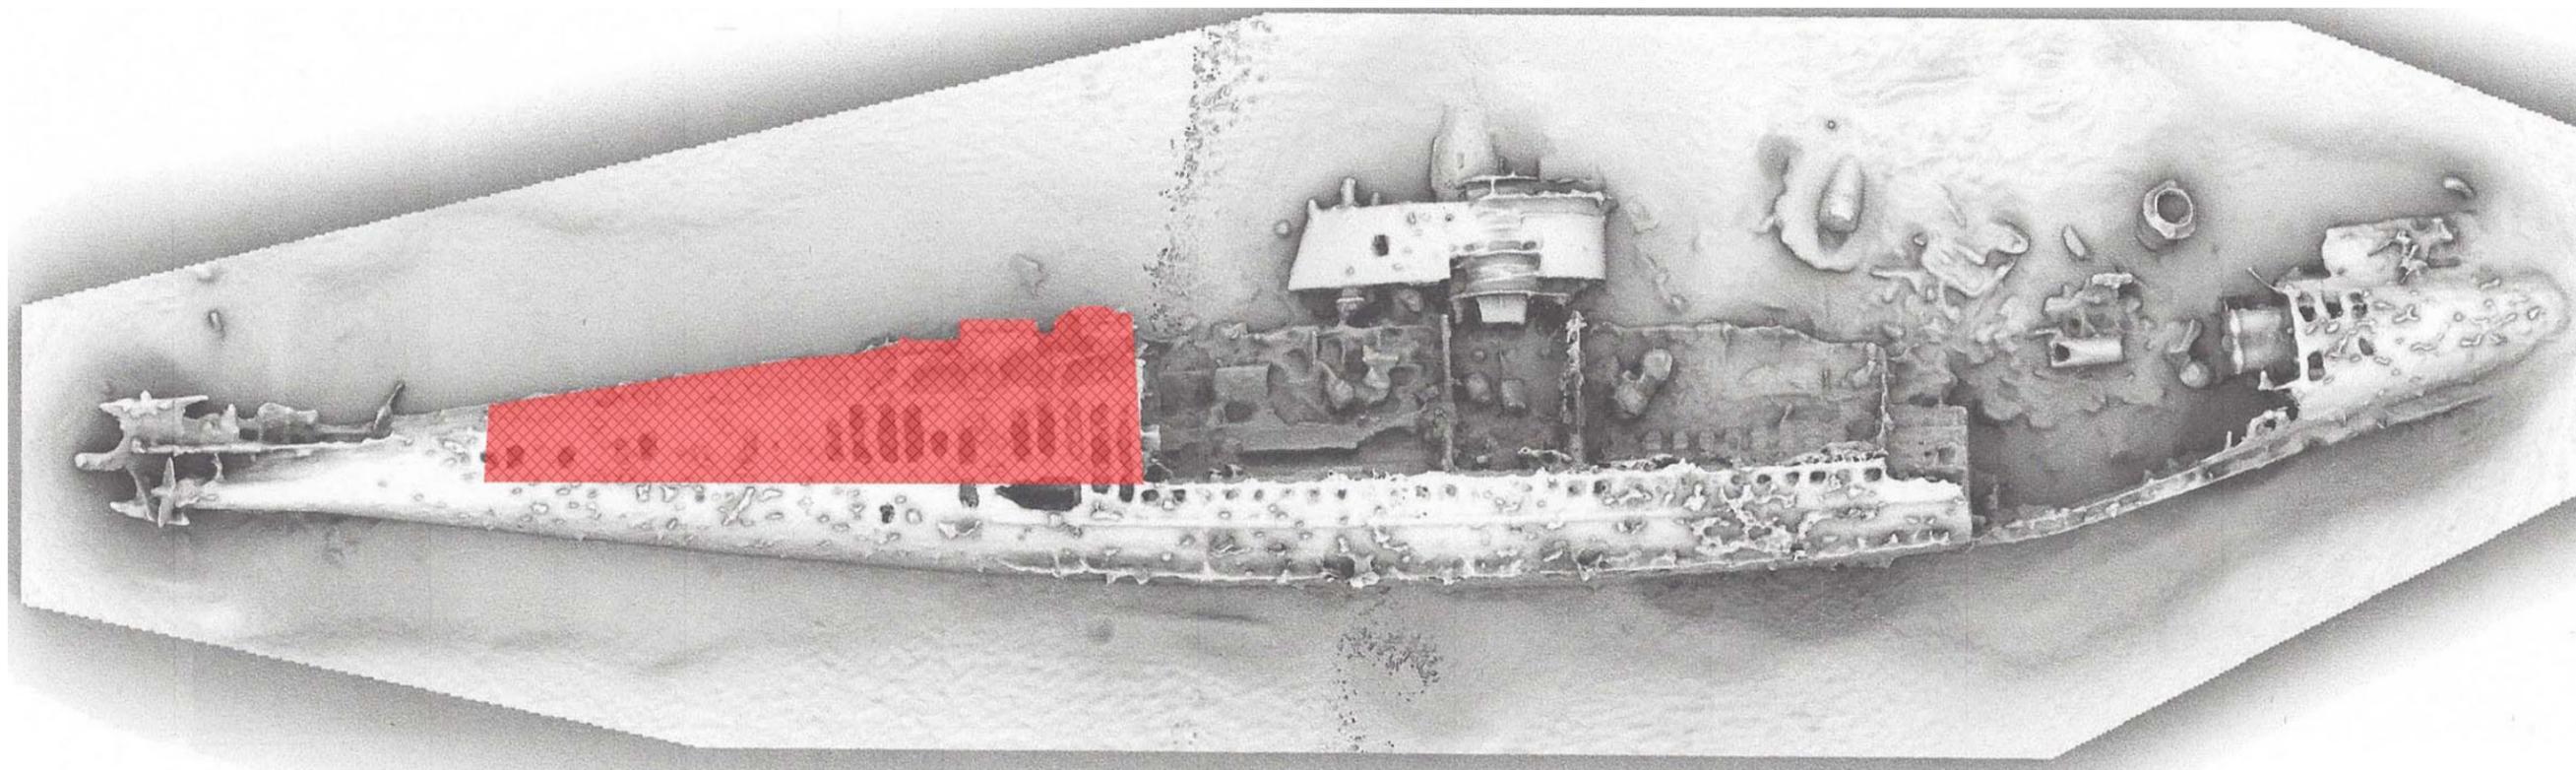
Figure 111. Site plan showing extent of disarticulated Engine Room hull plating.

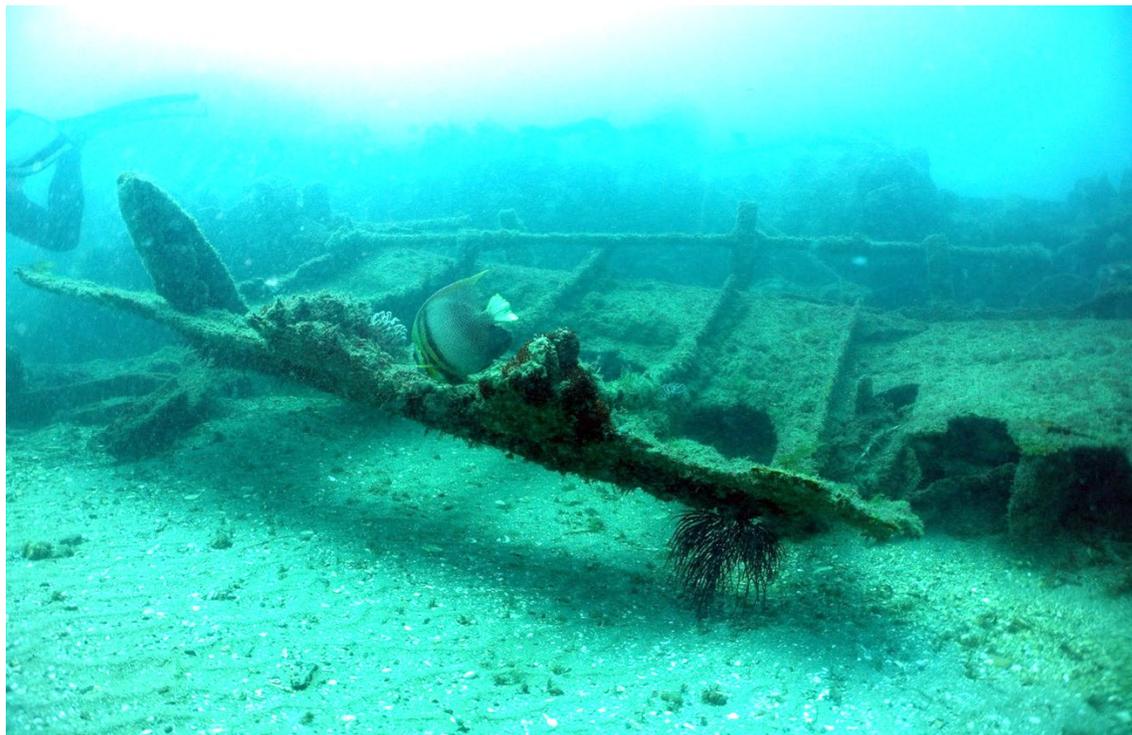
Figure 112. Engine Room hull plating.

The plating was lying concave side up in the sand along the port side of the wreck; indicating that instead of collapsing inward, it had folded away from the wreck (Figure 112). This differs from the displaced hull plating at the forward compartments, which is lying, for the most part, with the convex side to the sand. One plausible explanation for this is that with the submarine resting on its port side, the weight of the exhaust system induced a reaction force, similar to the forces induced by placing a weight on the end of a cantilevered beam, which tore the plating off at the rivet line on the starboard B-strake, rolling the plating outboard. It is also conceivable that dragged anchors or other human interference is responsible for this significant recent damage.

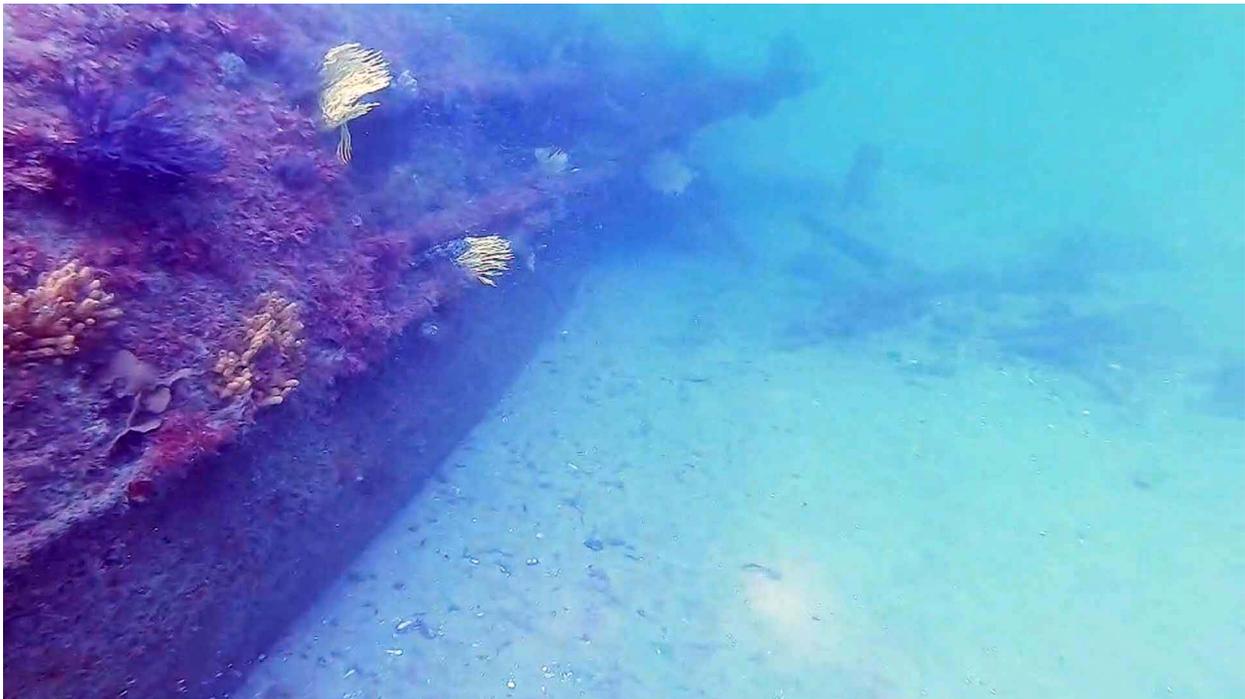
Figure 113. H-1 port side looking aft.

Aft of the collapsed engine room hull plating, the operating shafts for the stern planes and rudder could be seen as the two linear elements originating near a yellow fan coral and running aft along the hull toward the exposed section of the stern casting in the background. This casting supported control surfaces which were no longer attached to the casting. Parts of the control surfaces, likely the port stern plane, lay detached in the debris field (seen in the background, center right of Figure 113). A piece of galvanized wire protruded from this debris field, perhaps a remnant of a modern looting attempt. The two propellers remained fitted to the propulsion shafts, which is surprising since both have considerable value as scrap and as souvenirs; detachment of the stern planes may have been undertaken to facilitate their removal.

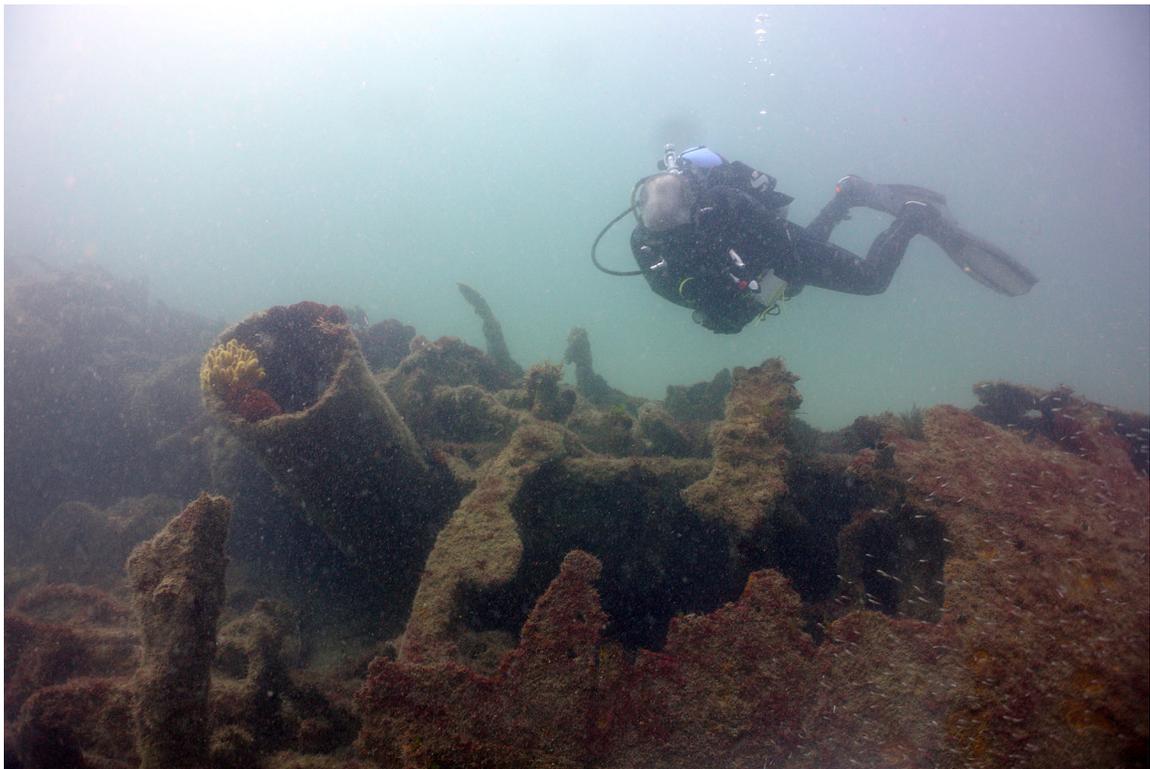
Figure 114. Submarine signaling bell tube.

Leaving the area of the stern gear and moving forward along the starboard side. The hull was relatively intact from the propellers forward to frame 10 and was heavily deteriorated going forward. A large open pipe (located in the center left of Figure 114) was the tube for the submarine signaling bell; situated centerline at frame 16, it provided a good visual reference for measuring hull loss and identification of engine room equipment (Figure 114).

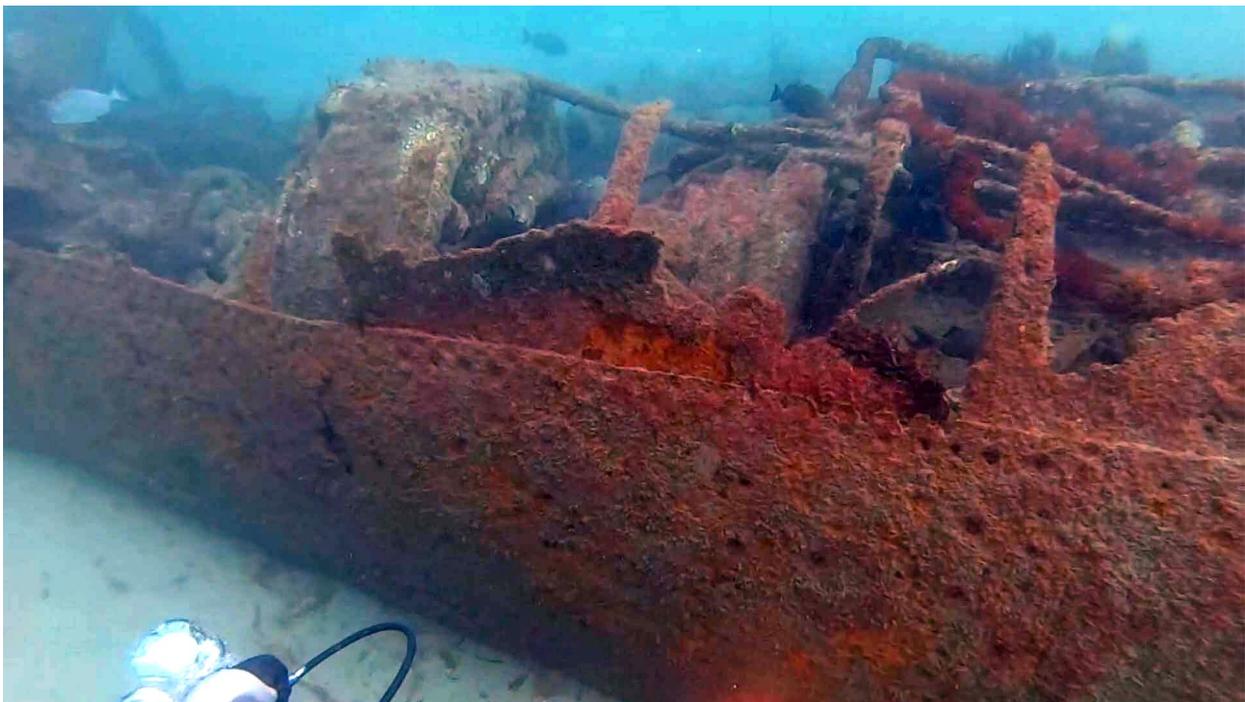
Figure 115. Starboard motor-generator.

Further forward along the starboard side shaft line components came into view, although much more was buried under a jumble of broken pipes and collapsed sections of the hull. The structure seen adjacent to the starboard main engine, shows the B-strake of the hull overlapping a remaining fragment of the C-Strake (Figure 115). The rivet holes are empty as the rivets, formed from a different steel alloy than the hull strakes, have corroded away. A vertical butt seam in the B-strake can be seen in the lower right of this image. Also visible, astern of the aft-most fragment of C-strake, are the starboard motor-generator and the starboard power pump.

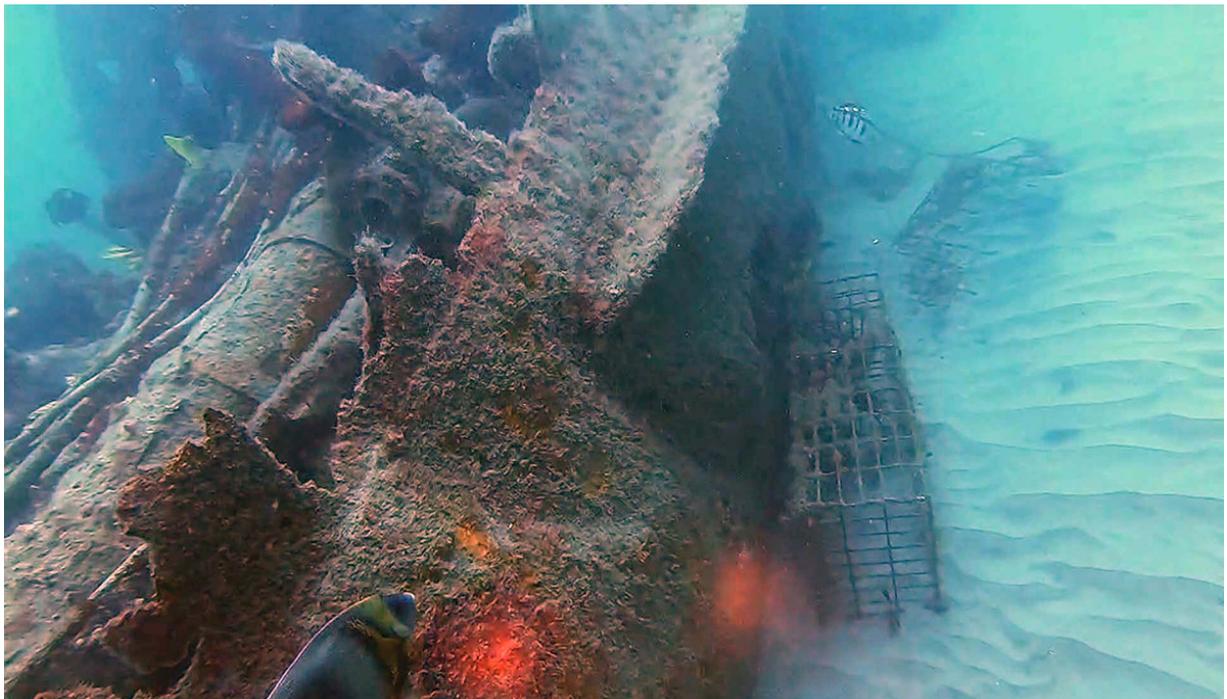
Figure 116. Starboard main engine looking forward.

Figure 116, taken adjacent to the starboard main engine looking forward, shows the upper section of the engine, the nearly-complete transverse bulkhead which separates the engine room from the aft battery compartment, and the bilge keel. Submarines are prone to rolling, due to the circular cross section of the hull, and bilge keels were fitted on the H-Class to reduce the rolling moment. Also visible in the image are several of the fishing traps which littered the wreck.

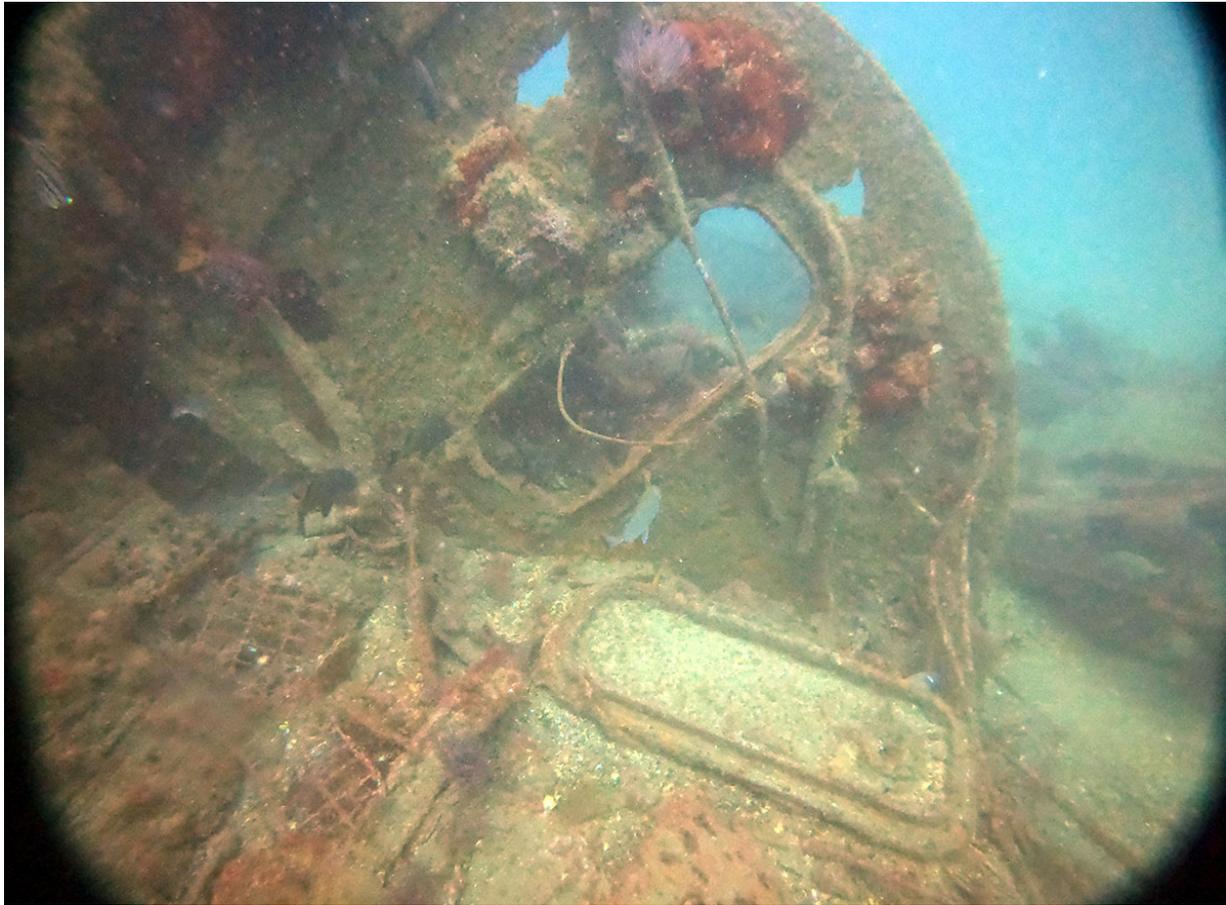
Figure 117. Aft Battery-Engine Room bulkhead.

The image in Figure 117 was taken in the aft battery compartment looking aft toward the engine room bulkhead. The watertight door in the lower right lies above previously-deposited material on the port side of the compartment, indicating that it remained on its hinges long after *H-I*'s sinking. In the left foreground the tops of battery cells can be seen, the straight lines of their casings interrupting the marine life growing on them. To the right of the bulkhead lies the collapsed hull plating which once covered the engine room.

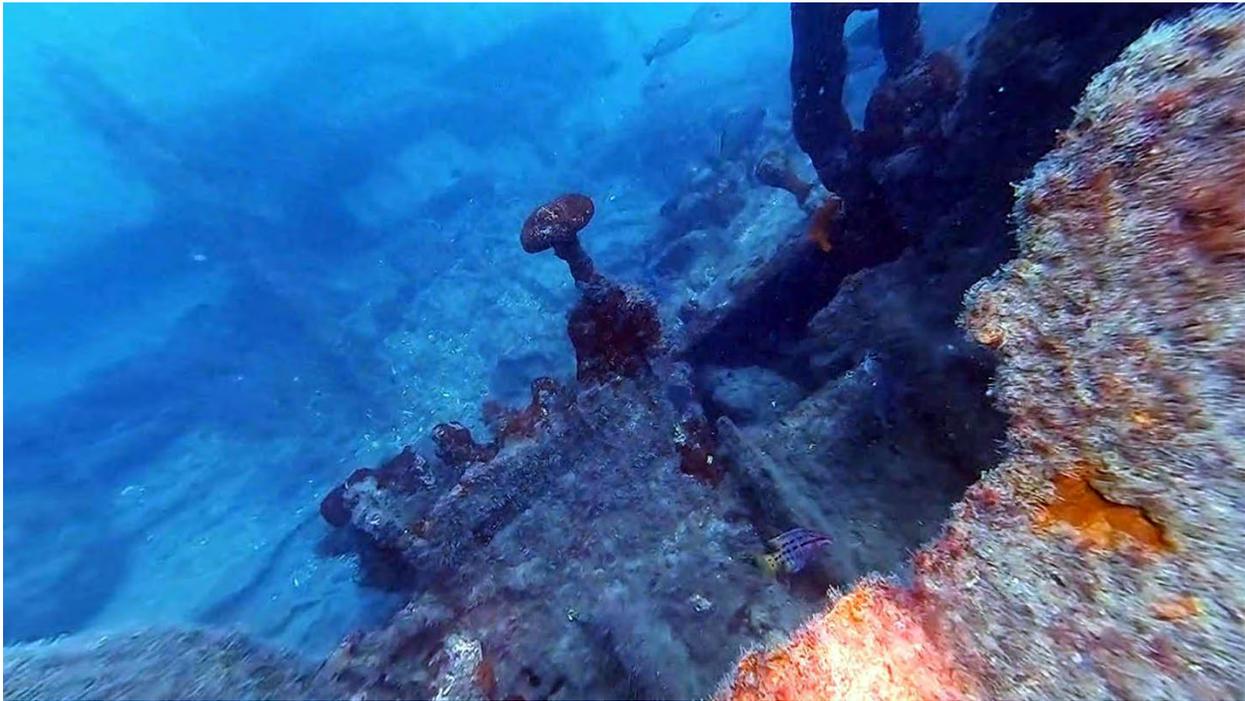
Figure 118. Control Room.

Figure 118 shows the remnants of the aft battery-control room watertight bulkhead and the base of the conning tower in the background. The operating handwheel for an unidentified valve is visible in the foreground. Like much of the rest of the site only the major structures in the control room were identifiable due to the deterioration of the metal and the spread of corals and other marine growth.

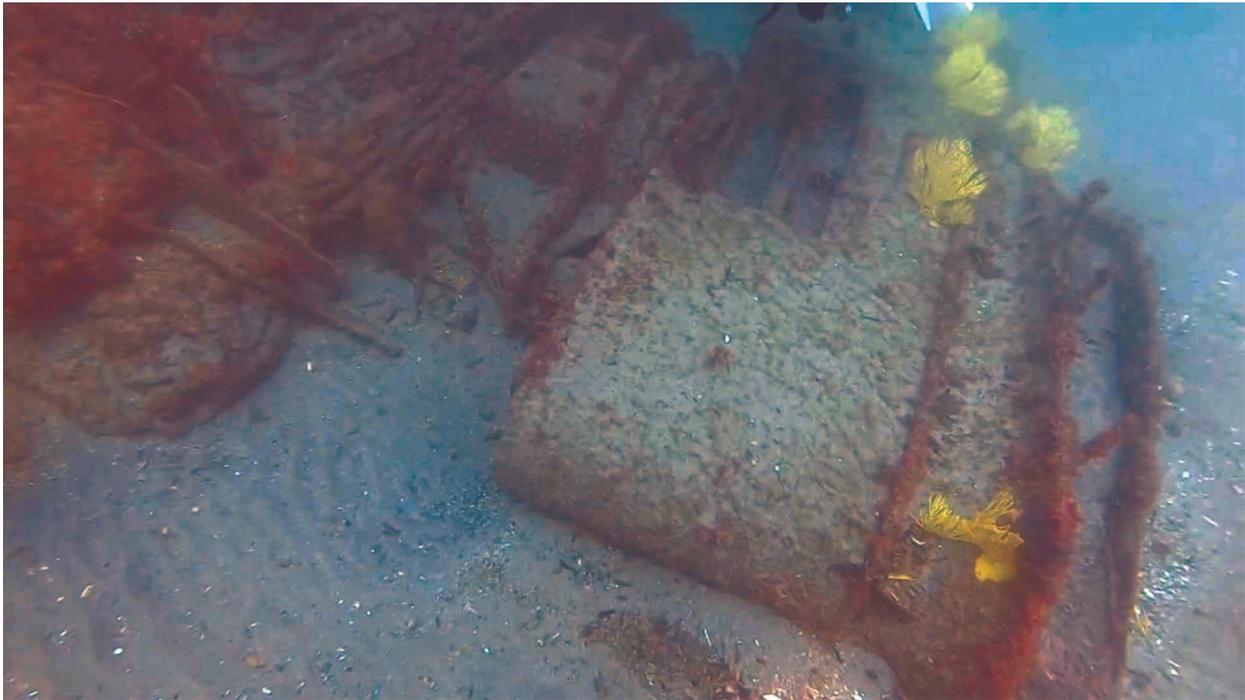
Figure 119. Conning Tower.

The conning tower and much of the surrounding structure was constructed using non-ferrous metal to avoid interfering with the magnetic compass. It was cast in sections; the bands where the sections join are visible to the left of the yellow coral (Figure 119). The more noble metals of the tower and surrounding structure have survived much better than the less noble hull and structural components.

Comparing the 2019 image in Figure 119 with an image taken from Yamafune’s photogrammetry model, imagery collected in January 2018, shows how quickly sand is being deposited on the sail. In 2018 sand was at the lower lip of the hatch, the periscope shears were substantially covered and forward ventilator pipes barely visible (Figure 120).

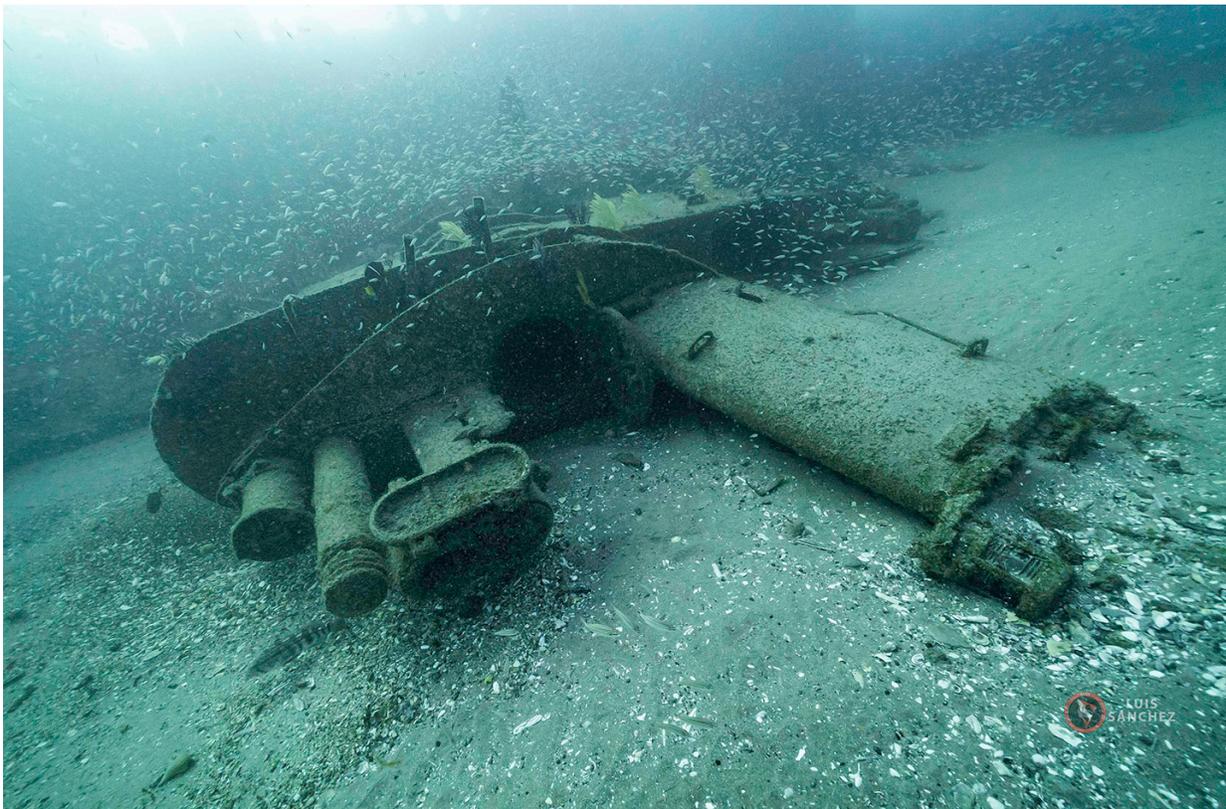
Figure 121. *H-1* Bridge 2016.

Figure 121, the earliest available imagery of the sail taken in August 2016, shows the top of the sail with the conning tower hatch (forward) and the bridge access hatch (aft) both open. Also visible are various ventilation standpipes, the periscope shears (the large oblong pipe between the conning tower and bridge hatches) with attached navigation light, and the steering stand (the oblong access hatch forward of the conning tower hatch). The conning tower access hatch, which measures 24 inches (61 cm) in diameter is clear of the sand in this image. Due to sand encroachment, none of these details were visible in 2019.

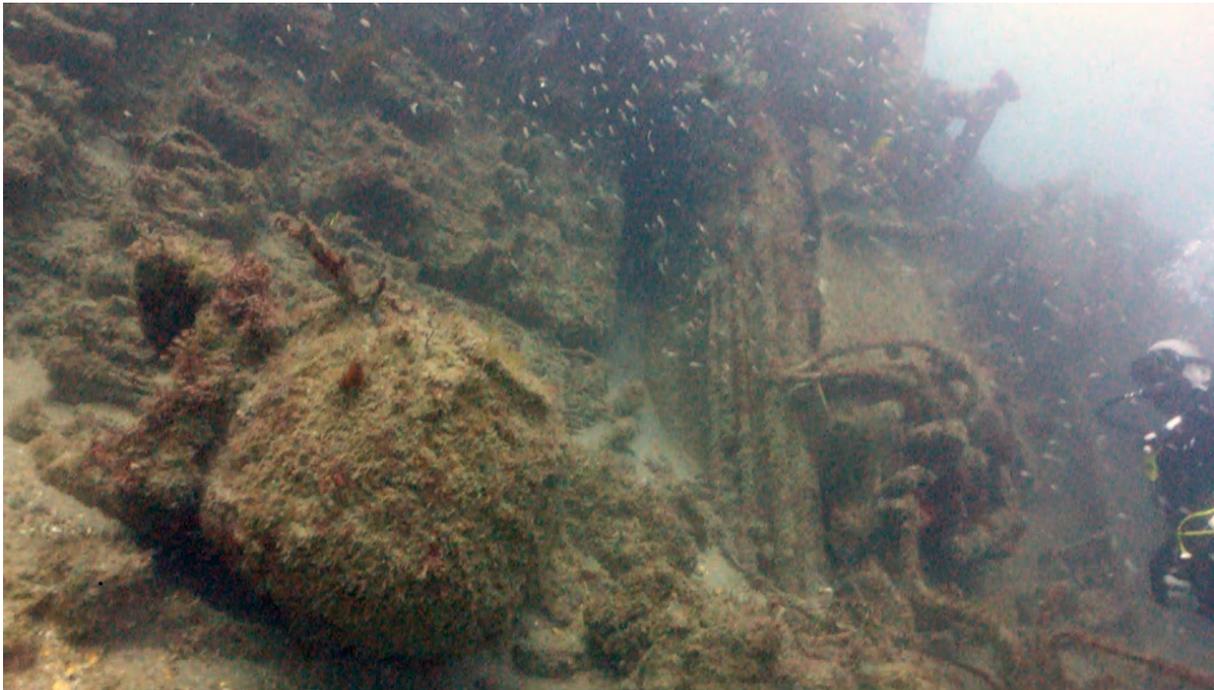
Figure 122. Forward Battery compartment

In the forward battery compartment (Figure 122) the plates of the individual battery cells are visible (center of image), also visible (on right) is the battery well's aft bulkhead. The round object in the foreground is believed to be the motor for the bow planes based on observable physical characteristics and the object's location in the space.

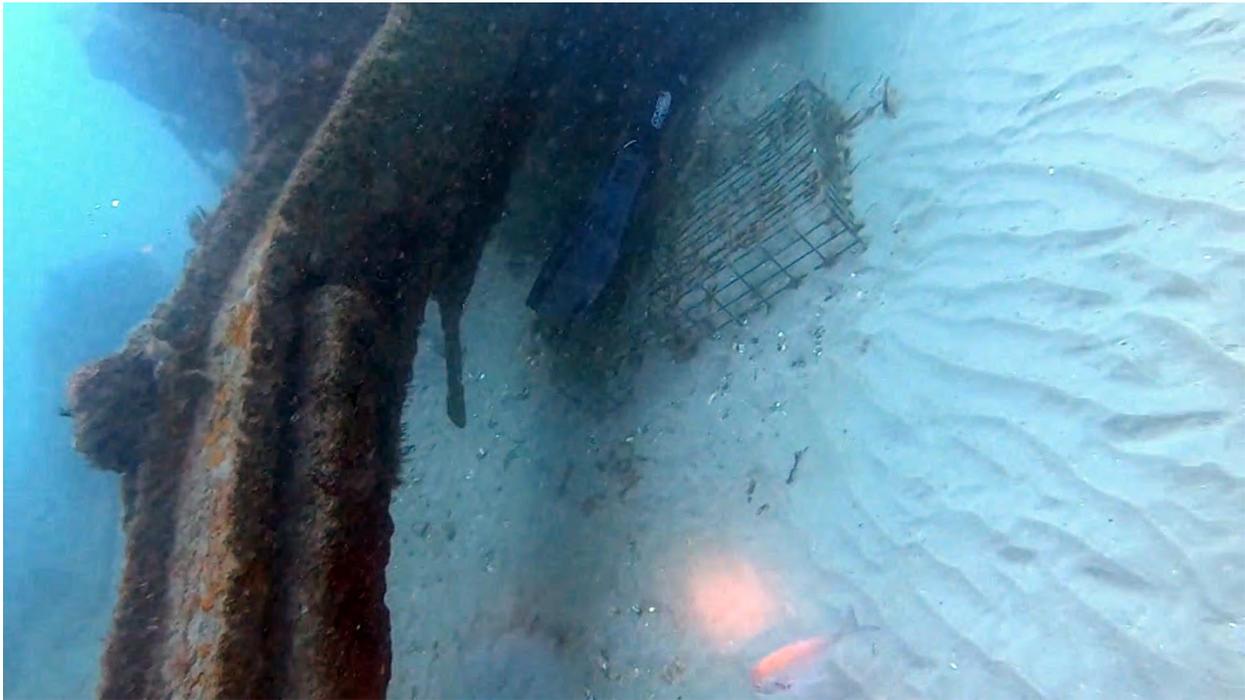
Figure 123. Deformed keel structure.

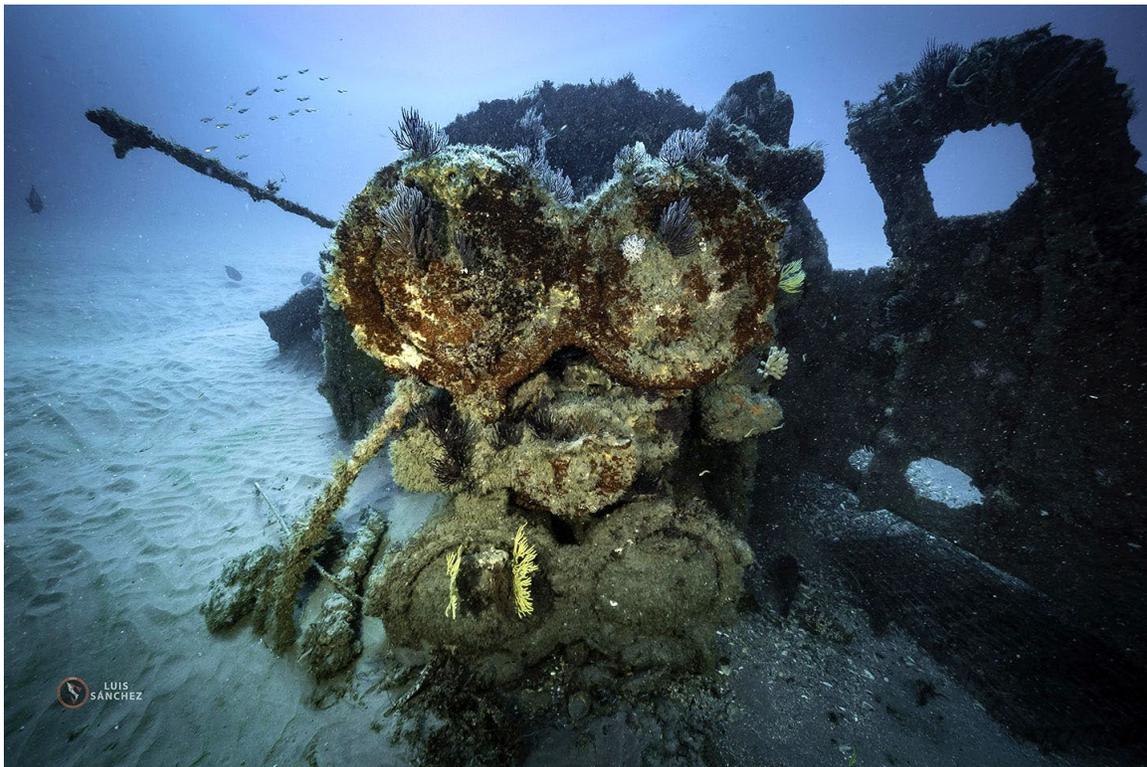
Figure 124. Torpedo tubes.

Bliss Levitt Mark 7 torpedoes remained loaded in each torpedo tube at the time *H-I* sank and there are no indications that they have been removed; the torpedo tube breech doors remain shut (Figure 124).²⁹⁹ This ordnance, although over 100 years old may still explode if disturbed. Results of a risk analysis conducted of the likelihood of detonation of a similar torpedo on the sunken Australian submarine HMAS *AE2* places the risk at 16% if the weapon was disturbed.³⁰⁰

²⁹⁹ Figure 124 was taken 21 July 2018 and is presented as no image publishable quality was taken of the torpedo tubes taken during the 2019. The hull plating at image right was significantly diminished in 2019.
