51ST TURBOMACHINERY & 38TH PUMP SYMPOSIA

Vibration Field Problem Resolved with Analytical Diagnostic Approach and Innovative Impeller Design

ATPS Case Study 51 – 22-25 February 2016, Singapore

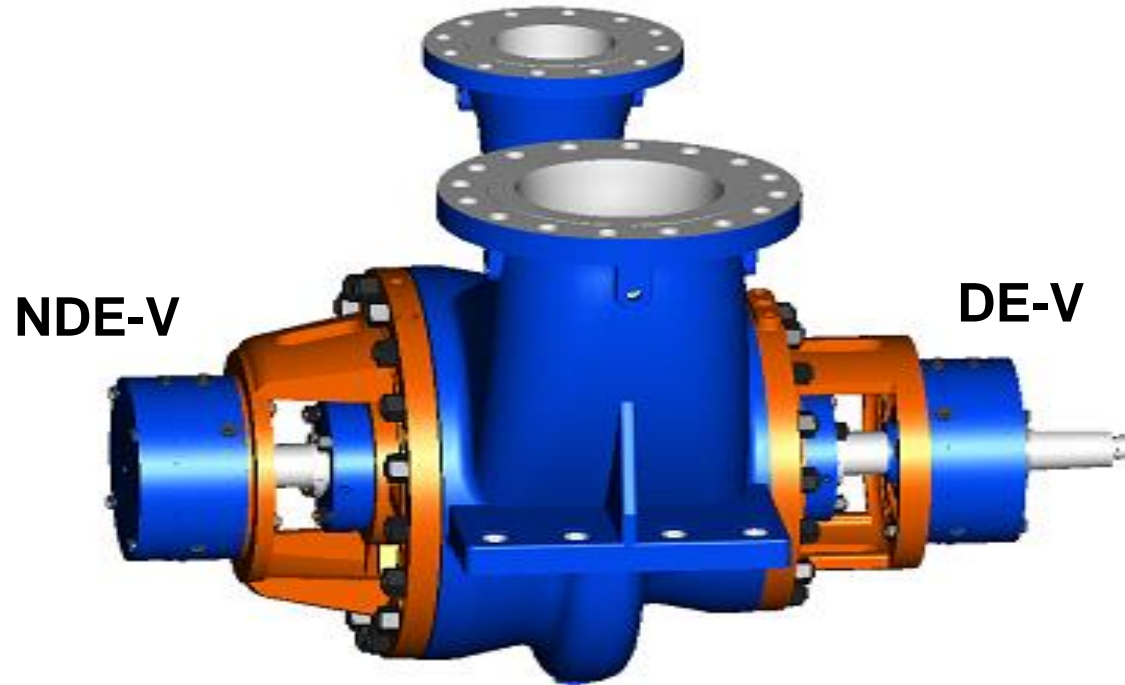
Bearing Housings – Vibrations Pickups

- DE-H Drive End – Horizontal
- DE-V Drive End – Vertical
- NDE-H Non Drive End – Horizontal
- NDE-V Non Drive End – Vertical
- NDE-H Non Drive End – Axial

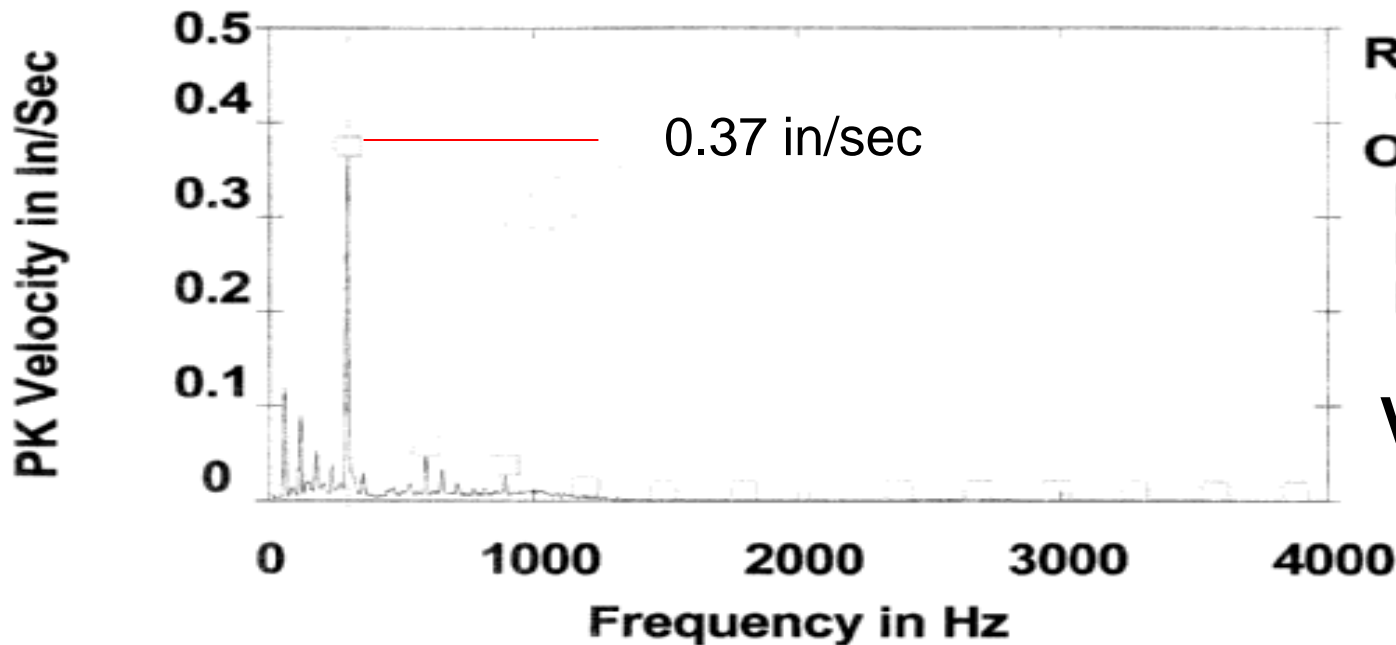
Vibration spectra at site - DEV

Qoper=2420gpm (78%Qrated)
(Case 2, SG=0.56, N=3565 rpm)

API acceptance criteria = 0.12 in/sec overall (RMS)

VPF= 5xN = 300Hz (17825cpm)

Key observations: CASE 2

- a) Most up to 1000Hz
- b) Dominant VPF (300Hz)
- c) Absence above 1000Hz up 4000Hz

High suspect of suction recirculation
High suspect of discharge recirculation
Absence or marginal cavitation

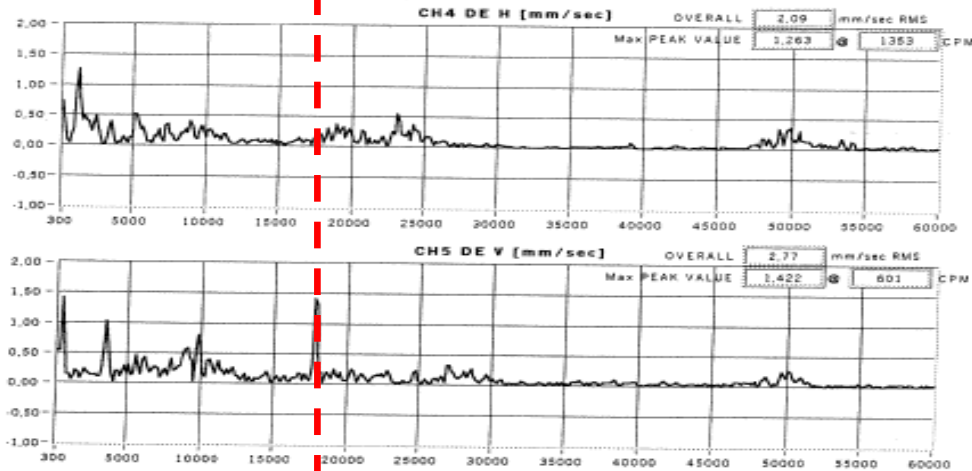
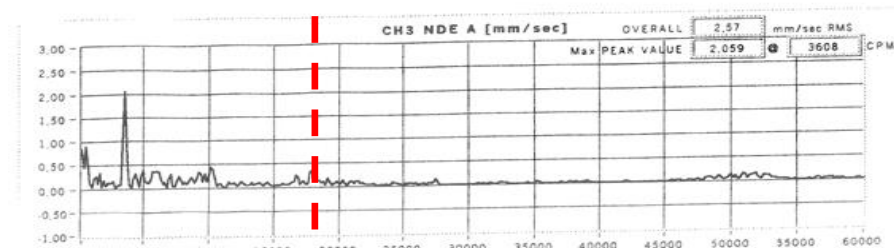
Shop tests

Shop test vibration spectra at 1750 GPM
57% of Q_{bep}-design (PK Velocity In/Sec)

N=3565rpm SG=1.0

17,825 cpm = VPF (5X)

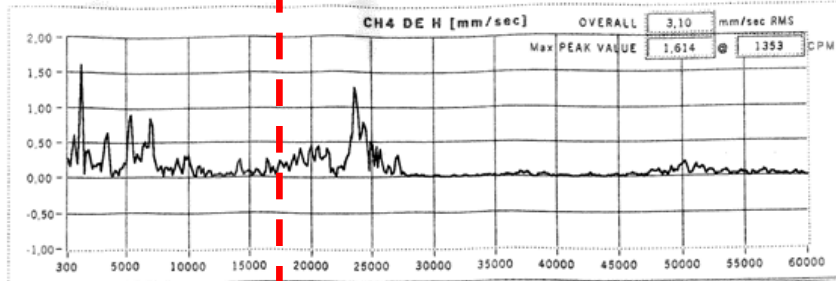
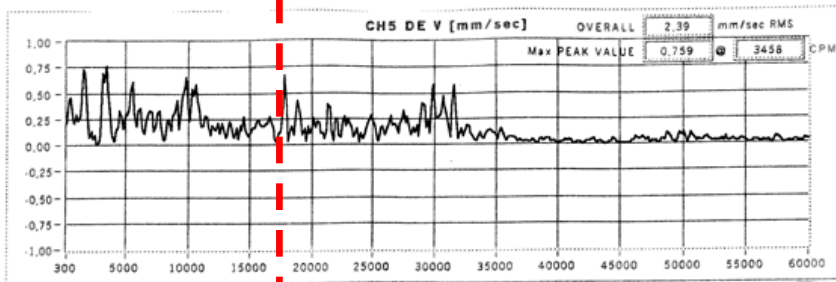
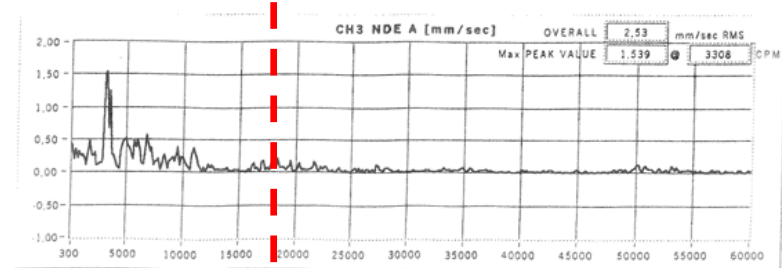
Shop tests

Shop test vibration spectra at 2690 GPM
87% of Q_{bep}-design (PK Velocity In/Sec)

N=3565rpm SG=1.0

17,825 cpm = VPF (5X)

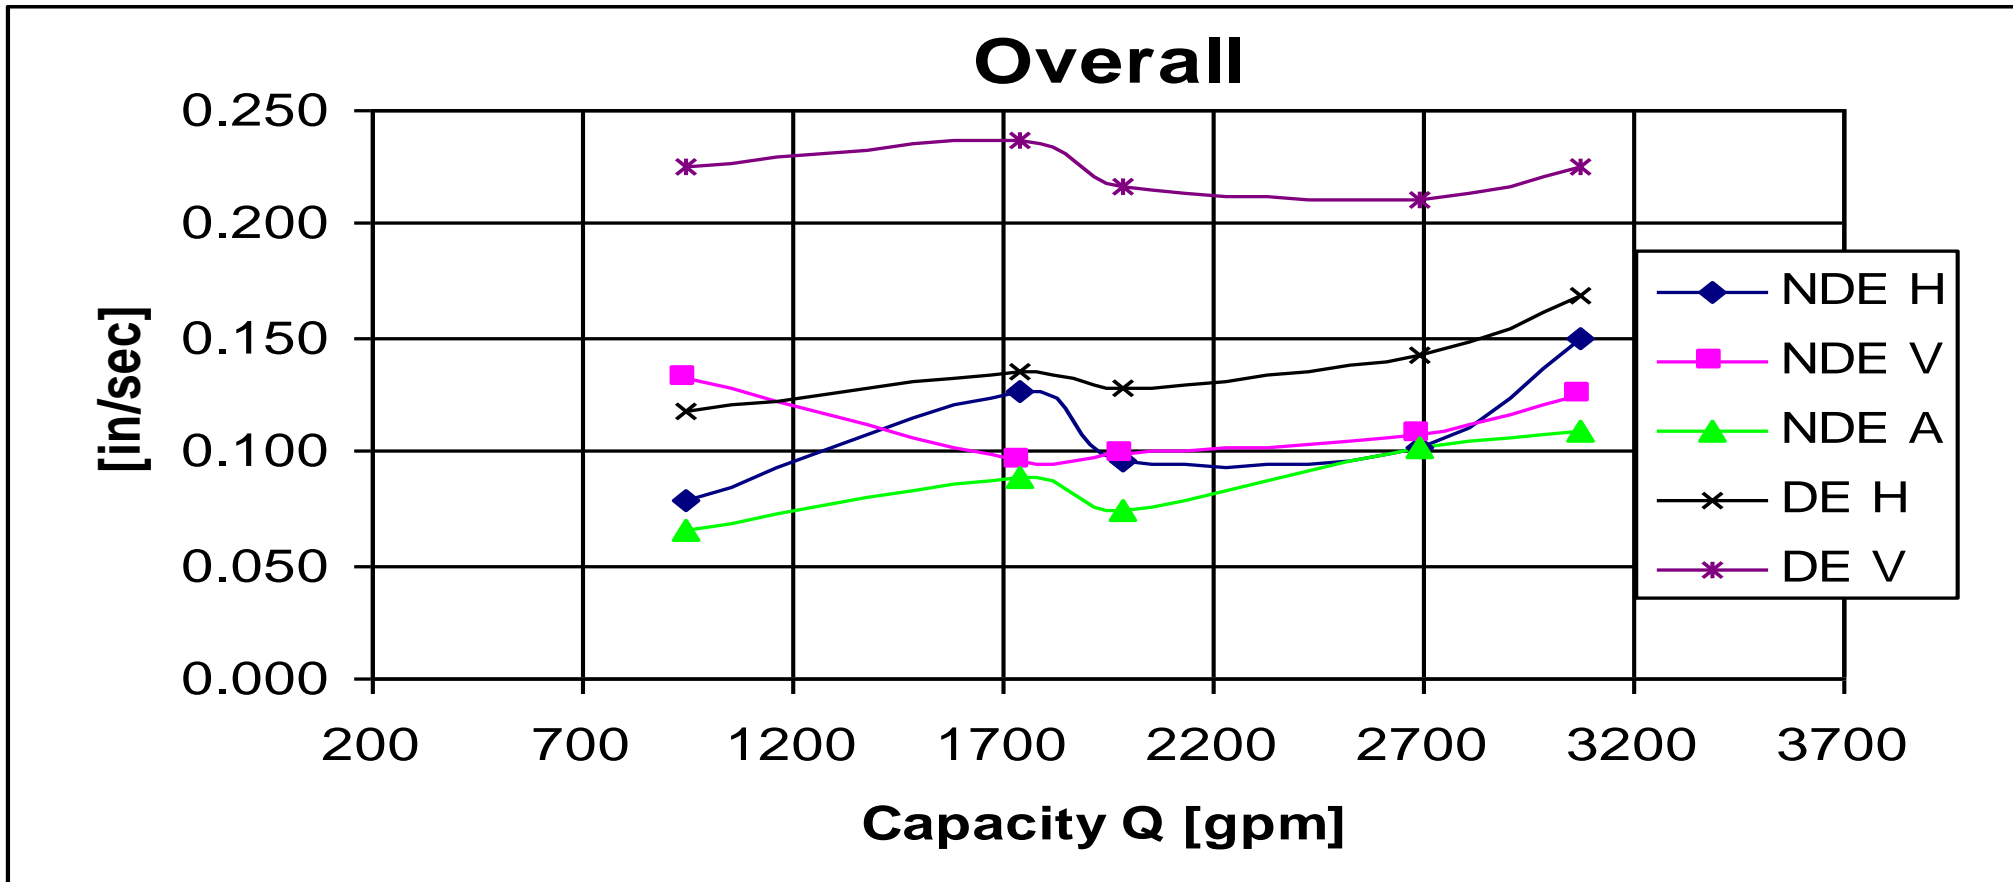
Original impeller

Shop test vibration spectra

Velocity PK In/Sec
N=3565rpm SG=1.0

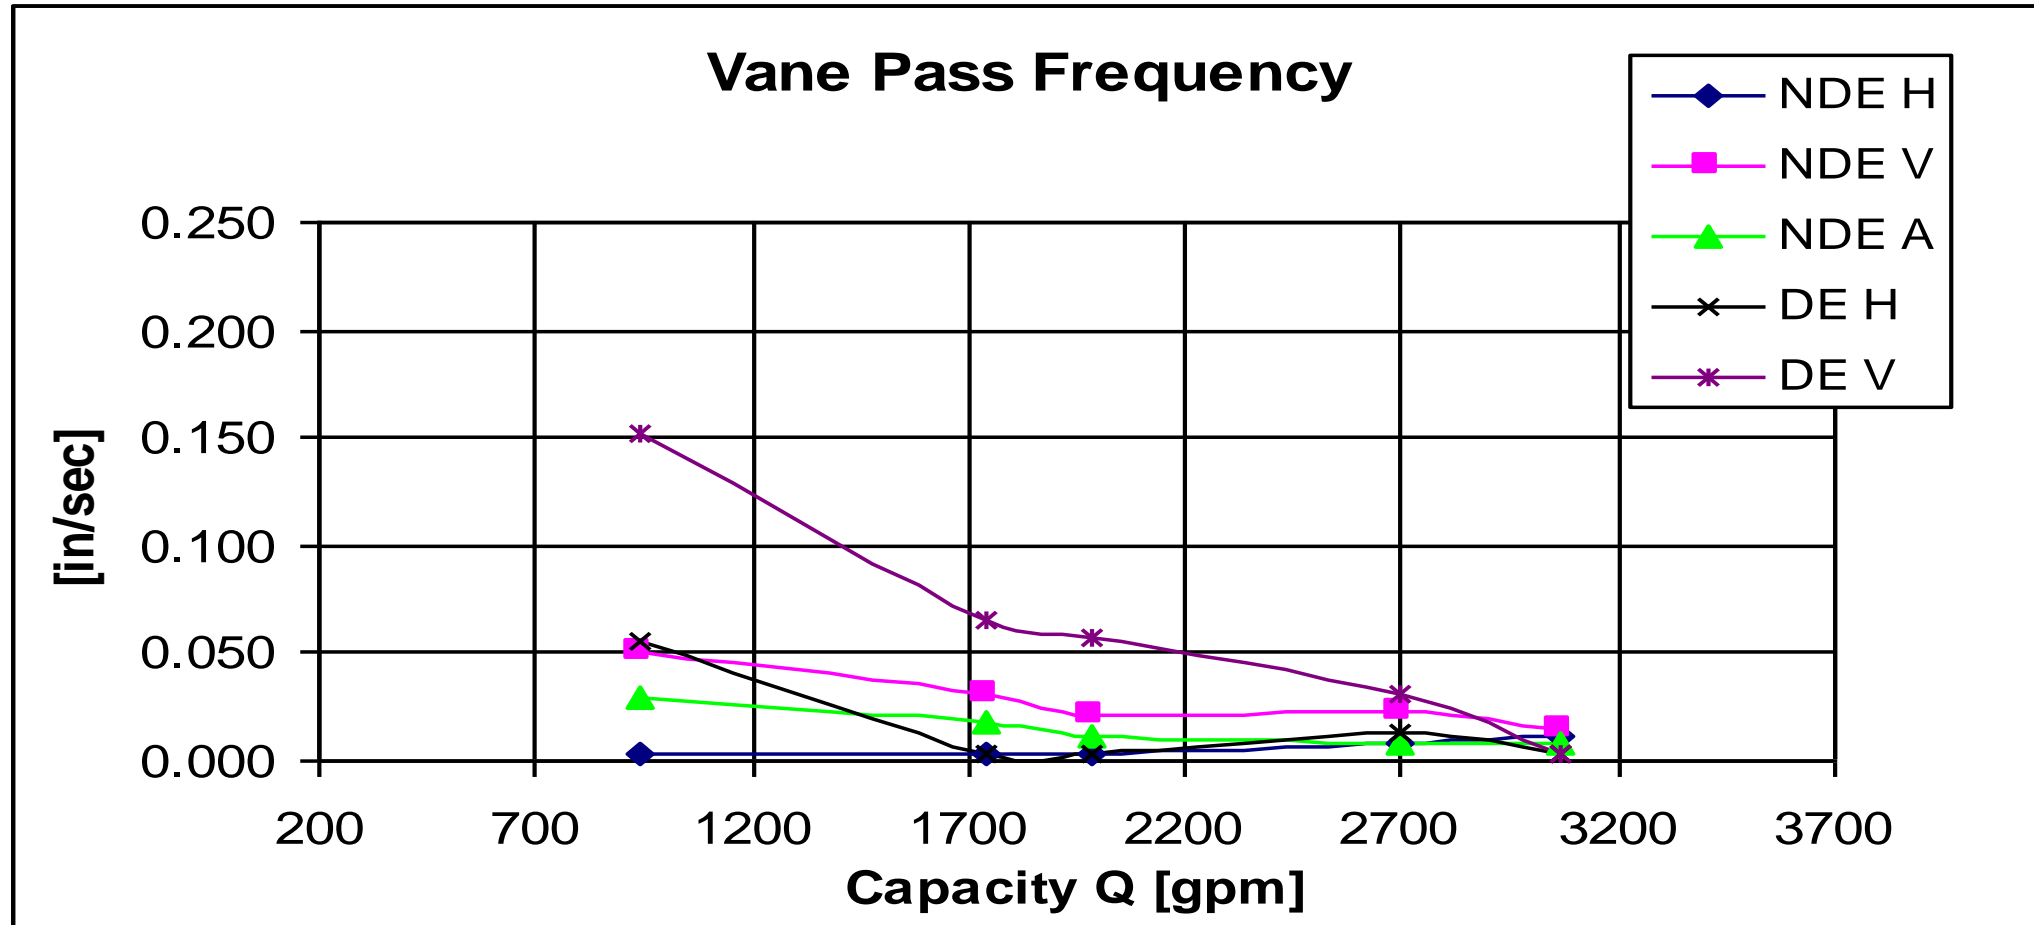
Original impeller

Shop test vibration spectra

Velocity PK In/Sec

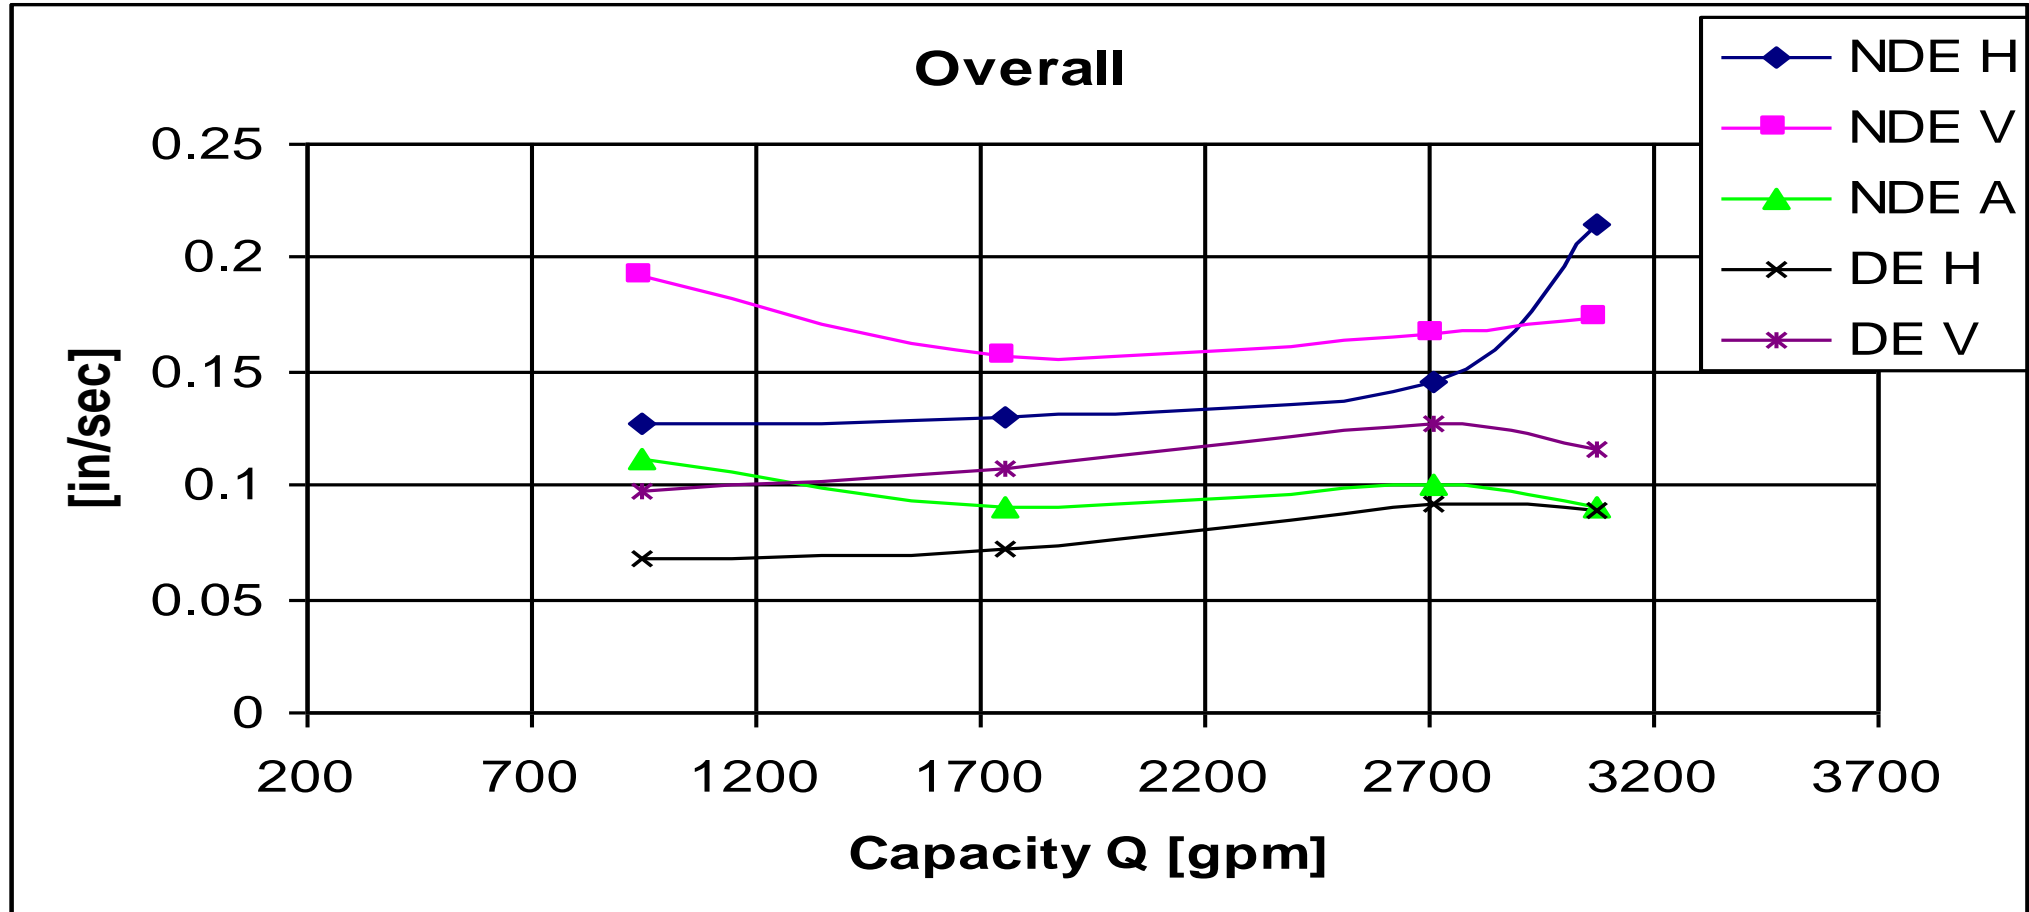
Modified pump (Mass added)

Shop test vibration results

Velocity PK In/Sec

- a) High vane pass frequency
- b) Increasing with flow reduction: Flow dependent
- c) Bearing housing responding to vane pass
- d) Added mass not effective

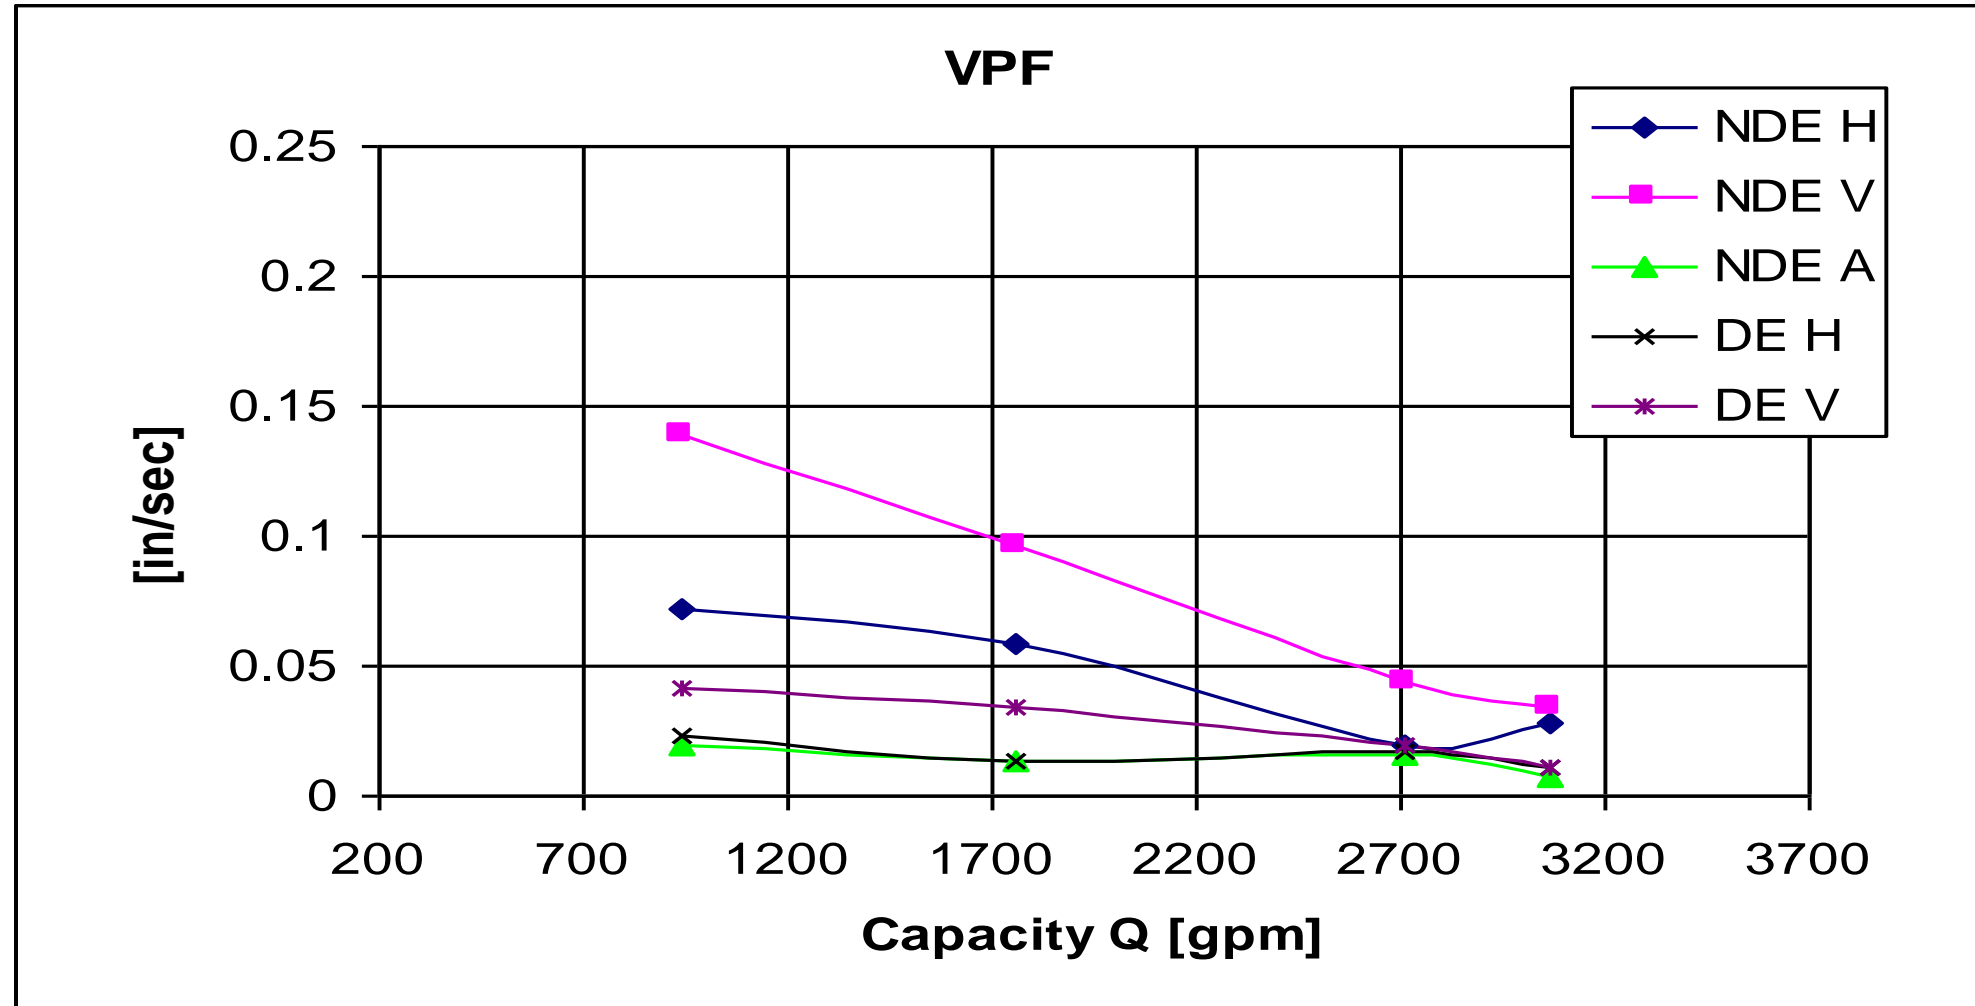
Modified pump (Mass added)

Shop test vibration results

Velocity PK In/Sec

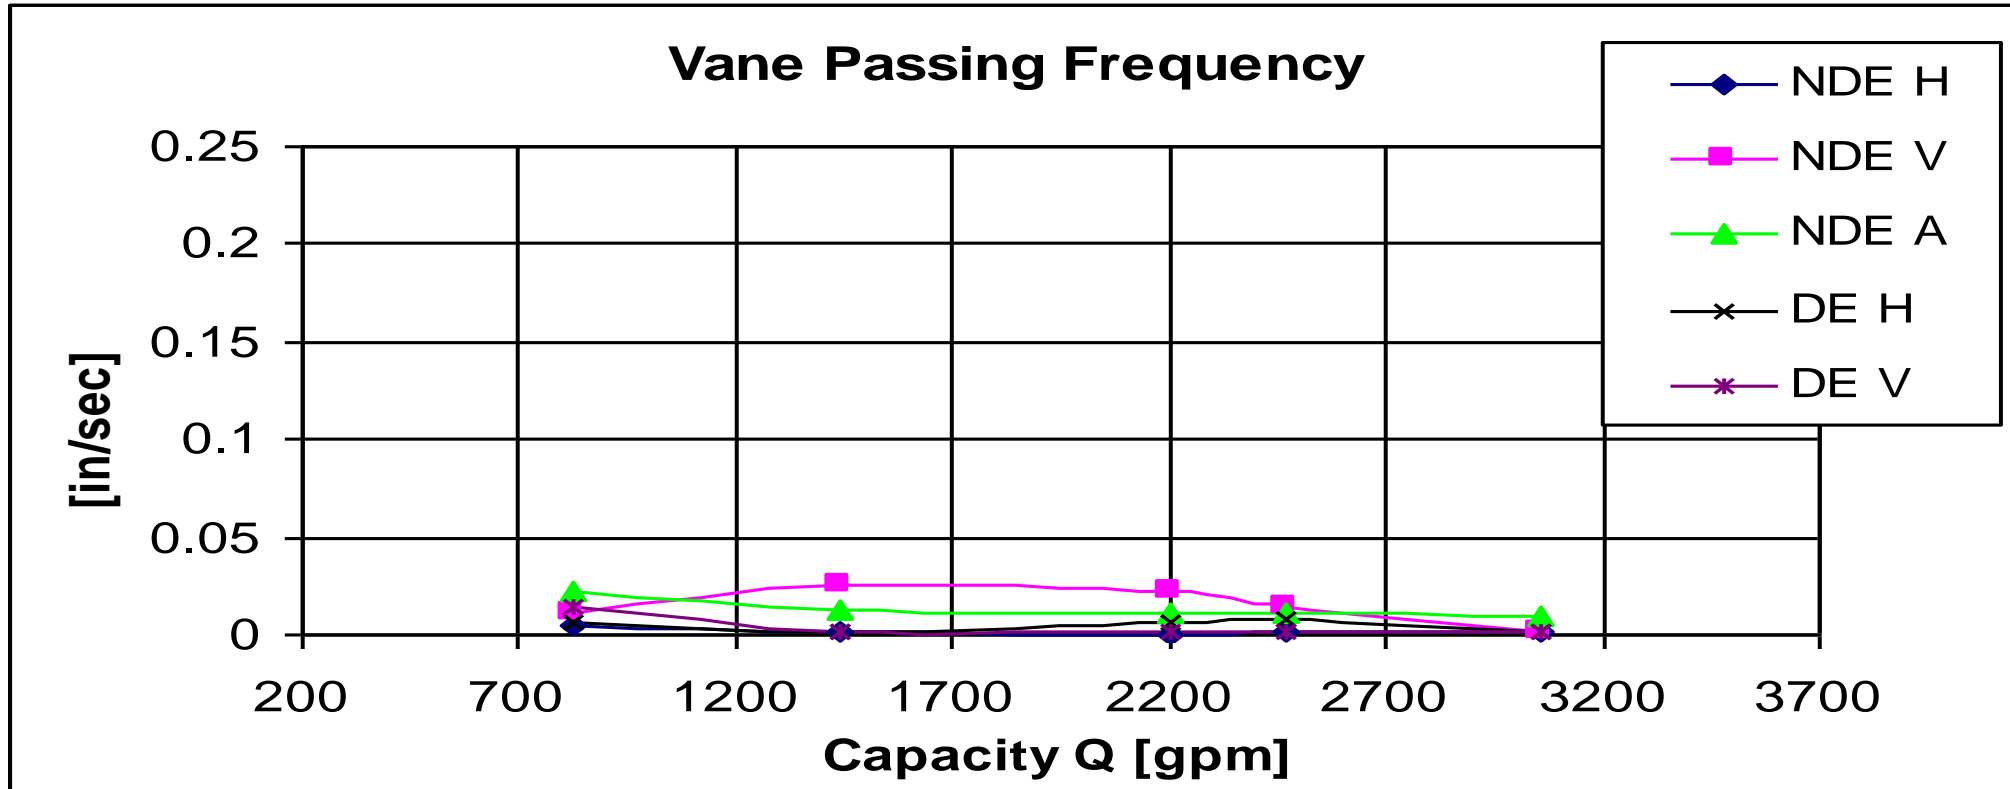
New Impeller Design

Shop test vibration results

Key remark : All Vibration components at VPF drastically reduced below 0.03 IPS even with SG = 1.0

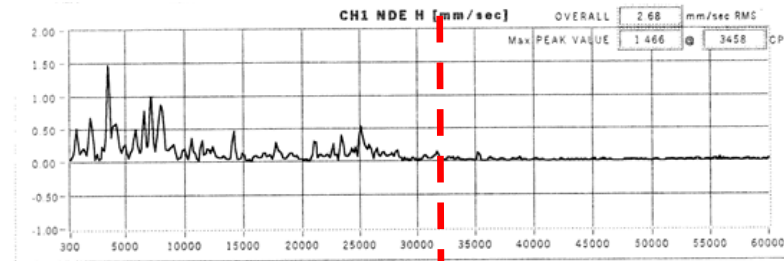
New Impeller Design

Shop test vibration spectra at 2690 GPM
87% of Q_{bep}-design (PK Velocity In/Sec)

N=3565rpm SG=1.0

32,085cpm = VPF (9x)

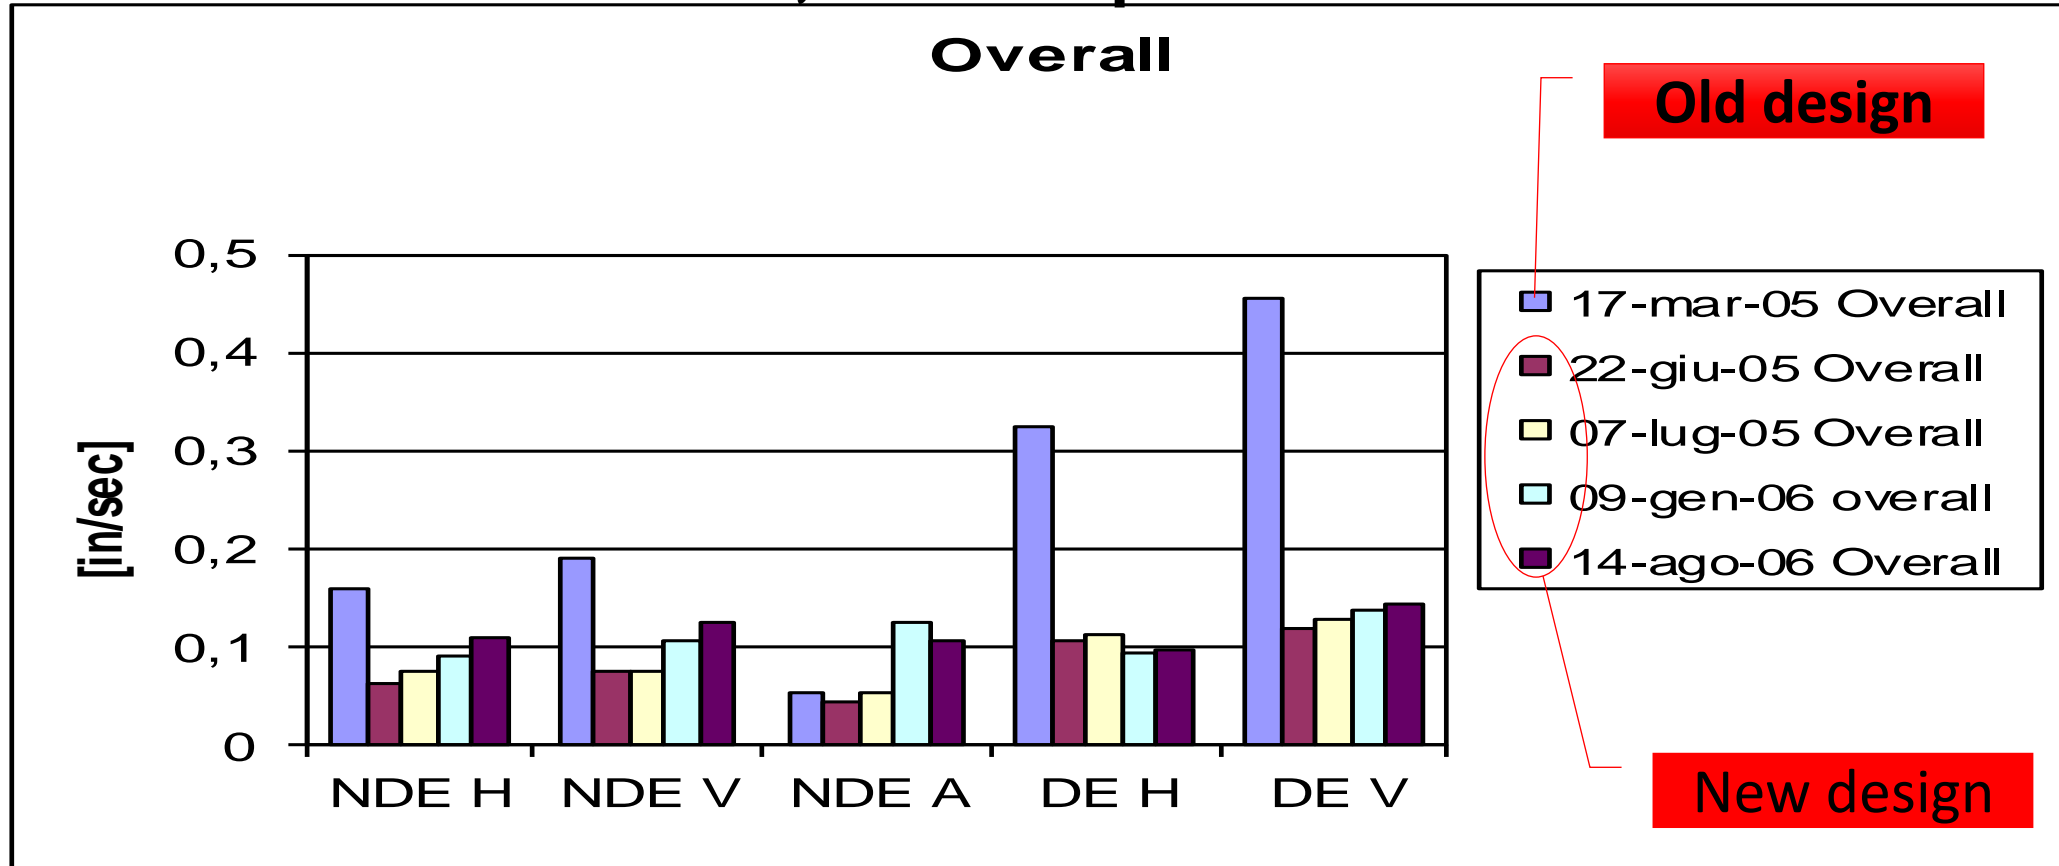
New Impeller - Vibration reading

Site results (Velocity PK In/Sec)

CASE 2, N=3565rpm SG=0.56

**Key remark : Original impeller design : Mar 2005 ,
New impeller design : Jun 2005 – Aug 2006**

Field data show further vibrations reduction with full satisfaction of the customer

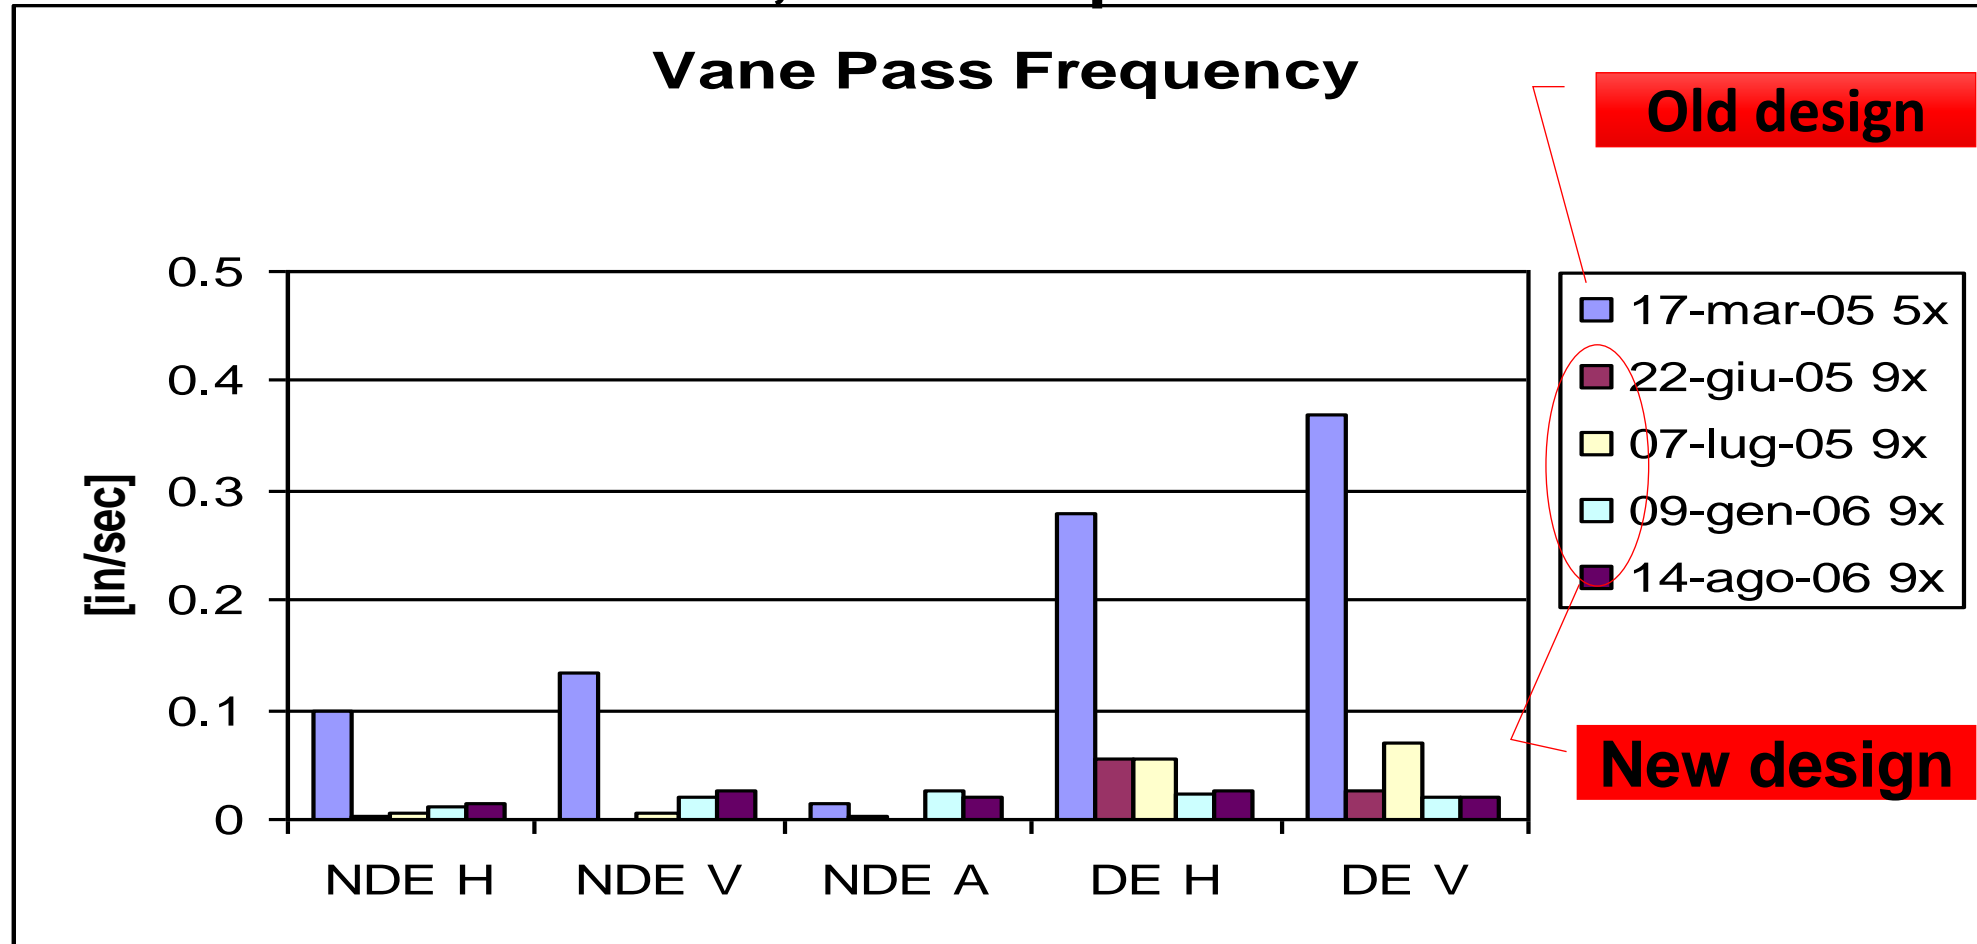
New Impeller - Vibration reading

Site results (Velocity PK In/Sec)

CASE 2, N=3565rpm SG=0.56

**Key remark : Original impeller design : Mar 2005,
New impeller design : Jun 2005 - Aug 2006**
