## **LONGEVITY OF DUCT TAPE IN RESIDENTIAL AIR DISTRIBUTION SYSTEMS: 1-D, 2-D, AND 3-D JOINTS**

BASS ABUSHAKRA  
ASSISTANT PROFESSOR  
MILWAUKEE SCHOOL OF ENGINEERING  
MILWAUKEE, WISCONSIN

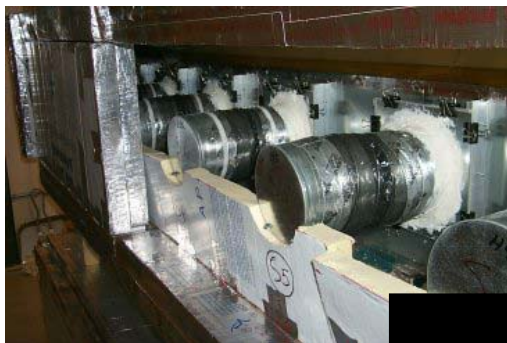
**Figure 1. One Chamber of the High Temperature Aging Test Apparatus**

Figure 1 shows samples mounted on the aging test apparatus. Heated air is continuously circulated through the test apparatus to both heat and pressurize the leakage sites. The apparatus is divided into an upper and lower chamber that each contains nine

samples. The inside of the test samples are exposed to high pressure heated air and the outside (shown in Figure 1) is in an insulated chamber that also becomes heated during the experiments by conduction through the test samples. This means that there is little temperature gradient across the samples. The hot air temperature is controlled using electric resistance heaters mounted directly in the air stream. The surface temperatures of each sample, the air temperature and the pressure across the leaks are

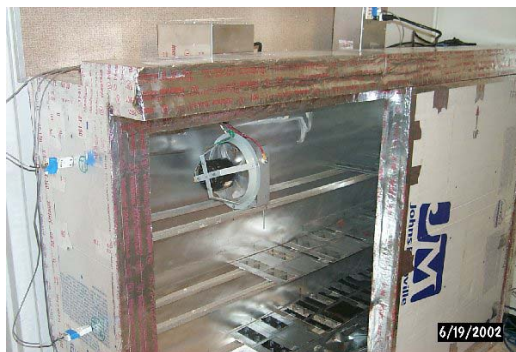
**Figure 3. The High Temperature Baking Apparatus**

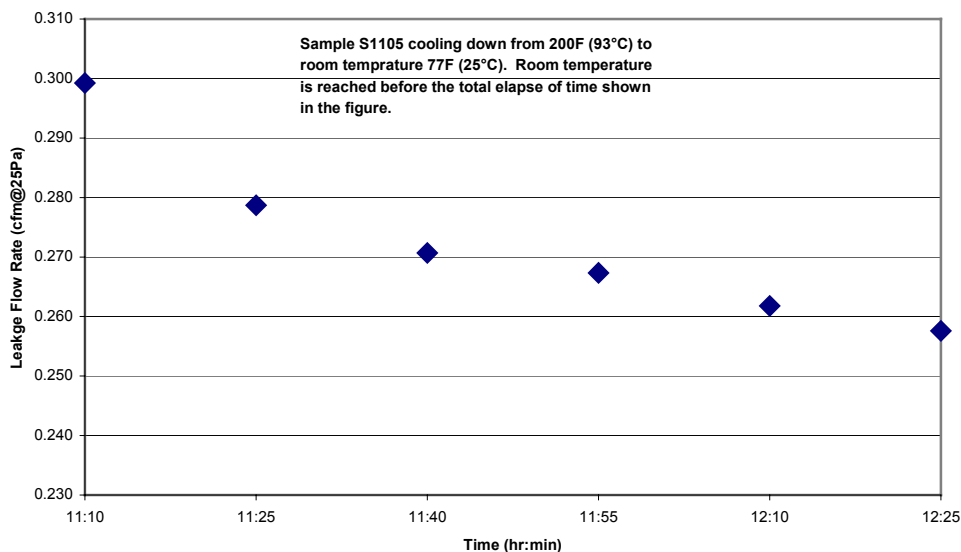
**Figure 4. Decay in the Measured Leakage as the Specimen Cools Down From 200F (93°C) to Room Temperature**

Because the aging test involves heating the specimens continuously at 200°F (93°C), it takes some time for the specimens to return to room temperature. Therefore the elapsed time between removal from the test chamber and measurement of leakage could have an effect on the results. To examine this effect, a specimen was tested six times at 15-minute intervals, with the first measurement taken at its highest temperature (200°F (93°C)). The experiment took place in the laboratory where room temperature is 77°F (25°C). Figure 4 shows the decay in the leakage flow as a function of cool-off time. The leakage flow at the highest temperature is 16% higher than the last value taken 1 hour and 15 minutes later. The difference in leakage is attributed to the “re-sealing” of the joint as it shrinks and hardens at lower temperatures. For consistent results the samples need to cool to room temperature before being leakage tested.

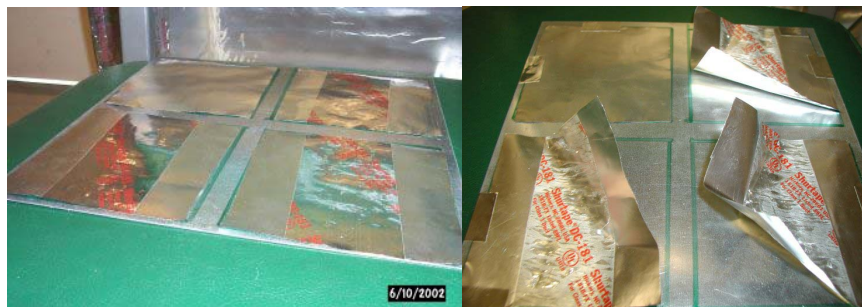
**Figure 7. A Baking Specimen Following the UL 181B Temperature Test Protocol Consisting of Three Samples of Tape (Tape 3) and One Control Sample of the Substrate (Aluminum Foil) Before Testing and After Four Weeks of Testing**

For each duct tape (Tape 1, Tape 2, Tape 3, and Tape 4), twelve specimens were made by applying a strip of tape to three 4 by 4 inch (100 by 100 mm) samples of each of the following materials: aluminum foil, polyethylene, polyethylene terephthalate (PET), and sheet metal (steel). Another 4 by 4 inch (100 by 100 mm) control sample of each of the substrate materials is included in the specimen without applying the tape to it. The control sample serves as a means to quantify the deterioration attributed to the substrate in isolation from the duct tape. A specimen set in the baking test, therefore consists of three similar samples and one control sample, all carried by a sheet metal tray in the oven (Figure 7). Since the

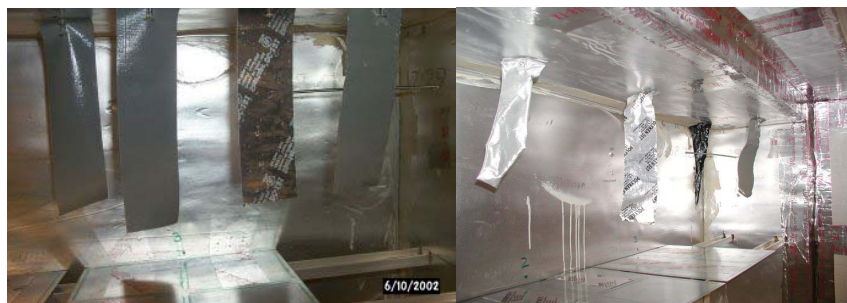
**Figure 8. Hanging Specimens of Tapes 1 to 4 in the High Temperature Baking Apparatus Before Testing and After Three Weeks of Testing**

Visual inspection of the baking specimens showed gradual deterioration in the specimens over the 60 days period of the test (as required by the UL standard), whereas specimens of the duct tape tested which were hung in the oven without being applied to any substrate showed considerable deterioration after only two weeks of baking. After the first week of baking, the specimens showed the following: (1) No significant deterioration among all specimens, (2) No noticeable shrinkage of the tape on the sheet metal substrates, (3) The Aluminum Foil and PET specimens tended to roll (curl), (4) The hanging specimens tended to "curl" as well, and (5) The Polyethylene specimens did not show any rolling; their surface in fact became "rougher" (the polyurethane used is a "woven film").

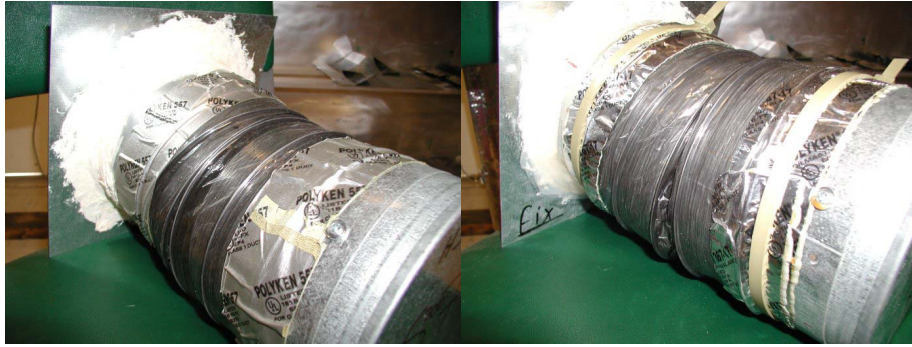
**Figure 9. (Left) Shrinkage and Delamination Among the Unclamped Specimens (Showing Here Result of 5 Months of Aging), and (Right) Oozing of the Adhesive Layer in the Foil-Butyl Tape (Tape 4) Specimens (Showing Result of 5 Months of Aging)**

- shrinkage and delamination among the unclamped specimens (Figure 9, Left)
- oozing of the adhesive layer in the foil-butyl tape (Tape 4) specimens (Figure 9, Right)
- little shrinkage and delamination in the strapped specimens
- discoloration of the plastic strapping in the clamped specimens

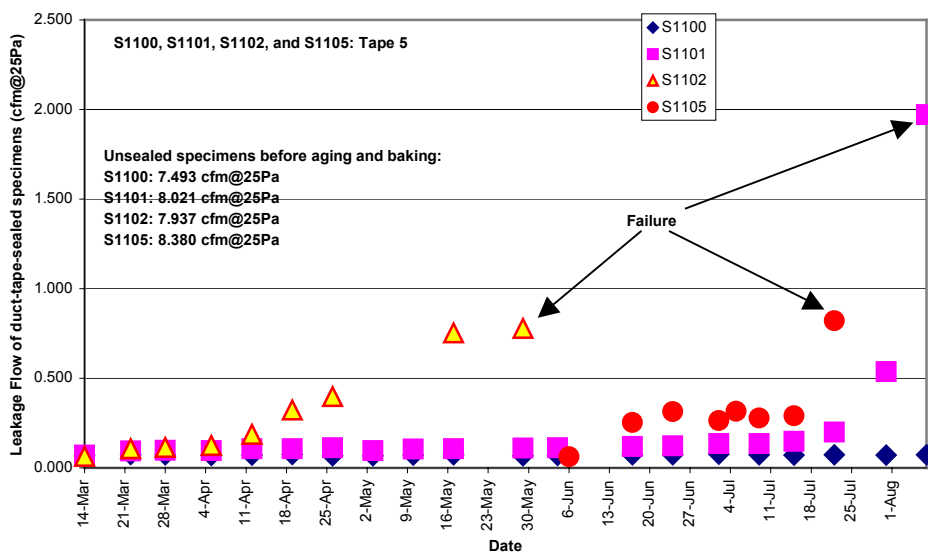
Figure 11. The Measured Leakage of the Collar-To-Plenum Joint Tape-5 Specimens

In addition to the aging tests of the flexible duct, core-to-collar joints, we also repeated the tests of the collar-to-plenum joints aging tests that were conducted in previous studies. These tests were performed for a new duct tape product that has been developed to have an improved high temperature performance (Tape 5), as well a sample of Tape 1 (described earlier). The new tape failed in 9 days (using the >10% of unsealed leakage criteria), showing shrinkage and pulling away from the sheet metal plenum. Figures 11 and 12 show the results of these tests. Because they were mounted in a different location on the test apparatus, these collar-to-plenum were exposed to different temperatures than the core to collar samples. These samples were placed between the left and right chambers (shown in Figure 2) where in previous phases of longevity testing the samples experienced cycling temperatures. Table 4 shows the temperatures the specimens were exposed to during the test, and the corresponding elapsed time before failure. Specimen S1102 failed after 2.5 months, and was replaced with specimen S1105. Specimen S1105 appeared to leak at a faster rate at the beginning, then leveled off, then showed a catastrophic (sudden) failure, contrary to the gradual

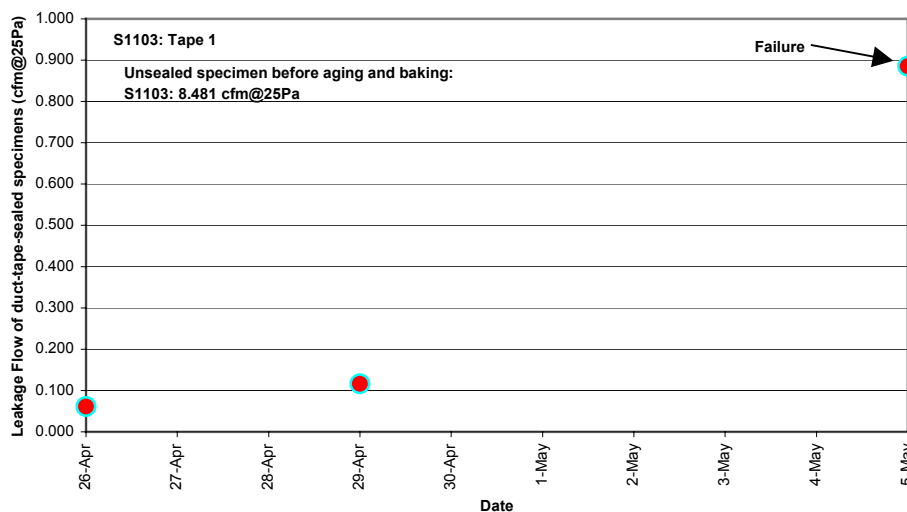
Figure 12. The Measured Leakage of the Collar-to-Plenum Joint Tape-1 Specimen

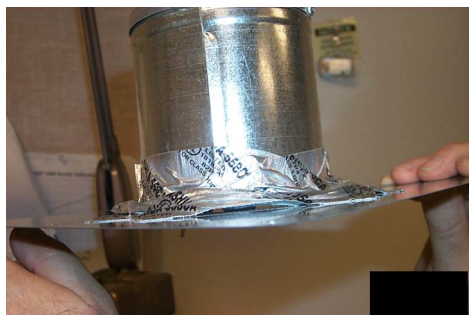
**Figure 13. A Typical Failure of the 3-D Collar-To-Plenum Joint**

failure of S1002. It took specimen S1105 only one month and three weeks to fail. Figure 13 shows the failure of the 3-D joint as the duct tape tends to pull away from the sheet metal, thus uncovering the series of overlapping fin-joints.
