Documentation and Conditions Assessment of Banks' Battery, St. Helena (CHC-2020-01-03)

**Report prepared for the British Napoleonic Bicentenary
Trust and St. Helena Government**

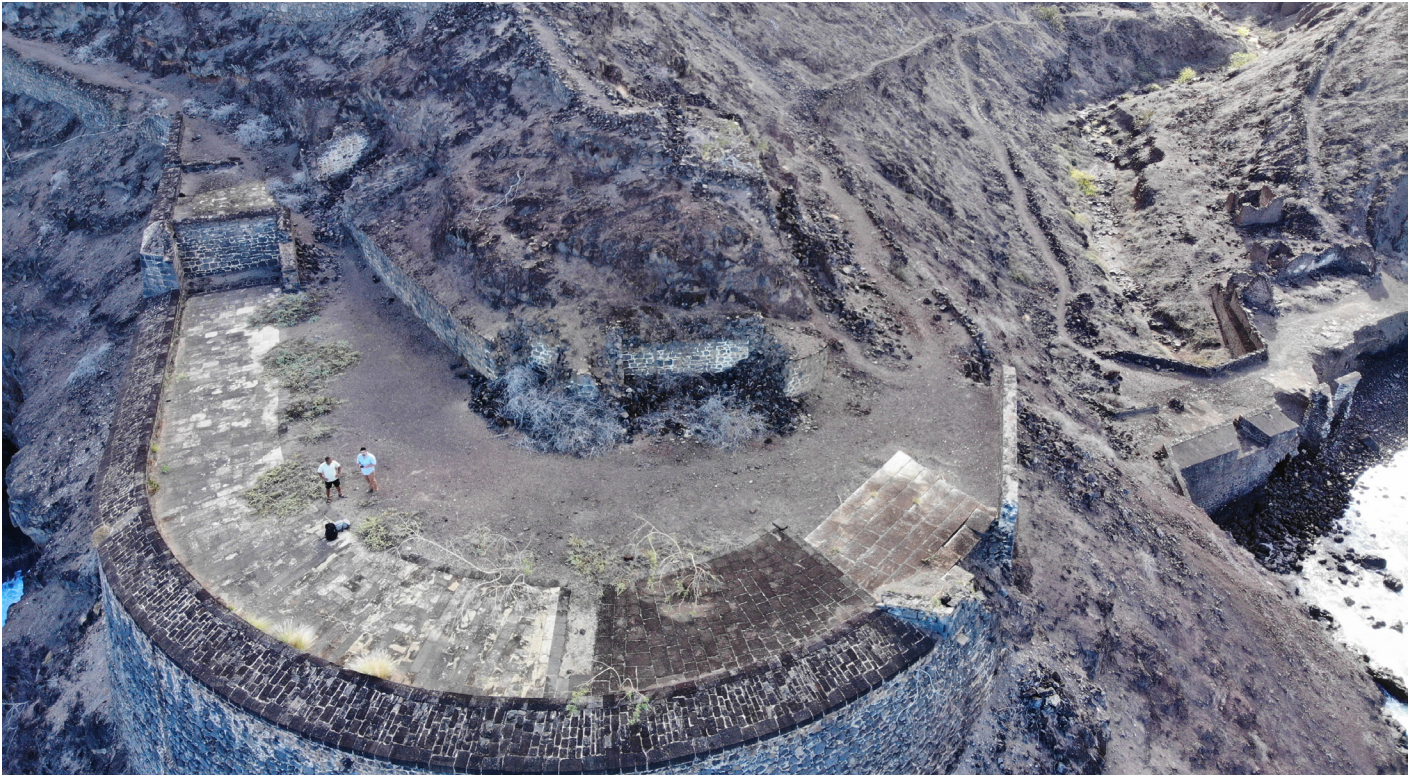
The ruined buildings are in various states of decay, however they all are constructed of worked local stone bonded by lime-based mortars. In some cases, repairs have been made with cementitious mortars. Of note is that some interior plaster survives at the officers' barracks.

Figure 46: Oblique aerial view of ruined structures at Upper Banks' (Image: B. Fortenberry).

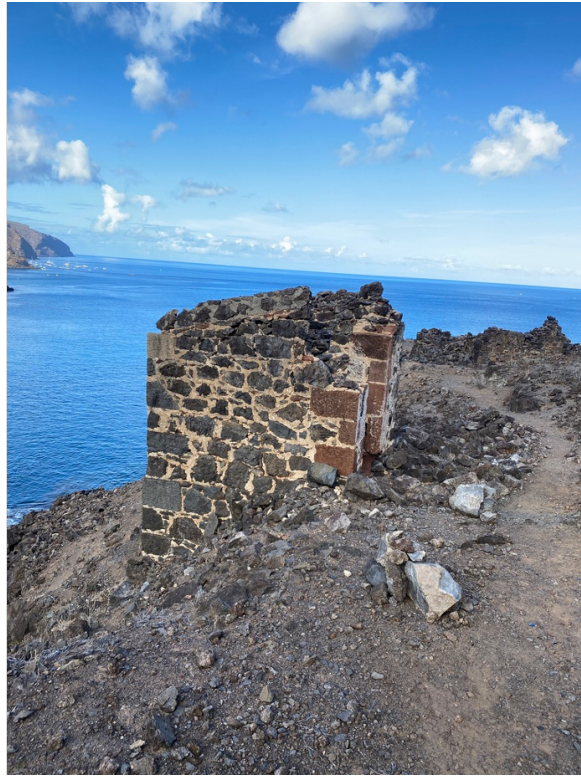
Figure 56: Privy remains at Upper Banks' Battery (Image: B. Fortenberry).

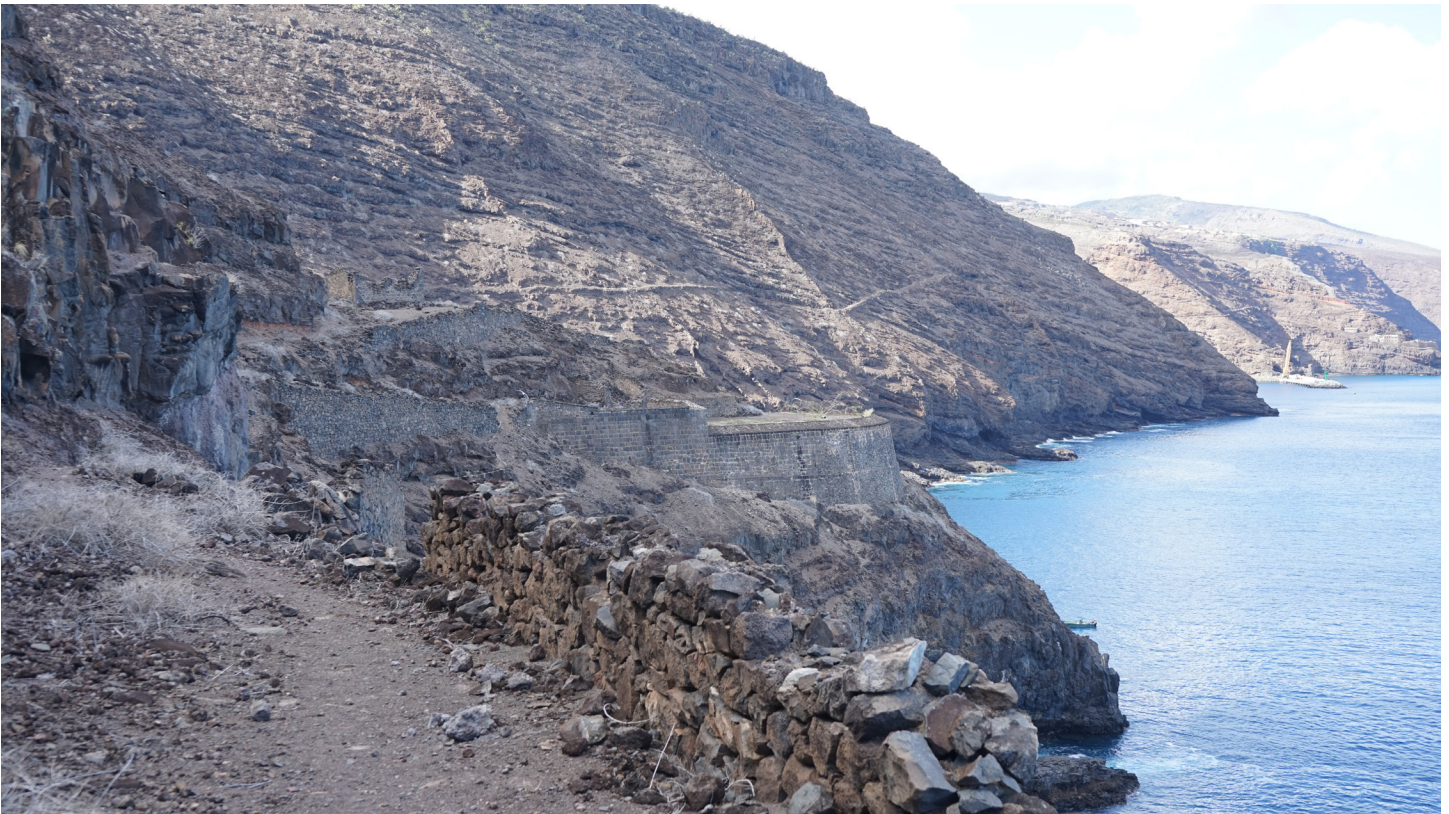
Figure 63: Upper Banks' Half Moon Battery from the north (Image: B. Fortenberry).

4. Immediate action should be taken to segregate this area from the public areas of the site. There are no barriers, permitting individuals potential access to hazardous areas in and around the collapse of the Half Moon Battery wall. The area needs to be marked using health and safety guidelines.

1. **IMMEDIATE:** Isolate the collapsed wall elements at Upper and Lower Banks from the public, these areas are dangerous and could cause health and safety issues on the sites.
2. **SHORT TERM:** Consult an architectural engineer for wall rehabilitation of the structural collapse on the Curtain Wall and the Half Moon Battery
3. **MEDIUM TERM:** Conserve the ruins in place with minimal wall reconstruction.
